12 June 2005

Report: Electromagnetic Field Mitigation in Childcare Centre at 481 Canning Street, North Carlton.

Client: Noel Arnold & Associates Pty. Ltd.

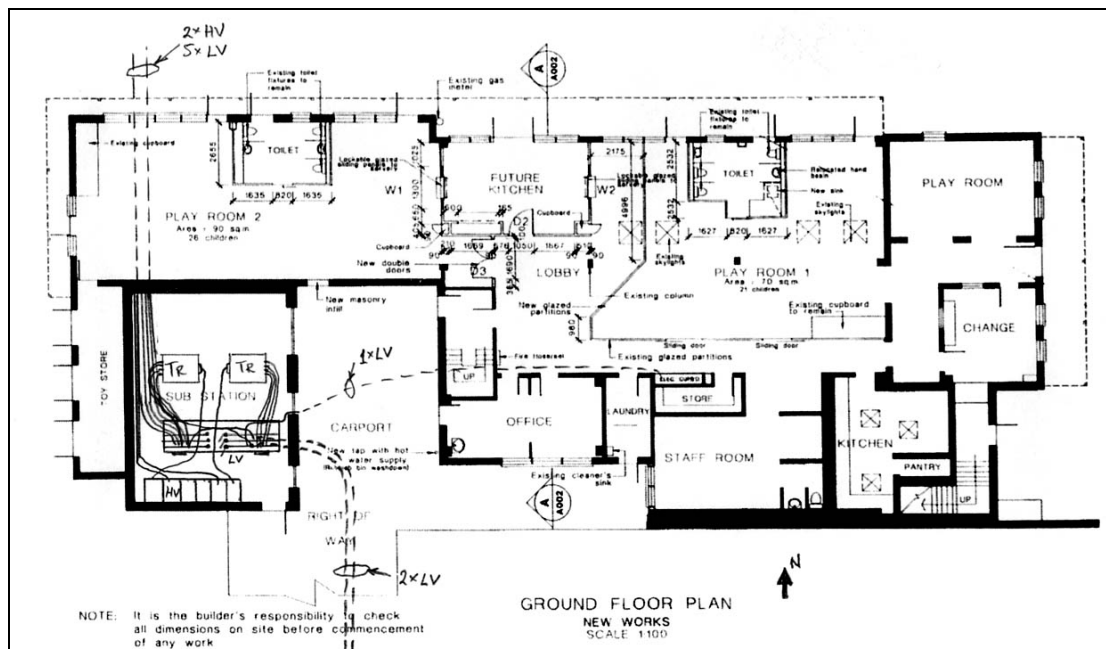
Fig.1 Ground Floor Plan of Childcare Centre (Substation Room is in the bottom left corner).

The substation room is located within the land allocated for the Childcare Centre such that along its northern wall it is adjoining the Play Room 2 (currently known as the “3-5 years old Program Room”), the Toy Store is located across its western wall and the Carport is across its eastern wall (see the Ground Floor Plan of the Childcare Centre in Fig.1 below).

- The substation contained two 1000kVA, 11kV/415V oil-filled transformers located approximately 2.5m away from the northern wall, one low voltage (LV) switchboard located approximately 5.5m from the northern wall and the high voltage (HV) switchgear located along the south wall of the substation room (for details see Fig.1).

It should also be noted that the LV cable that feeds the Childcare Centre is installed in the ceiling space adjacent to the Office, the Lobby and the Staff Room (see Fig.1). It is also located close to occupied areas on the 1st floor of the Centre. This cable, due to high residual current, causes strong EMF along its path.
