APPENDIX 3

Appraisal Data

The research data presented below features information from community appraisal of disability access at railway stations in the City of Yarra. Records about each station are presented in individual tables with description of the current level of compliance, suggested improvements and other commentaries and images, which are referenced against the eight accessibility categories (TGSi, shelter at WAP, ramp gradient, ramp width, WAP, handrails, signs, accessible parking bays) and against potential hazards. In some instances an additional row is added as 'other improvements', when more opportunities for better accessibility, beyond the listed categories, has been observed. For terminology and abbreviations please refer to *Section 2 Key Findings* and to *Appendix 2 Glossary* in the main report (pp. 6 and 16).

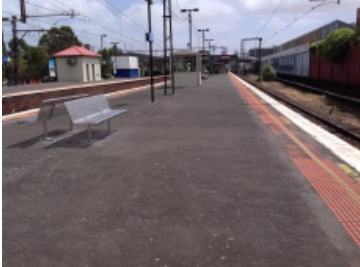
TABLE 1. BURNLEY STATION APPRAISAL RECORD			
Category	Compliant	Needs Improvement	Image/Commentary
TGSi	TGSi platform edge 4/4 TGSi entrance 4/4 TGSi Ramps 2/3	<ul style="list-style-type: none"> • Large parts of TGSi are worn out and present trip hazard. • Damaged TGSi needs replacing. • Madden Grove top of ramp TGSi is worn out and needs replacing. • Tunnel from Madden Grove towards Swan Street does not have directional TGSi for pathway finding. 	<p>Evidence of damaged TGSi on platform.</p>

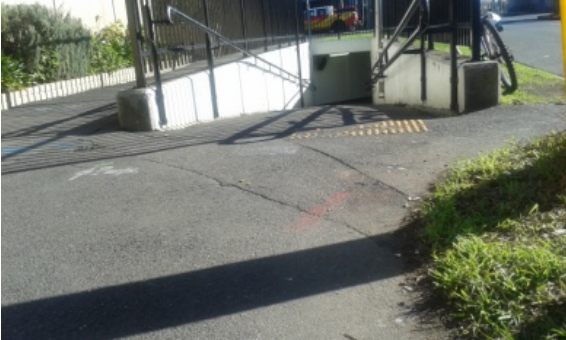
TABLE 1. BURNLEY STATION APPRAISAL RECORD			
Category	Compliant	Needs Improvement	Image/Commentary
			<p>Madden Grove exit ramp shows TGSi worn out.</p>

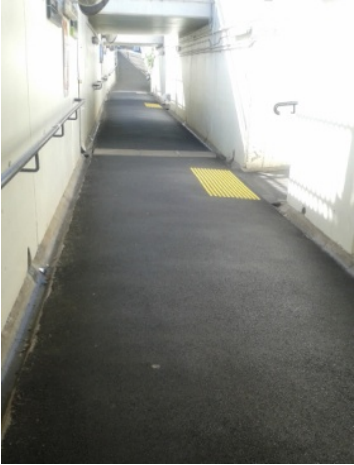
<p>No directional TGSi in tunnel from Madden Grove heading towards Swan Street.</p>

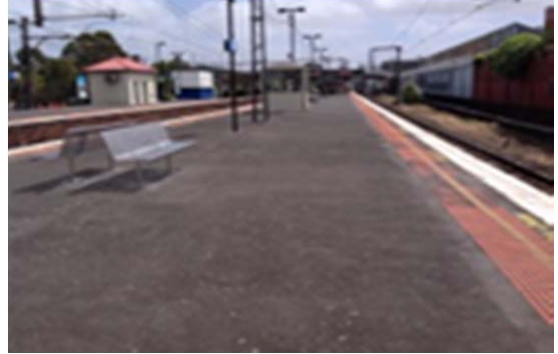
TABLE 1. BURNLEY STATION APPRAISAL RECORD			
Category	Compliant	Needs Improvement	Image/Commentary
Shelter at WAP	Shelter at WAP available 1/3 Shelter on P3 &4 has a combined platform and shelter	<ul style="list-style-type: none"> Platform P1 and P2 require shelter.

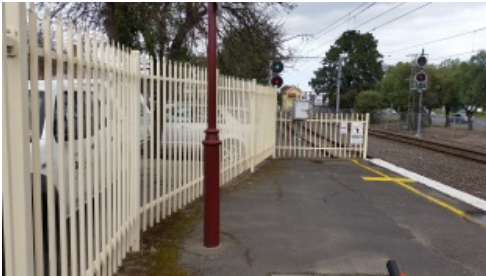
Ramp Width	Ramp width compliant 4/4		
WAP	WAP 1/2 P 2 = 5.5m	<ul style="list-style-type: none"> • P 1 = 2.8m • P1 can be easily widened. 	<p>This photo shows the narrowing of Platform 1 at the wheelchair access point for boarding the train. This point can be widened by pushing fence back, and thus meeting compliancy (which is 3145mm as per VRIOGS002.1</p>

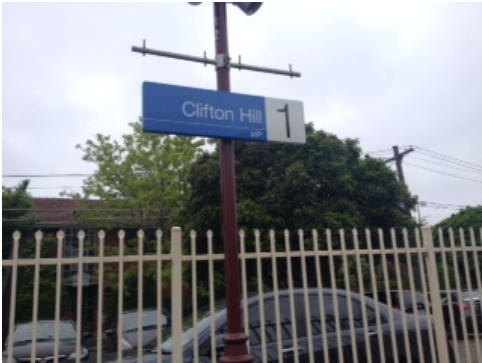
Handrails	Handrails 4/4 on the ramps Rails present on south side of tunnel 1/2	<ul style="list-style-type: none"> Handrail missing on north side of tunnel underpass and needs to be installed (1/2) 	
Signs	WAP signs compliant 2/2 on platform, P1 & P2 WAP at entrance compliant 2/2	<ul style="list-style-type: none"> Sign -Larger print on the Station name 	The Printed name on sign could be larger and bold writing.

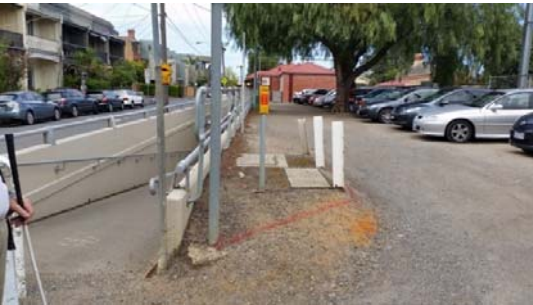
<p>Below is PTV land where some more accessible parking bays could be installed.</p>

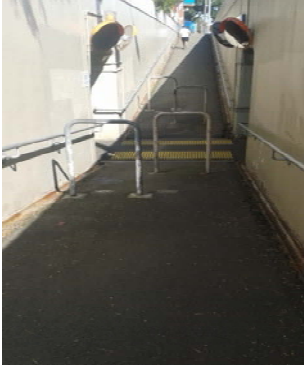
Hazard		<ul style="list-style-type: none"> Footpath Bollards/Barrier hoops. These bollards do not allow enough room for scooters, double prams and some wheelchairs. There is a space of 92 cm in 	<p>Footpath Bollards can be an obstacle for people with vision loss; and they are difficult to navigate around for people with twin prams, wheelchairs and scooters.</p>

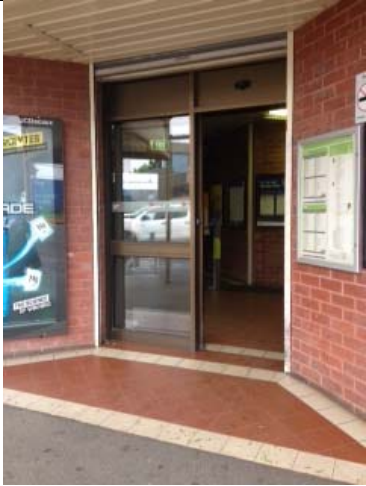
Other Improvements		<ul style="list-style-type: none"> • Widen P1 glass door at entrance. • The double entrance to platform 1 has a fixed glass door and an automatic opening door that slides. It would be strongly recommended to change the door for both sides to open making it accessible for wheelchairs, scooters and double prams. 	<p>Picture Clifton Hill P1 main entrance door which only half opens. Access through both doors would be advisable. The doorway measures at roughly 82 cm - far too narrow.</p>

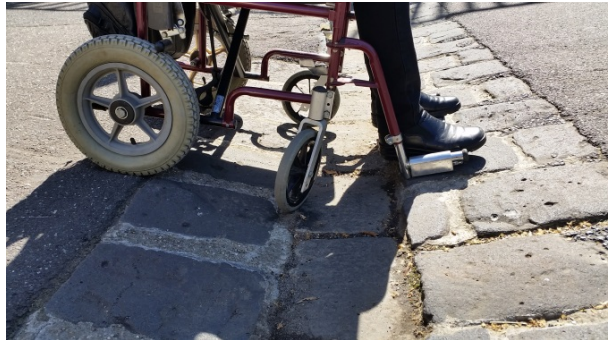
Hazard		<ul style="list-style-type: none"> Pedestrian crossover access is too steep. This needs to be recommended for Yarra City Council to fix. 	<p>This is a photo of a person using an electric wheelchair getting stuck on footpath crossover due to steepness of crossover. The front footplates are scraping the ground and could cause a wheelchair to topple over. This footpath crossover requires YCC to eliminate danger and modify crossover.</p>

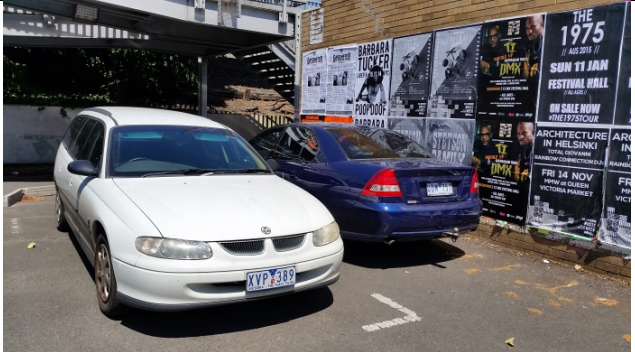
TABLE 3. COLLINGWOOD STATION APPRAISAL RECORD			
Category	Compliant	Needs Improvement	Image/Commentary
Other Improvements: No 1		<ul style="list-style-type: none"> Car parked blocking pedestrian access - install bollards. The Blue sedan is parked in a pedestrian walkway. This path leads to the Collingwood Library. This occurs extremely often. These car parking bays belong to PTV.

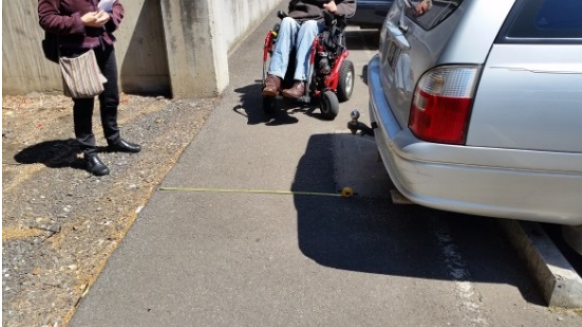
Other Improvements: No 2		<ul style="list-style-type: none"> Towbar obstructs pedestrian footpath. This footpath access's Gipps Street and Stanton Street to Collingwood Library, Collingwood Railway Station and Collingwood Town Hall. It is used by many. Blocked footpath provides only 110 cm pass for pedestrians. Move cement blocks further away from the footpath. 	<p>These cars are parked on PTV land, the cement rectangular blocks guide cars on how far they can park. The cement blocks are too far back and cars overhang onto footpath. It is an extra hazard if cars have a towbar.</p>

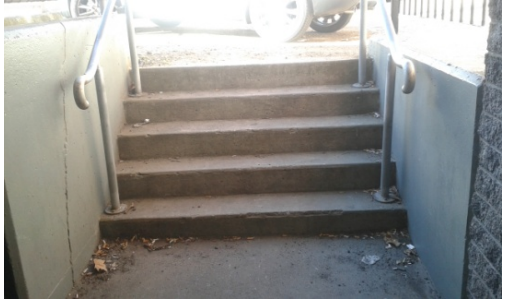
TABLE 4. EAST RICHMOND STATION APPRAISAL RECORD			
Category	Compliant	Needs Improvement	Image/Commentary
TGSI	TGSI Platform edge 2/2 TGSI at Entrance 2/2 TGSI Ramps 2/2 TGSI Stairs 0/2	<ul style="list-style-type: none"> Both Platform 1 and 2 have stairs requiring TGSI. 	<p>P1 missing TGSI on top and bottom of Stairs.</p>

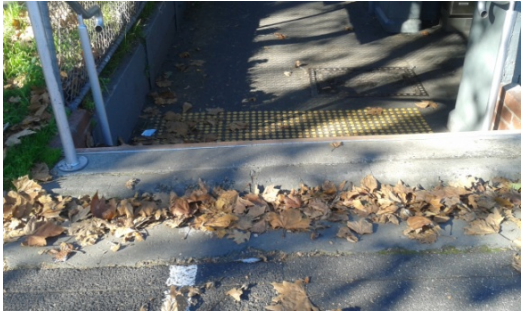
<p>P2 missing TGSI at top of stairs. There is also a step up from the gutter which is a hazard. Flat entry to steps is advisable.</p>

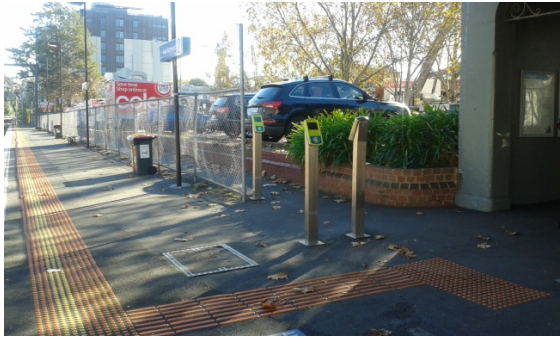
<p>This is a flat entrance to East Richmond Platform 2 that is currently not being used but with some modifications could be an excellent wheelchair accessible entry. The pathway leads to a car park.</p>

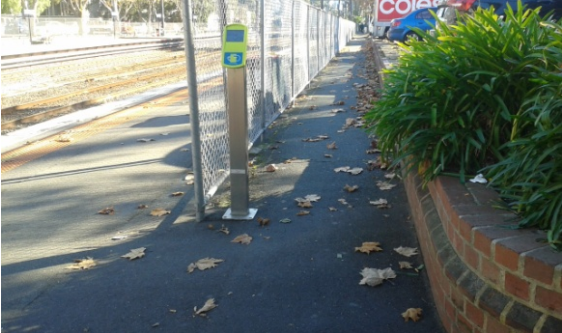
TABLE 4. EAST RICHMOND STATION APPRAISAL RECORD			
Category	Compliant	Needs Improvement	Image/Commentary
			<p>The ticket scanner could be moved over for clearer access. Path width is 1400 mm (there are possible room for pathway to be widened).</p>

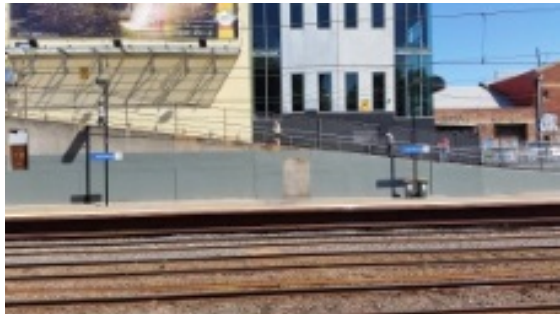
Signs	<p>WAP sign Platform edge 0/2</p> <p>WAP sign Entrance 2/2</p>	<ul style="list-style-type: none"> WAP sign on edge of Platform 2 to be installed. Sign - larger station name sign. 	<p>Train station name sign could be larger text size and illuminated for night time visibility.</p>

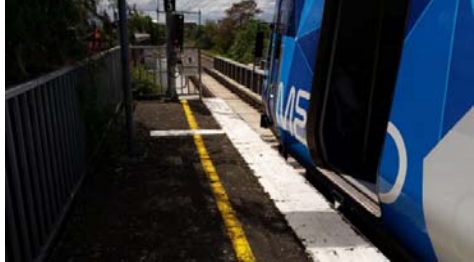
Ramp Width	Compliant 4/4 P1 = 2.2 P2 = 2.2		
WAP	Compliant 0/2	<ul style="list-style-type: none"> • Non-compliant 2/2 P1 = 1.9m P2 = 2.2m • P1 is dangerous and most people in wheelchairs would avoid this at all costs. Once the portable ramp is put in place by driver there is just over 1 metre to get off train, navigate a wheelchair and make a left turn in wheelchair to head to exit gate. 	<p>Photo shows extremely narrow WAP boarding point (3 metres is the minimum WAP recommendation.) Dangerous for people requiring wheelchair access. Also limited room for blind people to navigate safely.</p>

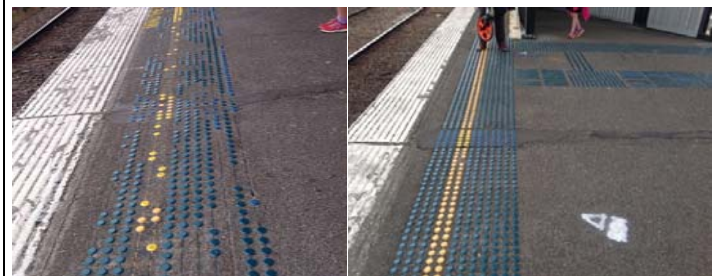
TABLE 6. RICHMOND STATION APPRAISAL RECORD			
Category	Compliant	Needs Improvement	Image/Commentary
TGSI	TGSI 10/10 TGSI on Platform 10/10 TGSI on entrance 10/10 TGSI on Ramps 10/10 TGSI on Stairs 10/10 External Ramps Swan street and Punt Road entrance. Sports Subway Sports Subway entrance Olympic boulevard to Brunton Ave Swan to Stewart Stewart Street entrance Main Customer service entry point at east end of Station from Swan St ramp and stairs. Richmond middle corridor from stairs to platform.	<ul style="list-style-type: none"> TGSI Blue low contrast, replace with high contrast TGSI. Replace (they are wearing out) TGSIs (i.e. on ramp, platform, etc.). Requires TGSI at entrances, ramps internal and external steps. Swan Street stairs have TGSI on top but <u>not</u> bottom of stairs. Swan Street Ramp - TGSI at top but not bottom of ramp. Richmond Sports Subway entrance of Railway Station does not have TGSI at northern entrance near ticket validation machine nor directional TGSI heading to platforms. Install TGSI directional way finder TGSI at Punt Road end of Sports subway. Stewart Street stairs. Replace TGSI at top and bottom of stairs. Choose a better colour for high colour contrast. Stewart Street ramp. Replace worn out TGSI with 	At Richmond train station, there are many points where the TGSI are worn out making it difficult to see or feel. Replace with high colour contrast TGSI. The blue TGSI is not considered a high colour contrast. It is not easily seen by those with low vision. High colour contrast is best. Other TGSI colours used by PTV are orange, yellow and terracotta. When replacing TGSI in future use a higher colour contrast TGSI.

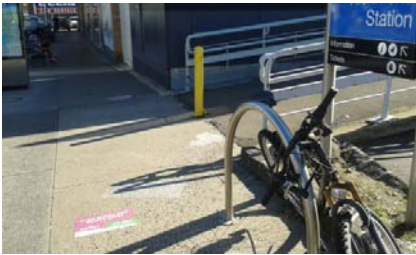
<p>Swan street ramp does not have TGSi at bottom of ramp.</p>

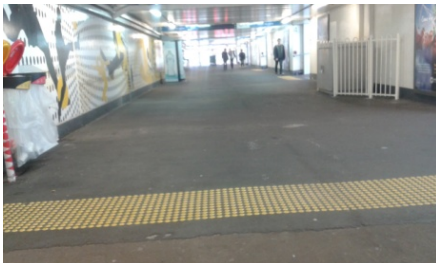
<p>Richmond Sports Subway does not have TGSi at northern entry point/Ticket validation machine. Directional Way finder TGSi to platform entrance is also missing.</p>

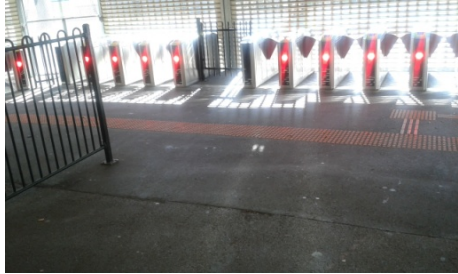
TABLE 6. RICHMOND STATION APPRAISAL RECORD			
Category	Compliant	Needs Improvement	Image/Commentary
			<p>Lack of TGSI directional way finder from Sports Subway Swan street.</p>

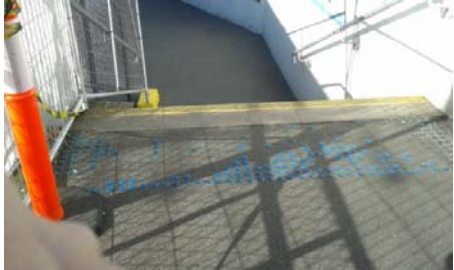
<p>Worn out TGSI at top and stairs.</p>

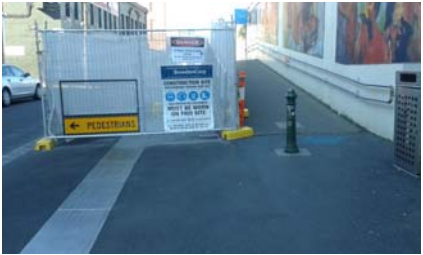
<p>Worn out and low contrast of TGSI on ramp. Replace with high colour contrast TGSI.</p>

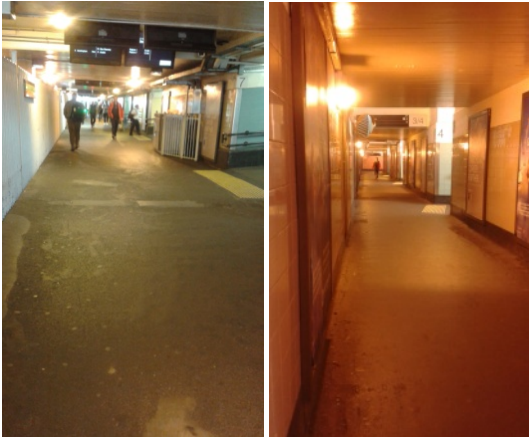
TABLE 6. RICHMOND STATION APPRAISAL RECORD			
Category	Compliant	Needs Improvement	Image/Commentary
			<p>a) Missing TGSi at Ticket Validation point and lack of directional way finding TGSi and b) Lack of TGSi directional Way finder at steward to Swan street eastern subway entrance.</p>

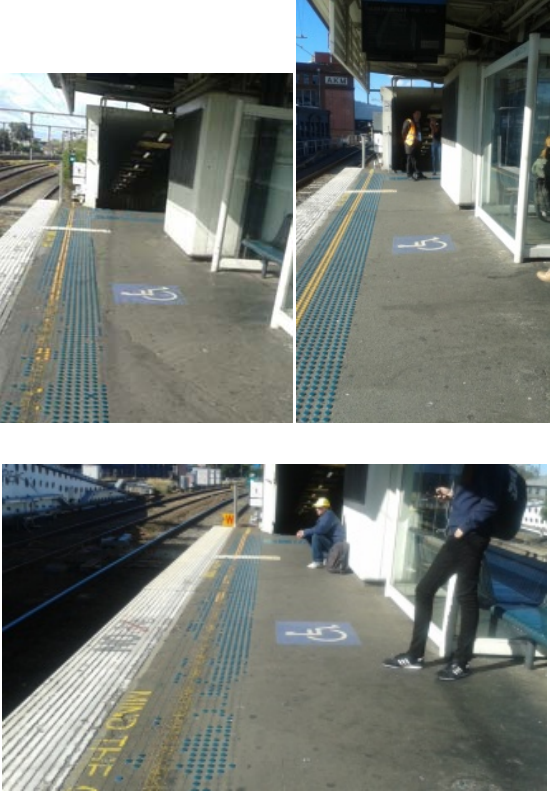
TABLE 6. RICHMOND STATION APPRAISAL RECORD			
Category	Compliant	Needs Improvement	Image/Commentary
WAP	Compliant WAP 1/10 (P 1 = 3.1)	<ul style="list-style-type: none"> 9 out 10 WAPs are non-compliant. WAP is restricted by platform furnishing. P2 = 2.6 P9 = 2.8 P10 = 2.8 	<p>Platform furnishing can cause smaller area for WAP. Either move furnishings away from WAP sign or move WAP sign and place of boarding.</p>

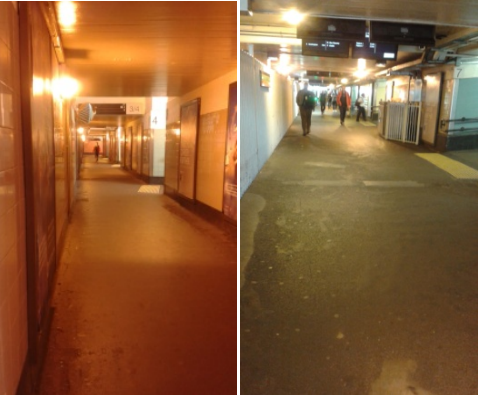
TABLE 6. RICHMOND STATION APPRAISAL RECORD			
Category	Compliant	Needs Improvement	Image/Commentary
Handrails	Handrails 10/10 Handrails in tunnel 0/4 Handrails in main entrance 0	<ul style="list-style-type: none"> Requires handrails in both tunnels, main entrance and city 	<p>a) Middle tunnel from stairs to platform missing handrail, and b) Missing handrail in corridor from Swan to Stewart Street.</p>

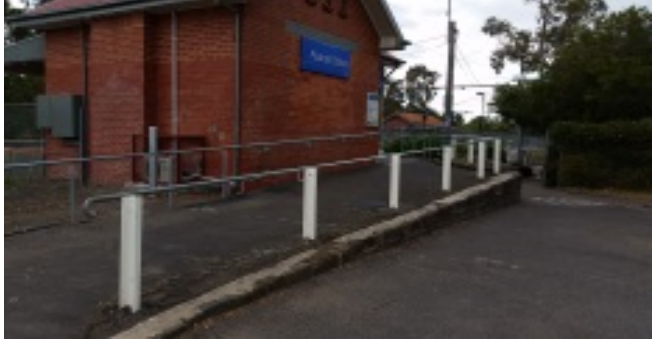
TABLE 7. RUSHALL STATION APPRAISAL RECORD			
Category	Compliant	Needs Improvement	Image/Commentary
			<p>Photo of P1 above gradient that meets compliancy. This is graded at 1:6. The only one in Yarra that is compliant.</p>

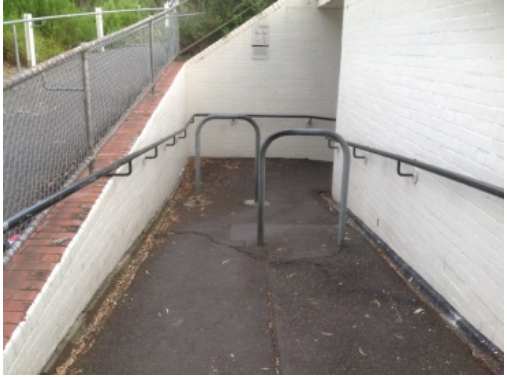
Hazard		<ul style="list-style-type: none"> • Bollards are a hazard for people who use scooters, double prams and those with low or no vision. • Black Pole needs colour contrast. 	<p>The photo below shows a footpath bollard located on P1 and on P2 ramps to railway station. Footpath Bollards can be an obstacle for people with vision loss and difficult to navigate around for people with twin prams, wheelchairs and scooters.</p>

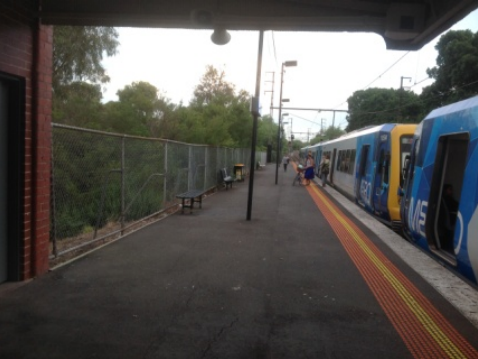
TABLE 7. RUSHALL STATION APPRAISAL RECORD			
Category	Compliant	Needs Improvement	Image/Commentary
			<p>Black poles are a hazard for people with low vision (particularly when overcast). To make poles more visible, paint entire pole with a bright colour contrast coloured paint or add a high colour contrast strip, at eye level.</p>

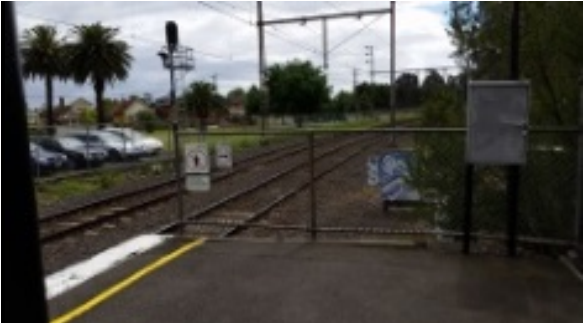
Other improvements		<ul style="list-style-type: none"> • Surrounding access to station. • P1 side of station is inaccessible. Consider either putting in a level crossing or another crossing that has a better ramp gradient. • P1 possible crossing across train tracks. • An accessible pathway from P1 to P2 would need to be put in place. • P2 can be extended by PTV. 	<p>This photo of Platform 1 is a possible crossing over train tracks to make Rushall Station accessible for people. A recommended accessible parking bay could be located on P2 side where these cars in photo are parked.</p>

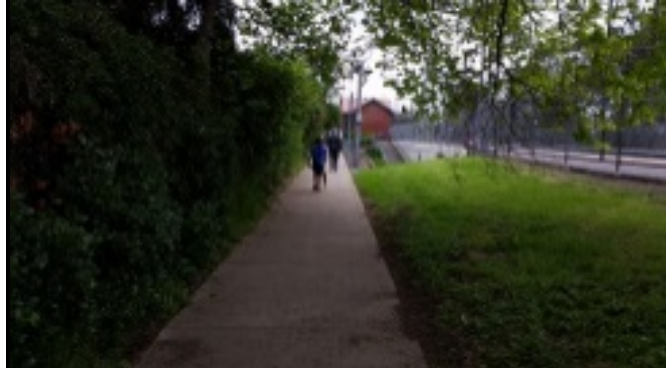
TABLE 7. RUSHALL STATION APPRAISAL RECORD			
Category	Compliant	Needs Improvement	Image/Commentary
			<p>This is the southern point of P2 walking path to train station. There is space for pathway, ramps or other railway access improvements.</p> <p>It is recommended to make Platform 1 accessible otherwise commuters can only travel in one direction which means, although P2 is accessible, it will not be used of a commuter cannot return.</p>

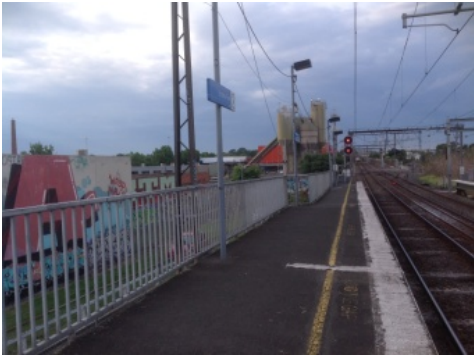
TABLE 8. VICTORIA PARK STATION APPRAISAL RECORD			
Category	Compliant	Needs Improvement	Image/Commentary
WAP	WAP 1/2 P 1 = 3m	<ul style="list-style-type: none"> P2 = 2.1m, which is too narrow for wheelchairs and scooters or to turn. 	<p>The photo indicates that P2 is too narrow at WAP point. It is 2.1 metres wide. WAP width is recommended to be 3 metres or more.</p>

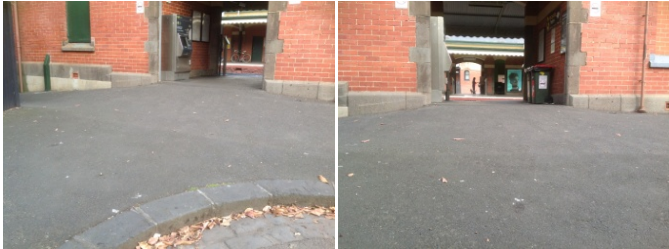
<p>Platform 1</p>
Hazard		<ul style="list-style-type: none"> Station entrance to P2 is steep (1 in 10 G) & slopes to the road. -Jika Place (gradient is 1 in 10). 	<p>Sudden steep footpath at entrance of P2 is a trip hazard. Asphalt is dark colour and darker when it rains making it difficult to see and navigate.</p>

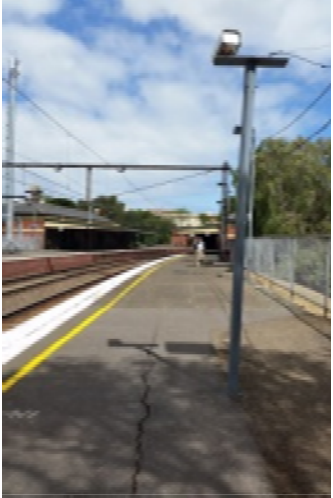
Category	Compliant	Needs Improvement	Image/Commentary
			<p>The black pole is a hazard for people with low vision (particularly on overcast days). To make the poles more visible, paint entire pole with a bright high colour contrast paint, or colour at eye level.</p>

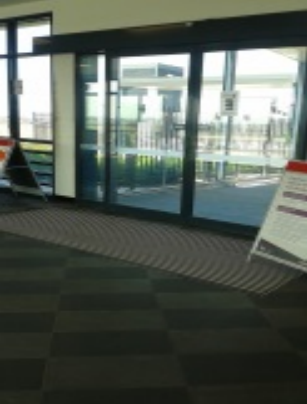
<p data-bbox="1325 803 2047 925">This photo showd TGSi at internal main entrance on one side of door but not the other side of the door. The directional TGSi are missing both internally and externally.</p>

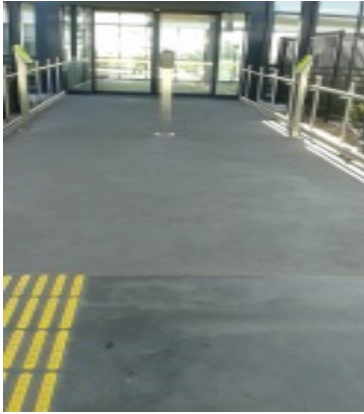
Category	Compliant	Needs Improvement	Image/Commentary
			<p>Both TGSIs are missing in front of double doors and the directional TGSIs leading to platform.</p>

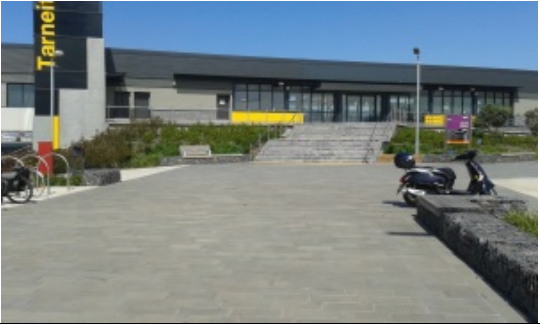
<p>TGSIs are at top and bottom of stairs. TGSIs are missing from other external area to main entrance, such as from bus stops, car park, elevator or car park.</p>
