Memo

Subject Options analysis for Tree T1, AMCOR paper mill, Alphington
Distribution City of Yarra
Date 12 August 2019
Project P119162.10_Tree_Collapse_Bank_Slump_Investigation

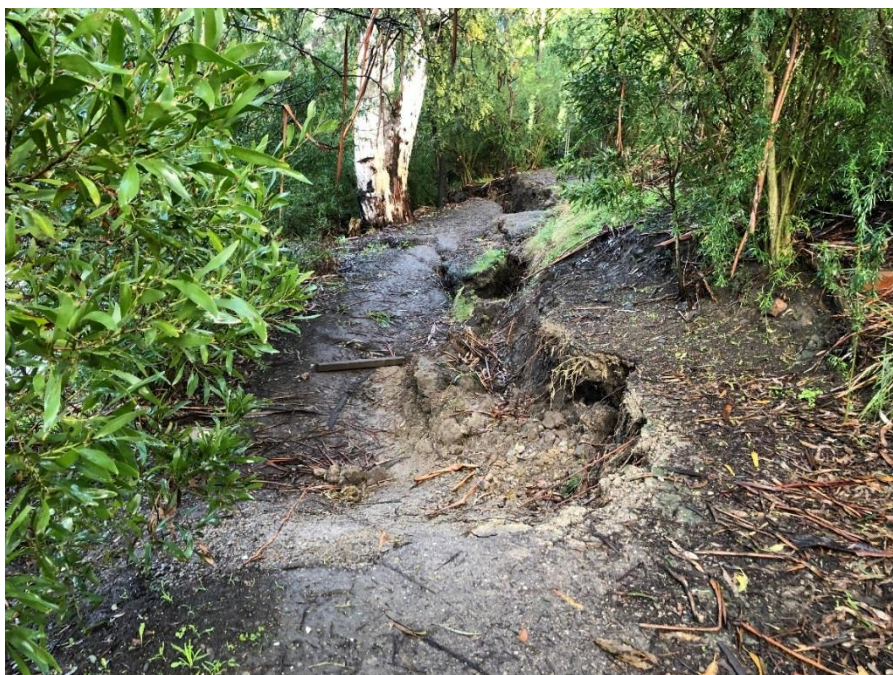
The primary driver of T1 collapse will most likely be further ground movement destabilising the tree. Tree T1 has tilted due to bank slump and unless this issue is addressed, there is an imminent (weeks to months) risk of Tree T1 falling. Further slumping will lead to further tilting of the tree and the ultimate collapse of the tree

The expert panel has identified a rise in groundwater in lower the terrace of the Yarra River at the subject site as the likely cause of the bank slumping. The expert panel noted the poor condition (and death) of some of the introduced vegetation on the lower terrace and lower levels of the steep embankment. While a decline in vegetation condition could be the result of many factors, it is consistent with the elevated groundwater levels, indicating water logging of roots.

However, the subject tree in its current form threatens the bank stability. Council officers, have advised that the subject riverbank has undergone significant further movement over the weekend (10 and 11 August 2019), refer figure below. The subject bank is active. Further bank slumping can be expected over the forthcoming days and weeks.

Tree T1 on and related bank slump 12 August 2019

Option 1 (Remove the tree and retain trunk for habitat and root ball for bank protection) provides a predictable outcome for the site and enables most short- and long-term objectives to be achieved. While the loss of the tree will have some impact on the character of the site, this is the only option that provides for the practical and feasible resolution to the risks posed by the severely compromised tree T1. Option 1 is the only feasible option that addresses the immediate risk of damage to property (riverbank).

Option 1 is recommended for implementation as a matter of urgency. The active movement of the bank and the extent of damage to both property and the Yarra River, constitute 'an immediate risk to property' and enables activation of clause 42.03-3 of the state planning provisions, creating an exemption for emergency works.
