INTERIM REPORT:

Tree collapse and bank slump investigation on Yarra River adjacent to former Amcor site at Alphington

August 2019

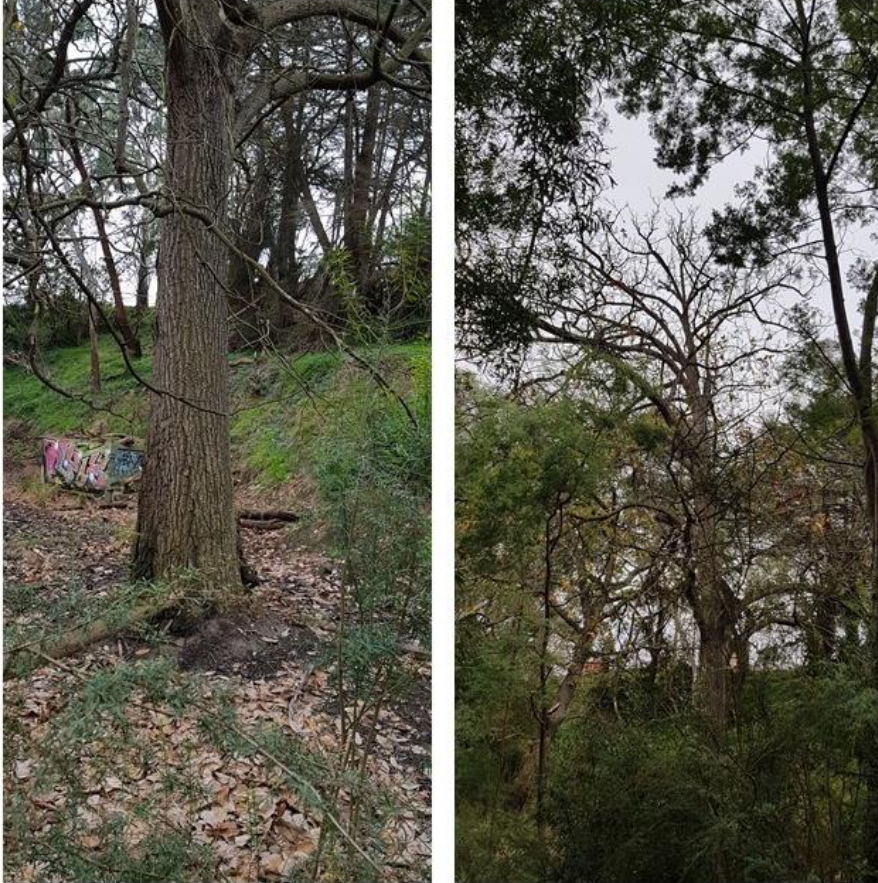
Figure 15: *Oak in waterlogged area*

Some mature Oak trees are growing within and adjacent to a waterlogged area. These are significant local trees and would be a priority to be retained in a future landscape. One of these (see Figure 15) appears to also be suffering from the waterlogged ground. These trees need to be assessed in spring to check the seasonal regrowth and their health.

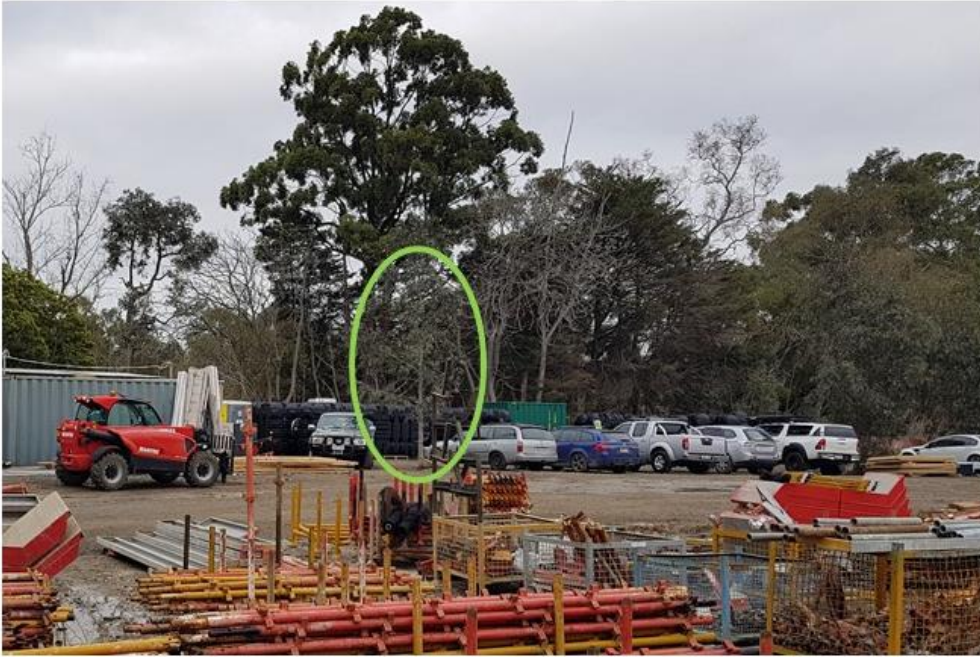
Figure 16: Juvenile tree in carpark - old logistics hardstand

A Eucalyptus species (see Figure 16) has grown in the construction carpark with was a concrete covered hardstand (see Figure 23). This tree has grown >4.5m since 2016. This indicates that the ground in this area is not highly compacted and has moisture to enable rapid growth. This rapid tree growth suggests that the carpark area has well-watered but free draining soils, consistent with a site that has high levels of surface water infiltration.
