**13.1 Update on Yarra Riverbank, Alphington**

<b>Subject</b>	Site visit briefing report
<b>Distribution</b>	John Ghasperidis – City of Yarra
<b>Date</b>	29 July 2019
<b>Project</b>	Tree collapse and bank slump investigation at historical paper mill site, Fairfield

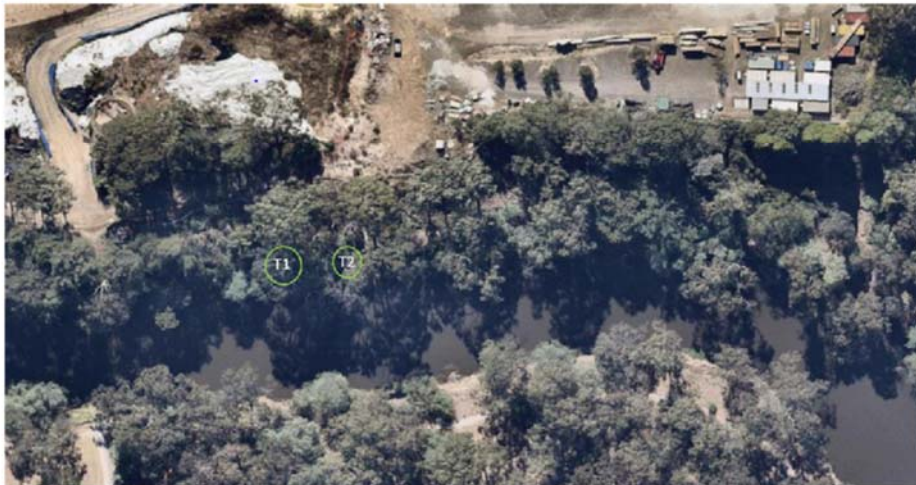
**Figure 1.** Location of trees assessed at bank slump zone

Three trees occur within and adjacent to a recent bank slump. One of these has fallen into the river and is not covered in this memo. Two other trees (shown in **Figure 2** and **Figure 3**) have been identified as at risk of failure during previous visits by others.

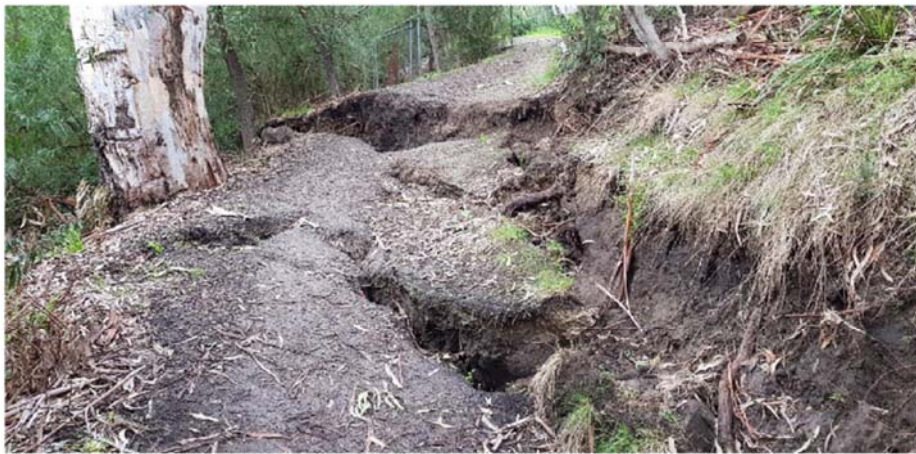
**Figure 2.** Tree (T1) and bank slump site visit by Alluvium

1. The bank collapse is most likely associated with an increase in groundwater levels and lubrication at the site
2. There are limited practical management interventions that can be applied in the immediate and short term to address the groundwater and prevent further bank collapse
3. Ongoing bank collapse (instability) will continue to occur at the site until groundwater issues are addressed
4. The bank instability threatens a number of large trees on the riverbank. Two of these trees have been the subject of four recent arborist reports and are the main focus of this memo.
5. Two trees, referred to as T1 and T2 have been identified at imminent risk of collapse. The outcome of the arborists reports on these two trees is set out in Table 1 below.

This tree is within a bank slump which has damaged the informal earthen pedestrian path along the riverbank. This is now an unsafe pathway and has been fenced off preventing pedestrian access. If the tree were to fall it is most likely to fall towards the river and would cause further damage to the path. This would increase the hazard to path users due to damaged ground. The risk to people being struck by the falling tree is unlikely and is mostly to those who are in a boat on the river – more than people on the bank.

Using the Risk Assessment method applied by Ryder Arboriculture we consider the *Likely failure* to be **Imminent** with the *Likely Impact* to be **Very Low**. With a *Consequence* of **Severe** the *Risk Rating* outcome is **Low**.

Note: Changing the *Likely Failure* in the risk matrix has not changed the *Risk Rating* assessment. This risk is not immediate and with the fencing in place would not be considered an emergency.

- The existing trees at the site be photographed as a record of the current riparian vegetation for the site. This record can inform the future vision for the site and ultimate landscape plan.
- Tree T1: We consider T1 is at imminent probability to collapse (this could be at any time within a few months) and should be removed to reduce the future risk to public safety and bank damage.

- Continue to restrict access to the site maintain public safety. Consider signage along the riverbank warning people on the river of the tree hazard.
- If tree removal is undertaken, the stump and root plates must be retained to reduce damage to the bank and to provide ongoing soil stability.

- While we recommend that T1 is removed a tree removal permit will be required to remove either tree (as per Ryder Arboriculture report). Reviewing the risk assessment (likelihood and consequence framework) used by Ryder Arboriculture has not changed the risk assessment finding of Low risk. With pedestrian controls in place this situation (while not ideal) does not constitute an emergency. Therefore, these trees do not meet the Permit exemption conditions of immediate risk as required under the terms of the Victorian Planning Provisions - Significant Landscape Overlay (SLO 42.03-3) and Native Vegetation (VPP 52.17-7). (See excerpts from the Planning Provisions below).

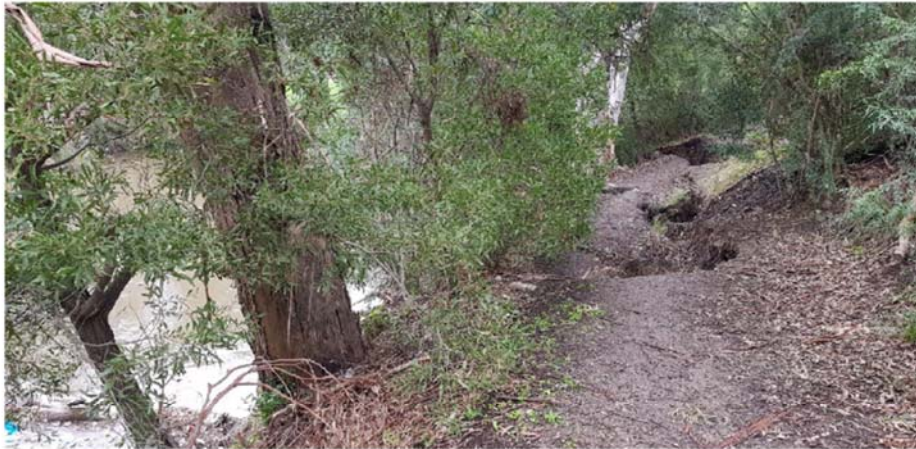
**Figure 3.** Tree collapse (T2) at the edge of bank slump

- Tree T2: We are less certain of the imminent fate of T2. This tree has not received majority support by Arborists for removal. The tree appears to be outside the zone of the existing tension cracks. We suggest that the tree not be removed until:

- Such time as it is observed to lie within tension cracks, and or
  - Results of contamination land assessment is complete, a remediation plan approved and the necessity for the removal of the tree as part of any such remediation plan is confirmed.

- Monitoring of the slump area and trees is undertaken weekly to determine if the conditions change and increase the likelihood of the trees falling. Installation of photo monitoring posts and tree tilt sensors should be considered.
