## **CITY OF YARRA**

**RSL MEMORIAL HALL**  
**152 Hoddle Street, Abbotsford**

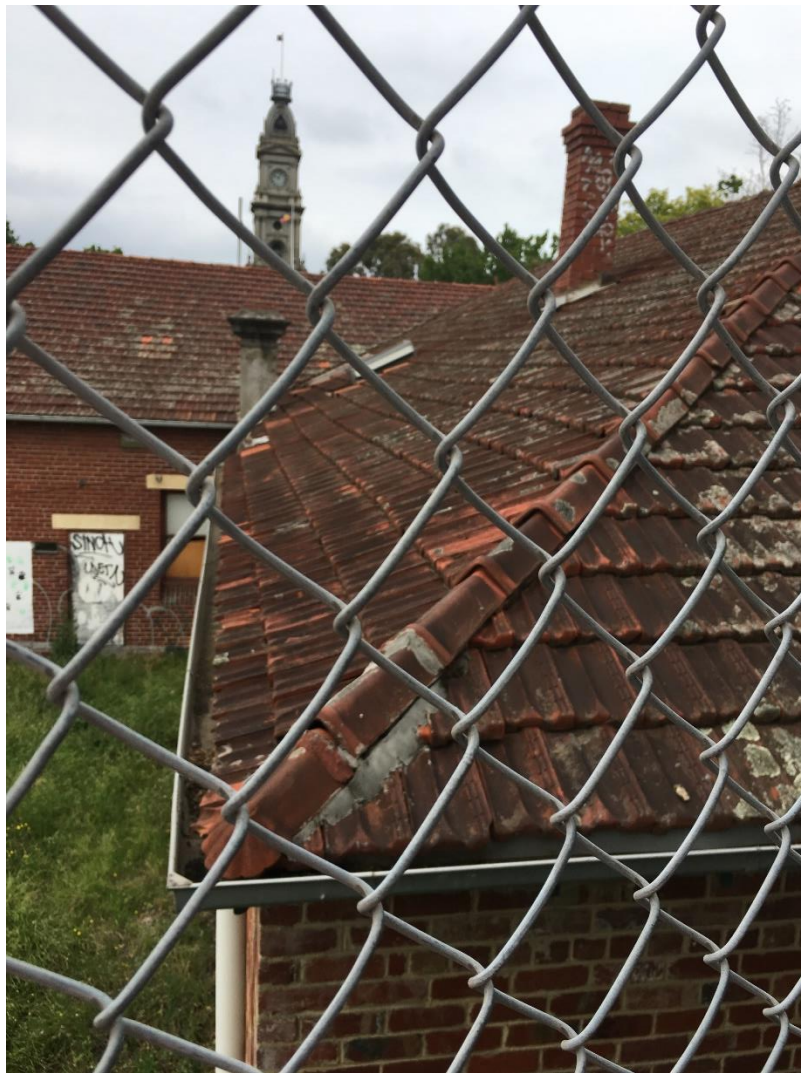
Photo 5: Tiled roof at North-East corner. Tiles to be removed, repaired and re-pointed. Eaves, gutters and downpipes to be replaced.

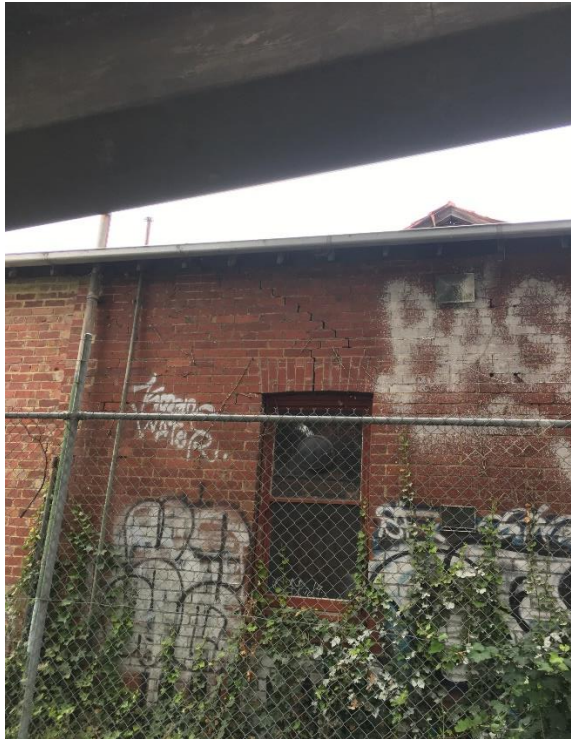
Photo 6: North Wall looking externally. Re-constructed where ivy had penetrated brick courses, Large crack right through lintel & reflective cracks right along north wall.

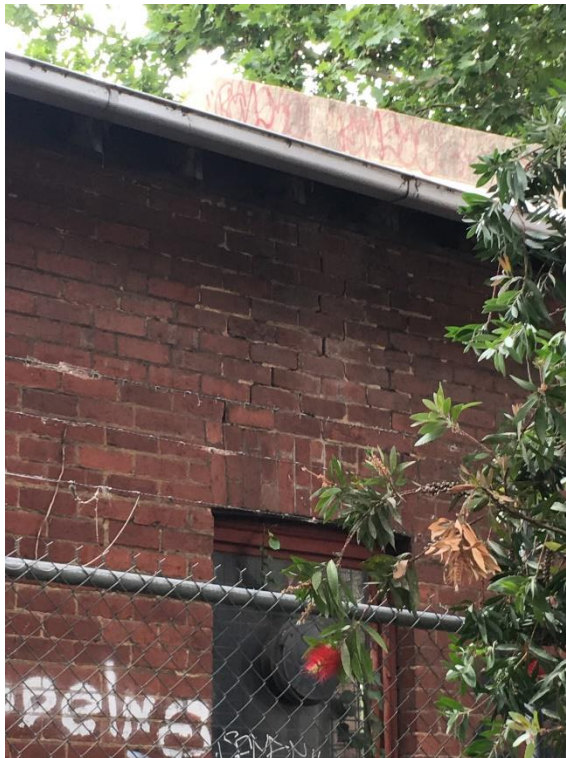
Photo 7: North wall has new formation of cracking above lintel, cracks are new and was not observed and documented in previous report.

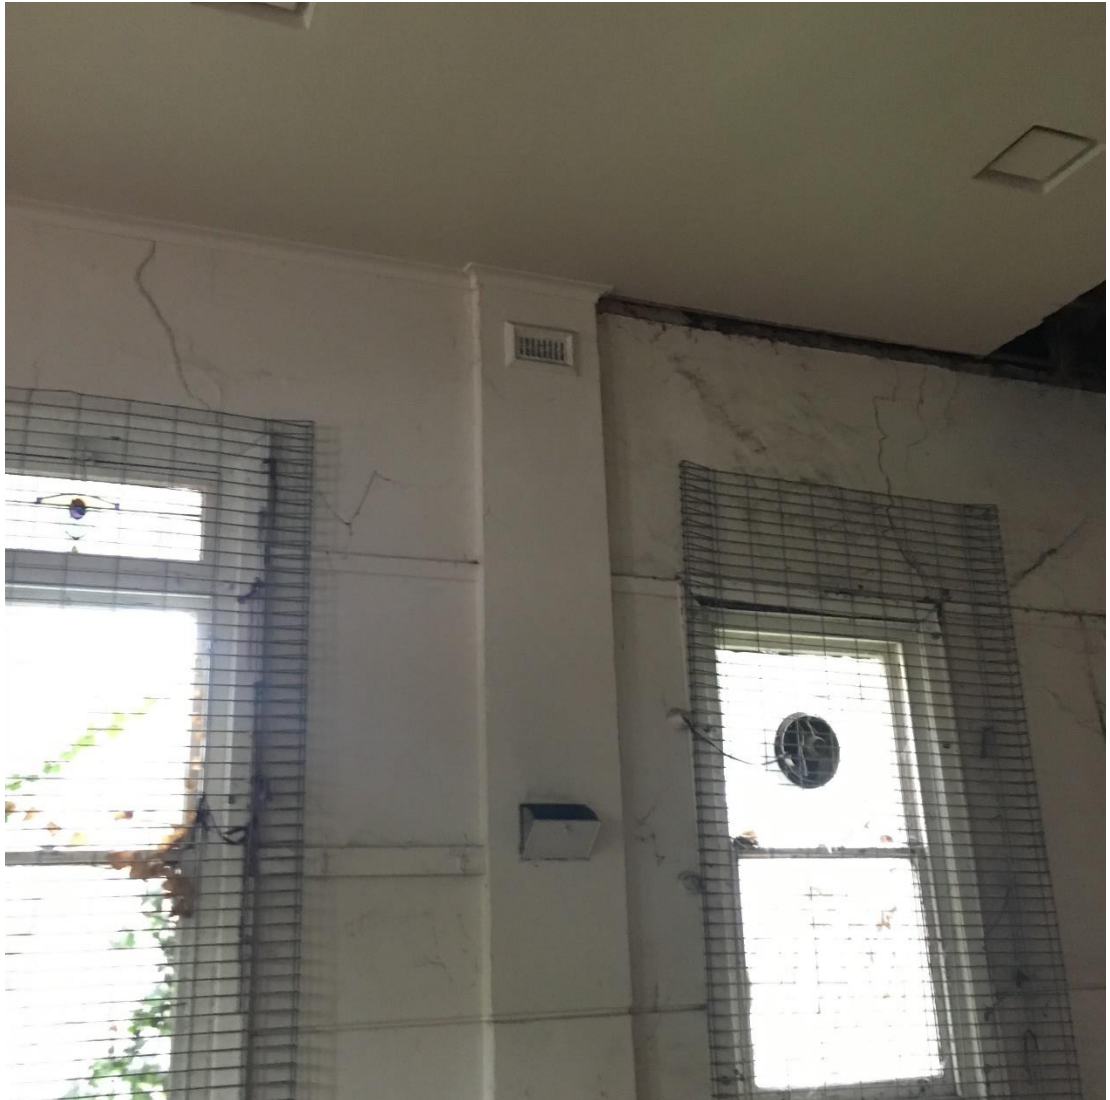
Photo 8: North Wall looking internally both previous photos 6 & 7 are the same cracks viewed externally.

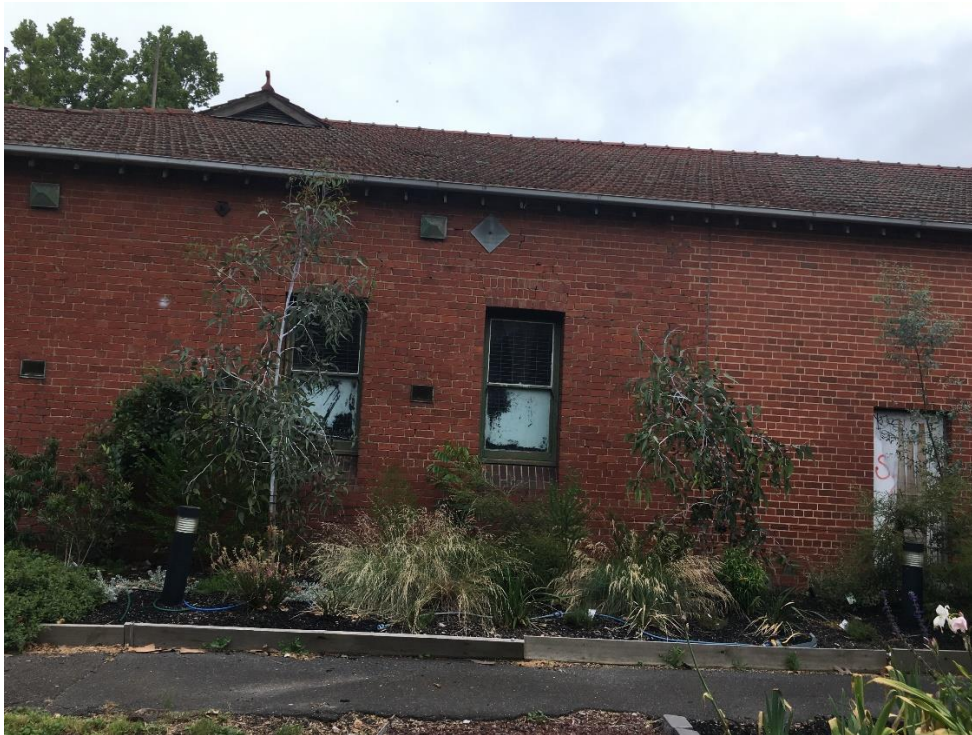
Photo 9: South wall reconstructed. Tie backs within the brickwork restraining wall.

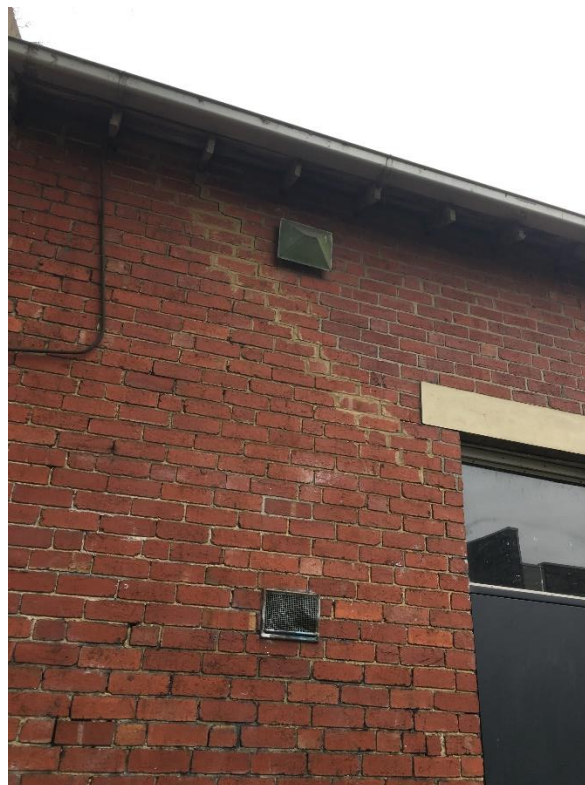
Photo 10: South-West corner of Hall. Foundation may have dropped. Wall repaired previously, in buildings current observation repair is starting to crack again at top of brick wall.

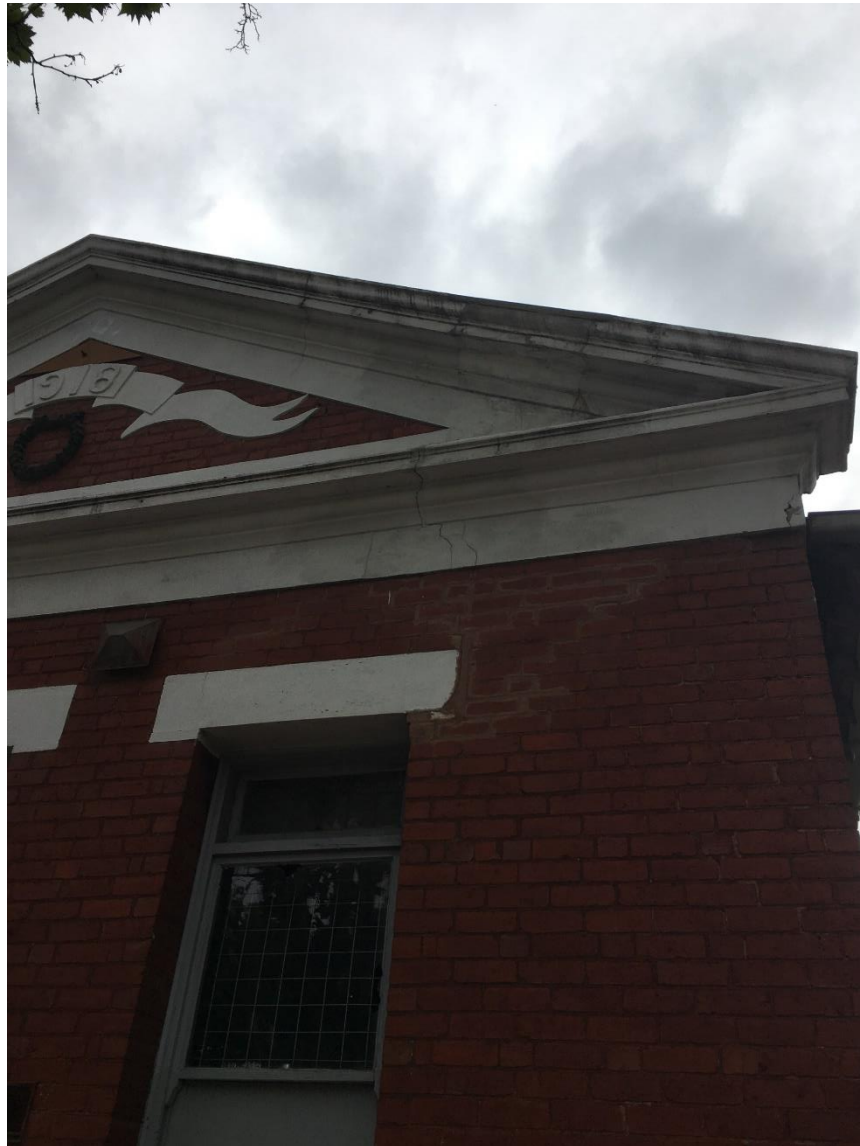
Photo 11: South-West corner of Hall – west wall. Cracks to wall repaired externally. Internal crack not repaired.

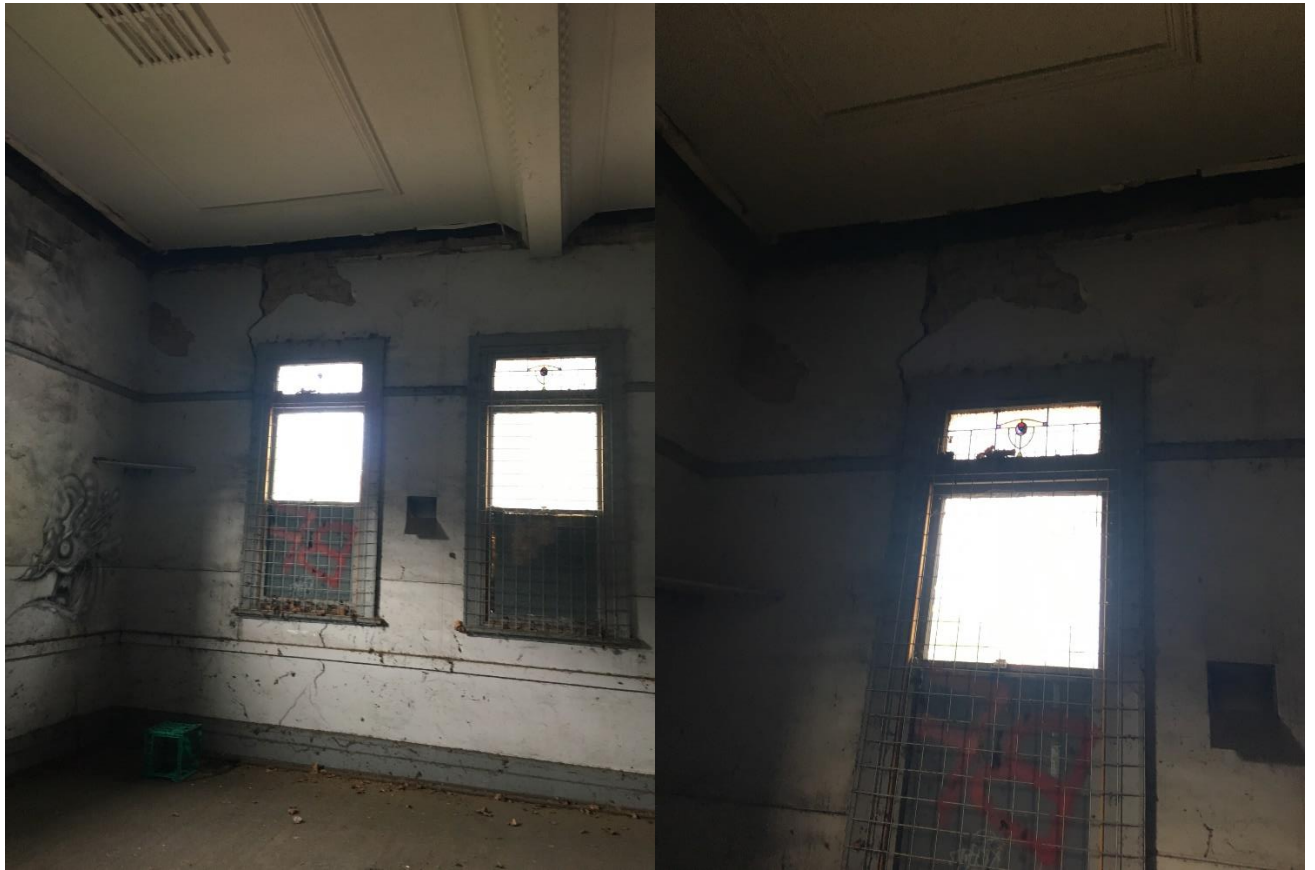
Photo 12: South-West corner of Room 9 (Hall). Crack to west wall not repaired, internally. Crack looks to have got larger compared to the photos in previous report.

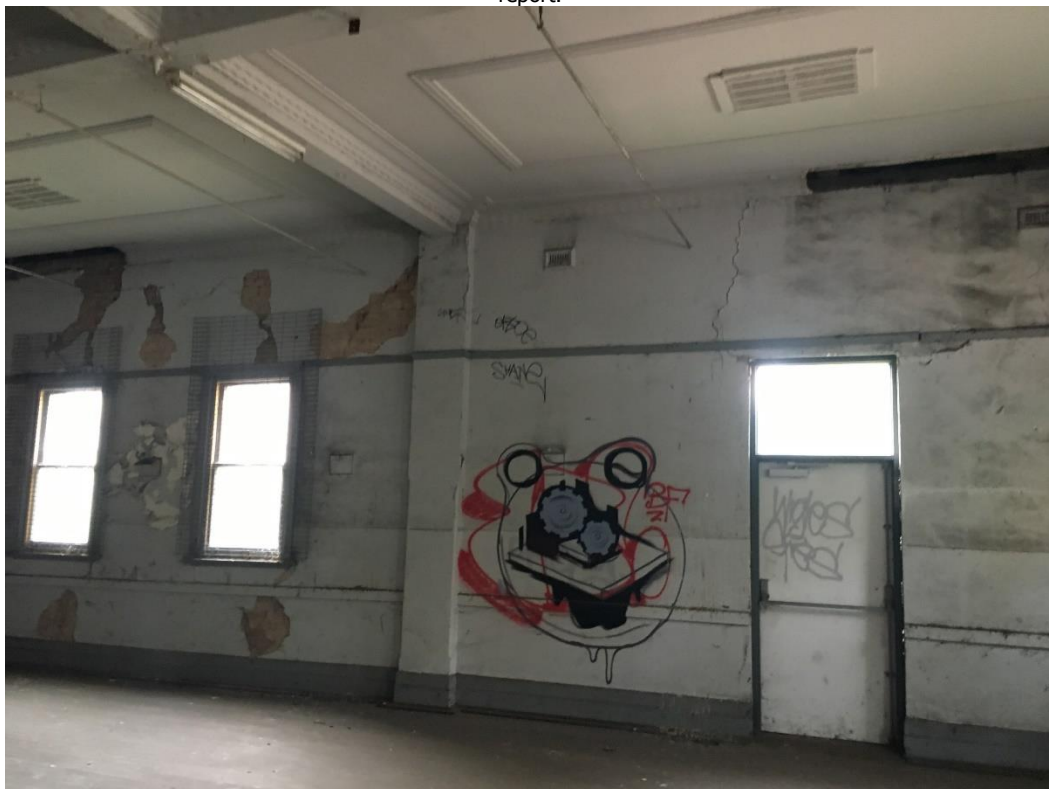
Photo 13: Looking at South Wall internally, cracks have not been repaired internally and run continuously across whole wall. Also brick ties can be seen just below roof level. Patchwork was only done externally, and no work has been done on internal face.

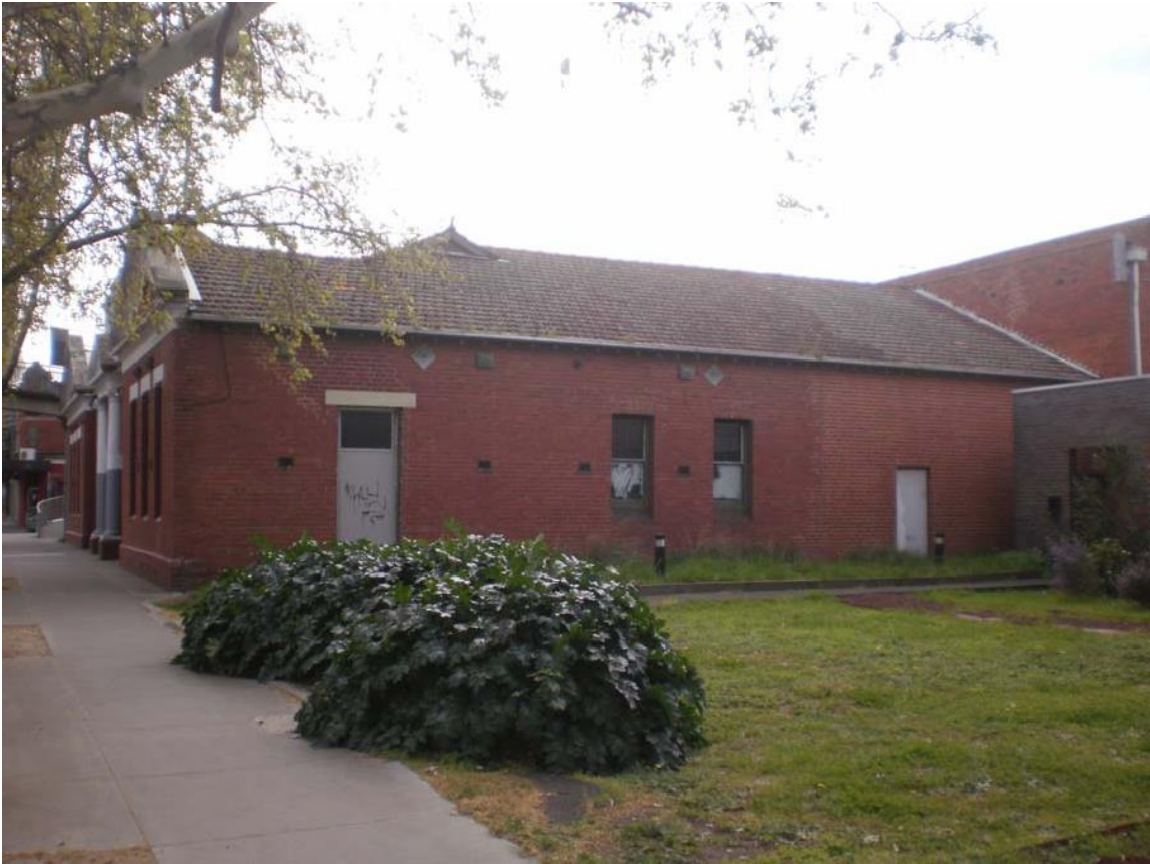
Photo 14: South wall of hall. Two number tie backs at line of internal engaged piers. Wall at east re-constructed.

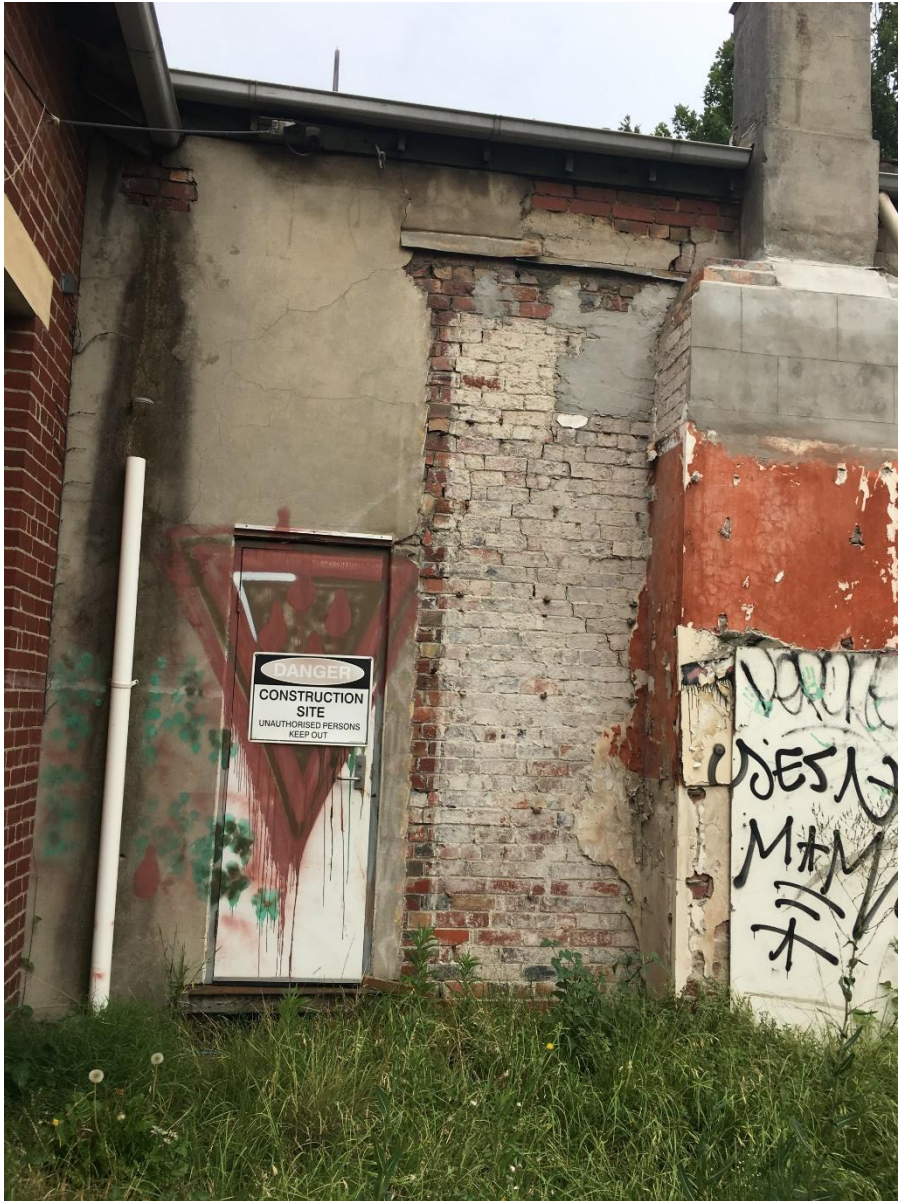
Photo 15: Rear Exit at east end of main entry hall. Disconnected downpipe and heavy water damage to external render. Single story toilet block has been demolished and external brickwork exposed which is heavily cracked.

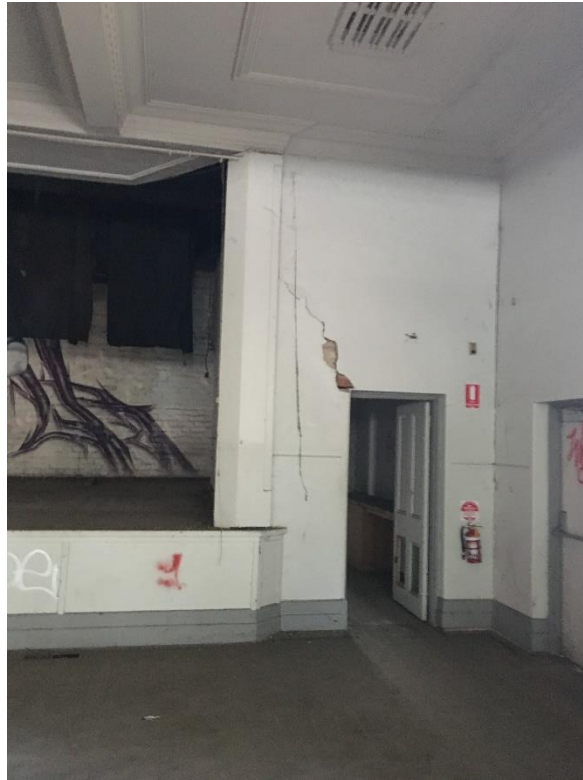
Photo 16: Cracking above door (leading from Hall (9) to Room 10A, cracking looks to not have gotten worse since previous report.

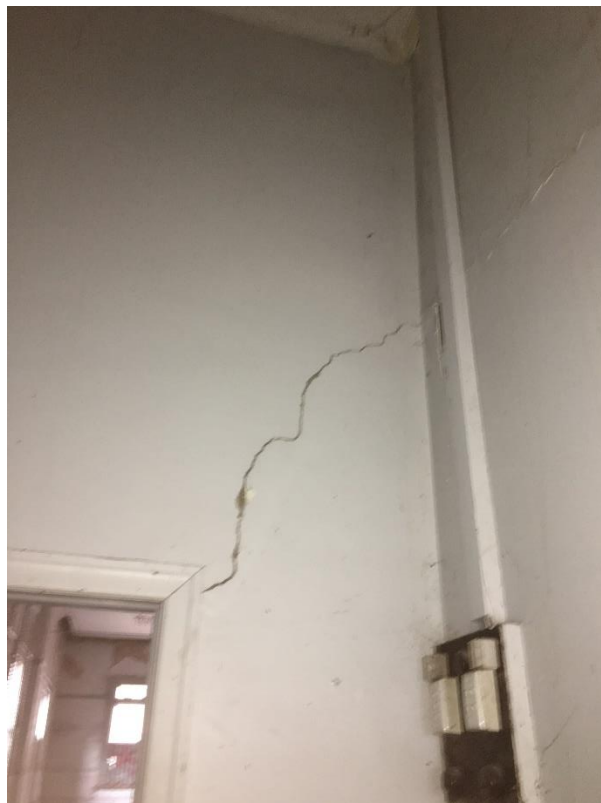
Photo 17: Other side of wall shown in photo 16, crack is on both faces of internal brick work wall.

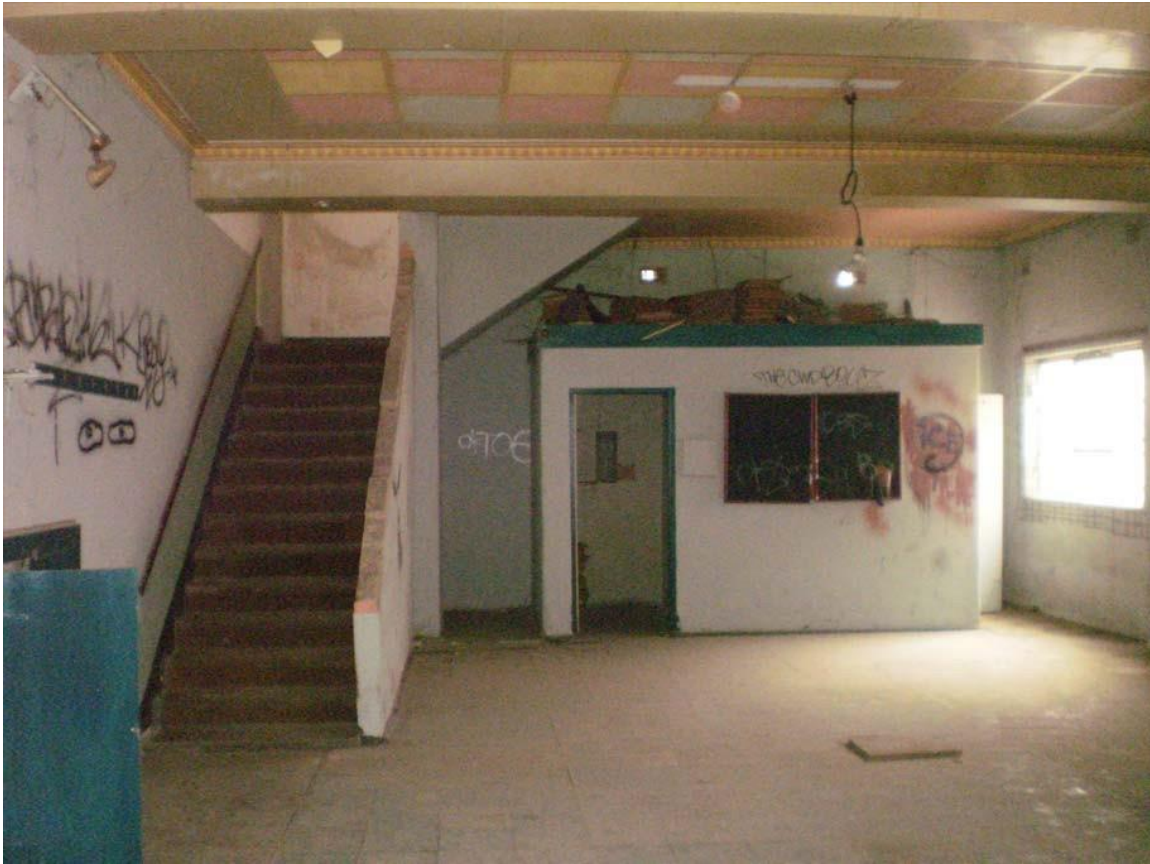
Photo 18: Room 11 viewed looking North. Concrete stair at left.

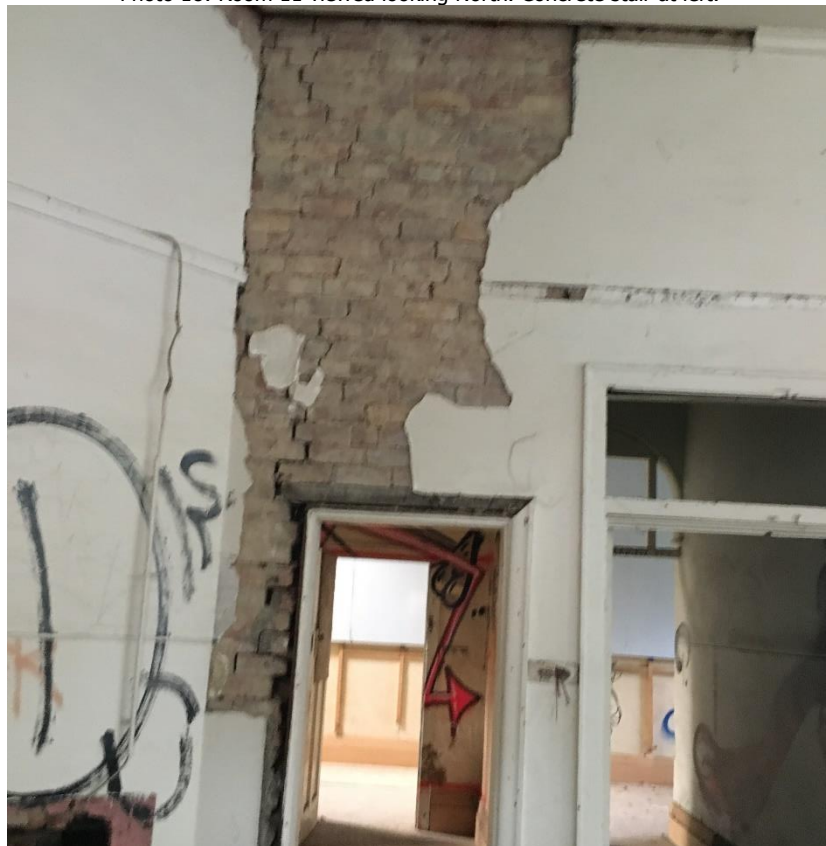
Photo 19: Large cracking at internal wall, room 1/6 interface

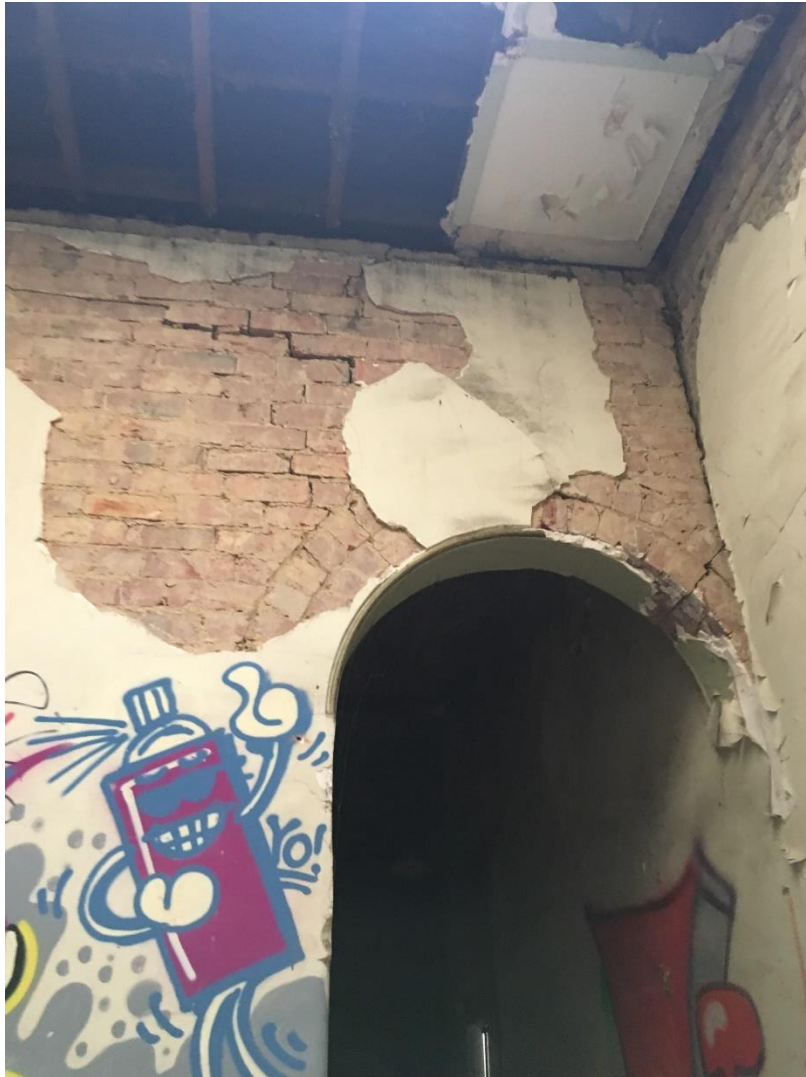
Photo 20: Internal arch leading from room 8 to 7, crack looks to have got worse since previous report.

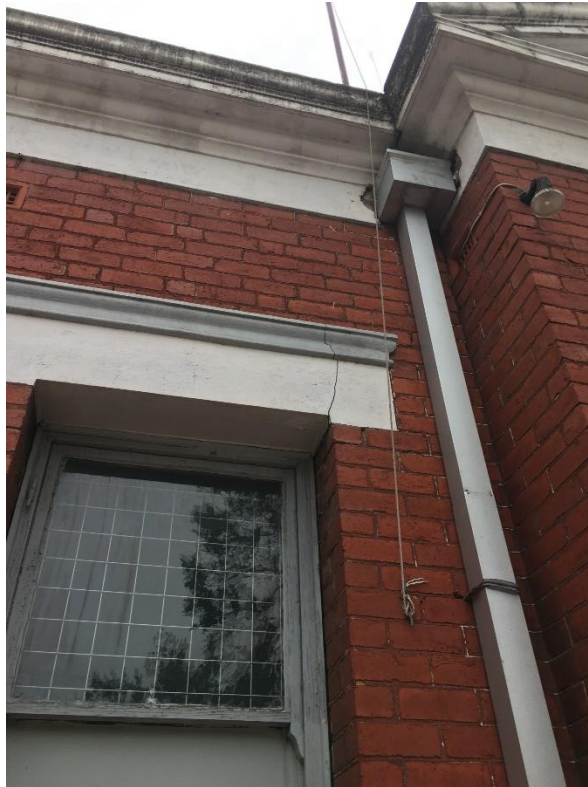
Photo 21: Front Façade West Wall (Hoddle St) has a large crack through lintel at support where lintel is bearing on brickwork. Was not observed and documented in previous report.

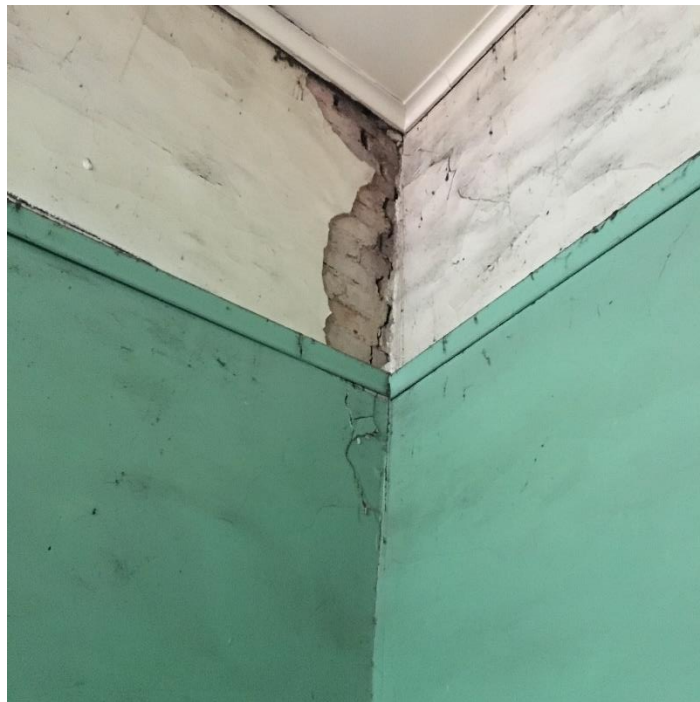
Photo 22: Large cracking in room 4 where brick wall meets each other at corner. Was not overserved and documented in previous report.

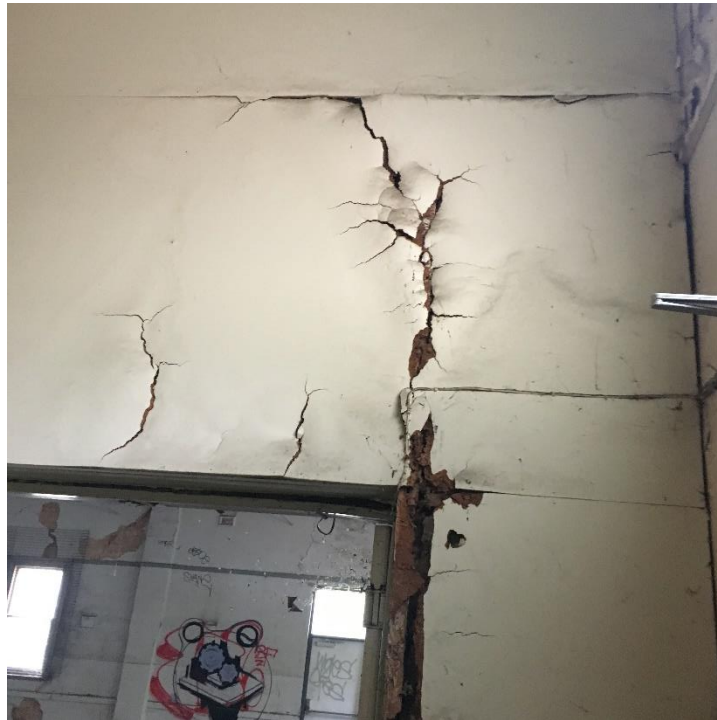
Photo 23: Large cracks & rotting of timber walls from settlement movement and water damage. Crack was observed at entrance of room 8 & 6.

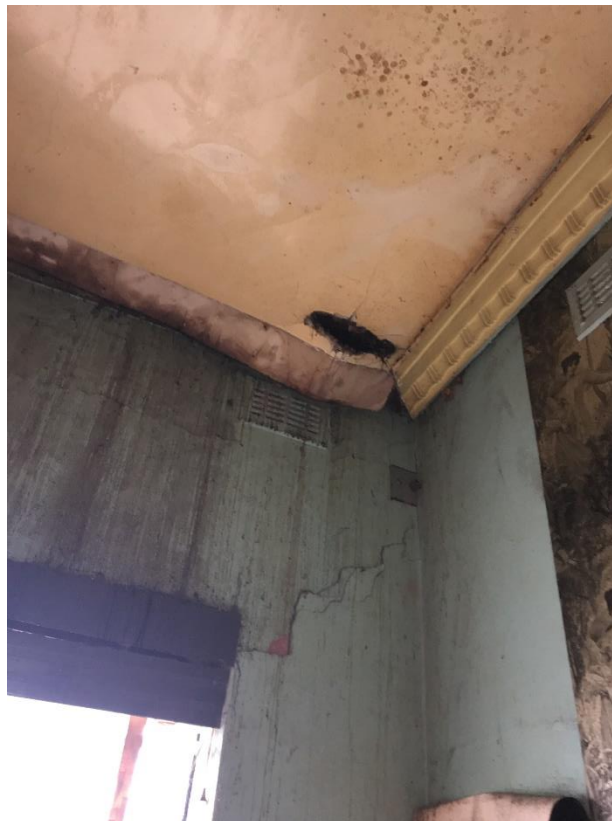
Photo 24: Room 12, first floor at corner of south east wall, cracks starting to form, and roof is starting to fall down from heavy water damage. Walls are heavily water damaged also with large amounts of rot.

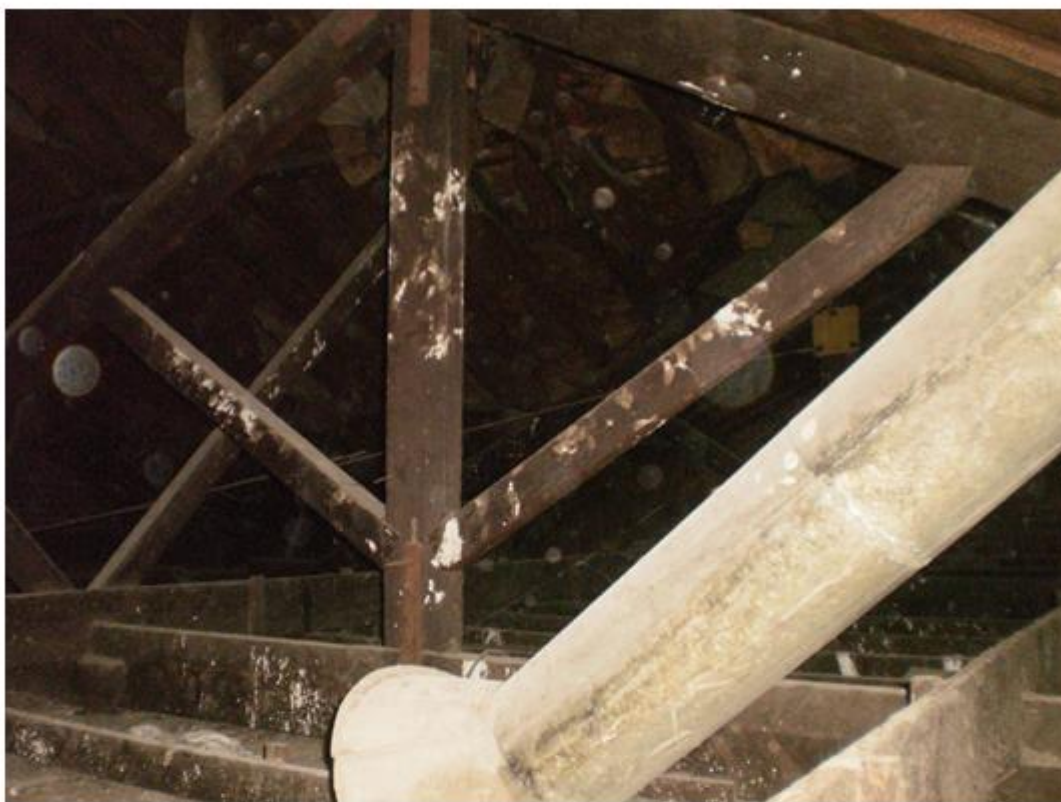
Roof Truss above Room 1 (viewed looking South-West).

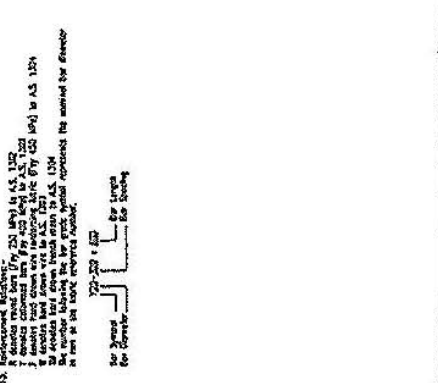
- UNDERPINNING CONSTRUCTION PROCEDURE:**
- THIS PROCEDURE PRESUMES AN EXISTING REINFORCED CONCRETE FOOTING WITH SUFFICIENT STRUCTURAL CAPACITY TO SPAN 1.5M.

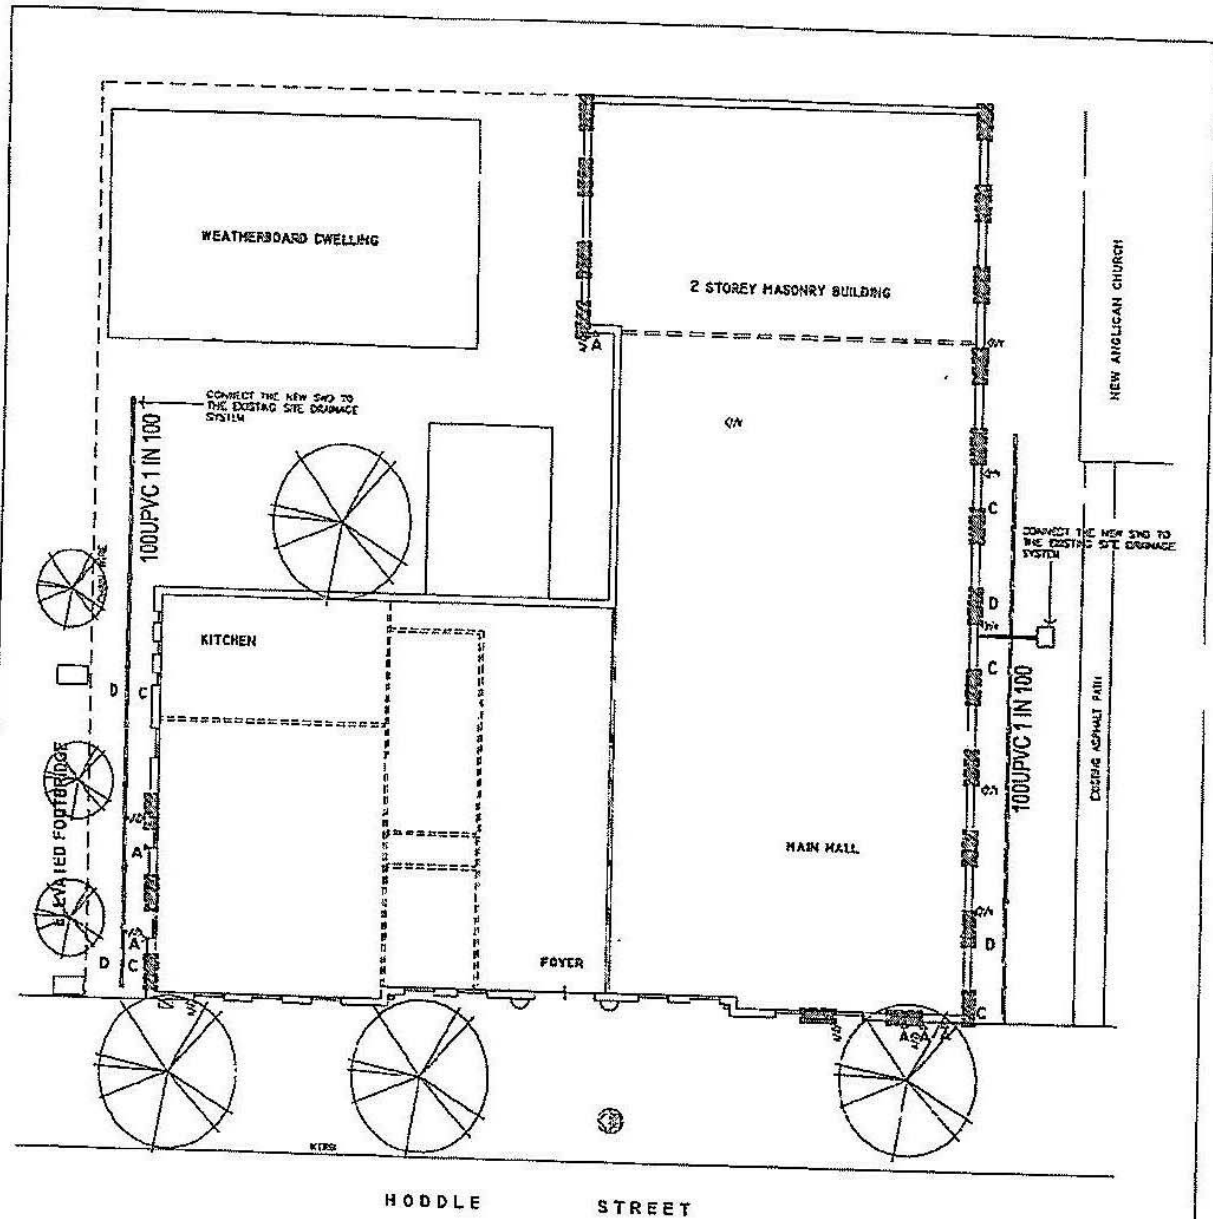
**PROPOSED FOUNDATION UNDERPIN PLAN**
