Report on Geotechnical Investigation and
Groundwater Study

Yarrabend: Riverfront Area
Heidelberg Road, Alphington

Prepared for
Alphington Developments Pty Ltd

Project 79075.12
R.012.Rev0
12 March 2020

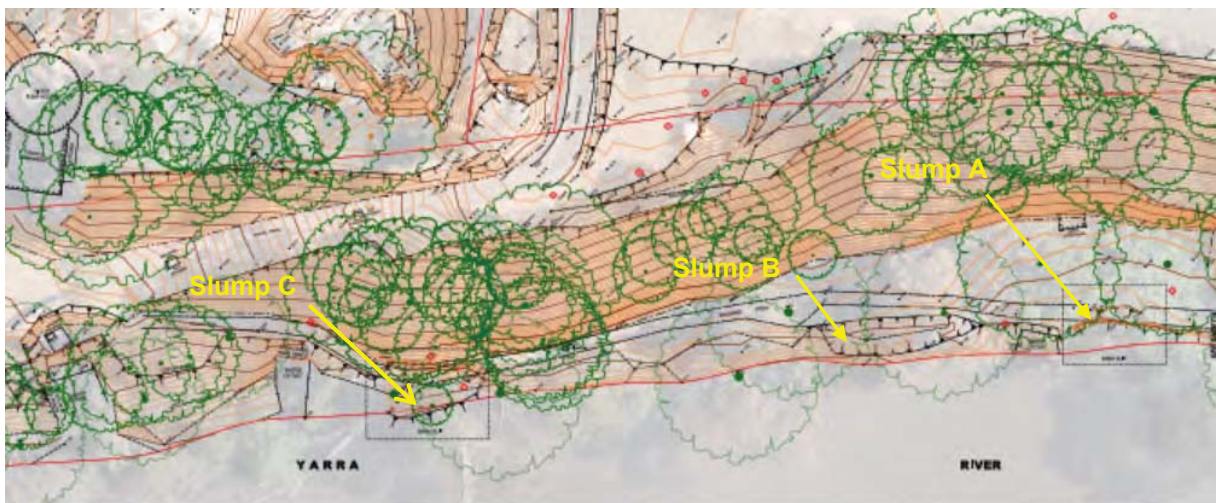
Figure 5: Slump Locations and (Reeds survey drawing extract, January 2020)

Slumping of the sub-vertical, variable height, riverbank adjacent to the Yarrabend site has occurred at the locations shown on Figure 5, referred to as Slumps A, B and C. Detailed descriptions of Slumps A and B are provided in DP Ref: 79075.12.R.003, dated July 2019. Summarised descriptions of the slumps are presented below, with approximate locations shown on the survey drawing extract in Figure 5.

- Slump A: This area has exhibited intermittent drainage issues and wet ground (pre and post development, reported to DP by CSC). Historical slumping was reported at this location prior to May 2017, Ref: CDM Smith – 2019. Tension cracks at the upper edge of the riverbank have progressed to slump movement since mid-2019.

Water was observed emanating from the toe of the embankment adjacent to the terrace in January and February 2020 and further slumping has occurred where the former tension cracks were observed. Minor surface flow was seen trickling through depressions across the terrace and over the slumped bank.

- Slump B. This slumping instance reportedly occurred in the days prior to 1 January 2019. A single tree toppled into the river. The tree was removed by Melbourne Water on 23-25 January. From ref: CDM Smith – 2019, water was not observed emanating from the ground in the immediate slump area but was near slump A. The slump straddled the toppled tree stump and is approximately 6 m long and 2 m wide. The slump does not appear to be active (to be confirmed by monitoring, discussed in Section 8).

- Slump C: This slumping instance occurred on or near 31 May 2019, affecting adjacent trees located at the river edge. One tree toppled into the river and two others were destabilised but remained standing. One of the remaining trees was cut down on the advice of a consulting arborist/s as a safety requirement. The stumps and root zones were left in place. The third tree remains in place. DP was engaged by AD to assess this slumping instance and provide initial advice regarding tree and riverbank stability in DP-2019/July. Surface water or wet ground was not observed in the area of this slump when inspected by DP in June 2019.

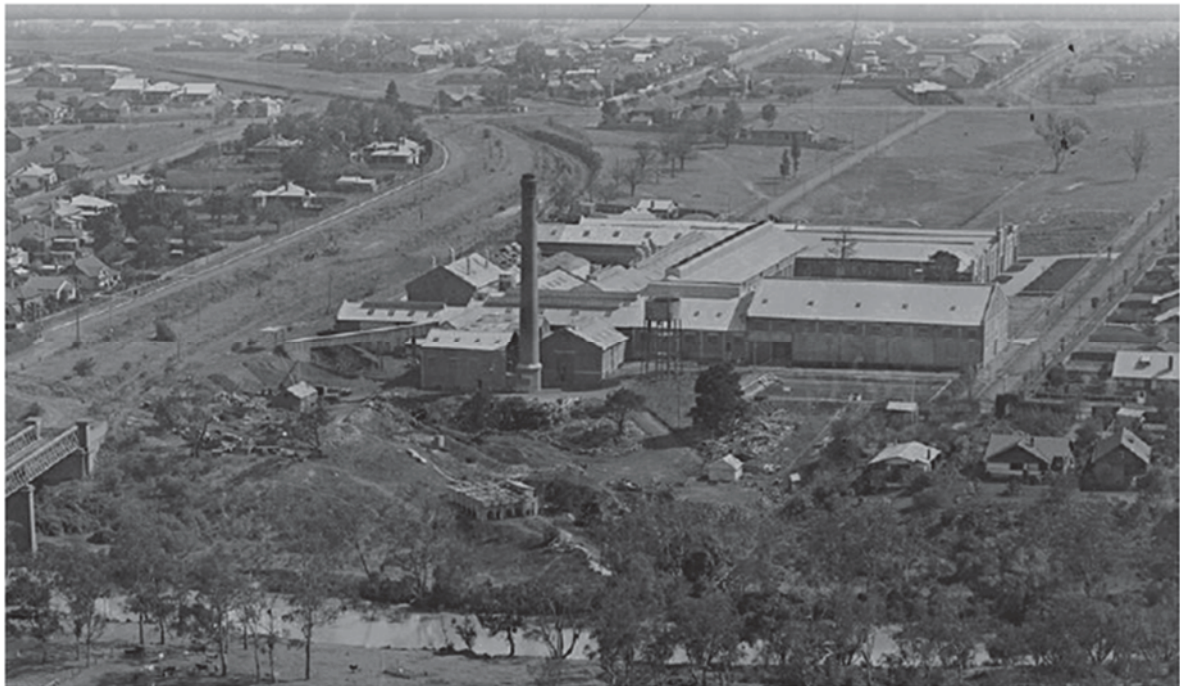
Figure 6 : 1920's Aerial Image of Site and Northern Yarra River Bank viewed form the South

Where not obscured by vegetation filling is visible at the surface in the terrace zone, below the toe of the adjacent batter. Visual inspection of the surface soils indicated silty clay and clayey silt material with trace foreign matter (bricks) consistent with some modification of the river bank. Note Figure 6 below showing historic image 1920s view form the south.

Historical information indicates the importation of fill early in the development of the AMCOR site. This included apparent infill of a former tributary entering the northern bank of the Yarra River as well as placement of fill to raise levels along the sloped embankment above the terrace. Fill over the site predominantly comprised gravelly clay.

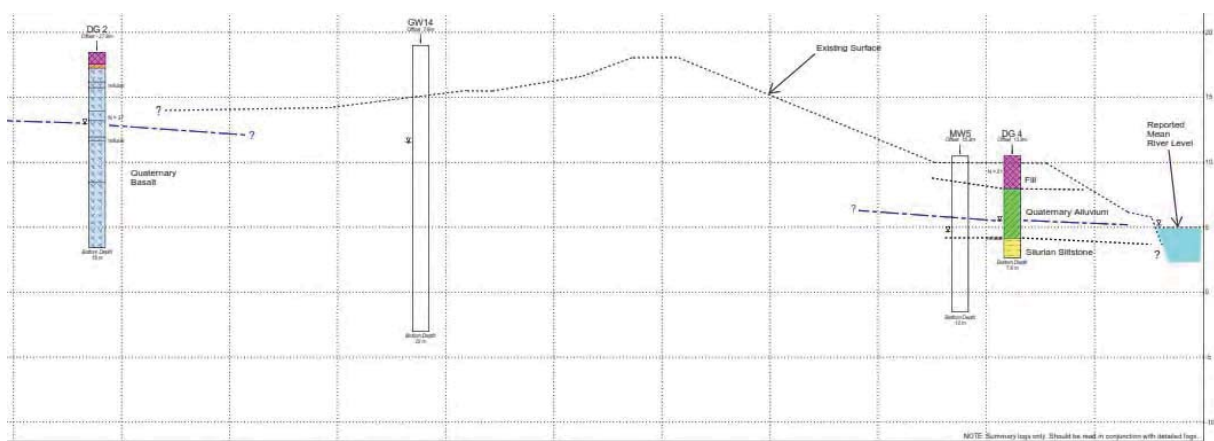
Figure 7 : Cross Section A2 Extract (see Appendix B for full cross section drawing)

Available data indicates minor engineered clay fill to a depth of 0.9 m in DG2, in the zone just south of the boiler house. It is noted that the fill at this location was removed and replaced during remediation works in 2017. The rock was typically highly to moderately weathered with occasional extremely weathered zones. Strengths ranged from low to very high. From visual inspection the basalt extends to the crest of the riverbank.

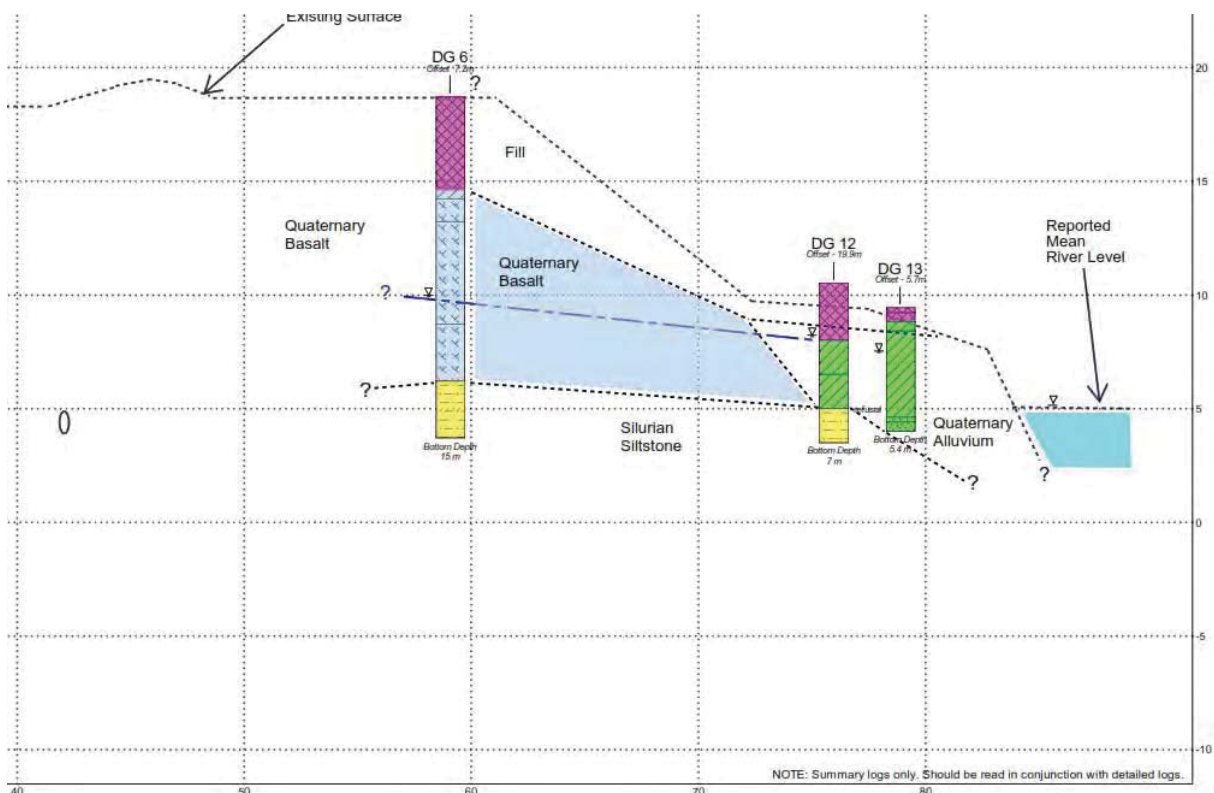
Figure 8 : Cross Section C-2 Extract (see Appendix B for full cross section drawing)

In this area the edge of the basalt flow interfaces with the fill and natural alluvium in the terrace zone. The surface of the siltstone falls away to the north (see borehole DG1 and cross-section C2-2, Appendix B). The embankment and apparent edge of the basalt flow are at their closest to the river at this location. It appears that there is a local peak in the Silurian surface around DG5 and DG6.

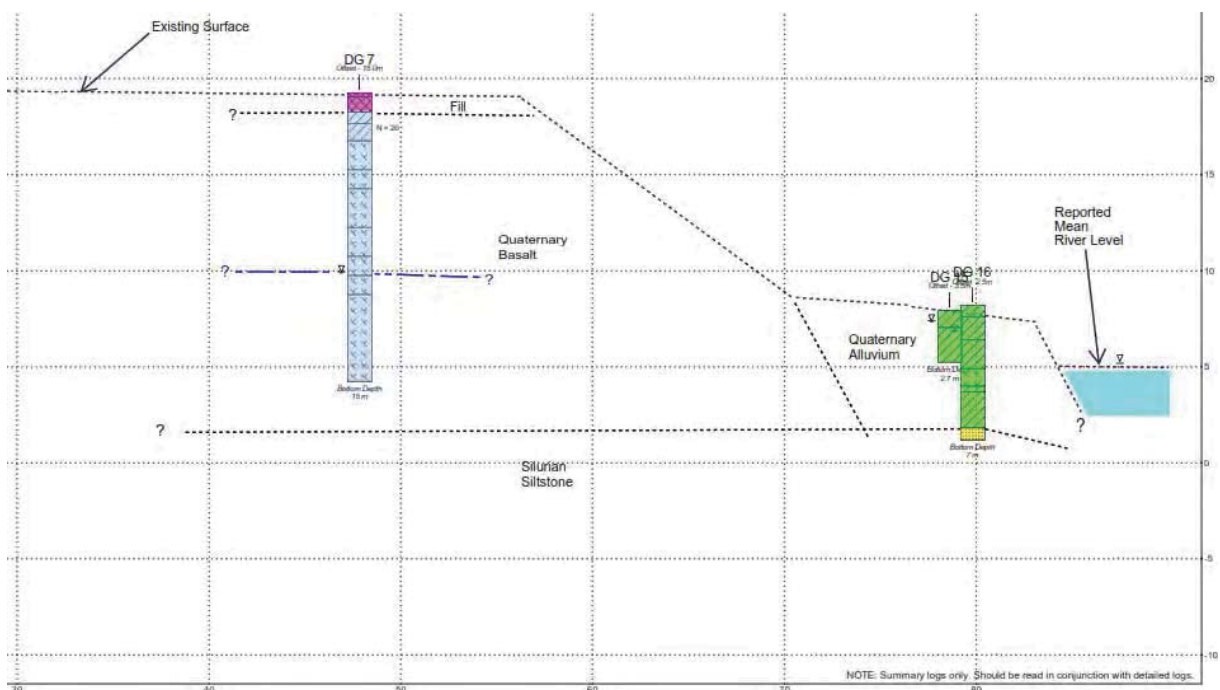
Figure 9 : Cross Section C-2 Extract (see Appendix B for full cross section drawing)

Relevant edge of the basalt flow appears to interface with the natural alluvium in the terrace zone adjacent to the river. There is minor clay fill (1 m thickness) above the natural residual volcanic clays at the embankment crest. The embankment toe and edge of the basalt flow are located about 12 m to 15 m from the river. Groundwater was observed emanating from the toe of the bank at this point, consistent with the water level in standpipe DG7.

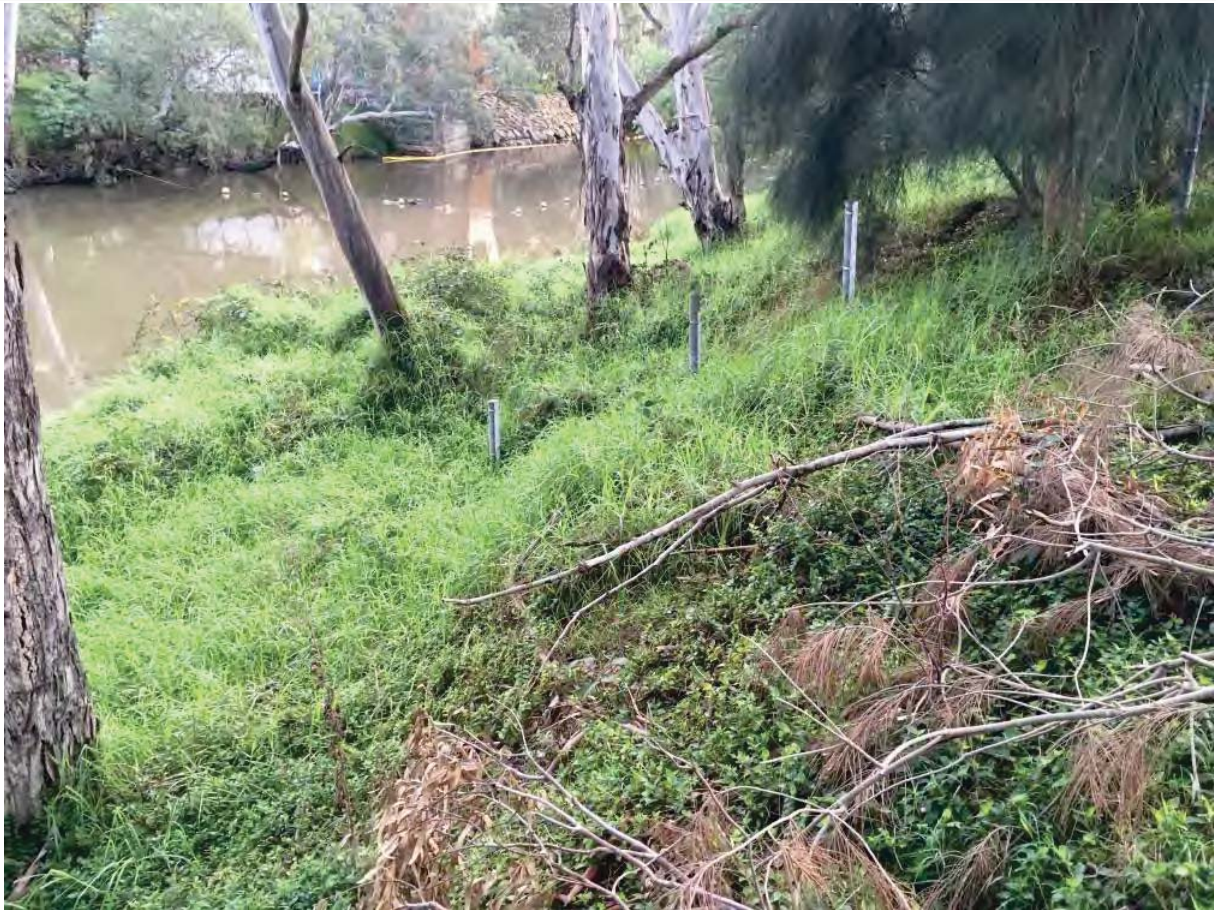
1 Old slump area, west of recent slump.

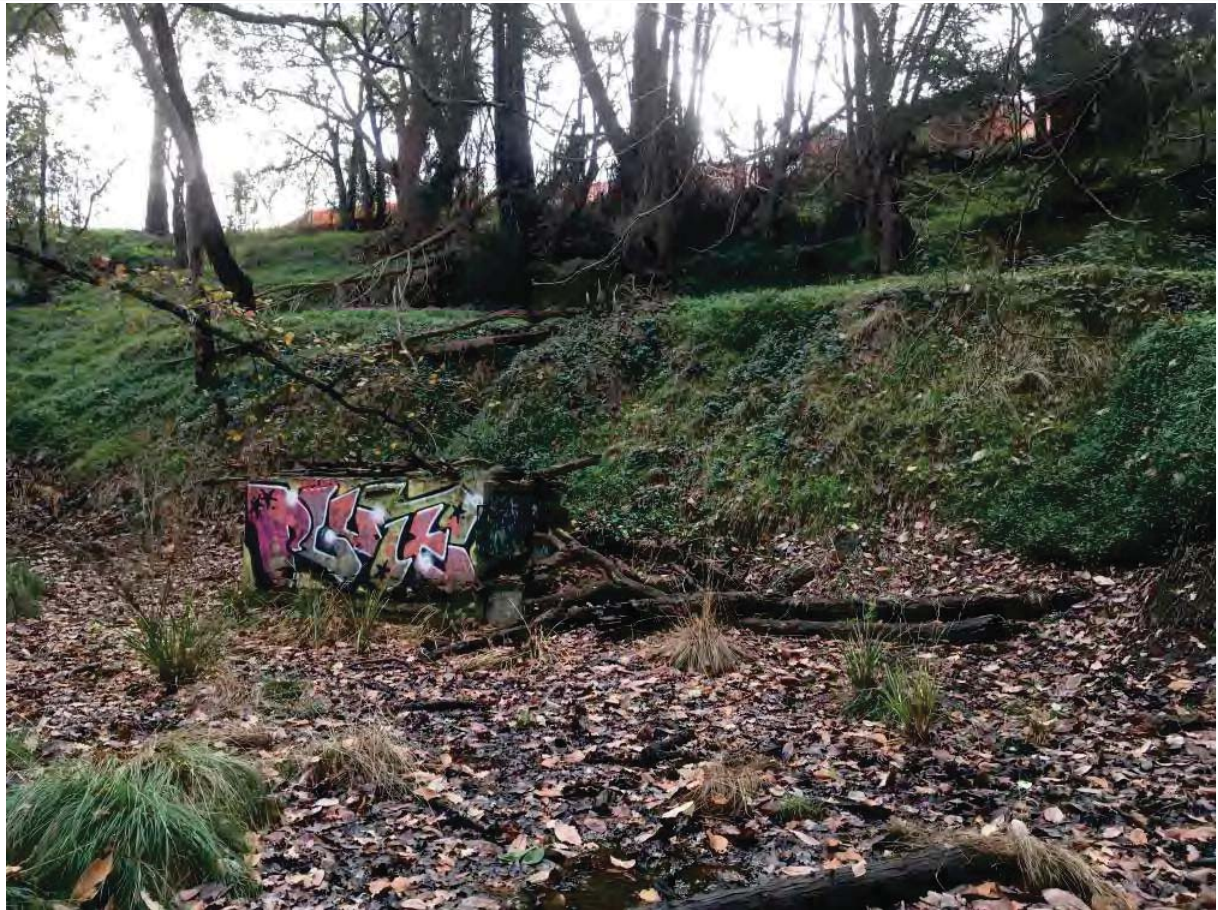
Seepage was reported in this area in January 2019. Tension cracks were observed by DP in June 2019. Wet ground was observed in this area at this time, consistent with prolonged poor drainage and intermittent wet ground, as shown in Plate 11 Appendix B (extract from of DP-July2019).

11 Terrace area.
