SUMMARY REPORT:

Tree collapse and bank slump investigation on Yarra River adjacent to former Amcor site at Alphington

February 2021

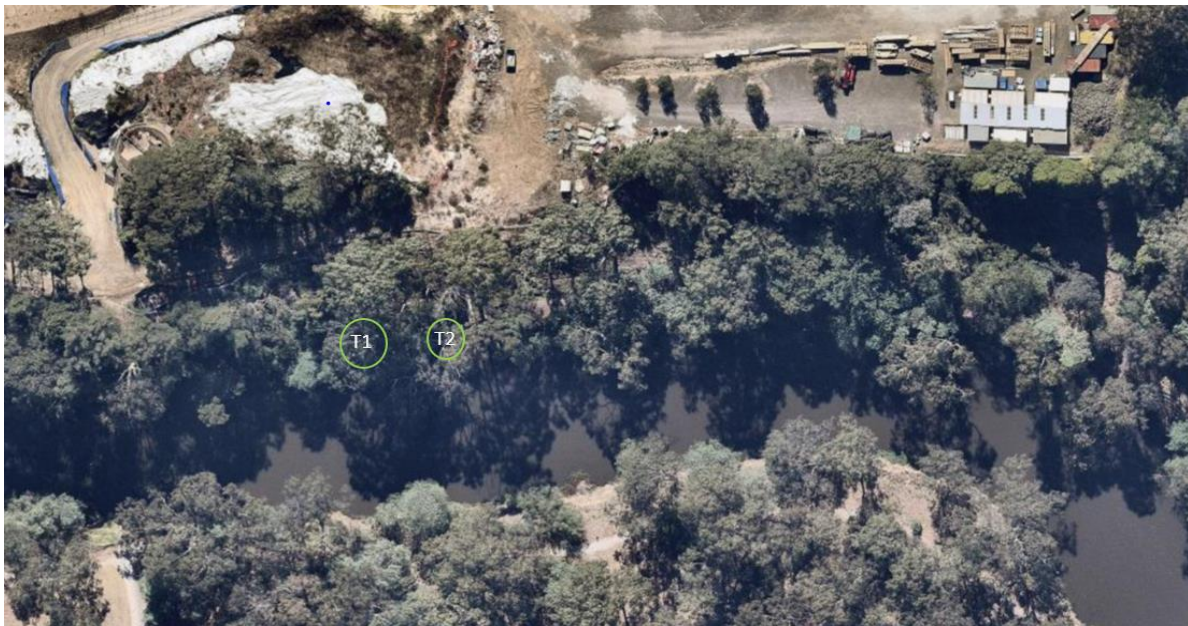
Figure 1. *The bank slumping zone on the Yarra River, with the location of trees assessed at bank slump zone*

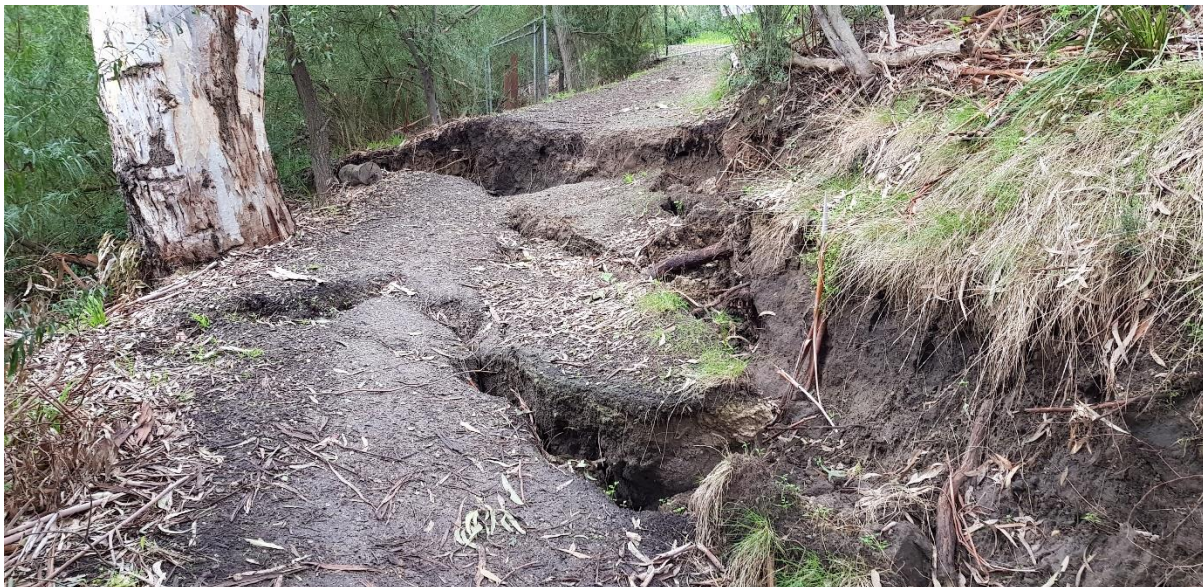
Figure 2. *Tree (T1) and bank slump site visit by Alluvium (August 2019)*

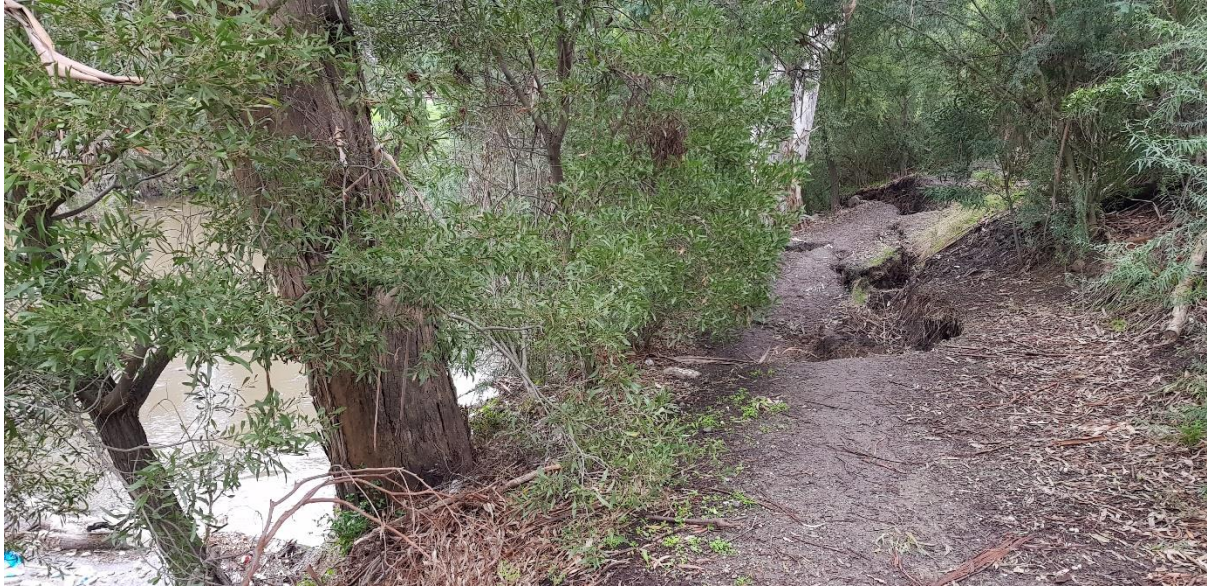
Figure 3 *Tree collapse (T2) at the edge of bank slump (August 2019)*
