RE: Site inspection 17 February 2021

I advise the following in relation to the inspection of trees along the corridor in response to Amcor observations of soil cracking on 16.02.21

A site inspection was undertaken on Wednesday 17 February 2021.

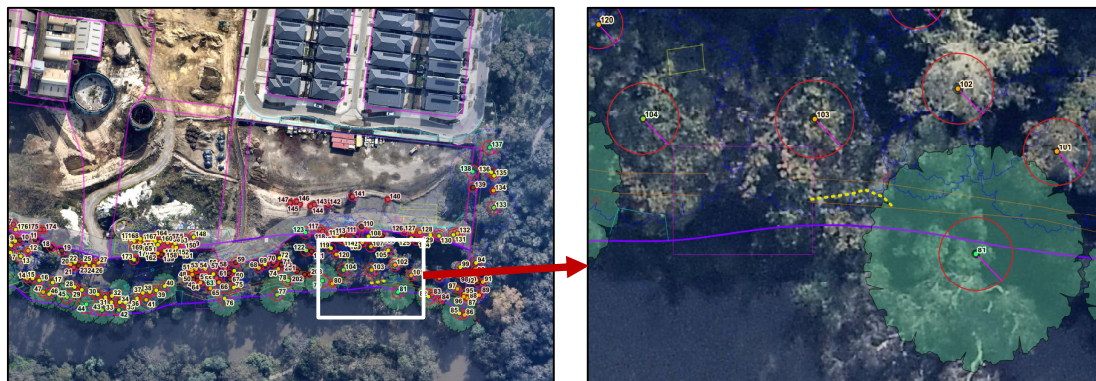
The cracking appears to be a relatively minor extension of an area already fenced off with fluoro-para webbing, i.e. an area that is already identified as a slumping risk. The most significant of the new cracks has appeared in the path ~0.5m north of the eastmost extent of the para-webbed area. The other path cracks are comparatively smaller but extend a further ~6.4m to the east.

The largest crack is ~7.1m south of Tree 103, while the eastmost cracking is 7.7m west of Tree 81. The approximate location of the observed cracking relative to the two trees is shown in Figures 1 & 2.

Figures 1&2. Approximate length of soil cracking (yellow dashed line) relative to the closest of the assessed trees. Red circles indicate SRZs.

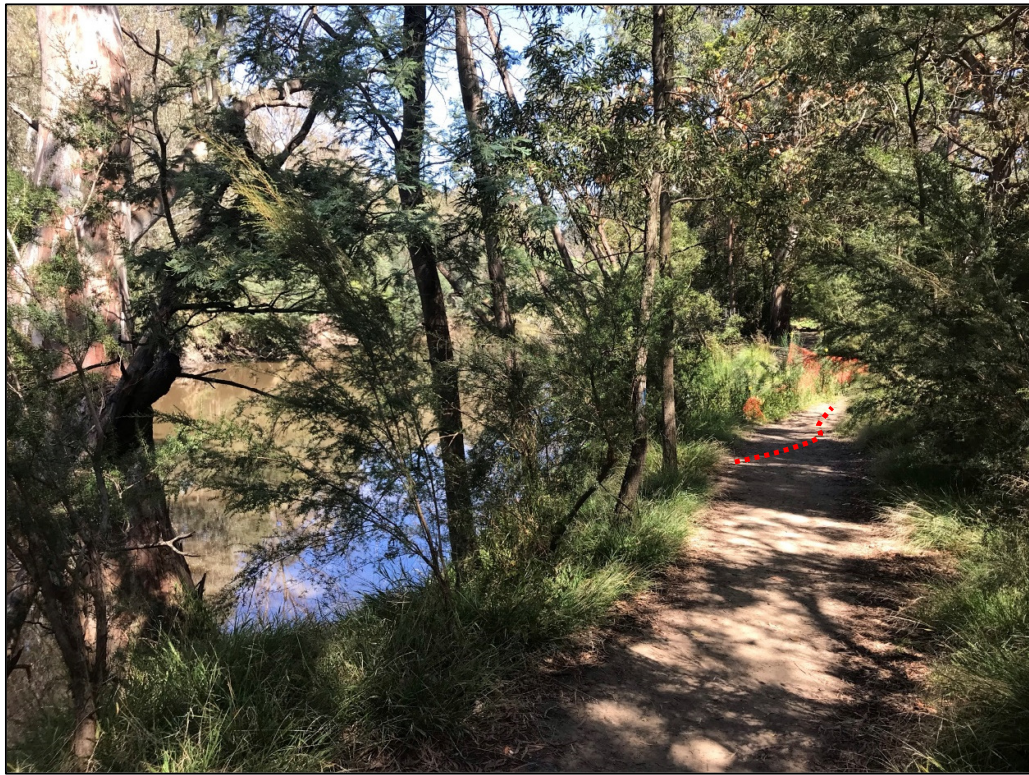
Image 1. Taken from next to Tree 81 (left) looking west. The red dotted line shows the approximate length of the newly appeared soil cracking.

The cracks appear to be an extension of an area already flagged due to its past slumping and presumably due to its potential for further soil instability. Thus far, the newly formed cracks are of a sufficient distance from the nearest significant trees (Trees 103 & 81) to warrant any immediate concern, i.e cracks are well outside the SRZs of both trees, so the root plates and structural roots of both trees are not expected to be impacted.

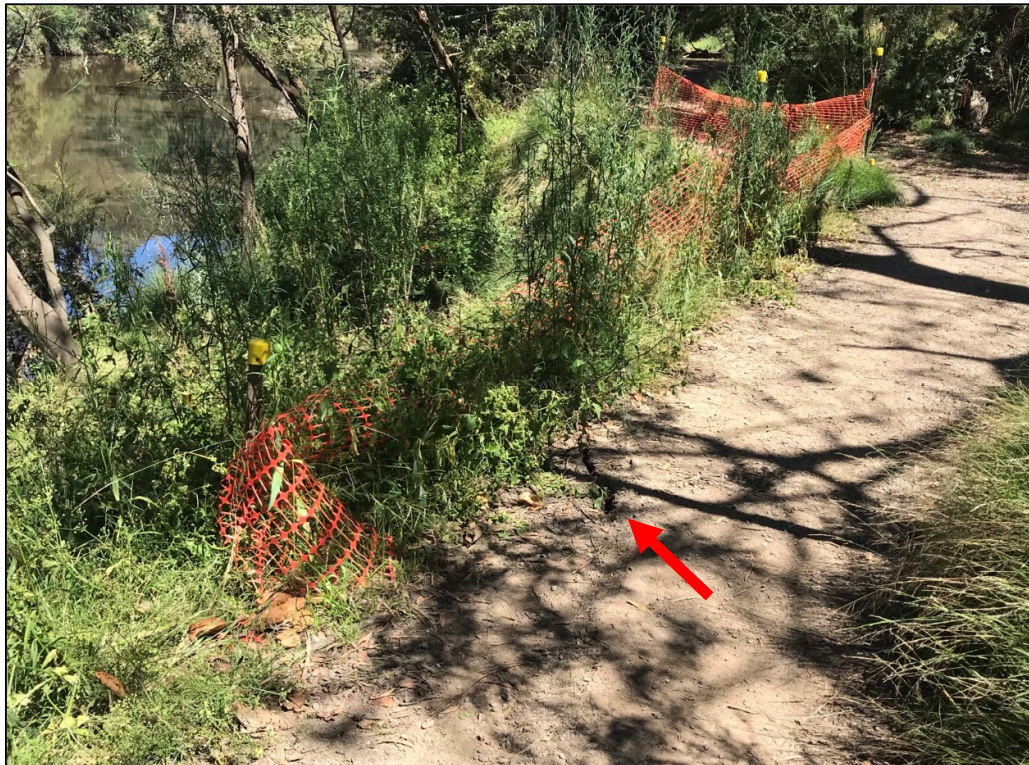
Image 2. Looking west, with arrow pointing to the largest of the newly appeared soil cracking, next to the existing para-webbed exclusion zone.

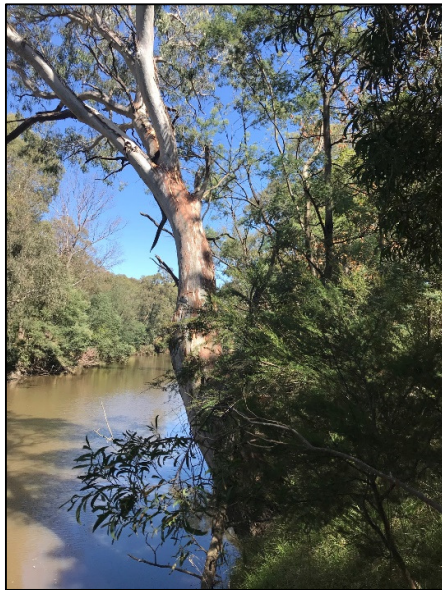
Trees 81 is a maturing River Red Gum (*Eucalyptus camaldulensis*) growing on the riverbank (Image 3). It exhibited fair and typical health and structural characteristics. It is not part of the Reeds monitoring program.

There were no observations indicating change of lean or root plate instability in either of the trees.

Images 3&4. Image on left shows Tree 81, Image on right Tree 103 and its location relative to the newly appeared soil cracking.

Regardless, it is recommended that Tree 81 be included in the Reeds monitoring program in case the issue worsens. Lean monitoring should continue on a monthly basis.

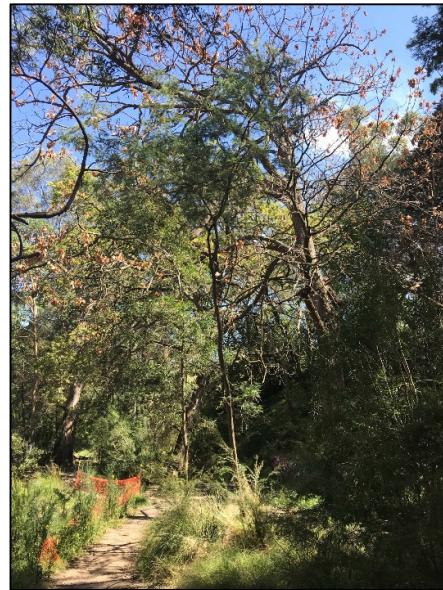
Tree 103 is a maturing Algerian Oak (*Quercus canariensis*) growing in the terrace area (Image 4). It was previously assessed as having poor health and this is still the case, with no live foliage observed. It is currently part of the Reeds monitoring program, which has thus far not detected any unusual movement in the lean of the tree.
