Tree Inspection Report for the City of Yarra

Applicant:		
Applicant address:		
Phone/Email:		
TRIM Reference:	230404-000195	Permit Reference: STree23/0031
Date of referral:	6/04/2023	
Property owner consent:	<input checked="" type="checkbox"/> Yes

Tree #1 Details

<p>TREE DIMENSIONS <small>TREES IN THE BUILT ENVIRONMENT</small></p>	<p>Inspection date: 11/04/2023</p> <p>Report date: 19/04/2023</p>
<p>Tree inspection was undertaken in accordance with section 39 of <i>Procedure and Protocol Manual - Yarra City Council General Local Law 2016</i>.</p>

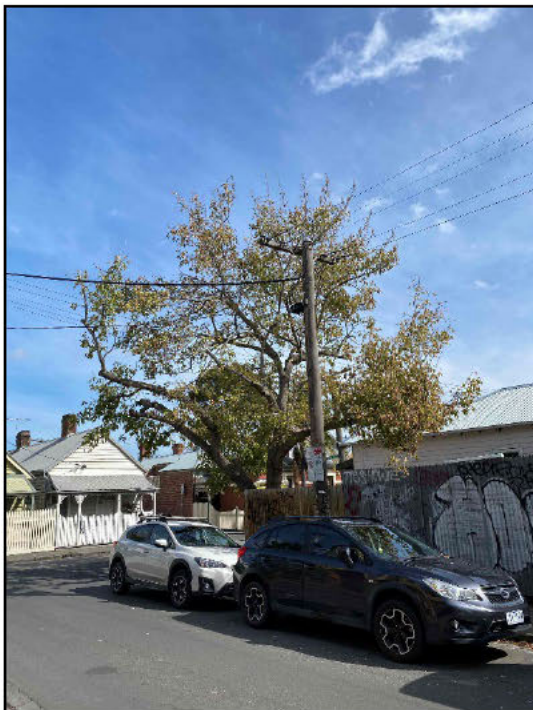
Tree #1 viewed form the north-east.

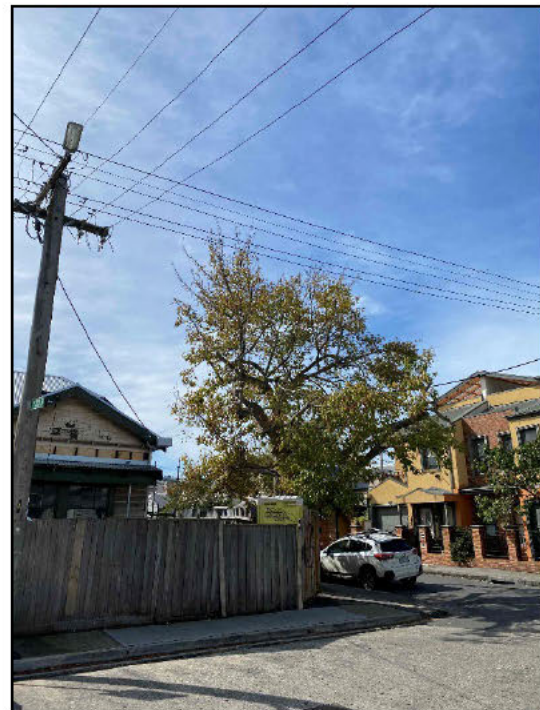
Tree #1, viewed from the south-west.

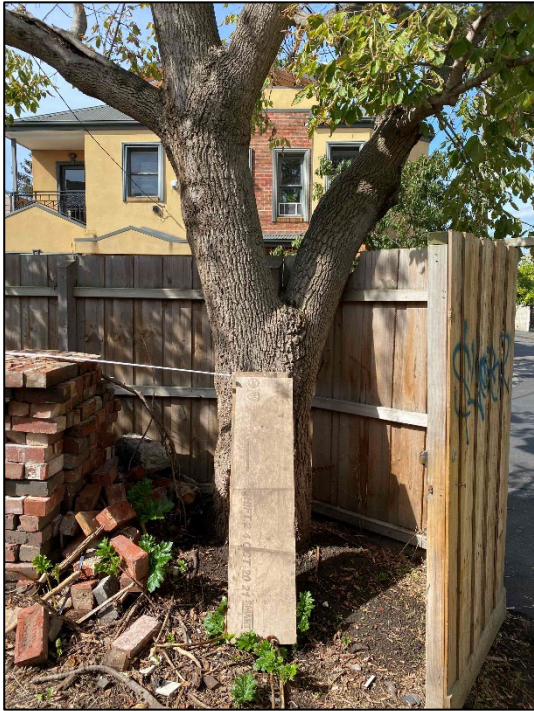
not appear compromised. The stem divides into two at about 1.0 m above ground level with bark included in the tight crotch above the union. Reaction wood has been produced on either side of the union.

Tree #1, the stem.

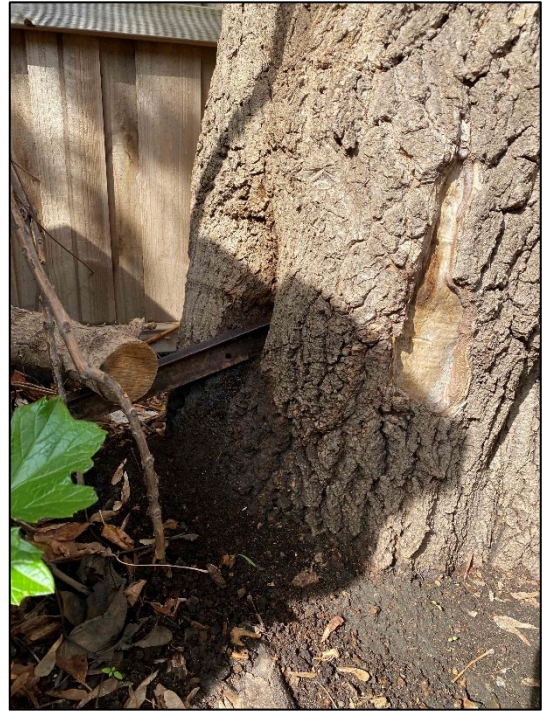
Tree #1, the stem base. A cavity (the steel picket was taken out to inspect the cavity) and a minor wound.

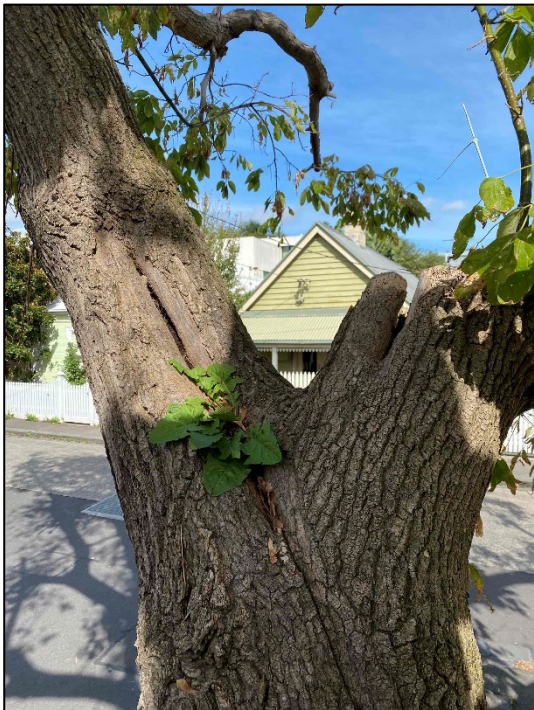
Old decaying wounds were visible on the top side of some primary branches. Reduction pruning has been undertaken on the crown on all sides, decreasing the load on decayed defects.

Tree #1, a decayed wound on the topside of primary branches.

Conclusions:	<p>This tree is of medium significance in the landscape and contributes high amenity to the area. It does not require removal.</p> <p>Because of recent pruning, no action is required at this time. However, further reduction pruning will be required every 2–5 years.</p>
Recommended action:	<p>Decline application for removal.</p> <p>Note: Pruning is to be done by qualified arborists (minimum AQF level 3) and must conform to the guidelines of AS4373 Pruning of Amenity Trees.</p>

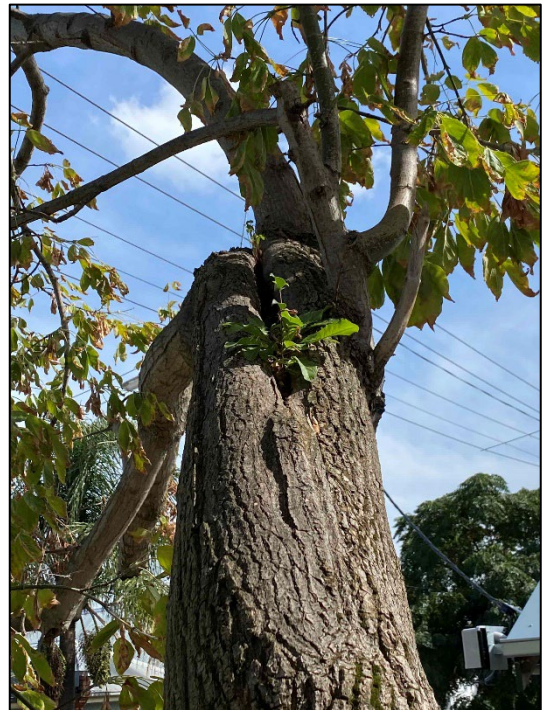
Tree #1, another decayed wound on the topside of a primary branch.

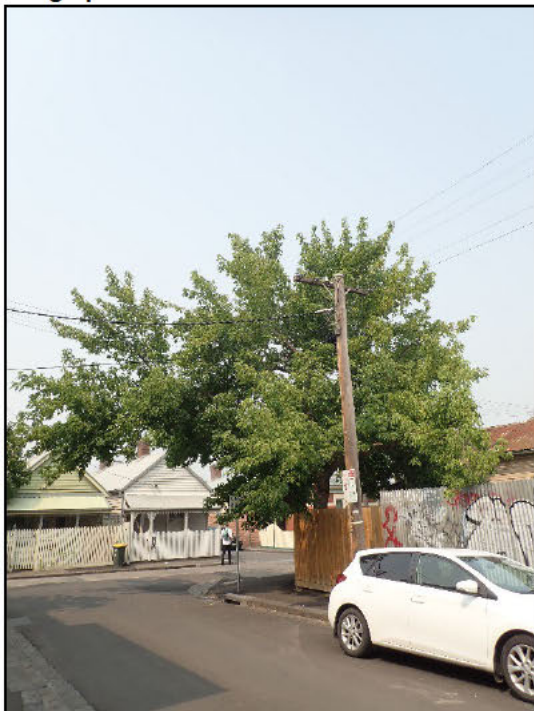
Tree #1 viewed from the north-east.

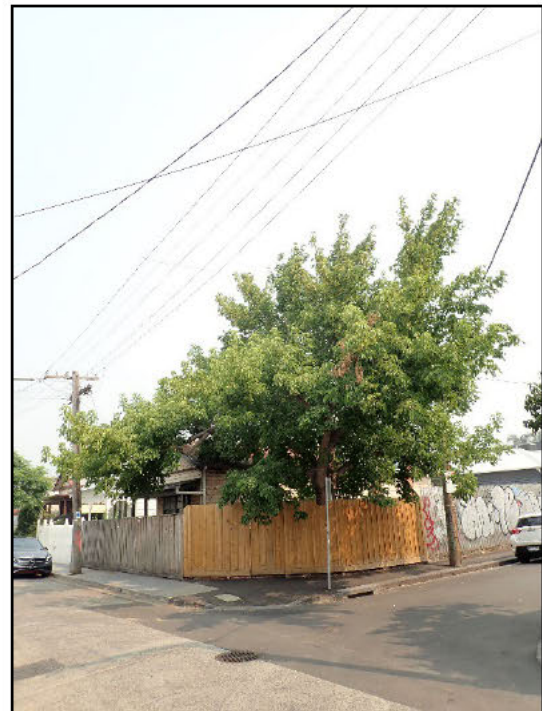
Tree #1 viewed from the south-east.

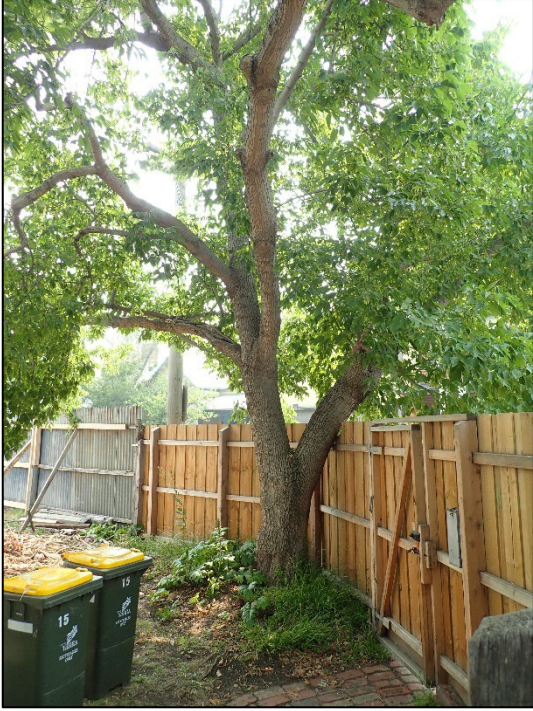
Tree #1's lower stem.

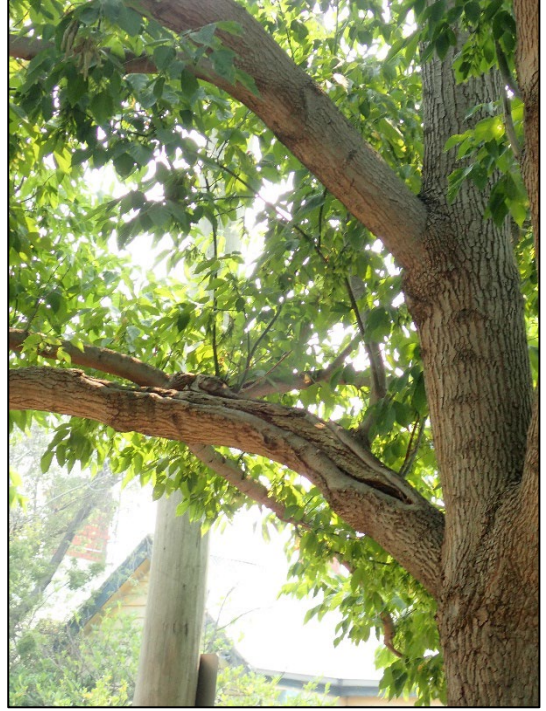
Tree #1: A decayed wound on the topside of a limb to the north-west.

Conclusions:	<p>This tree is of medium significance in the landscape and contributes to amenity and ecosystem services. It does not require removal.</p> <p>Reduction pruning to decrease weight on the eastern side and on decayed limbs/branches is a viable option to reduce the risk if limb failures. This will also shape the tree and reduce some of the canopy overhanging the road.</p>
Recommended action:	<p>Decline application for removal.</p> <p>Approve the following pruning:</p> <p>Reduction pruning, shortening the crown's length on the eastern side length (and therefore decreasing the weight), and pruning to reduce load on decayed limb/branches. A maximum of 15–30% live crown can be removed.</p> <p>Note: Pruning is to be done by qualified arborists (minimum AQF level 3) and must conform to the guidelines of AS 4373 <i>Pruning of amenity trees</i>.</p>

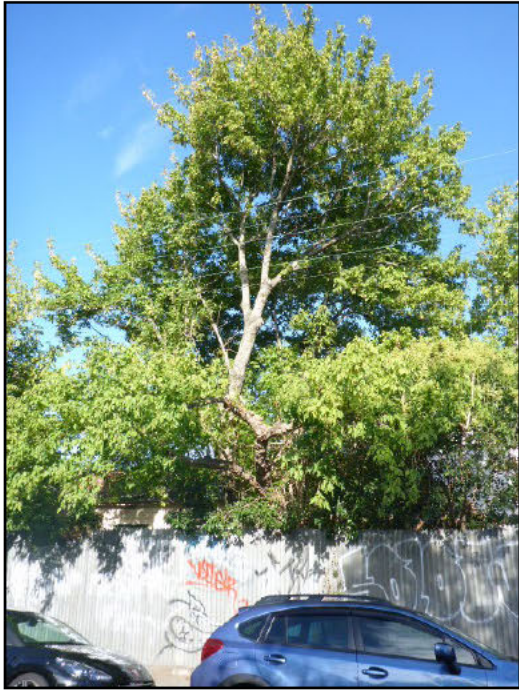
Tree #1 viewed from Miller Street.

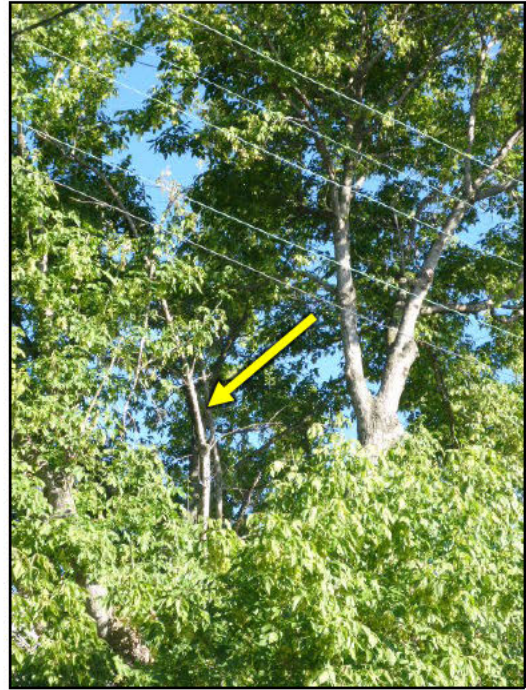
The northern tree (#1) has been pruned for powerline clearance on its eastern side. Viewed from within the site, the tree has also been lopped in the distant past. Epicormic shoots have since established from lopping points. The branch unions that were visible from the ground appeared sound. Some branches extend over a significant area of the dwelling's roof and may be of epicormic origin from the lopping points. If so, they may be weakly attached and pose a risk of failure. Some structural roots near the root flare are exposed and show early signs of decay.

Tree #1 has been pruned for powerline clearance and has large deadwood in its crown (arrow), along with established epicormic shoots.

<p>shape the tree and reduce the crown overhanging the south-east corner of the dwelling. Deadwood removal is also required.</p> <p>All trees shed leaves and twigs, which in urban environments will often fall onto roofs and gutters. Cleaning such debris is part of routine property maintenance and is not usually a reason for Council to approve tree removal.</p>
Recommended action:	<p>Approve application for removal of tree #1.</p> <p>Decline application for removal of tree #2.</p> <p>Approve the following pruning for tree #2: Deadwood removal; preventative weight-reduction pruning, reducing the length of branches by about 20% maximum canopy loss.</p> <p>Note: Pruning must be done by qualified arborists (minimum AQF level 3) and conform to the guidelines of AS4373 <i>Pruning of Amenity Trees</i>.</p> <p>Note: Removal must be done by qualified arborists (minimum AQF level 3) with appropriate insurance.</p>

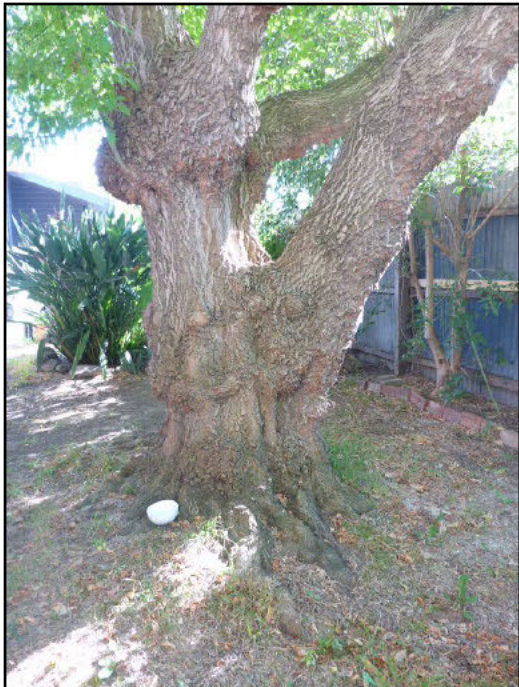
Tree #1's base; some exposed structural roots show early indications of decay.

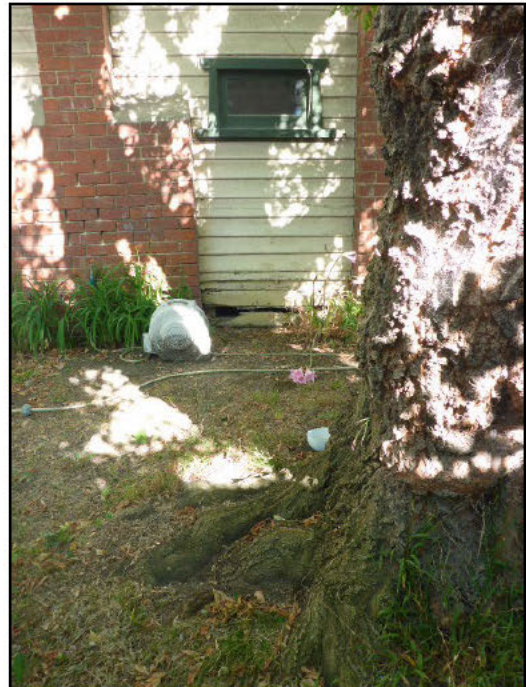
Tree #1's base in relation to the dwelling (2.5 metres).

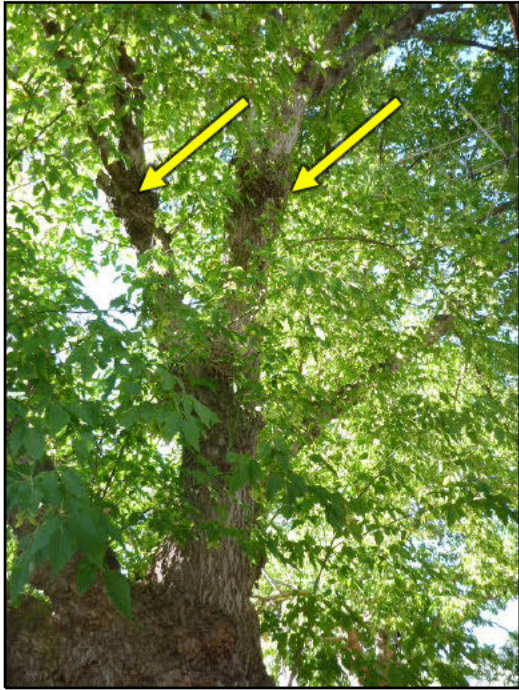
Tree #1's branches have been lopped in the past.

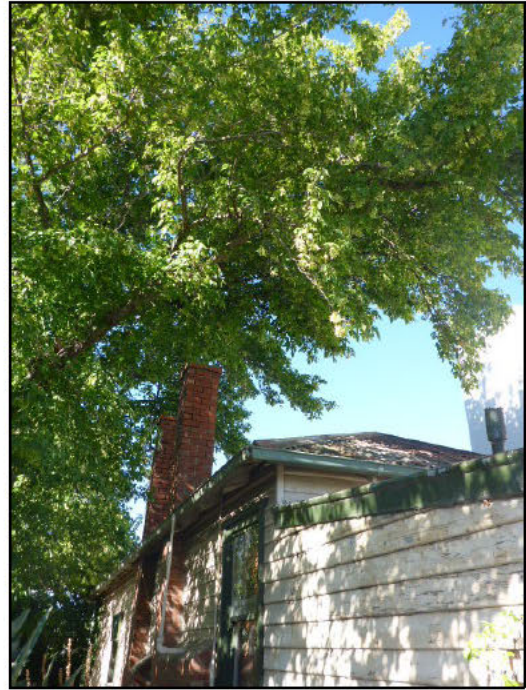
Tree #1's crown extends over the roof of the dwelling.

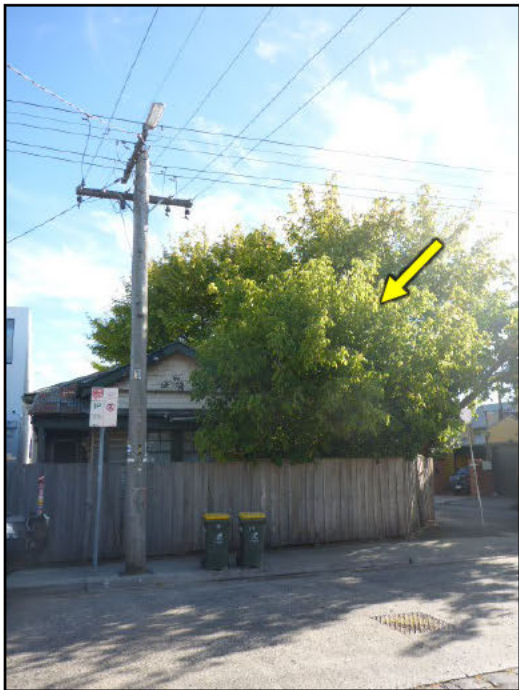
**Tree #2 viewed from Richmond Terrace
(Tree #1 is visible in the background).**

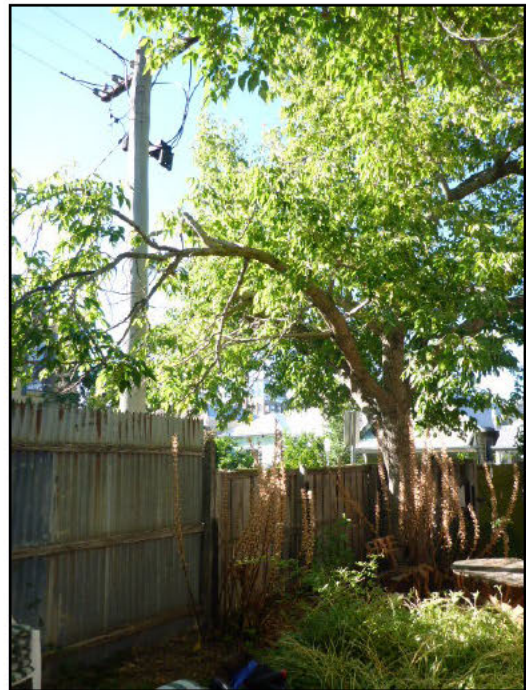
Tree #2 viewed from the north, within the site.

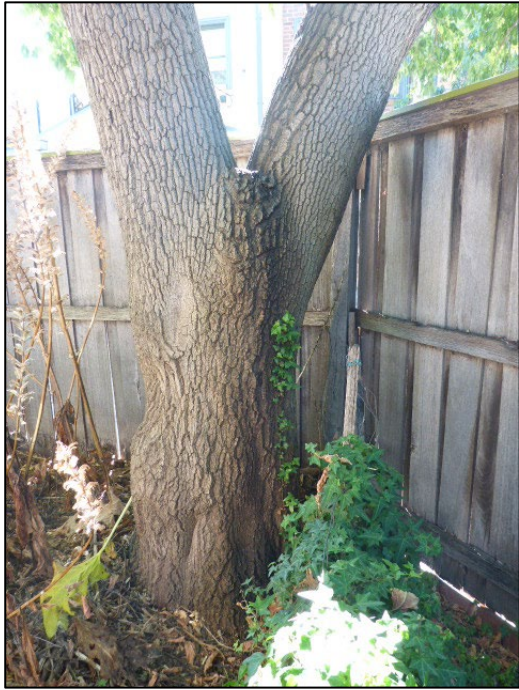
The southern tree (#2) grows over a section of the south-east corner of the roof. The tree has some established epicormic shoots in the crown. This tree's stem is bifurcated with a y-shaped union and has a sealed cavity at the base. The roots of this tree are not exposed.

Tree #2's bifurcated stem.

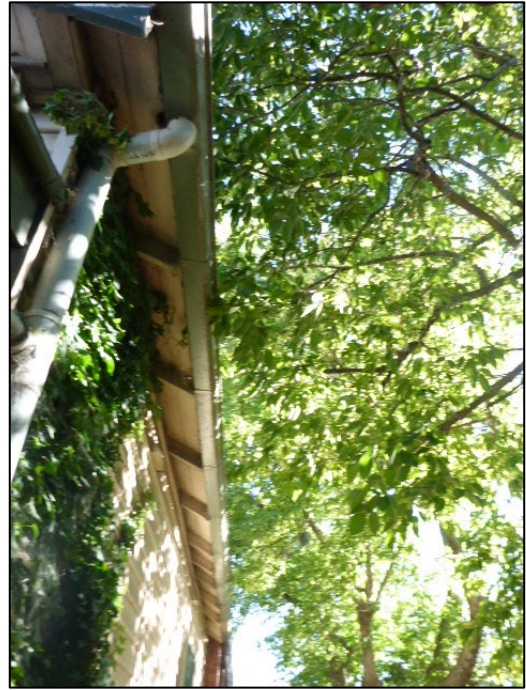
Tree #2's crown reaches the south-east corner of the dwelling.
