Heritage Impact Statement

Cairo Flats – Garden Wall Remediation

98 Nicholson Street, Fitzroy 3000

Date: 29/01/2021

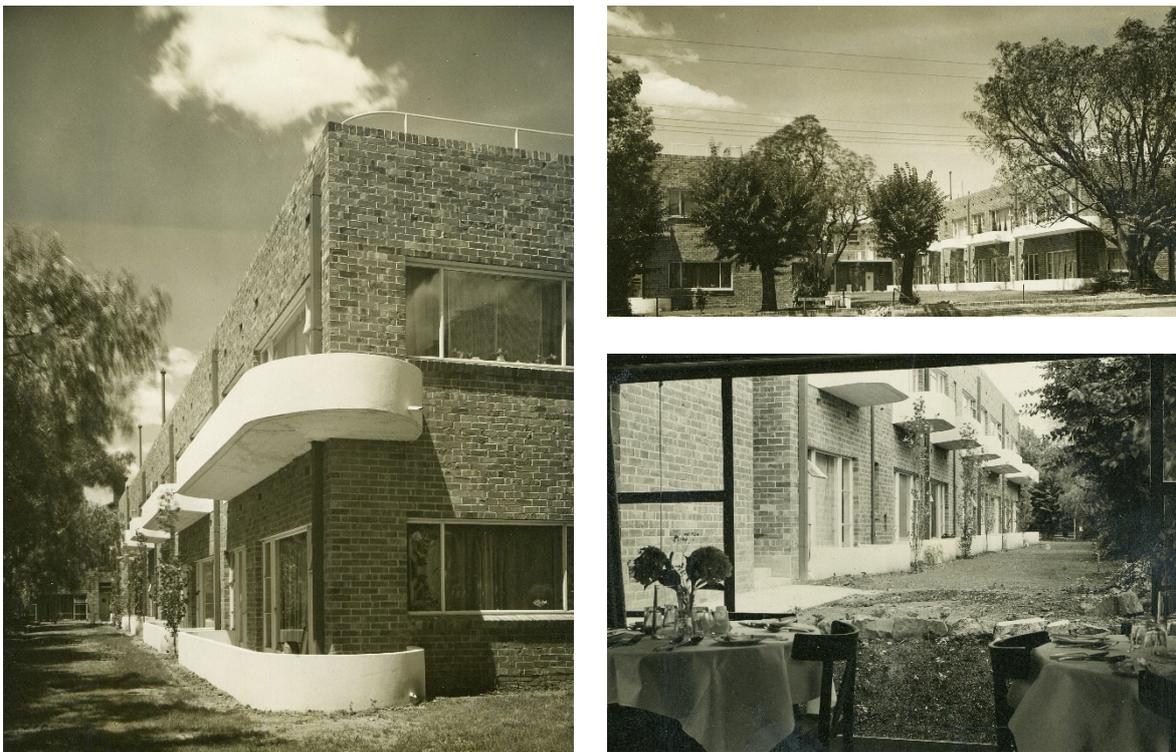
Figure 3 Views of Cairo yards. Left: view looking east down the north side of the property from Nicholson St, note the established peppercorn tree and elm along the fence line. Top Right: View of the front yard from Nicholson St indicating no low-level shrubs, along with a series of established Elms, Moreton Bay Fig (since removed) and Jacaranda (since removed). Bottom Right: View from inside the milkbar looking west along the northern edge of the site depicting Birch planted between the balconies and remaining established trees along the northern fence line.

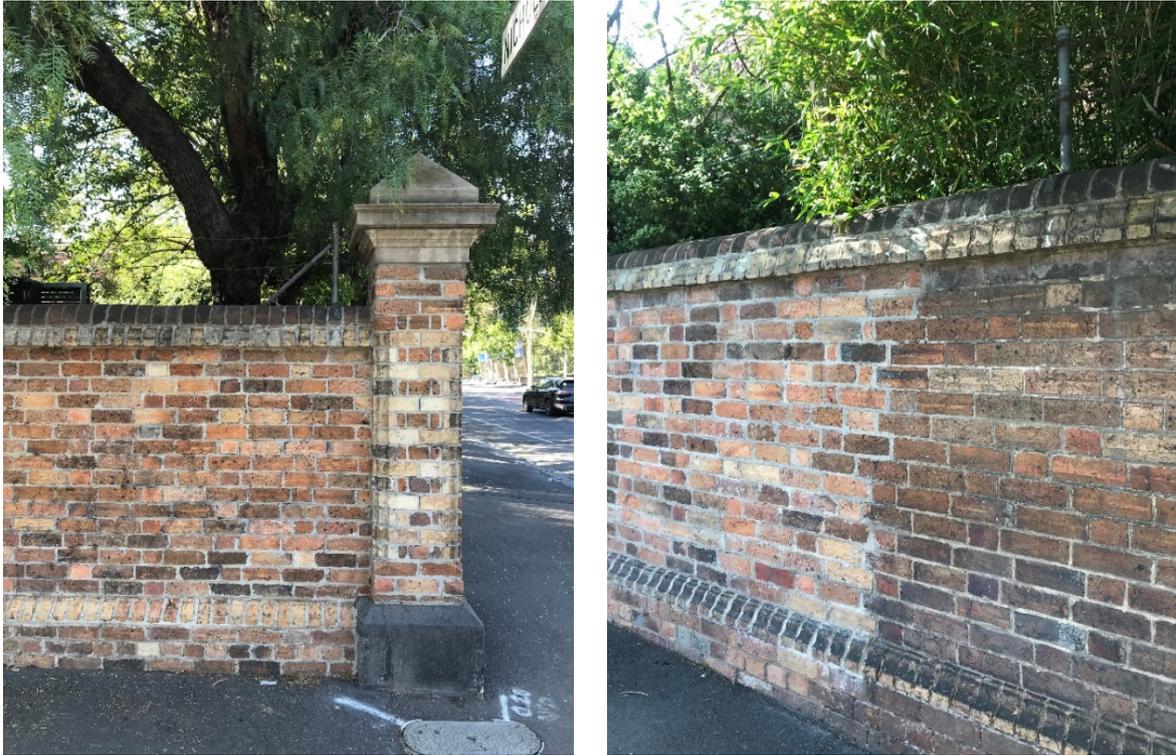
Figure 4 Hanover St garden wall. Left: Western end of the wall at the corner of Nicholson St. This section of wall was reconstructed in 2007. Right: Midway section of the wall indicating a junction between the existing and a section of reconstruction, note the difference in pointing and the colour of the bricks.

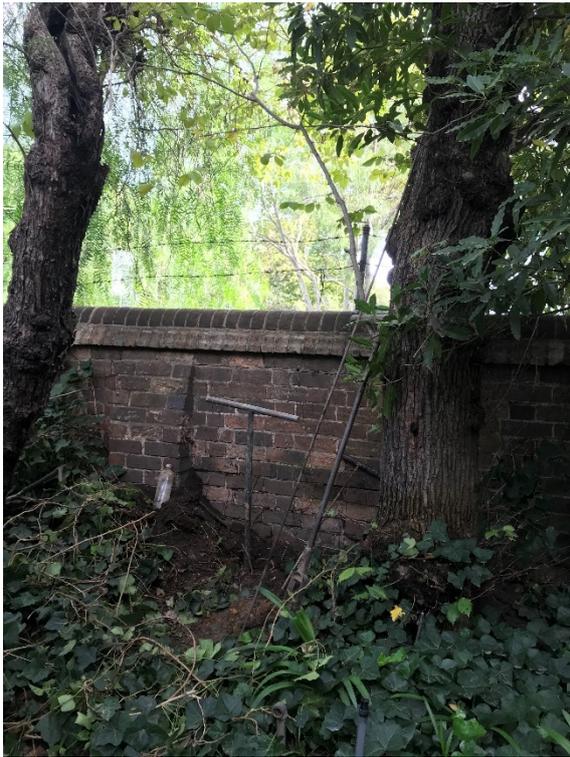
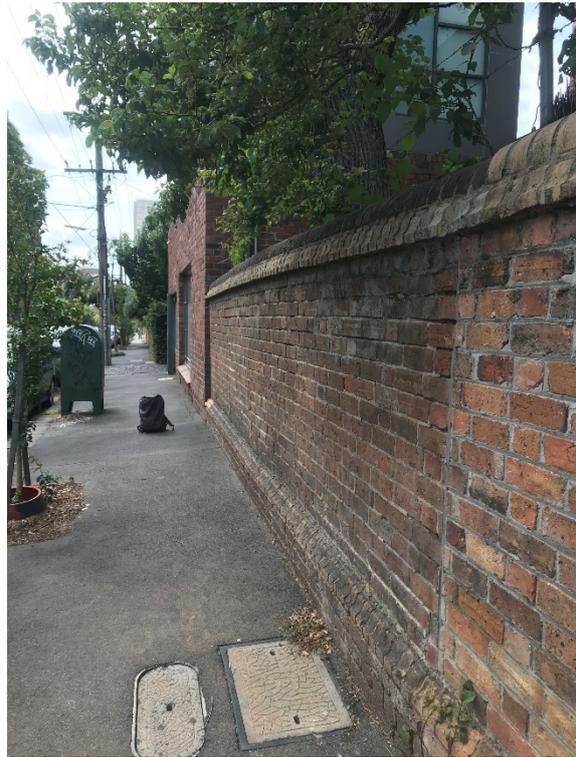
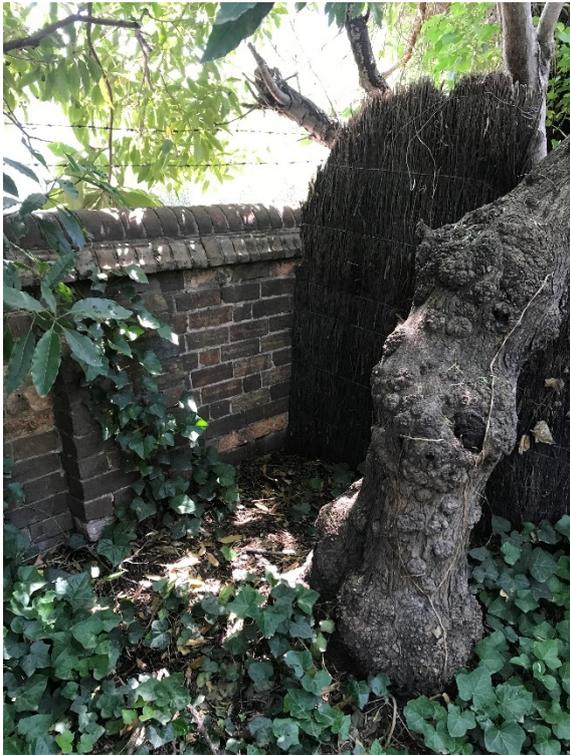
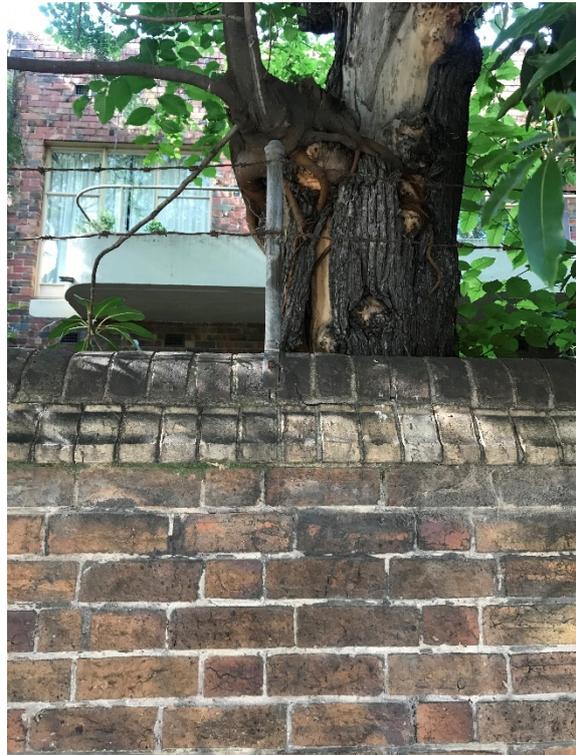
Figure 6 Left: Views of the inside of the wall indicating the build-up of ground level compared to the street view of the wall. Note irregularly occurring engaged piers in the rear of the wall and the close proximity of plantings to the wall. Right: Street views of the wall indicating the outward bowing and capping details.

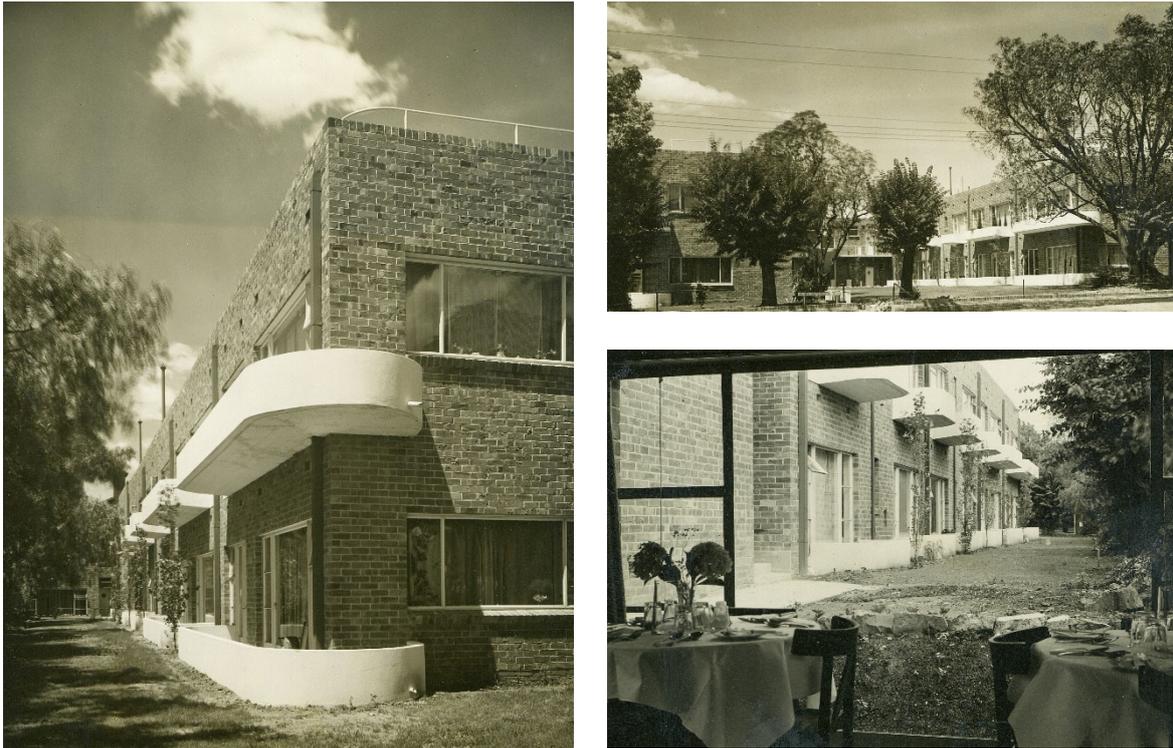
Figure 8 Views of Cairo yards. Left: view looking east down the north side of the property from Nicholson St, note the established peppercorn tree and elm along the fence line. Top Right: View of the front yard from Nicholson St indicating no low-level shrubs, along with a series of established Elms, Moten Bay Fig (since removed) and Jacaranda (since removed). Bottom Right: View from inside the milkbar looking west along the northern edge of the site depicting Birch planted between the balconies and remaining established trees along the northern fence line.

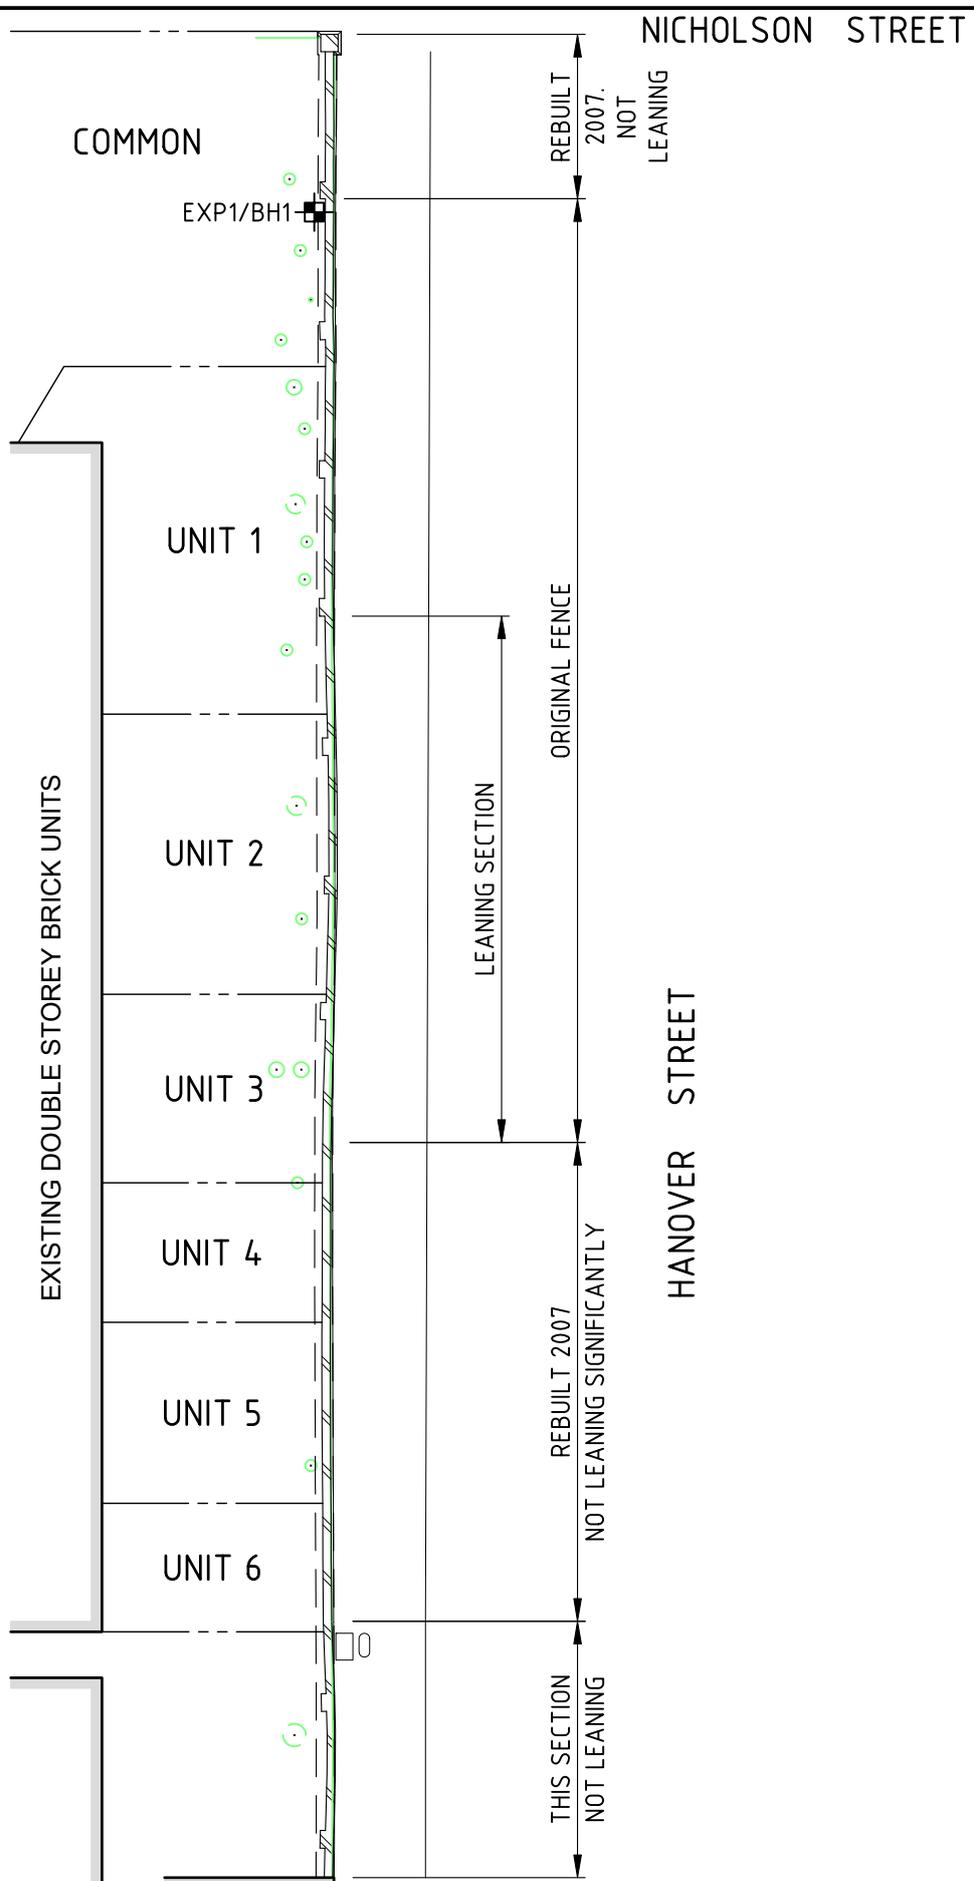
Job	CAIRO FLATS BOUNDARY WALL 98 NICHOLSON STREET FITZROY STRUCTURAL REVIEW	Date	MAY 20	Scale	1:200
		Surveyed	D.H	Drawn	W.H
Title	EXISTING CONDITIONS SUMMARY	Job No	7669	Sheet No	SK01

Outward leans to the wall have developed over a long period of time. The degree of lean varies from low to significant. Sections of the wall rebuilt on new footings in 2007 remain reasonably plumb and are not of current concern. A review of the wall was made by others last year, with the recommendation that the remnant original sections of wall be demolished and rebuilt. This investigation is aimed at:

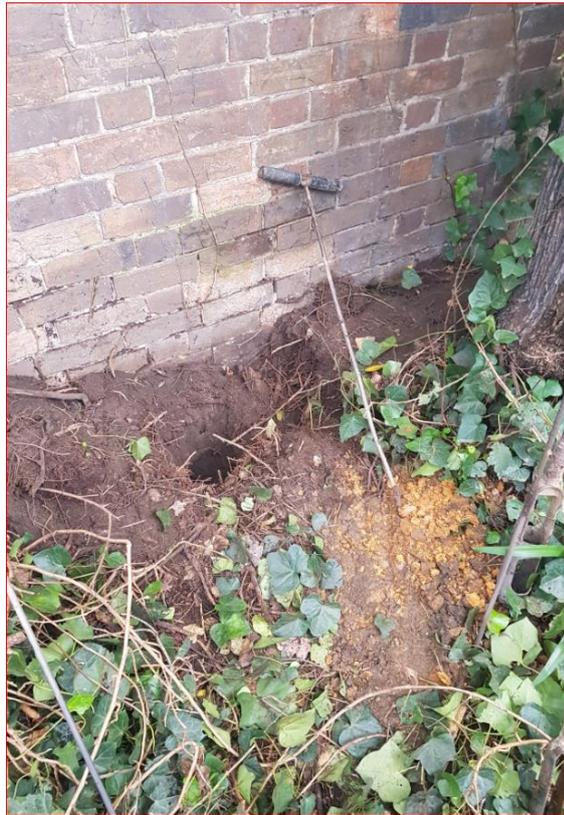
Location	Borehole 1	Borehole 2
	North boundary	North boundary
Type	Bluestone strip	Bluestone strip
Founding Depth	1000mm	1000mm
Depth of Footing	300mm	330mm
Projection	120mm	120mm
Founding Material	silty CLAY	silty CLAY
