Cathedral Stone, 395 Johnston Street Abbotsford, Victoria 3065
Commercial Builder (Limited) CB-L 31787
ABN: 360 506 079 06

2nd October 2018

PROJECT **293 CHURCH STREET, RICHMOND (Lalor House)**
SUBJECT **HERITAGE FAÇADE INSPECTION and CONSERVATION SCHEDULE OF WORK**

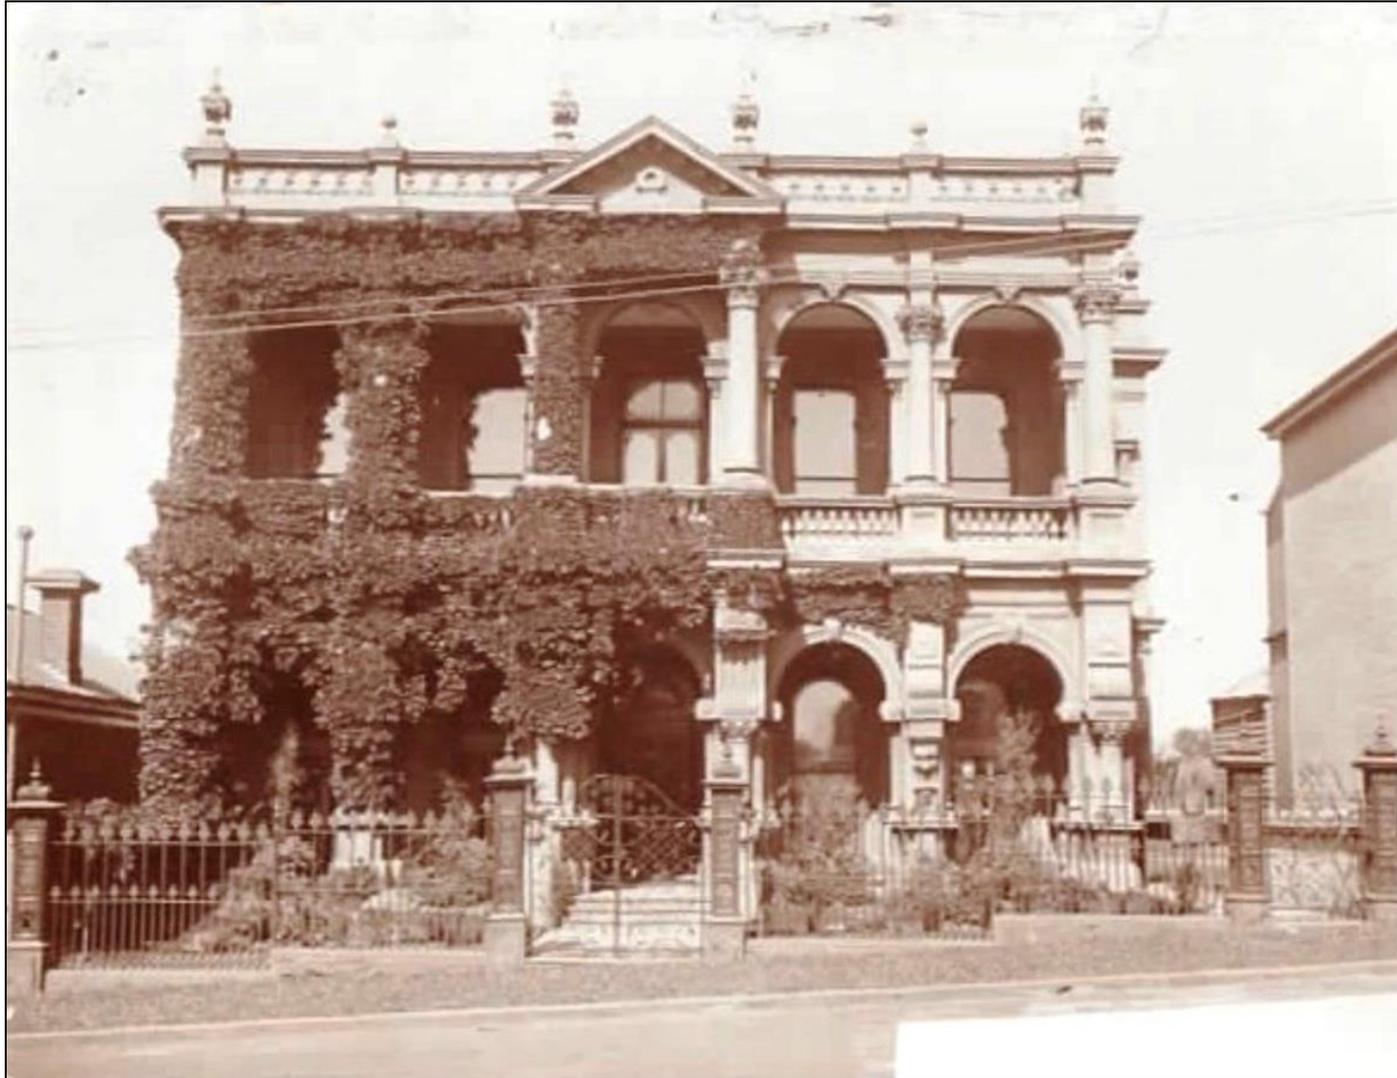
Figure 1. Former Lalor House, West Elevation. (Source: Supplied by Jeremy Quinn)

Undated historic photograph of Lalor House showing original parapet urn embellishments.

ITEM	DESCRIPTION	APPROX. DIMENSIONS	REPAIR CODE
050-053	Moderately drummy, extensive crazing, fatigued/eroded sand finish. Loss of Urns and Balls. Refer Figure 1, Section 8 of this Report.	20m ²	BIO, WSH, CRK, STR, STL, BRK, R1, R2, MLD. Replace missing decorations

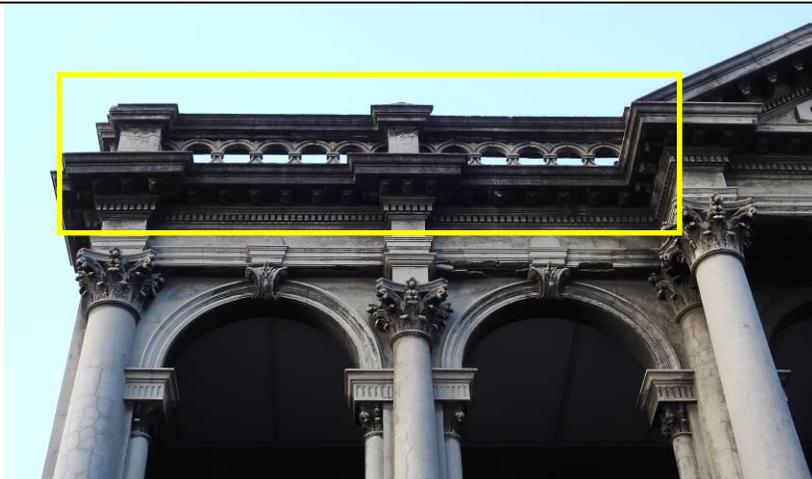
- Extensive cracked, fretting and drummy render
- Vertical and horizontal stress fractures resulting in loss of material
- Corroded steel/iron lintels appear to retain most of their original profile and integrity
- Moderate efflorescence to soffit moulds

ITEM	DESCRIPTION	APPROX. DIMENSIONS	REPAIR CODE
001	Parapet and coping experiencing advanced cracking	2m ²	BIO, WSH, CRK, STR, STL, BRK, R1, R2, MLD
002, 003, 004, 005	Horizontal cracking through parapet and above coping. Rusting lintels	Several metres (requires elevated access to quantify)	BIO, WSH, CRK, STR, STL, BRK, R1, R2, MLD
006, 007, 008, 009	Horizontal and vertical cracking through cornice. Efflorescence observed.	As Above	DES, WSH, CRK, STR, STL, BRK, R1, R2, MLD

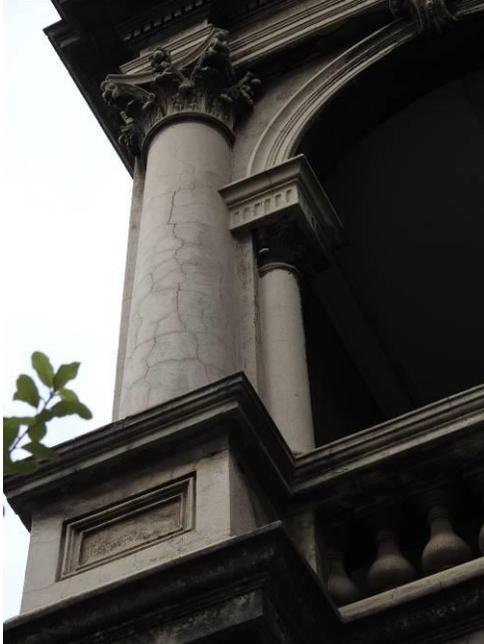
010

- Extensive crazed, cracked, fretting and drummy render
- Vertical and horizontal stress fractures resulting in loss of material
- Corroded steel/iron lintels to appear to retain most of their original profile and integrity

ITEM	DESCRIPTION	APPROX. DIMENSIONS	REPAIR CODE
010,011	Columns and pressed cement capitals display extensive crazing though structurally sound	2	WSH, Monitor, Inspect when scaffold erected
012, 013, 014, 015	Horizontal cracking through string course. Rusting lintels	Several metres (requires elevated access to quantify)	BIO, WSH, CRK, STR, STL, PIN, BRK, R1, R2, MLD

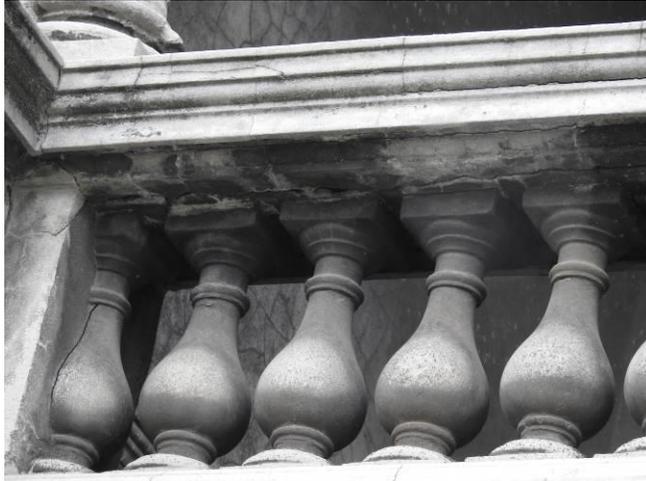
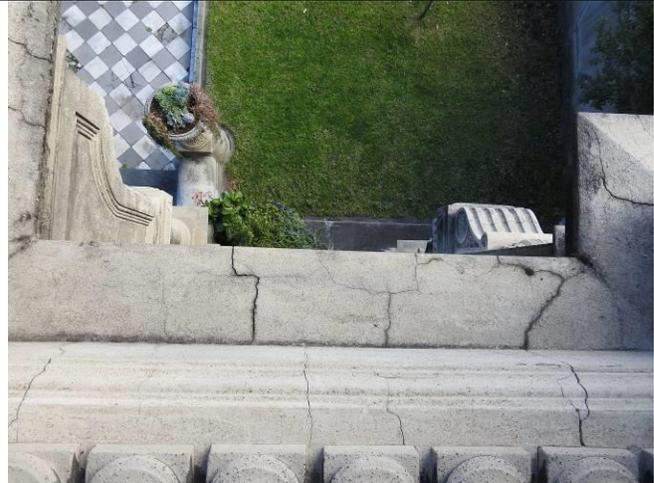
- Extensive crazed, cracked, fretting and drummy render
- Vertical and horizontal stress fractures resulting in loss of material
- Corroded steel/iron lintels appear to retain most of their original profile and integrity
- Moderate efflorescence to soffit moulds

ITEM	DESCRIPTION	APPROX. DIMENSIONS	REPAIR CODE
016,017, 018, 019	Horizontal cracking through parapet and above coping. Rusting lintels. Efflorescence observed.	Several metres (requires elevated access to quantify)	DES, BIO, WSH, CRK, STR, STL, BRK, R1, R2, MLD,

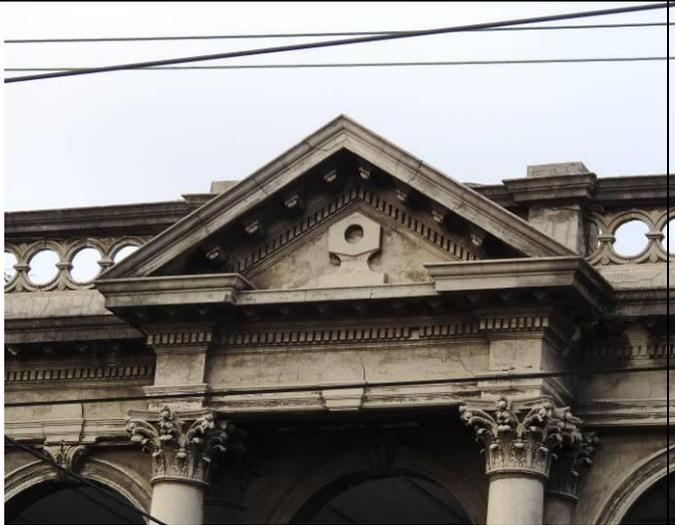
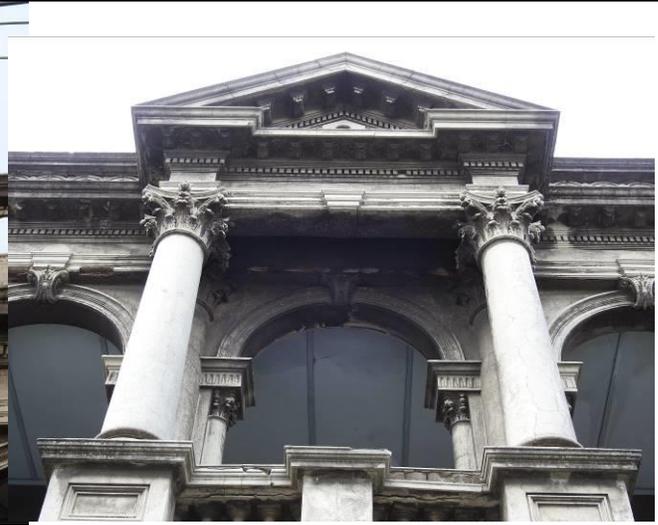
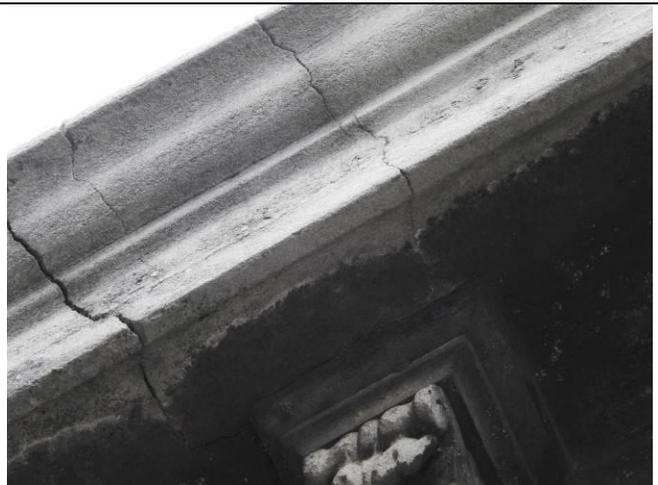
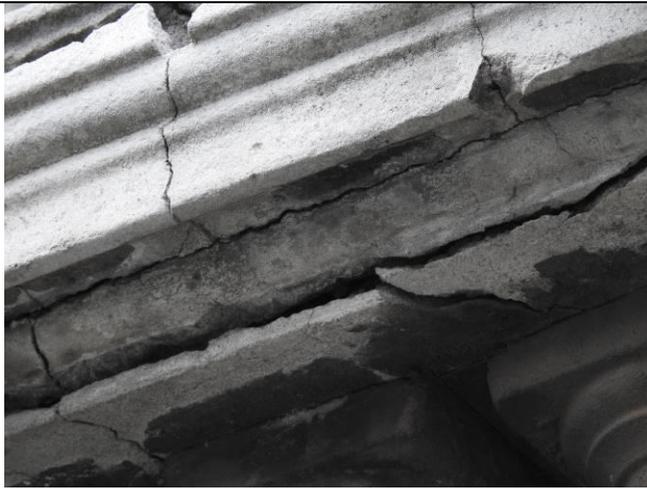
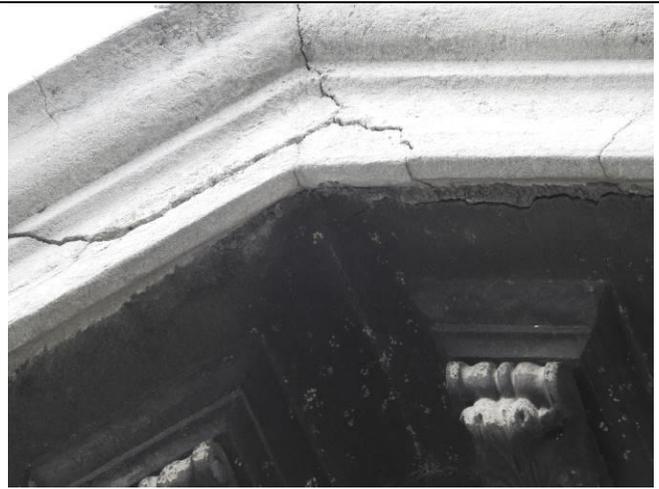
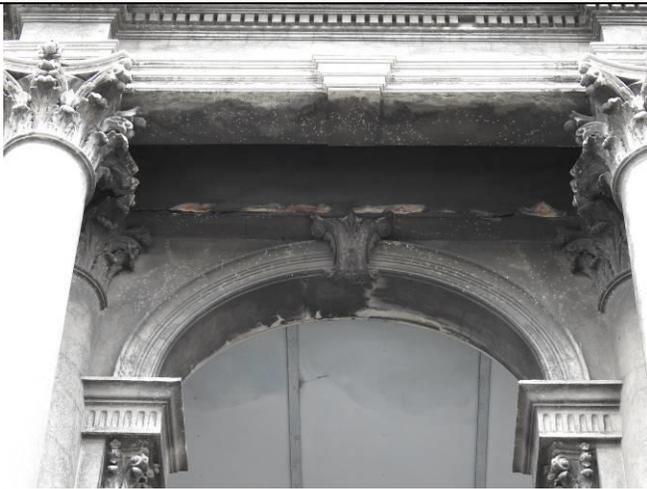
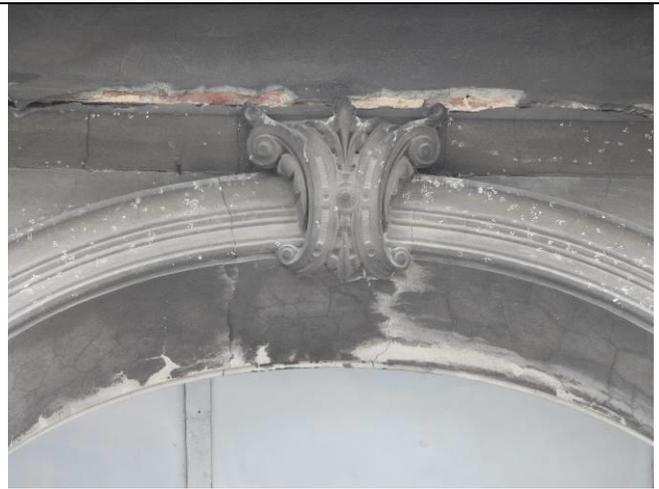
- Extensive crazed, cracked, fretting and drummy render
- Vertical and horizontal stress fractures resulting in loss of material
- Corroded steel/iron lintels appear to retain most of their original profile and integrity
- Moderate efflorescence to soffit moulds

ITEM	DESCRIPTION	APPROX. DIMENSIONS	REPAIR CODE
020-027	Horizontal cracking through parapet and above coping. Rusting lintels. Efflorescence observed.	Several metres (requires elevated access to quantify)	DES, BIO, WSH, CRK, STR, STL, BRK, R1, R2, MLD,

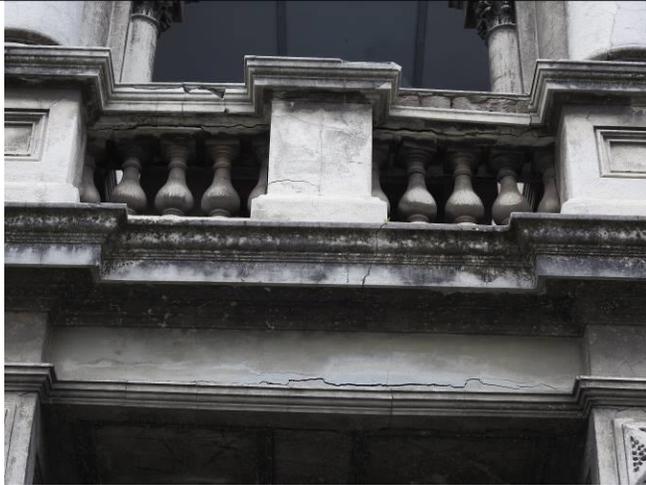
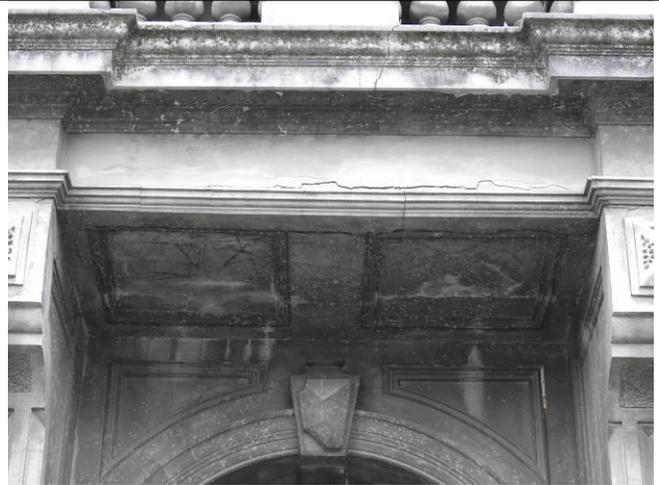
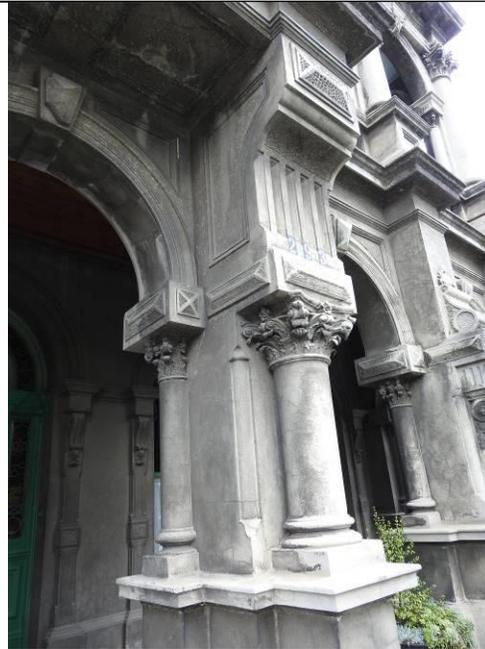
- Large areas of crazed and drummy render, though mostly sound
- Extensive horizontal and vertical stress fractures to balustrade
- Moderate efflorescence to soffit moulds

ITEM	DESCRIPTION	APPROX. DIMENSIONS	REPAIR CODE
028-031	Horizontal cracking through balustrade and above coping. Rusting lintels. Efflorescence observed.	Several metres (requires elevated access to quantify)	DES, BIO, WSH, CRK, STR, STL, BRK, R1, R2, MLD,

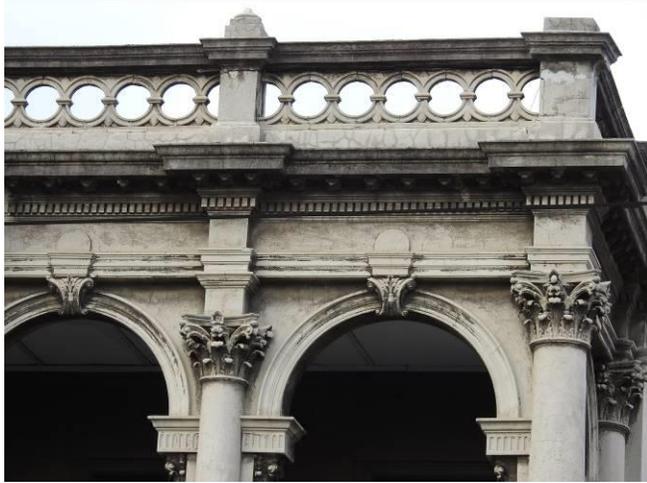
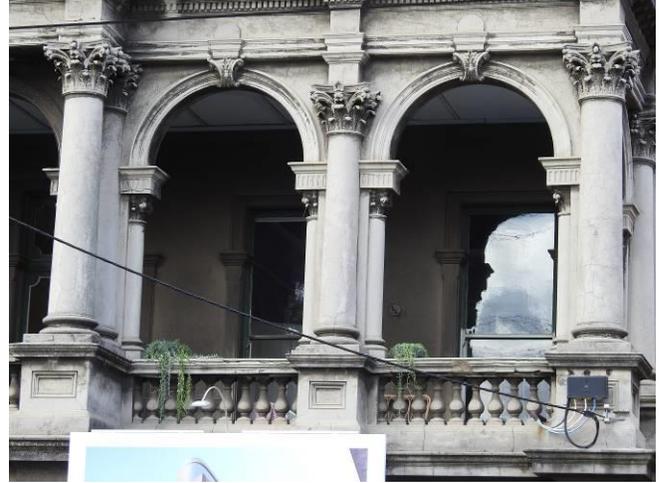
- Extensive crazed, cracked, fretting and drummy render
- Vertical and horizontal stress fractures resulting in loss of material
- Corroded steel/iron lintels appear to retain most of their original profile and integrity
- Moderate efflorescence to soffit moulds

ITEM	DESCRIPTION	APPROX. DIMENSIONS	REPAIR CODE
032-034	Extensive crazing though structurally sound	4	WSH, Monitor, Inspect when scaffold erected
035-041	Horizontal cracking through balustrades, cornice, string course. Rusting lintels and moderate efflorescence	Several metres (requires elevated access to quantify)	DES, BIO, WSH, CRK, STR, STL, PIN, BRK, R1, R2, MLD

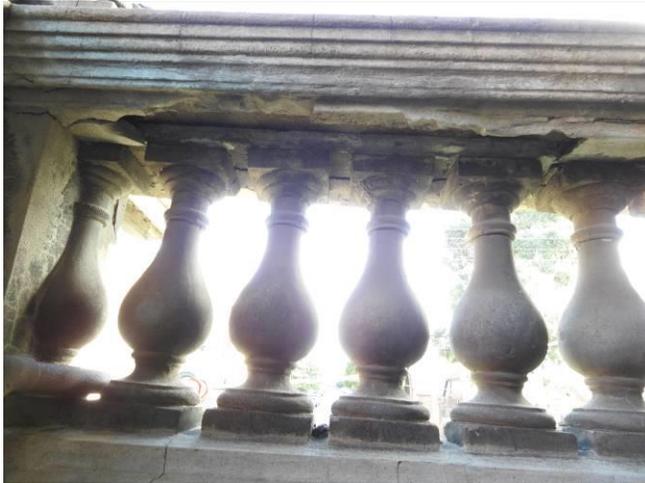
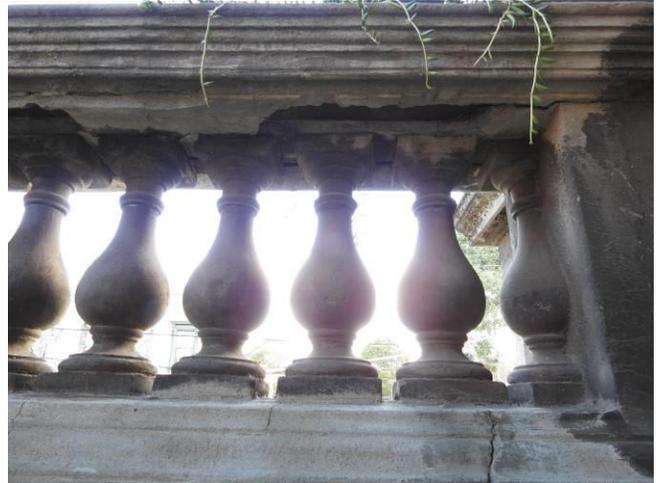
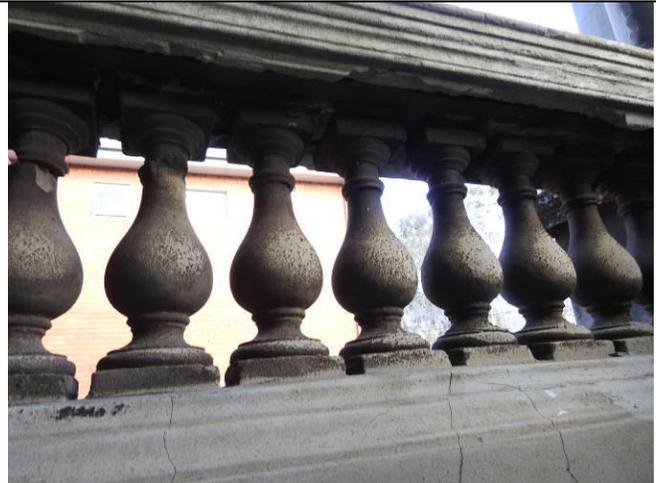
- Large areas of crazed and drummy render, though mostly sound
- Isolated vertical stress fractures
- Advanced horizontal cracking to lintels and copings
-

ITEM	DESCRIPTION	APPROX. DIMENSIONS	REPAIR CODE
042-045	Horizontal cracking through balustrades, cornice, string course. Rusting lintels and moderate efflorescence	Several metres (requires elevated access to quantify)	DES, BIO, WSH, CRK, STR, STL, PIN, BRK, R1, R2, MLD

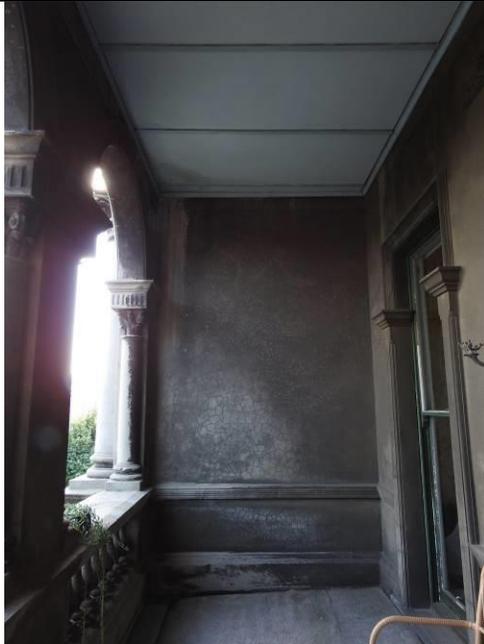
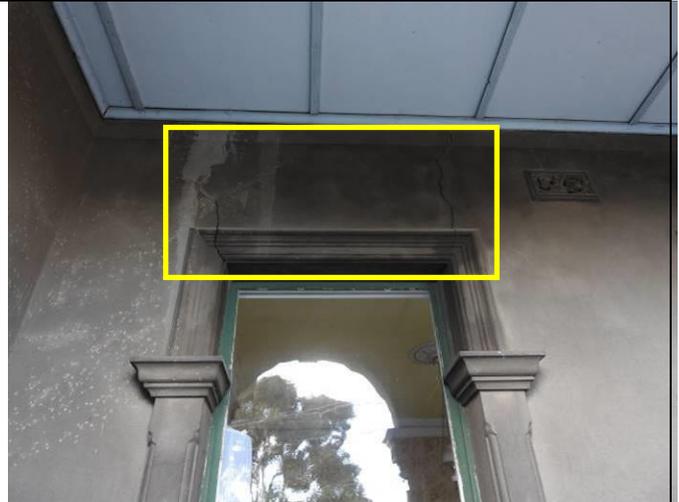
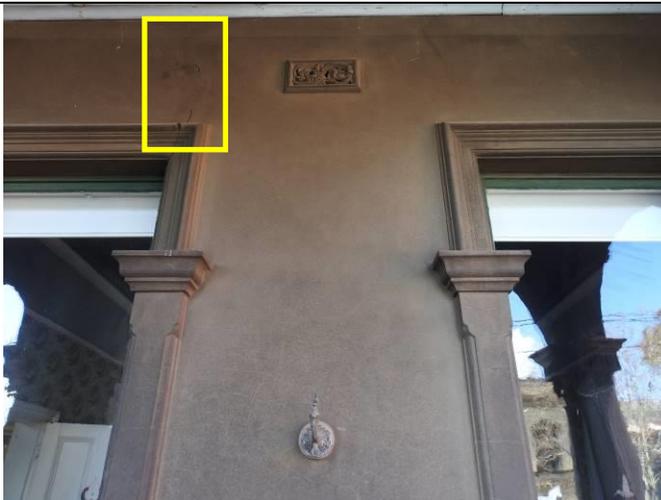
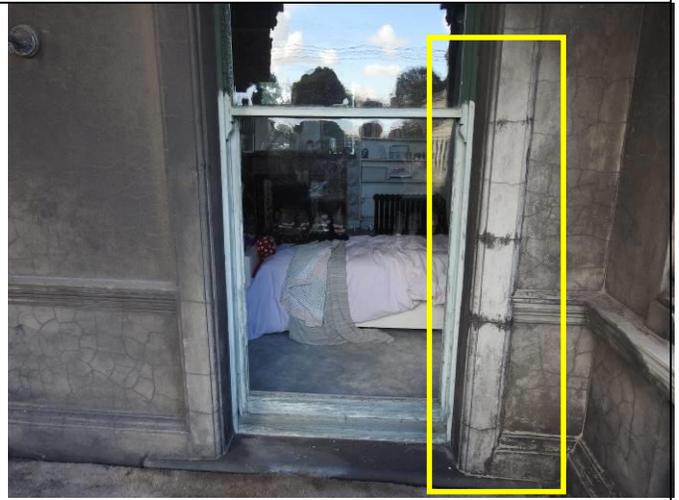
- Large areas of crazed and drummy render, though mostly sound
- Vertical stress fractures above two window lintels
- Moderate horizontal cracking to window jambs
- Moderate moisture penetration evidenced by washed, clean render surface in north west corner.

ITEM	DESCRIPTION	APPROX. DIMENSIONS	REPAIR CODE
046	Moderately drummy, extensive crazing	2m ²	Monitor
047	Vertical cracking through lintel and above window	2 x 400mm	WSH, CRK
048	Vertical cracking above lintel	1 x 400mm	WSH, CRK
049	Horizontal cracking previously repaired	4 x 150mm	WSH, CRK

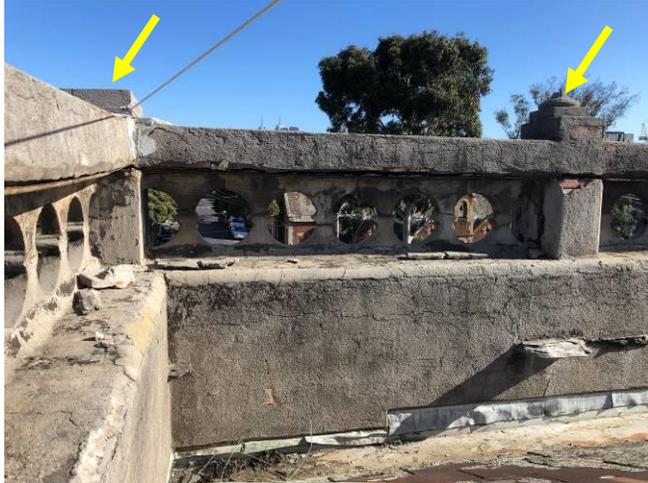
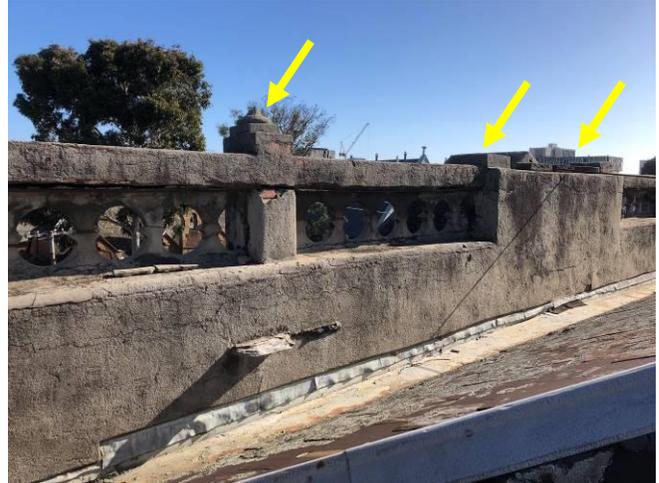
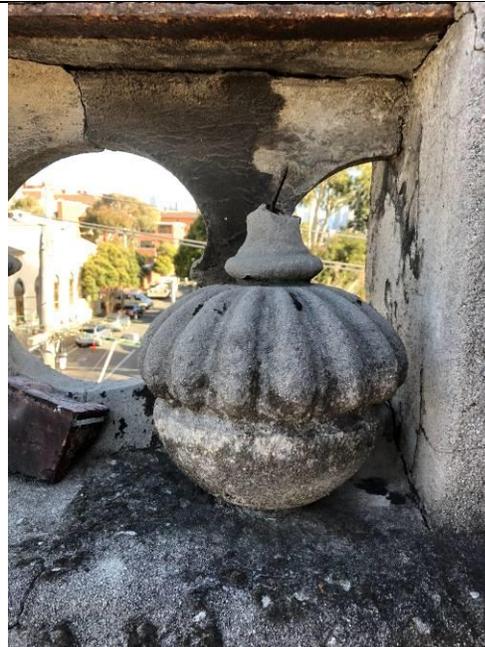
- Isolated areas of drummy and spalling render across whole back of parapet wall and ledges
- Crazing and weather fatigue to 100% of rendered areas
- Steel bracing in place to tie parapet wall back to roof structure
- Moderate corrosion of steel/iron reinforcement in balustrade pressed cement, with mild cracking of necks and joints associated. Bottles appear structurally sound with no threat of falling in the immediate term.
- 4 missing urns and 2 missing balls from top of coping.
- Lead flashing to be addressed by roof plumber

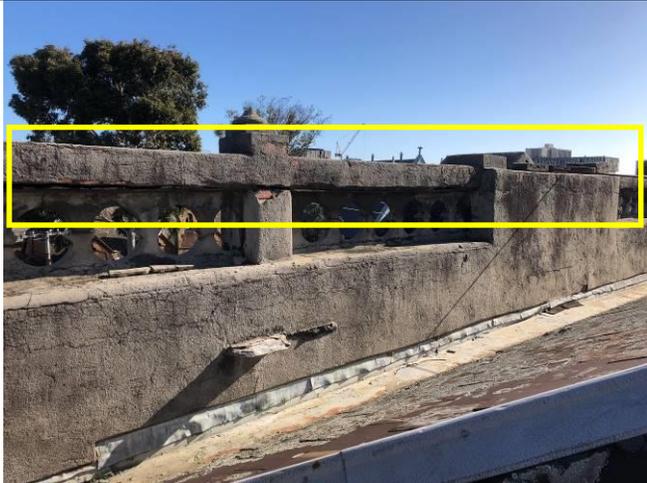
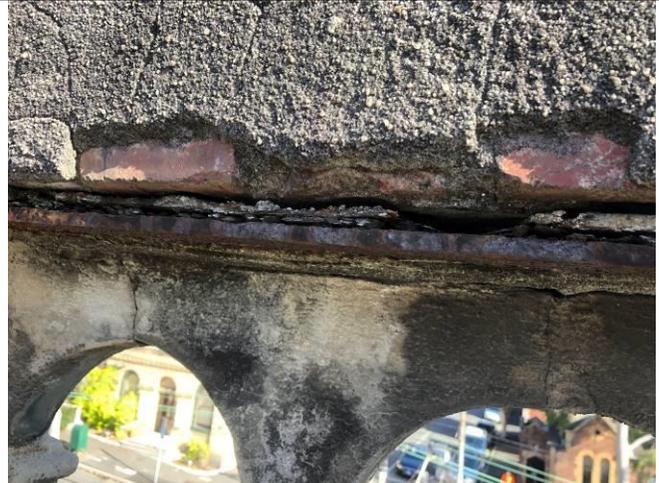
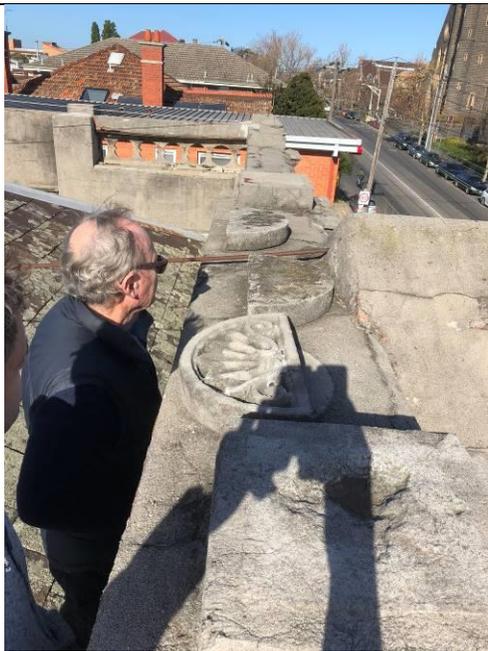
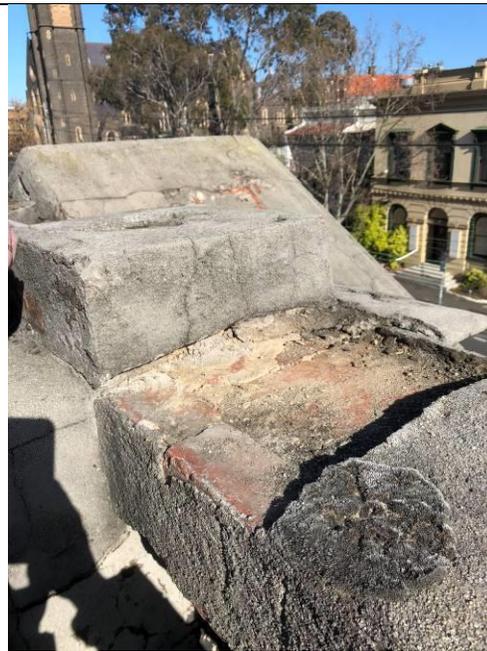
- Isolated areas of drummy and spalling render across whole back of parapet wall and ledges
 - Crazeing and weather fatigue to 100% of rendered areas
- Corrosion of steel/iron reinforcement in balustrade pressed cement, with mild cracking of necks and joints associated. Bottles appear structurally sound with no threat of falling in the immediate term.
- Lead flashing to be addressed by roof plumber

ITEM	DESCRIPTION	APPROX. DIMENSIONS	REPAIR CODE
054-057	Moderately drummy, extensive cracking and loss of material, fatigued/eroded sand finish. Corroded steel/iron reinforcement	15m ²	BIO, WSH, CRK, STR, STL, BRK, R1, R2, MLD. Replace missing decorations.

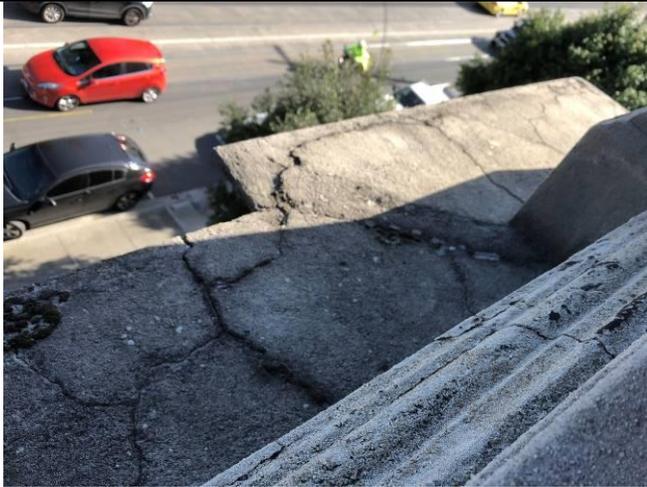
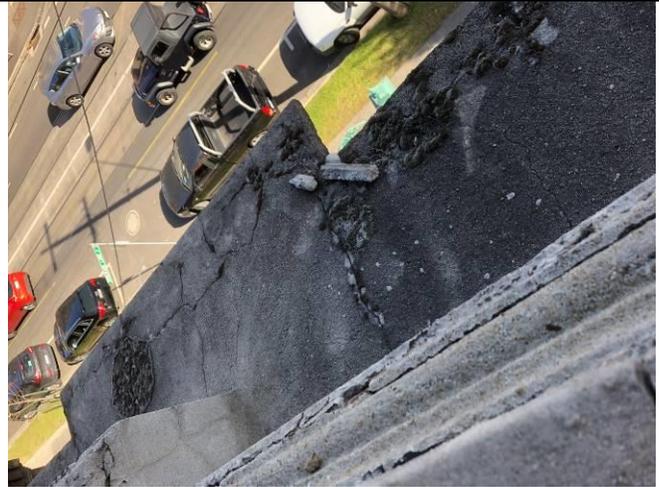
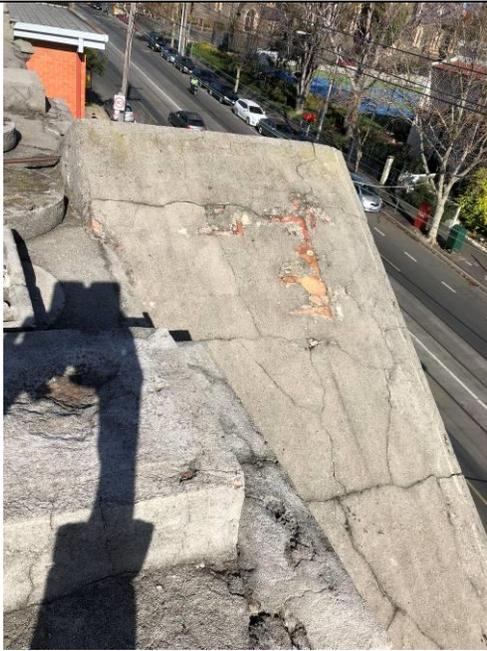
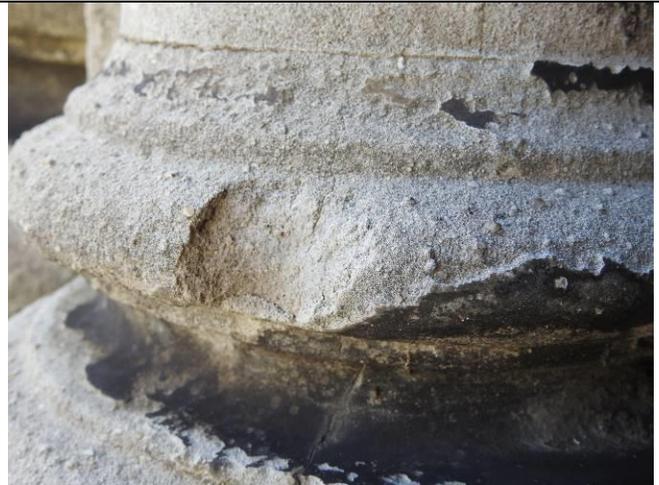
- Large areas of cracked and drummy render to all weathering surfaces, compromising the essential water shedding capabilities of these elements
- Heavily eroded top coat/sand finish exposing sand grains
-

ITEM	DESCRIPTION	APPROX. DIMENSIONS	REPAIR CODE
058-060	Widespread cracking, moderately drummy, extensive crazing, water penetration	All Areas	BIO, WSH, CRK, STR, STL, BRK, R1, R2, MLD. Consider flashing or water repellent
061	Heavily weathered surfaces generally observed integral to integrity of patina	All Areas	Monitor, repair only in high risk areas

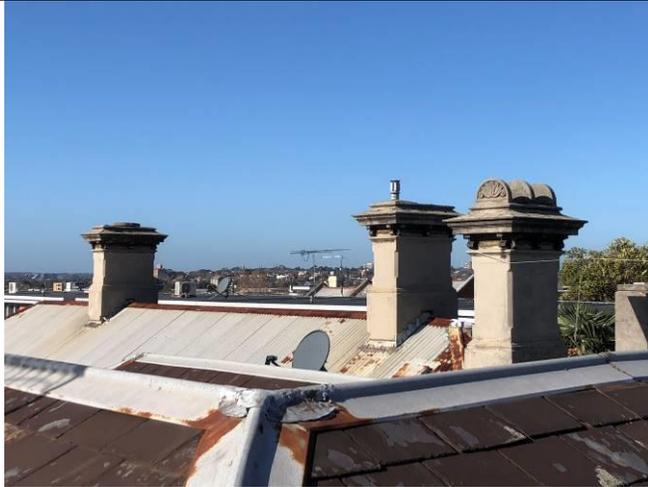
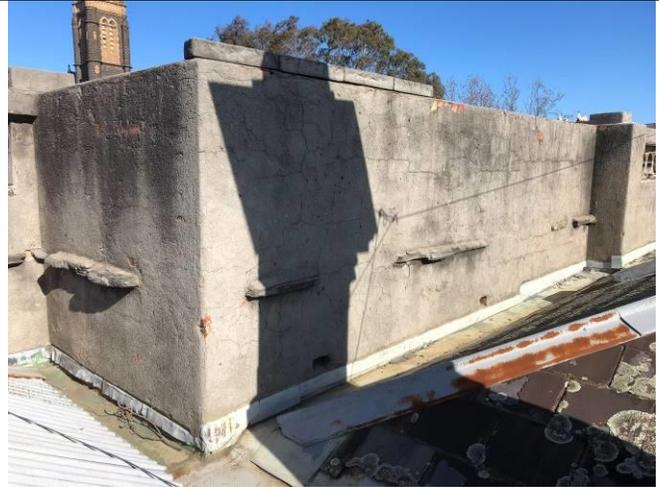
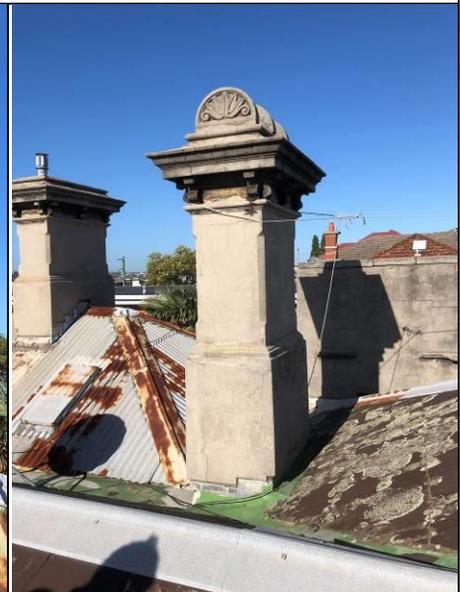
- Large areas of crazed and drummy render, though mostly sound
- Moderate horizontal cracking to chimney mouldings
- Decorative fans missing from two chimneys, compromising the integrity of these elements

ITEM	DESCRIPTION	APPROX. DIMENSIONS	REPAIR CODE
062-066	Moderately drummy, extensive crazing	2m ²	WSH, CRK, STR, STL, BRK, R1, R2, MLD. Replace missing decorations.

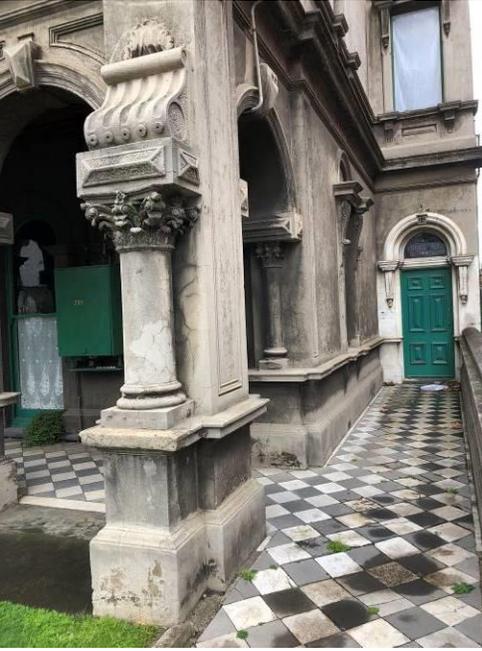
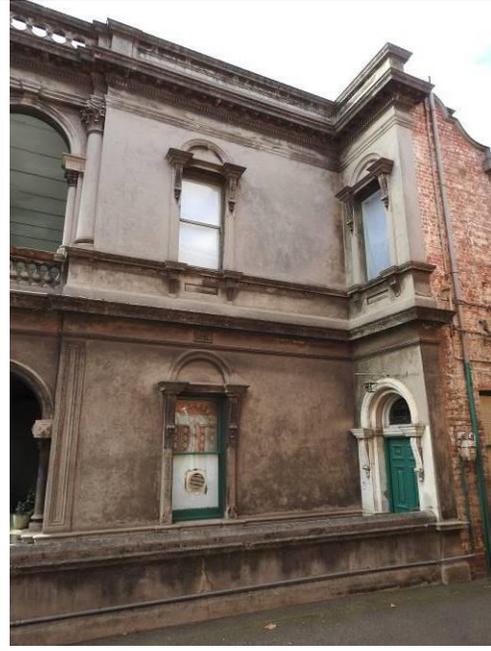
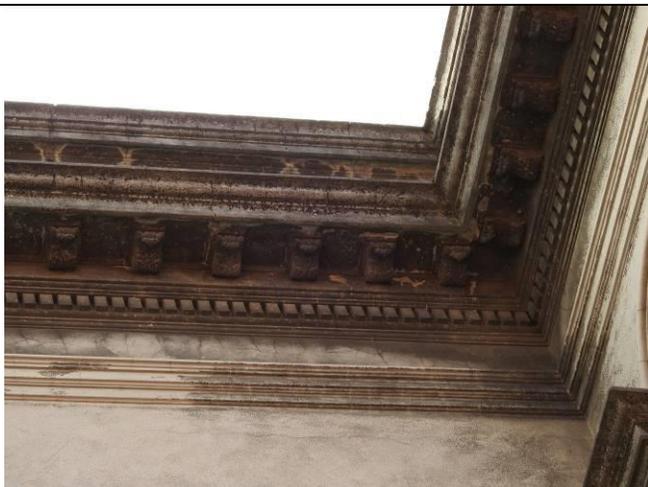
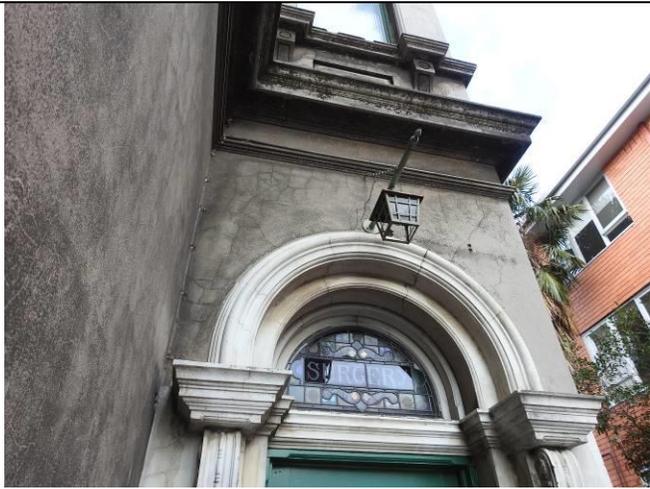
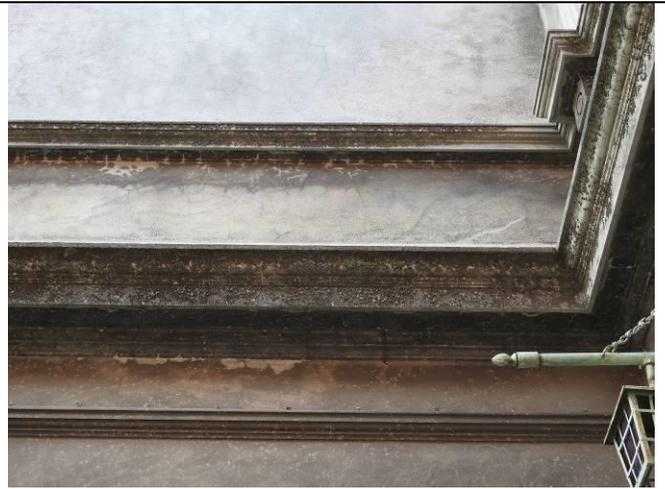
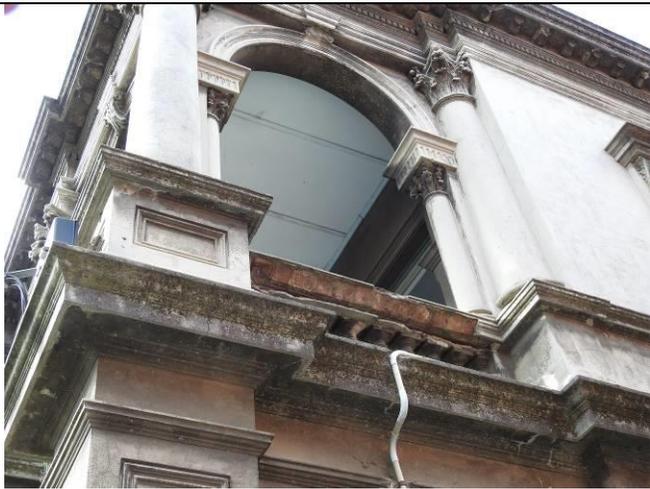
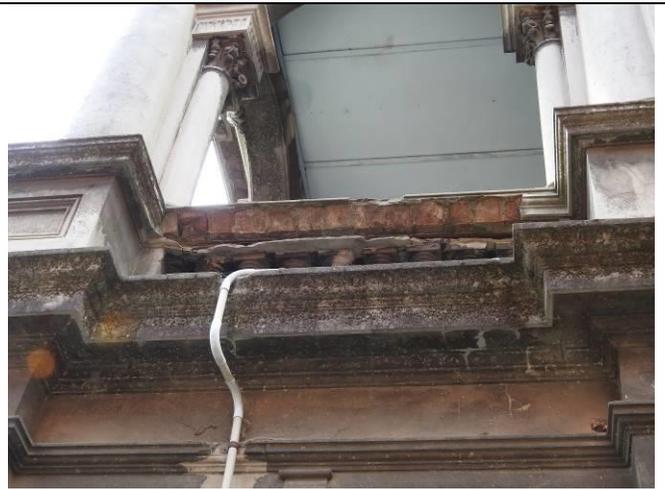
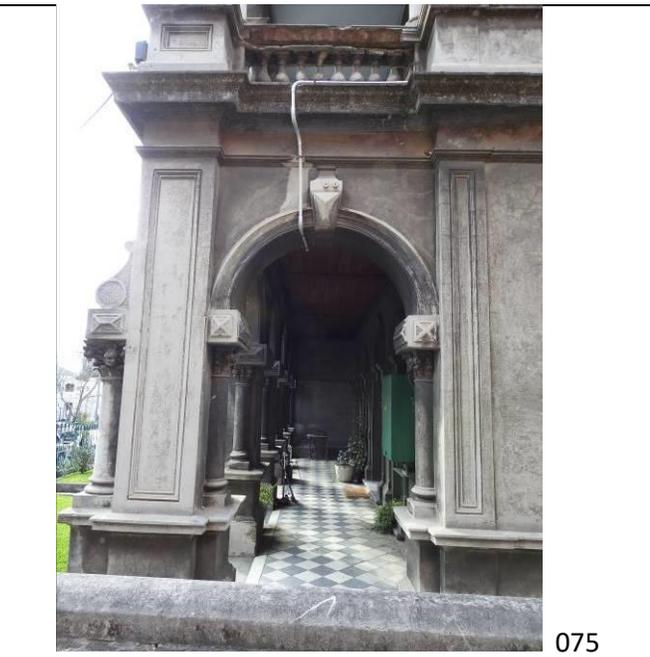
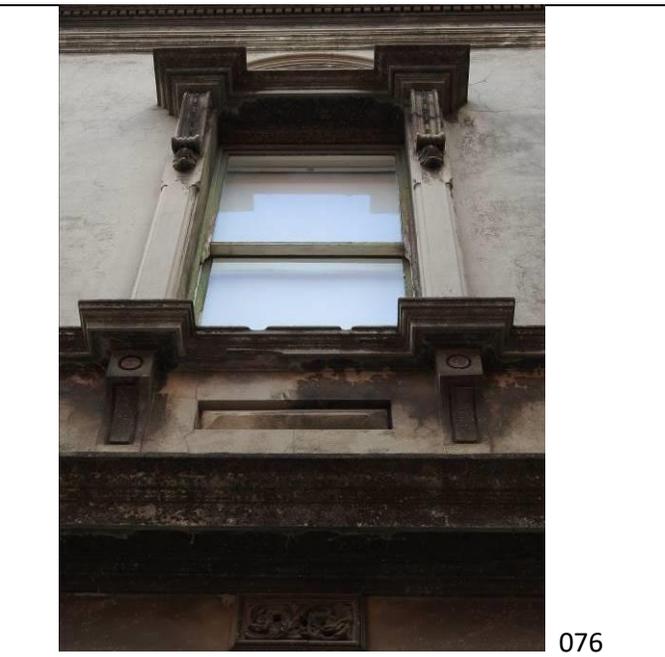
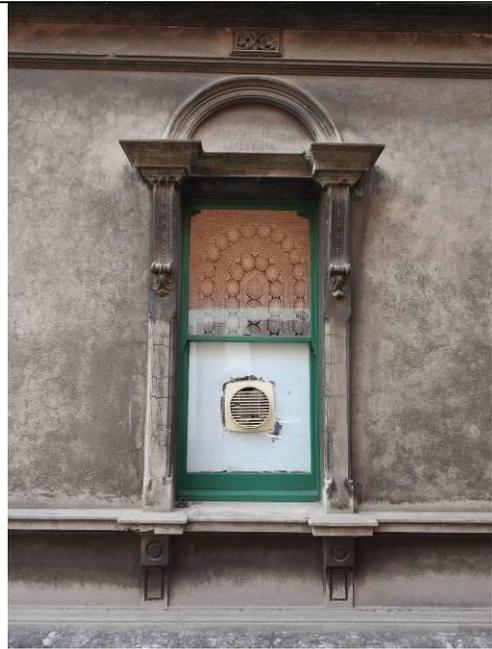
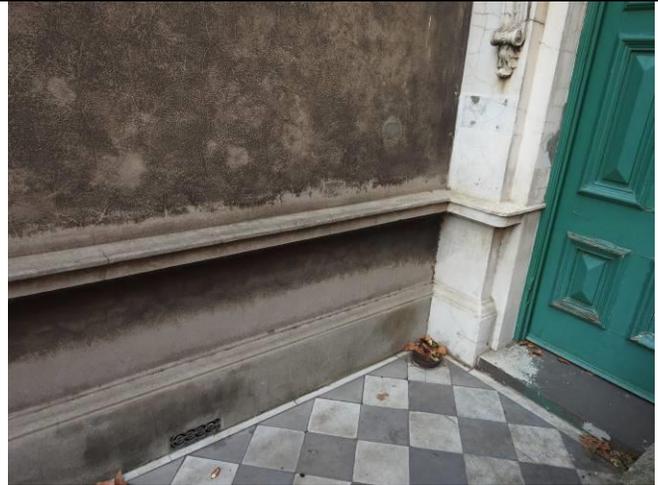
- Large areas of crazed and drummy render, though mostly sound
- Stress fractures, to lintels and sills resulting in lost fabric
- Moderate horizontal cracking to window and door jambs
- Moderate moisture penetration and corroded steel/iron in isolated areas

ITEM	DESCRIPTION	APPROX. DIMENSIONS	REPAIR CODE
067-080	Extensive crazing though structurally sound. Minor cracks.	All Areas, (requires elevated access to quantify)	BIO, WSH, CRK, STR, STL, BRK, R1, R2, MLD.

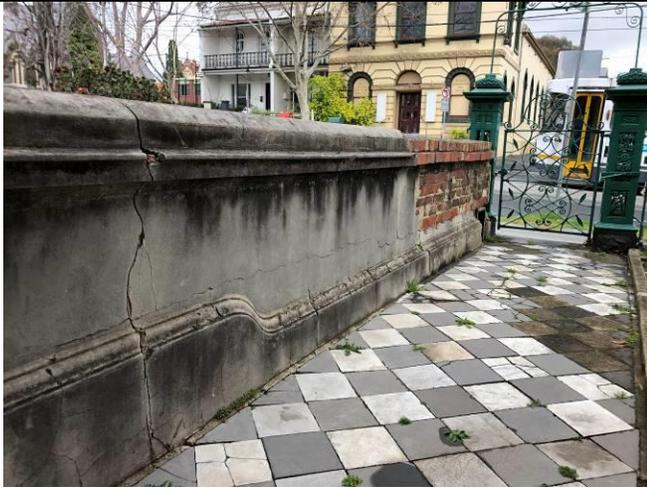
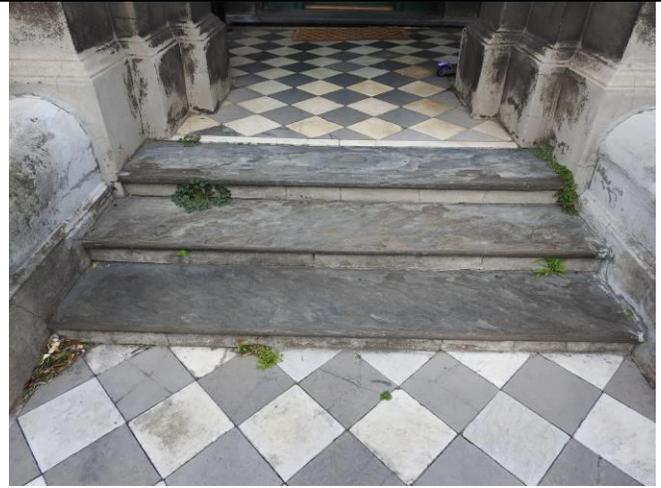
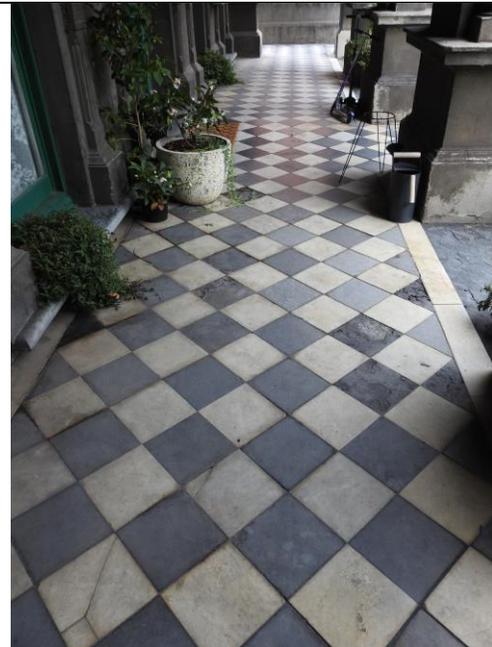
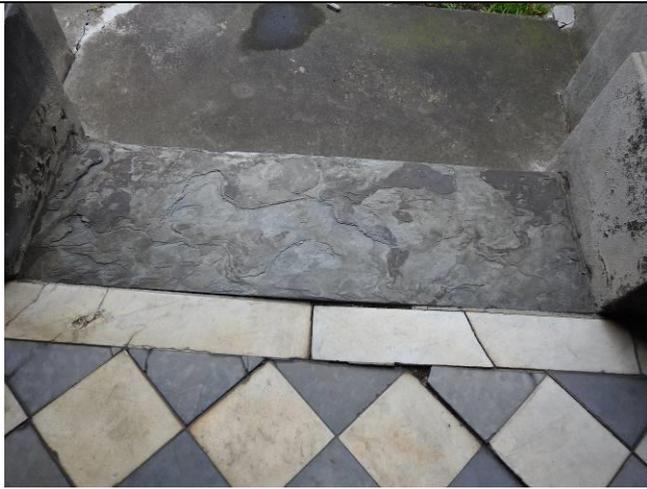
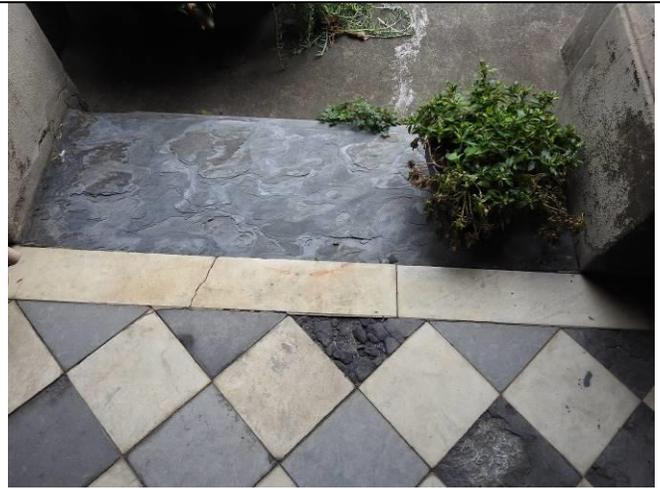
- Weathered and fretting floor tiles
- Eroded slate threshold stones and steps

ITEM	DESCRIPTION	APPROX. DIMENSIONS	REPAIR CODE
081-086	Cracked tiles, eroded slates, open joints	All Areas	Monitor, remove loose trips hazards, replace cracked/missing tiles, grout
