Heritage Overlay Study

QUEENS PARADE, FITZROY NORTH

November 2018

John Patrick Architects Pty. Ltd. has been commissioned by Yarra City Council to provide advice regarding an apparent anomaly in the application of Heritage Overlay HO93 of the Yarra Planning Scheme.

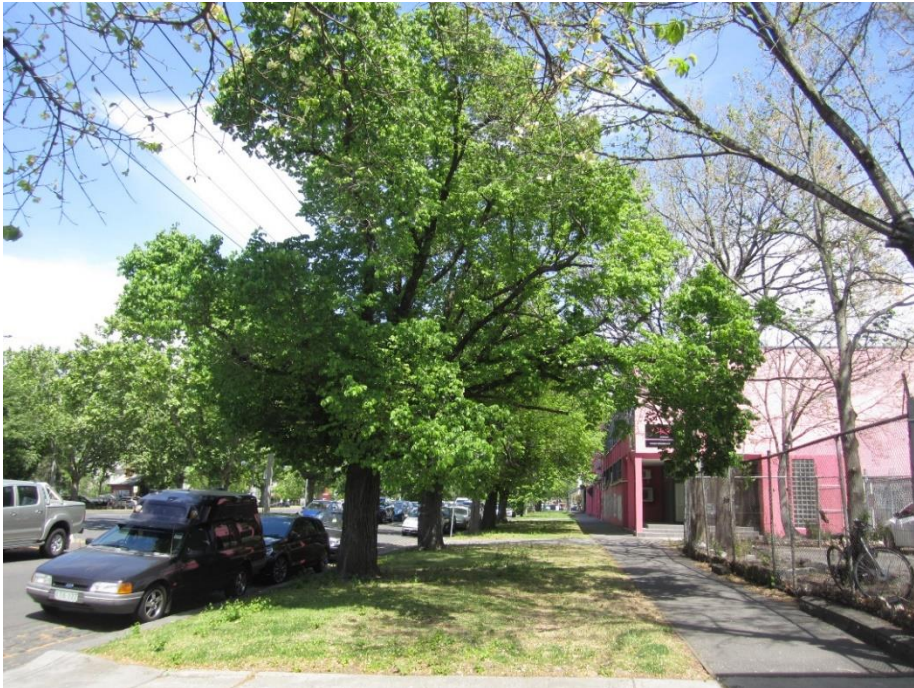
Regarding the Elm component of the avenue, generally appropriate infill and succession planting with English Elm (*Ulmus procera*) has been undertaken, with the majority of potential infill/succession planting locations utilised. This approach is considered appropriate conservation of the remnant fabric of the Elm component. Several instances of the inappropriate tree taxon Desert Ash (*Fraxinus angustifolia* ssp. *angustifolia*) were noted, as indicated on the attached Remnant Fabric (Vegetation) Plan HS-01.

Figure 1: The Elm component of the avenue tree planting is being appropriately conserved by infill/succession planting with English Elm.

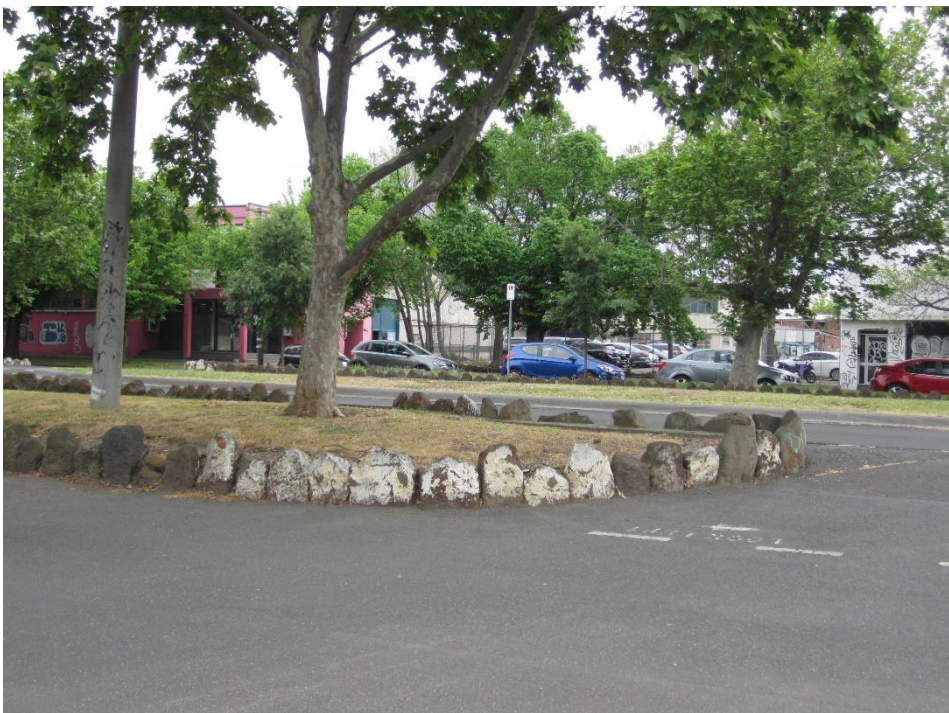
Remnant fabric vegetation consists of a double avenue, predominantly of London Plane (*Platanus x acerifolia*) within the medians between the central traffic lanes and the service lanes, and Elms (*Ulmus* sp.) between the outer curb and footpaths. It was noted that of the older avenue Elms both Dutch Elm (*Ulmus x hollandica*) and English Elm (*Ulmus procera*) are present. A portion of the street tree planting which deviates from this general arrangement is present at the south eastern end of the study area, between Wellington and Smith Streets, where London Planes (or Turkey Oak replacements) comprise both the median and curb rows of trees.

Figure 2: The London Plane portion of the avenue is generally located within the medians between the central traffic and service lanes, with the Elm portion to the outer curbs.

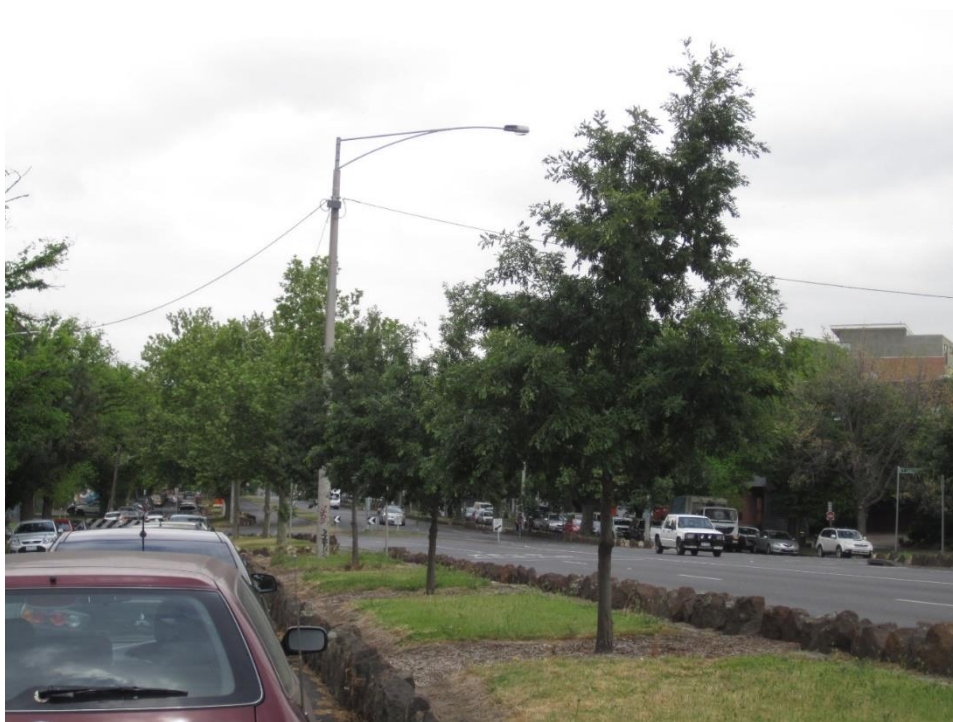
Successive replacement of the London Plane component of the avenue tree planting is being undertaken with Turkey Oak (*Quercus cerris*) as the replacement taxon. This strategy alters the detail of the heritage fabric, however Turkey Oak is considered an appropriate taxon for the location, as it is tolerant of site conditions and consistent with a double avenue tree planting of heritage significance.

Figure 3: Turkey Oak succession planting for London Plane is being undertaken. This strategy is considered appropriate as conservation of the street tree element of heritage significance.

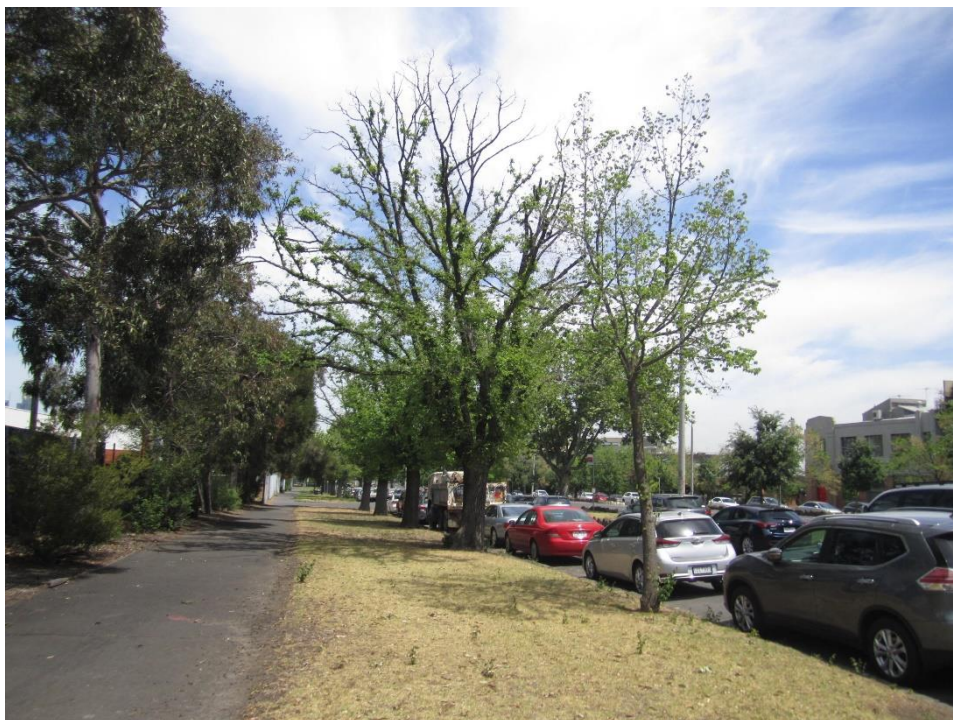
The majority of both the mature and developing Elms were assessed as being in fair to good condition, however a portion the Elm component of the avenue on the southern side of Queens Parade between Smith and George Streets was noted as exhibiting indications of stress or decline.

Figure 4: Elms within a portion of the avenue are exhibiting signs of stress and require remediation.

Elms in the portion of the avenue to the southern side of Queens Parade between Smith and George Streets were noted as exhibiting indications of stress or decline. Soil amelioration and deep watering of these trees is recommended to improve their appearance and extend their useful life.

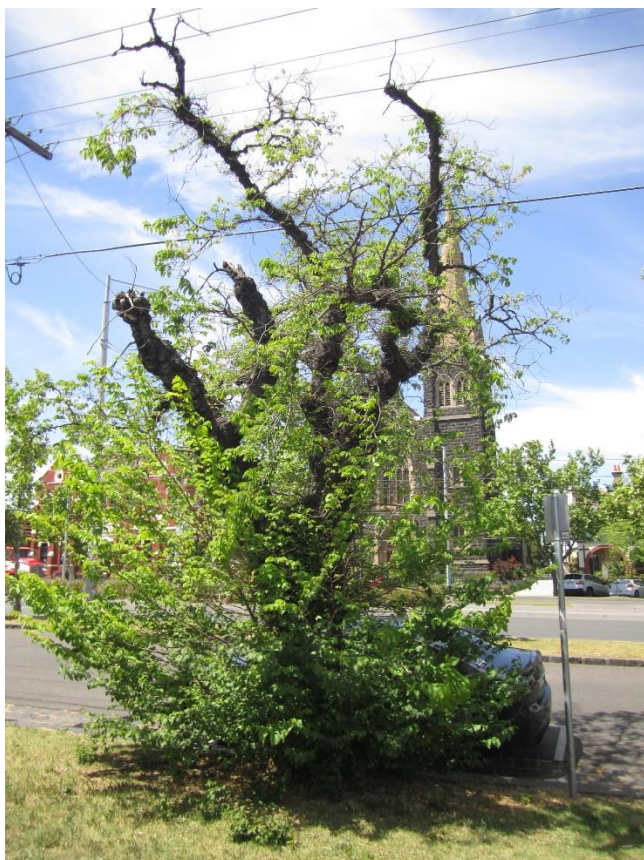
Recommended remediation measures are provided in this report, below. An Elm specimen within the nature strip in front of 240 Queens Parade is in very poor condition (Figure 5). Removal and replacement with English Elm (*U. procera*) is recommended.

Figure 5: An Elm in front of 240 Queens Parade is in poor condition. Removal and replacement is recommended.

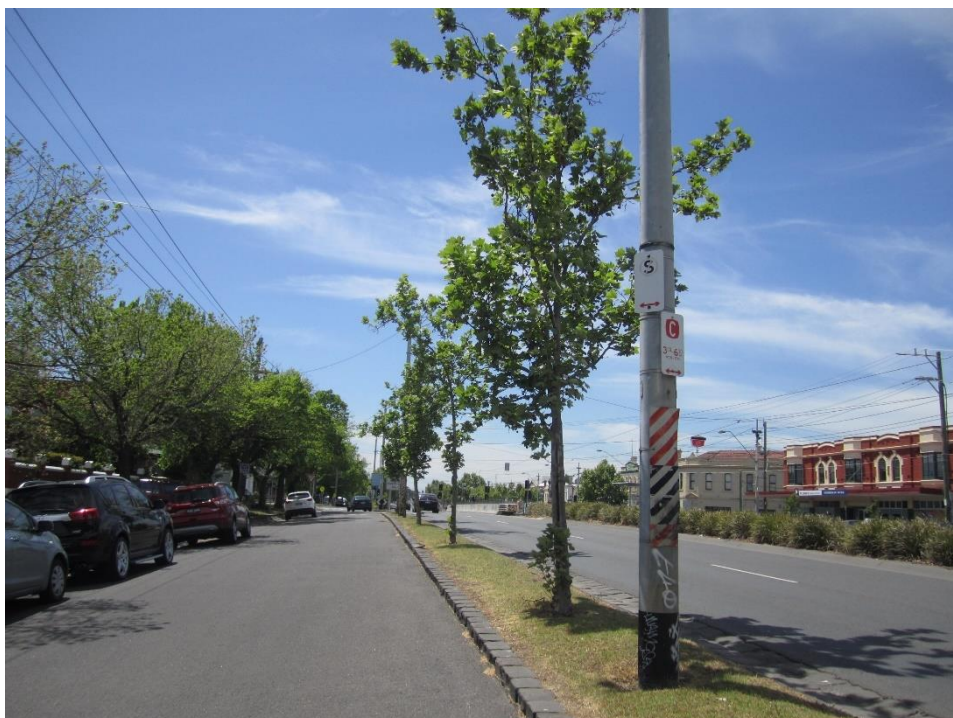
London Plane specimens were generally observed as in fair to good condition, however a portion of the London Plane planting, between Grant and Delbridge Streets were noted as stunted due to site conditions, and a likely sub-optimal soil conditions (Figure 6). It is likely that the roots of these trees are unable to effectively extend through compacted road base, resulting in reduced access to water and nutrients.

Figure 6: A row of London Plane within the median between Grant and Delbridge Streets are stunted due to soil conditions.

A portion of the median London Plane planting, between Grant and Delbridge Streets were noted as stunted due to site conditions. Improvement to this section would require installation of new tree stock following excavation of the existing planting medium and replacement with a planting medium conducive to healthy root growth (for example structural soil). Should resources become available to allow this replacement it would be considered beneficial.

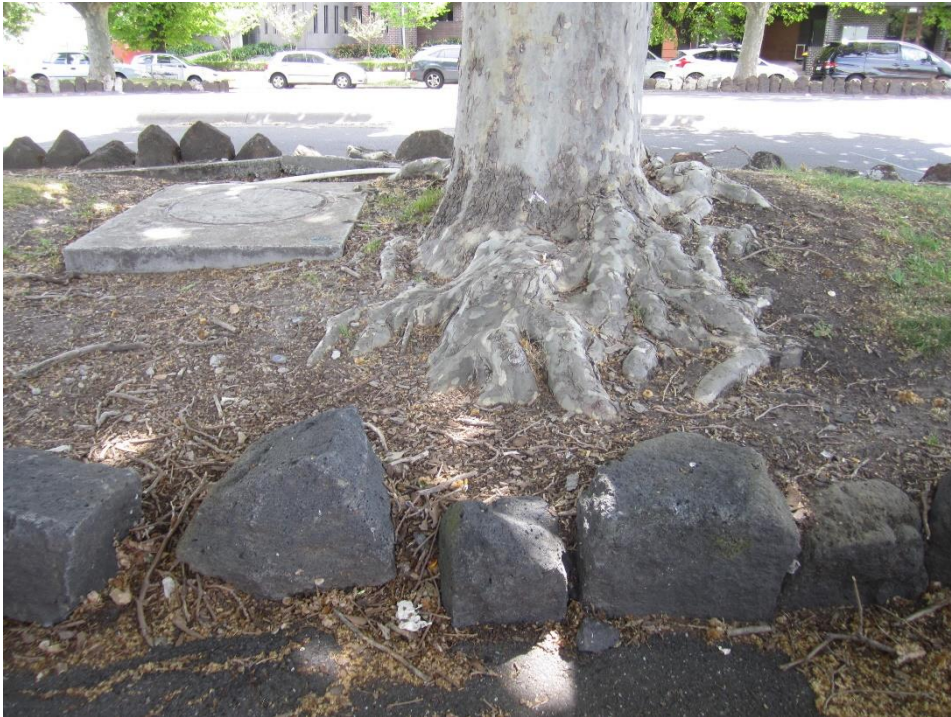
In several locations within the medians between the central traffic lanes damage to the median borders was noted, resulting from root growth of the adjacent London Planes. Such damage is likely to progress and affect further areas as these trees mature, particularly as roots of this robust taxon are aggressive.

Figure 7: Damage to the median border caused by roots of the London Plane.

The recommended approach regarding damage to significant median basalt borders by avenue tree roots is conservative management. Protection of the avenue trees is considered the primary priority. Damage to man-made fabric should be repaired to the extent possible without compromising avenue tree health. In some instances, damage to basalt elements repaired to an imperfect state is acceptable, with full restoration undertaken when the tree is eventually removed.

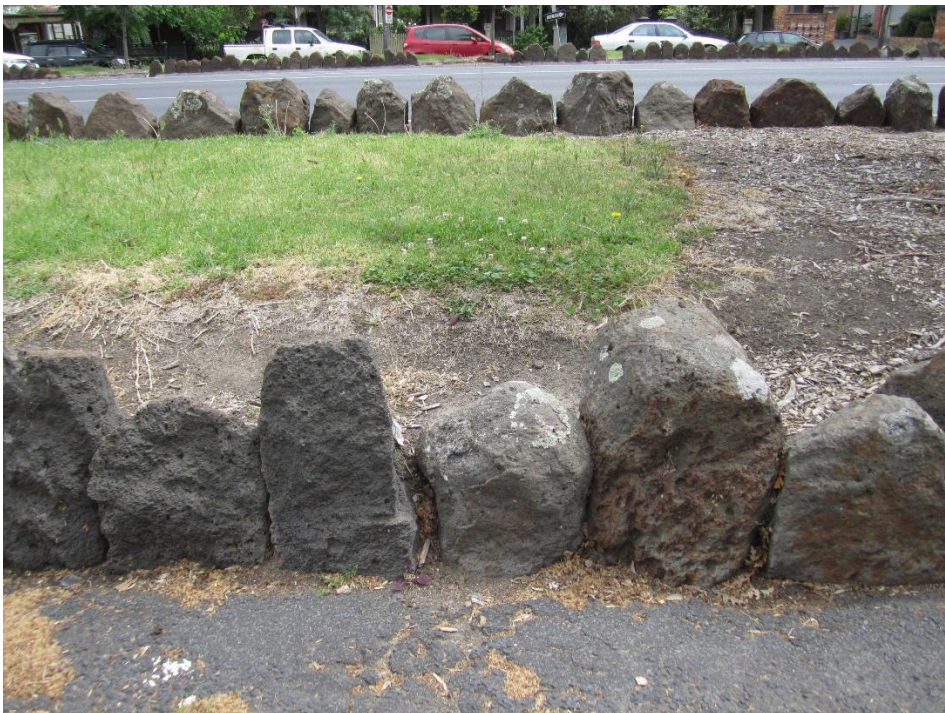
Generally, the medians separating the central traffic lanes and service lanes in the southern portion of Queens Parade are bordered by uncut basalt blocks, forming a prominent and decorative feature (Figure 8), as mentioned in the Landscape Citation. These blocks are set into a concrete edge on the central traffic lane side, however no visible concrete base is present toward the service lanes. Some of the uncut basalt blocks, particularly to the central lanes and crossovers, are painted white, presumably to improve visibility. The majority of the uncut block borders remain remarkably intact with only a few areas of missing or loose blocks.

Figure 8: Uncut basalt blocks form a prominent and decorative border to the medians. This remnant fabric is remarkably intact.

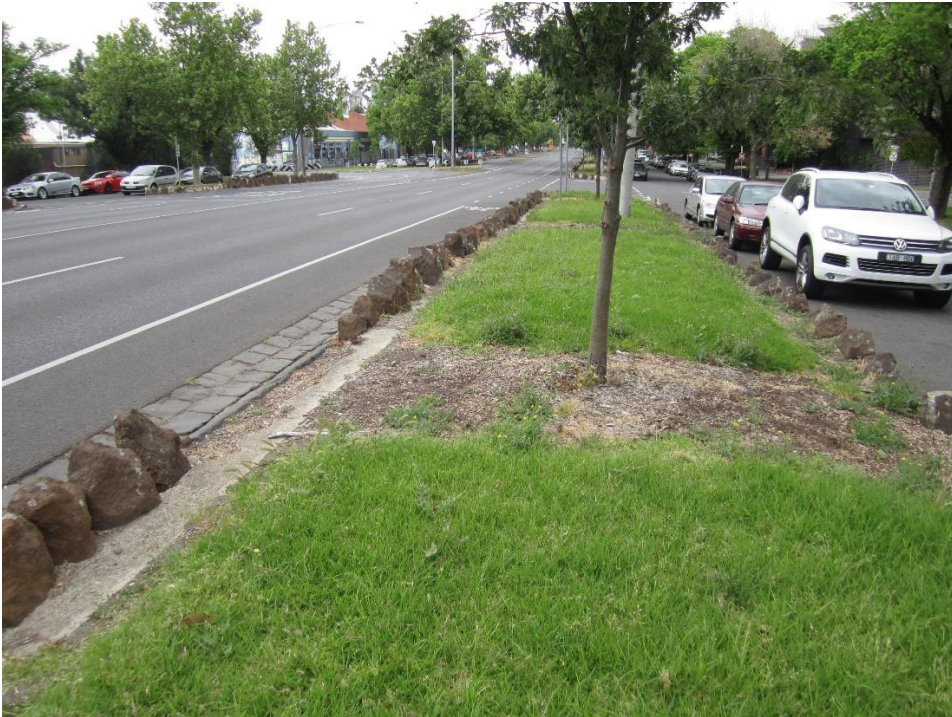
Figure 9: Median immediately north of Jamieson Street. A portion of the row of uncut basalt blocks toward the central traffic lanes is absent in two locations, apparently associated with tree planting. The concrete base toward the central lanes is visible at left of frame.

In instances where basalt blocks are missing, unrelated to damage caused by trees, replacement of blocks should be undertaken if suitable material is available. Loose blocks should also be reset.

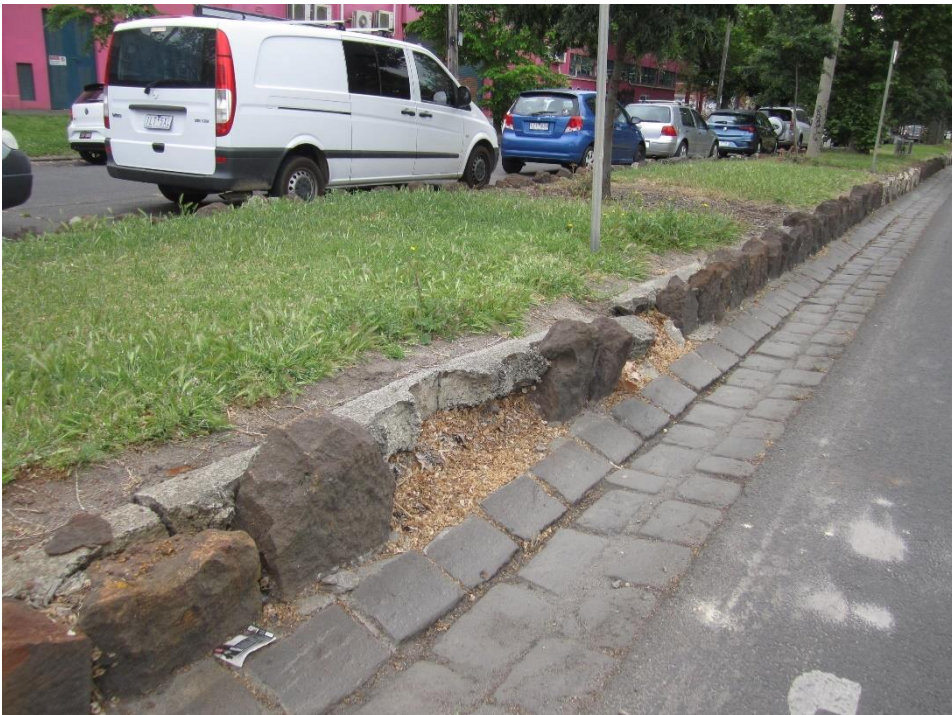
Figure 10: Median between Alexandra Parade and Napier Street. View of missing uncut basalt blocks and basalt pitcher drainage channel.

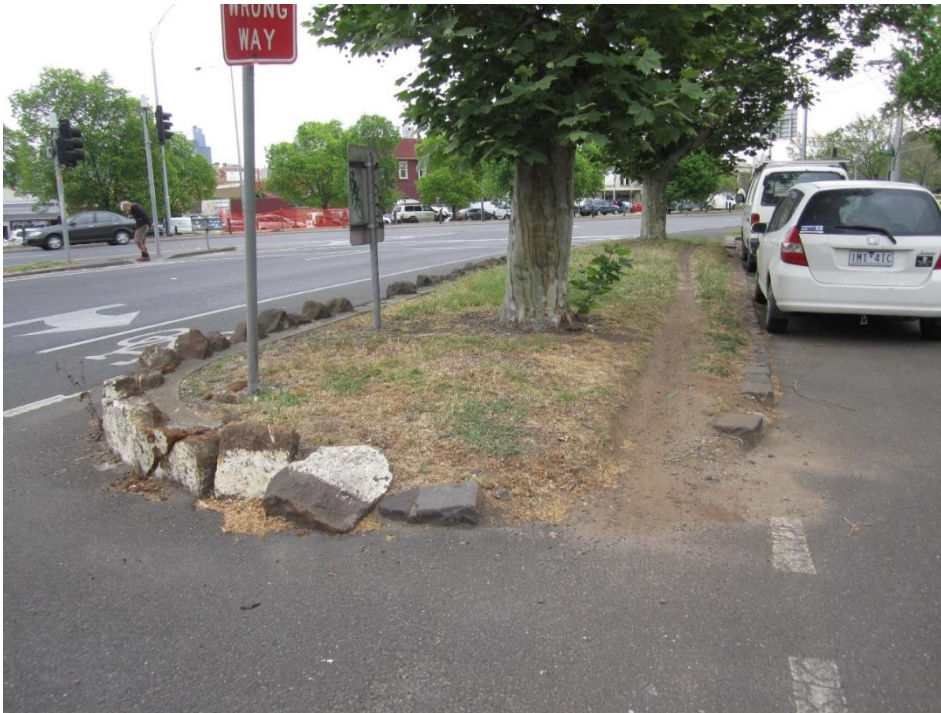
traffic lanes, however to the service lanes the border is of standard cut basalt blocks (designated Type A treatment, shown in Figure 11).

Figure 11: Westernmost median adjacent to the Alexandra Parade intersection. Uncut basalt blocks remain relatively intact to the central traffic lanes, with the border to the service lane comprised of standard cut basalt blocks.

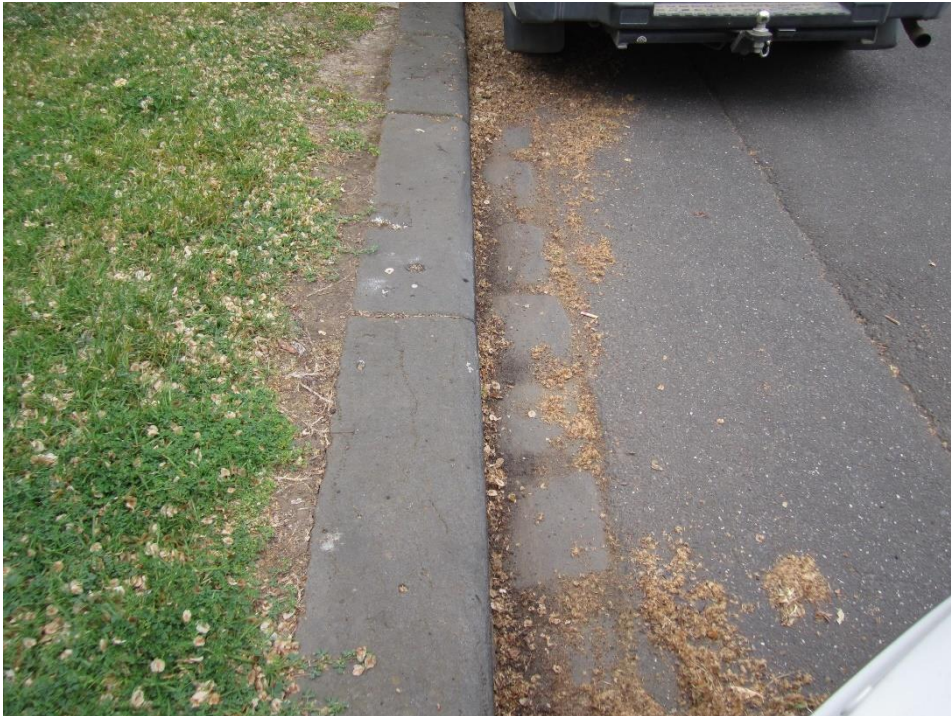
Type 2: Large, honed basalt block curb. Drainage channel one row of basalt pitchers.

Figure 12: Type 2 curb and drainage channel.

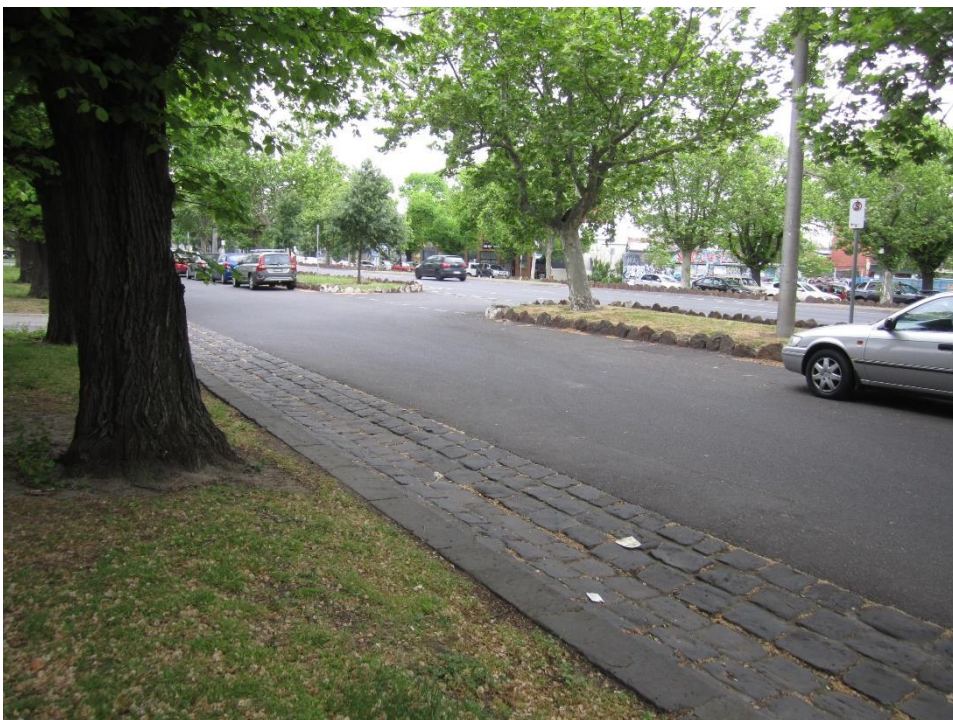
Type 3: Large, honed basalt block curb. Drainage channel six rows of basalt pitchers.

Figure 13: Type 3 curb and drainage channel.

All efforts should be made to retain existing curb and drainage channels, particularly those of Types 3, 4 and 5 which consist of large honed basalt curb and drainage channels comprised of several rows of basalt pitchers. If the opportunity arises, installation of a six row wide pitcher drainage channel to areas designated Type 1 and 2 would be a desirable heritage outcome. Replacement of inconsistent curb materials, such as in Types 6, 7 and 8 with large honed basalt blocks is also desirable.

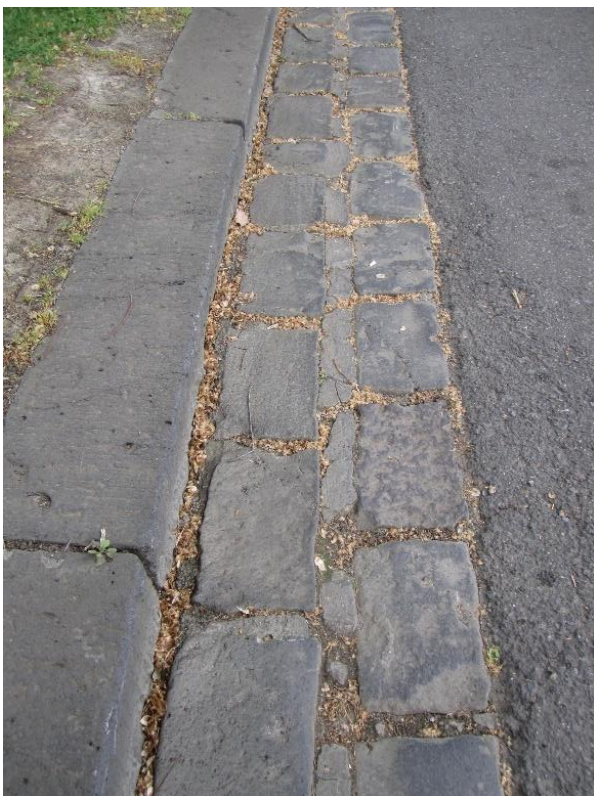
Type 4: Large, honed basalt block curb. Drainage channel two rows of basalt pitchers with a narrow central row of pitchers.

Figure 14: Type 4 curb and drainage channel.

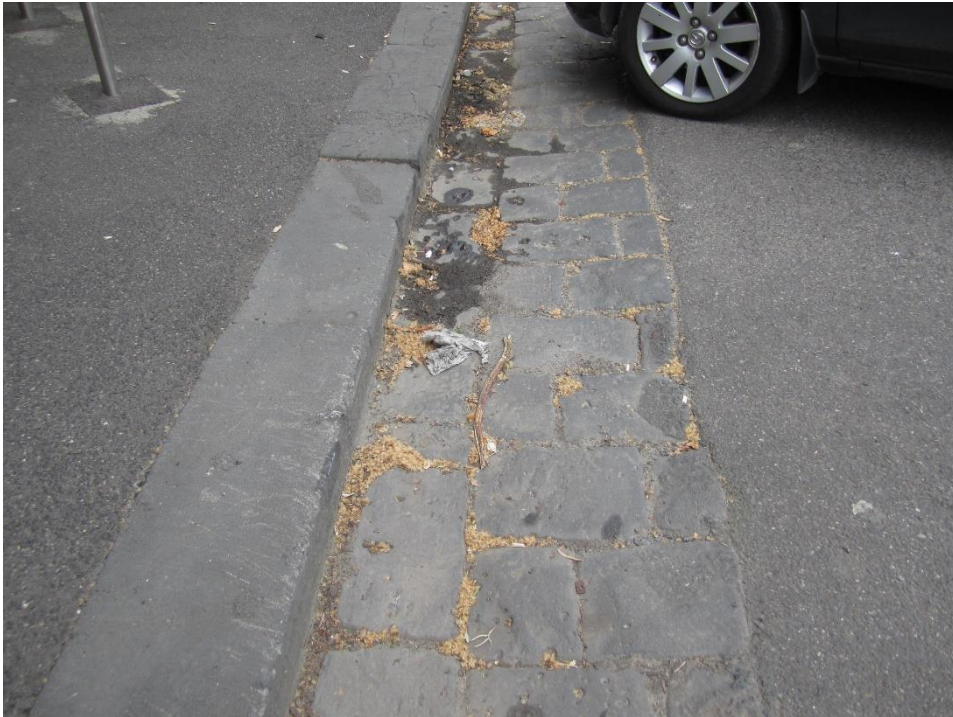
Type 5: Large, honed basalt block curb. Majority of drainage channel one row of basalt pitchers next to curb and randomly sized and arranged basalt pitchers equivalent to an additional two rows.

Figure 15: Type 5 curb and drainage channel.

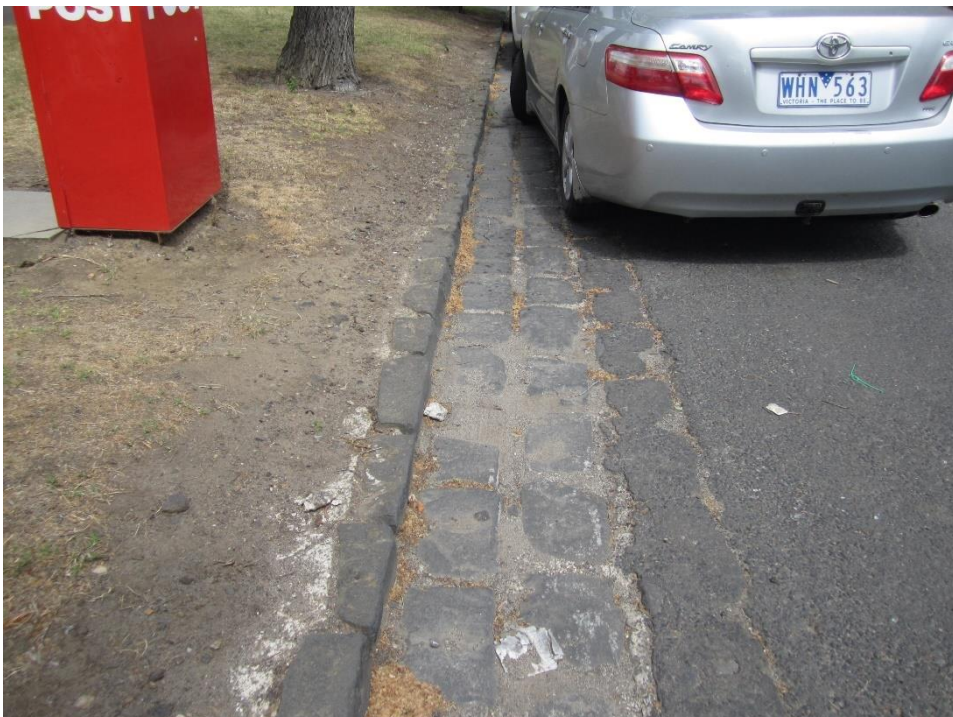
Type 6: Small basalt block (30cm L x 10cm W x 10cm H) curb. Drainage channel three rows of basalt pitchers, some asphalted over.

Figure 16: Type 6 curb and drainage channel.

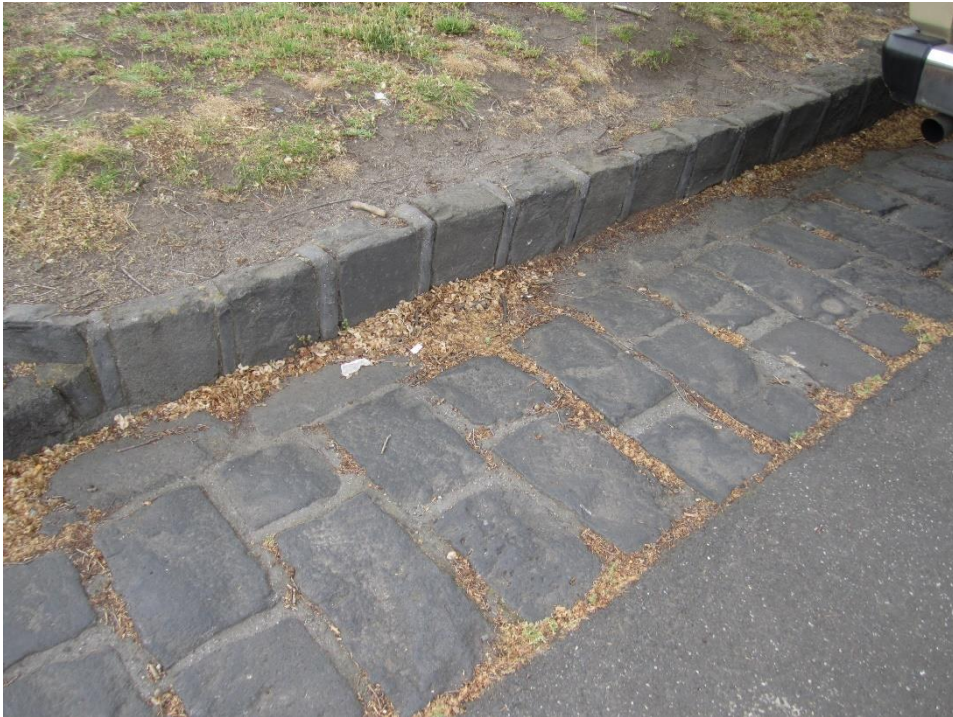
Type 7: Square basalt block (20cm L x 10cm W x 15cm H) curb. Drainage channel one row of pitchers and randomly sized and arranged basalt pitchers equivalent to three rows.

Figure 17: Type 7 curb and drainage channel.

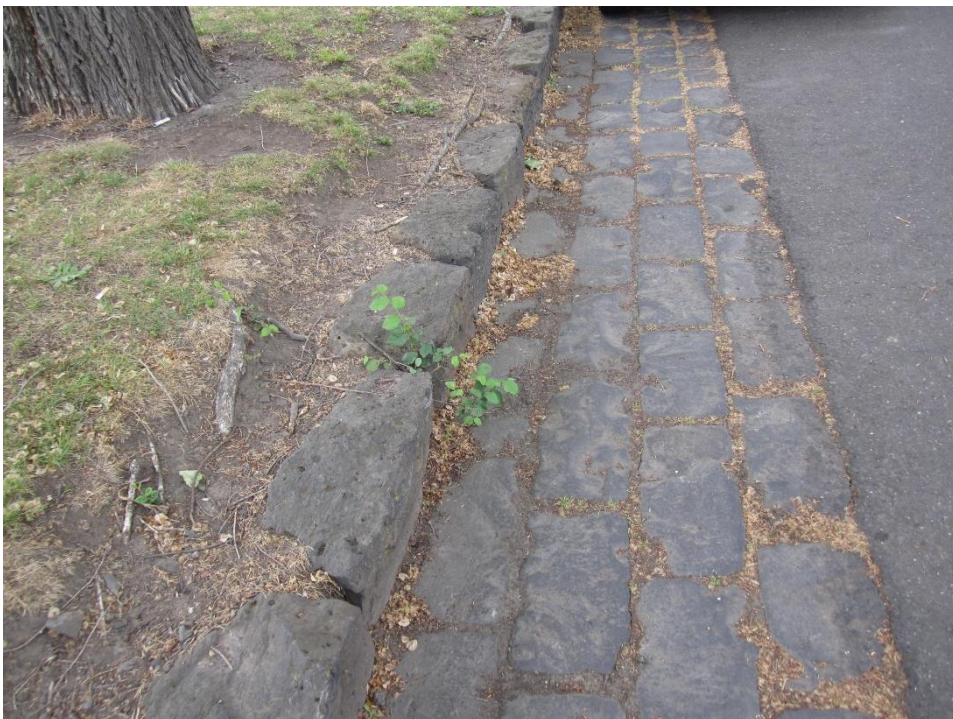
Type 8: Rough cut basalt block (50cm L x 25cm W x 20cm H) curb. Drainage channel four rows of basalt pitchers.

Figure 18: Type 8 curb and drainage channel.

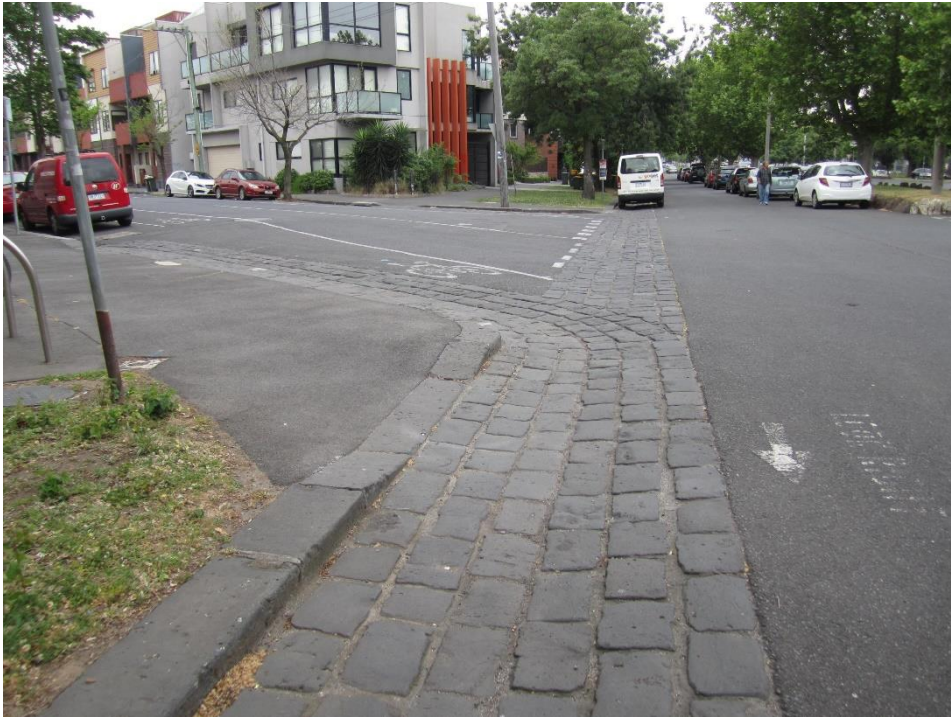
It was noted that the drainage channel comprised of six rows of basalt pitchers (Type 3) continues across the intersection of Napier Street and Queens Parade service lane (Figure 19), terminating at Jamieson Street.

Figure 19: Northern drainage channel configuration of six rows of basalt pavers continues across the intersection of Napier Street and the Queens Parade service lane, terminating at the intersection with Jamieson Street.

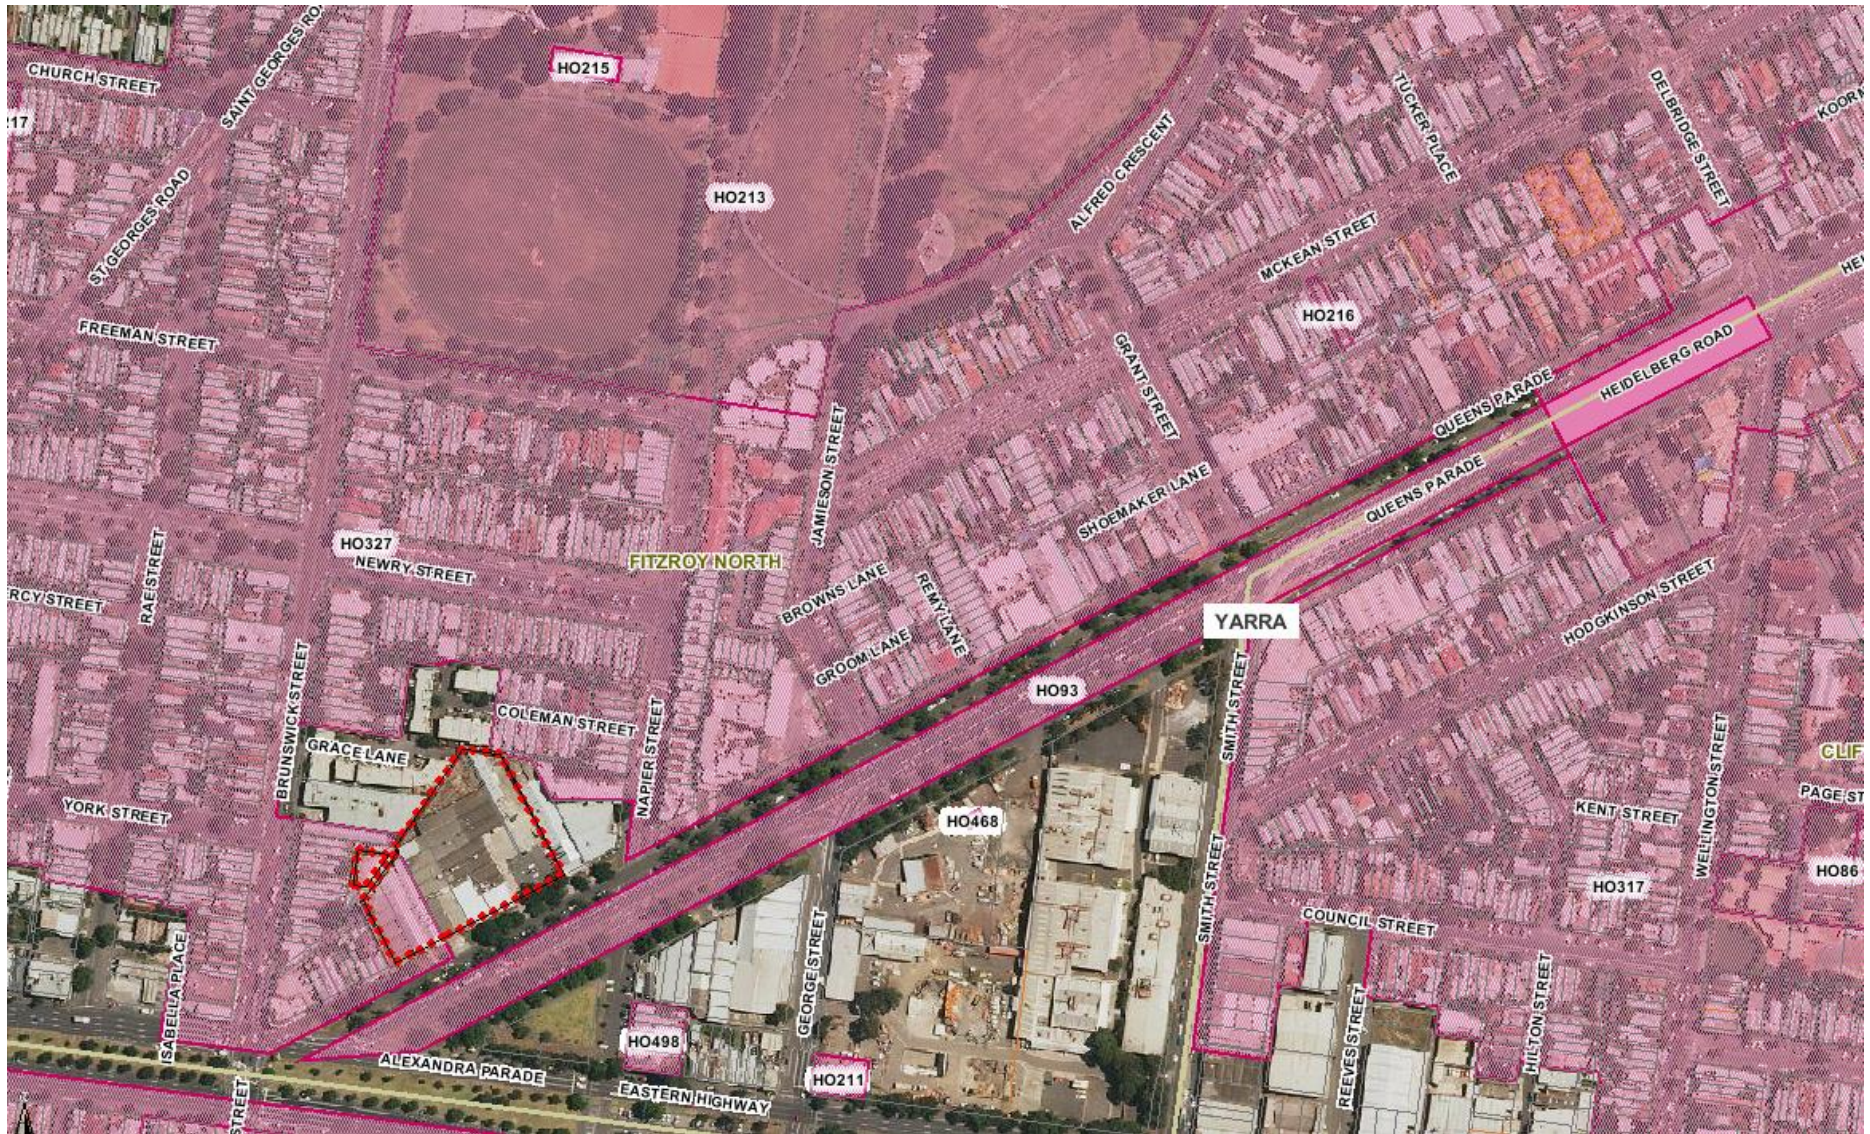
The current extent of HO93 excludes the northern Elm row of the avenue. Medians dividing the northern service lanes and central traffic lanes and their associated drainage channels are currently excluded, as is the southern portion of all medians dividing the southern service and central traffic lanes. Also excluded is the Elm portion of the tree avenue within the southern nature strips of Queens Parade (note that between Wellington and Smith Streets London Planes comprise this portion of the avenue).

Figure 20: Heritage Overlay HO93 of the Yarra Planning Scheme as indicated on Planning Maps Online (<http://services.land.vic.gov.au/maps/pmo.jsp>)

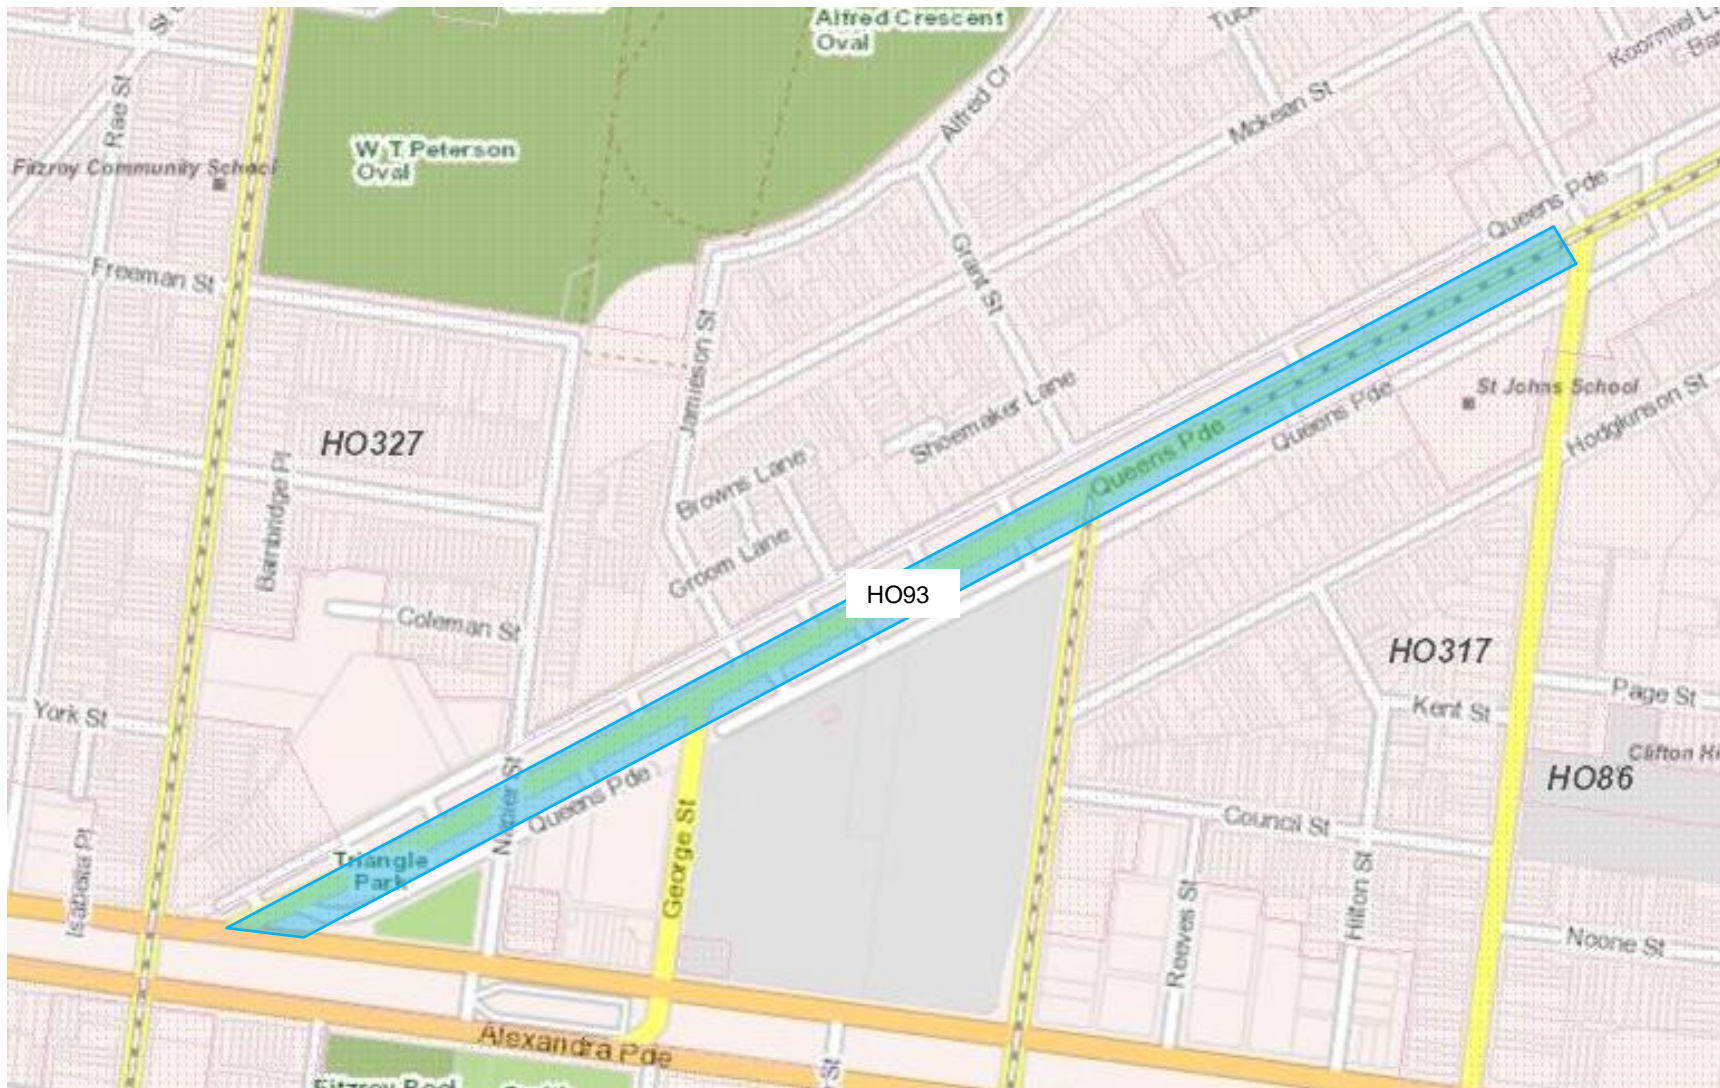
The current study confirms that Heritage Overlay HO93 of the Yarra Planning Scheme; *Queens Parade, between Alexandra Parade & Delbridge Street Clifton Hill/North Fitzroy, Street trees*, as indicated in Planning Maps Online (<http://services.land.vic.gov.au/maps/pmo.jsp>) and VicPlan (<http://mapshare.maps.vic.gov.au/vicplan/>) is currently incorrectly applied.

Figure 21: Heritage Overlay HO93 of the Yarra Planning Scheme as indicated on VicPlan (<http://mapshare.maps.vic.gov.au/vicplan/>)

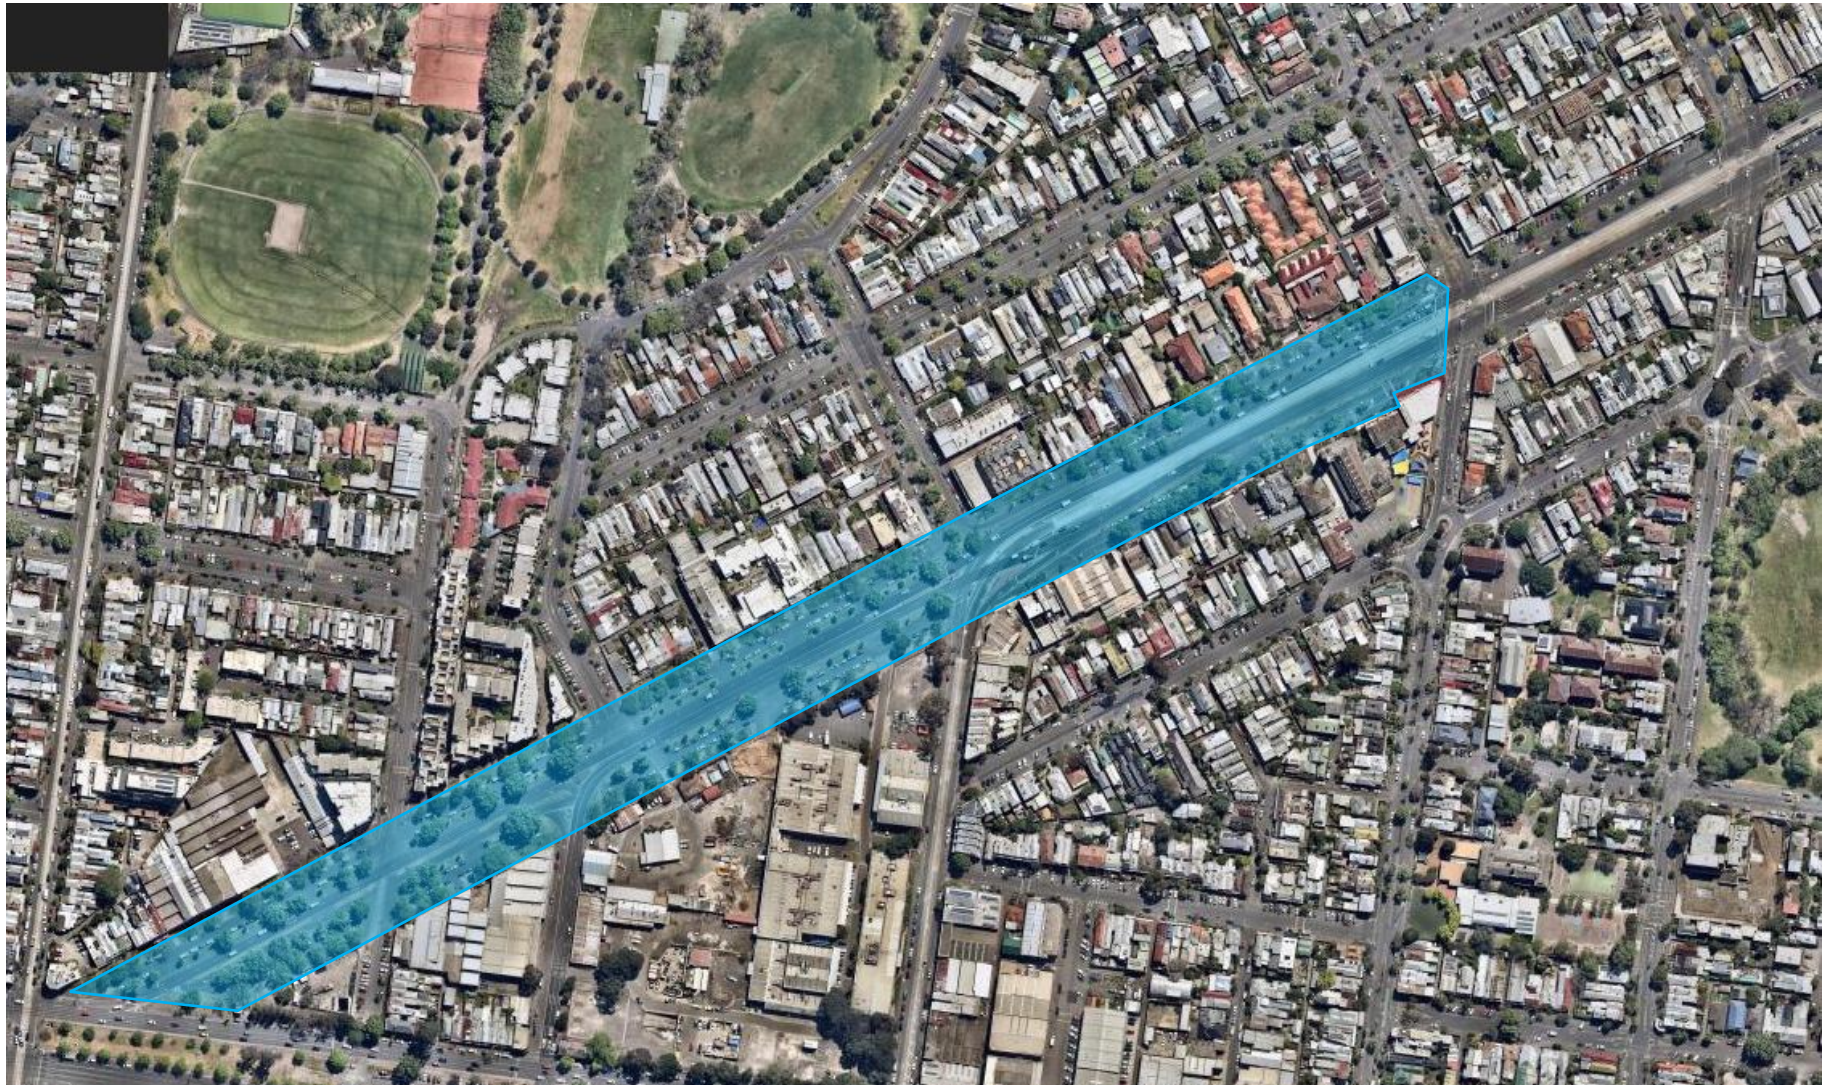
Figure 22: Recommended extent of Heritage Overlay HO93 of the Yarra Planning Scheme.

Alteration of the area to which Heritage Overlay HO93 applies is recommended, to include all elements which the Overlay is intended to encompass, as described above and indicated in Figure 22, below. It is noted that part of the area to be encompassed by HO93 is currently shown as covered by adjacent Heritage Overlay HO327 of the Yarra Planning Scheme.
