Heritage Overlay Study

QUEENS PARADE, FITZROY NORTH

November 2018

John Patrick Architects Pty. Ltd. has been commissioned by Yarra City Council to provide advice regarding an apparent anomaly in the application of Heritage Overlay HO93 of the Yarra Planning Scheme.

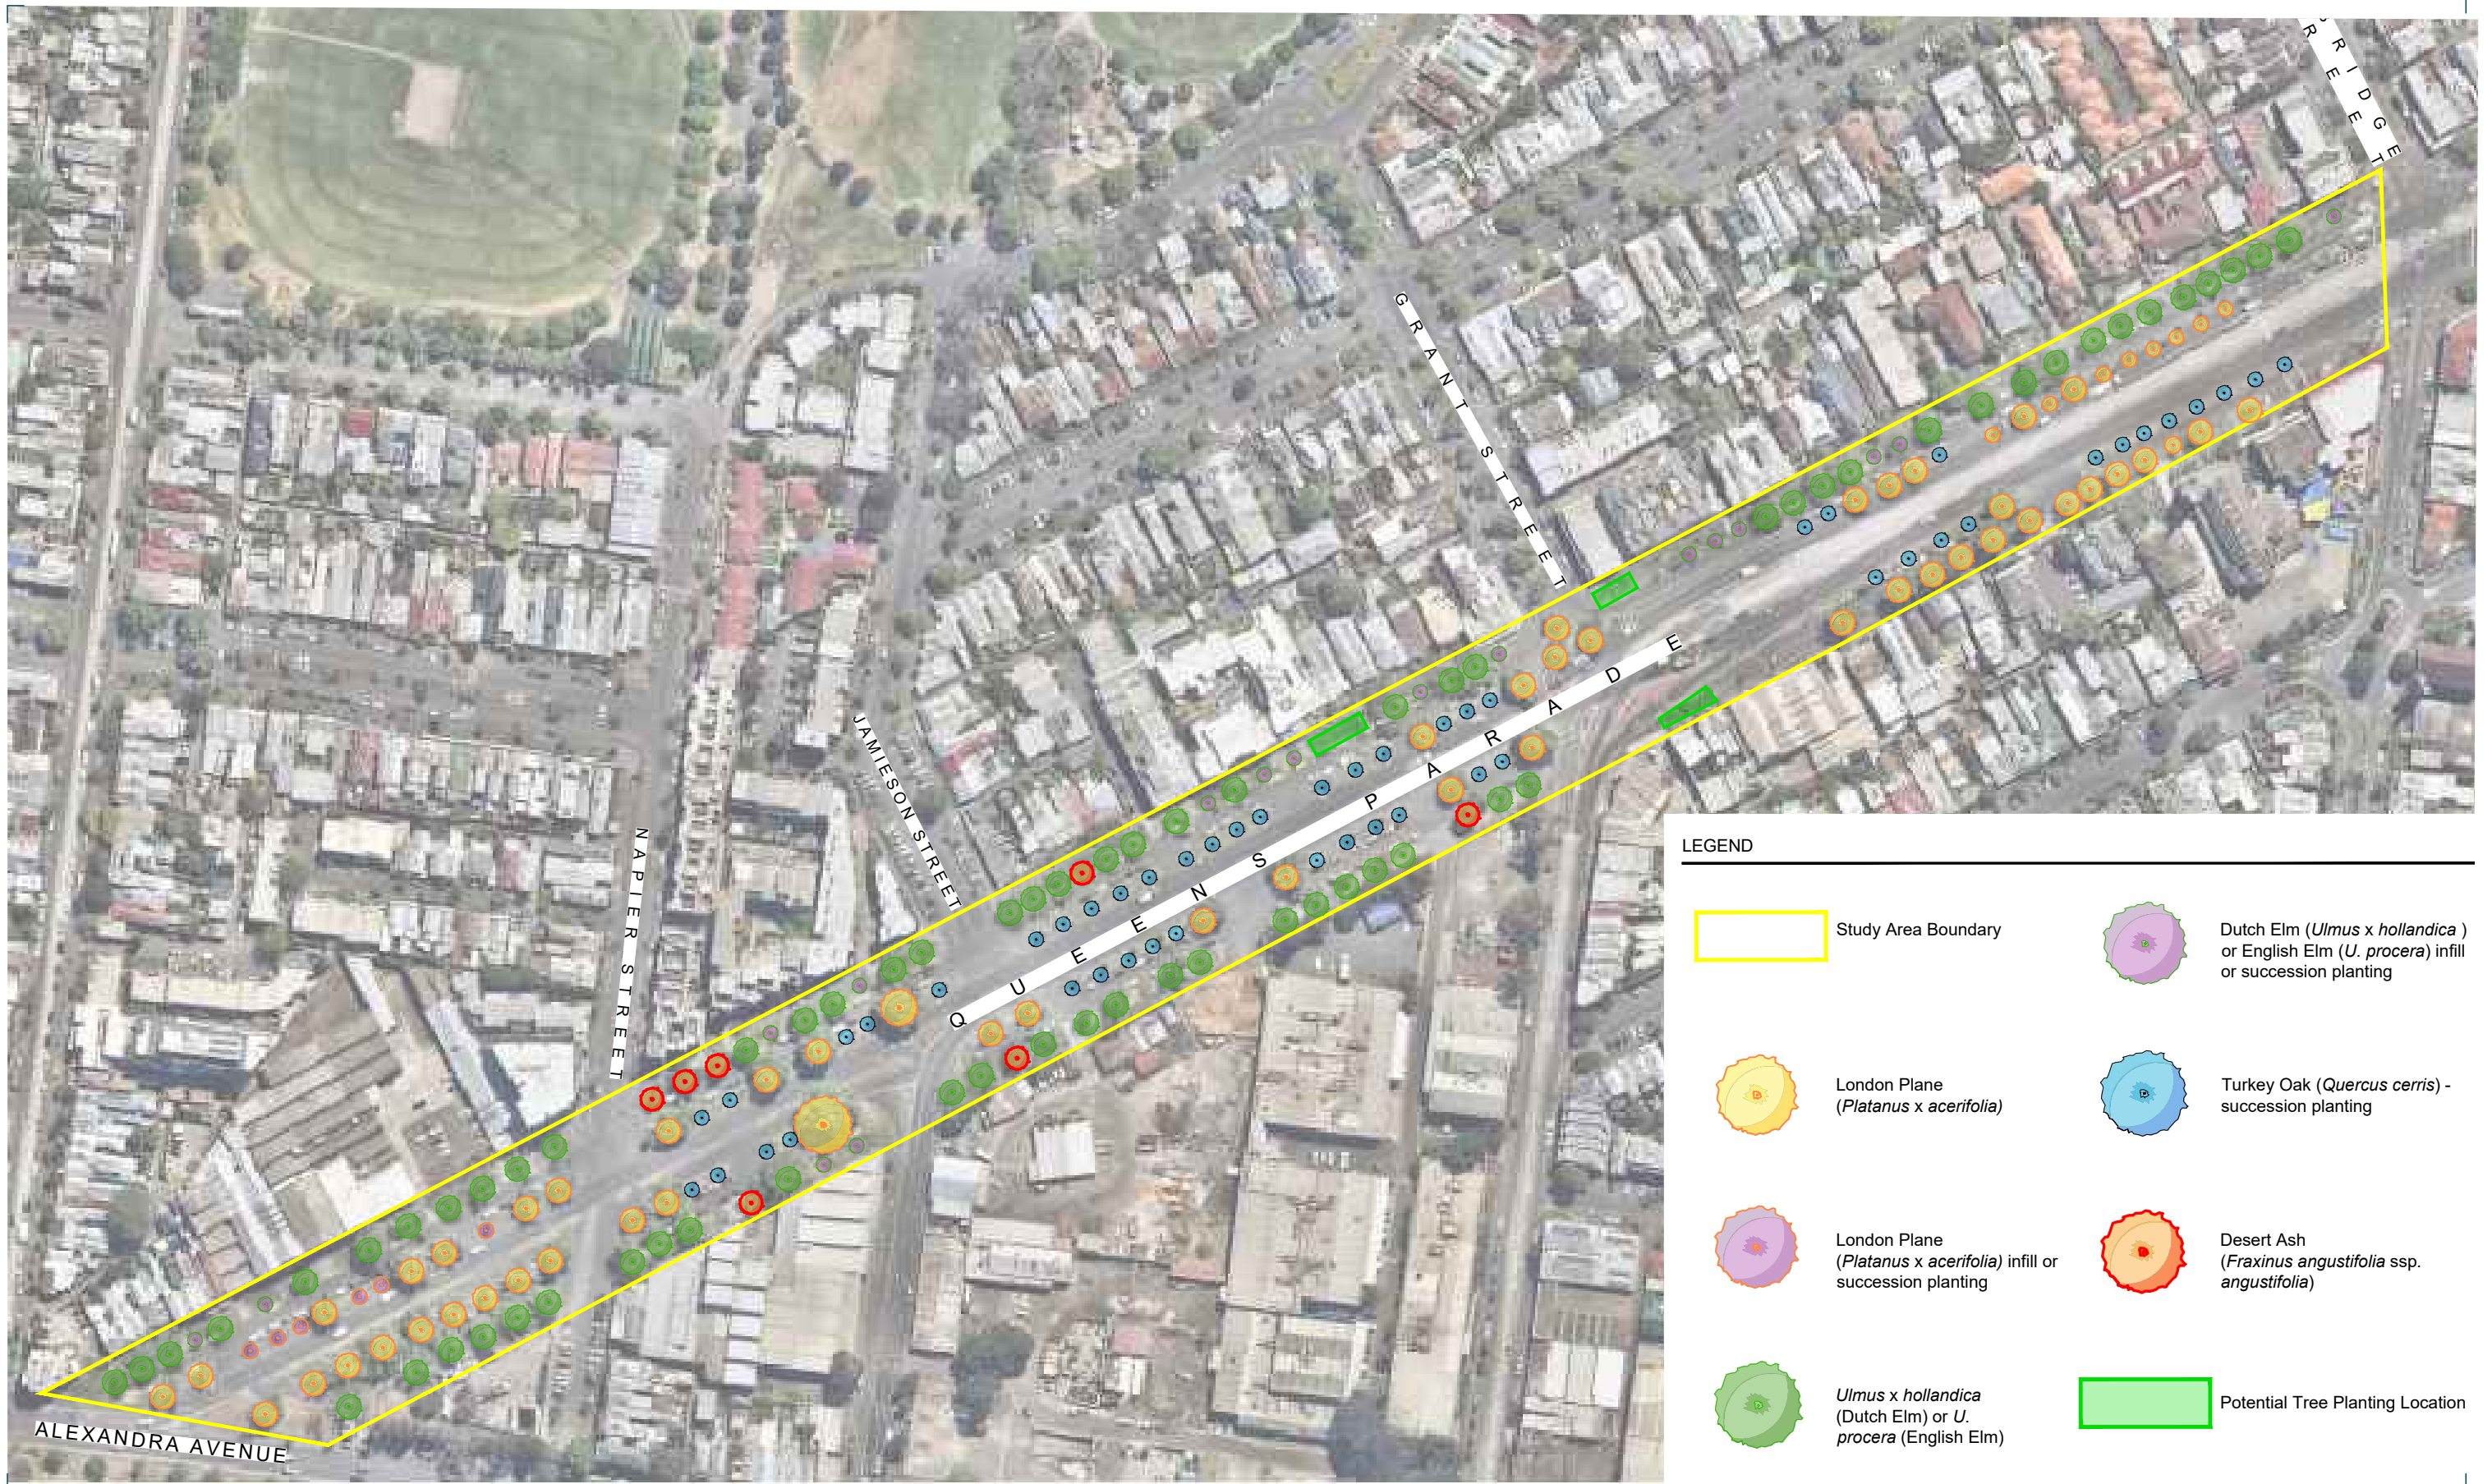
DRAWING
 Remnant Fabric (Vegetation) Plan

Regarding the Elm component of the avenue, generally appropriate infill and succession planting with English Elm (*Ulmus procera*) has been undertaken, with the majority of potential infill/succession planting locations utilised. This approach is considered appropriate conservation of the remnant fabric of the Elm component. Several instances of the inappropriate tree taxon Desert Ash (*Fraxinus angustifolia* ssp. *angustifolia*) were noted, as indicated on the attached Remnant Fabric (Vegetation) Plan HS-01.

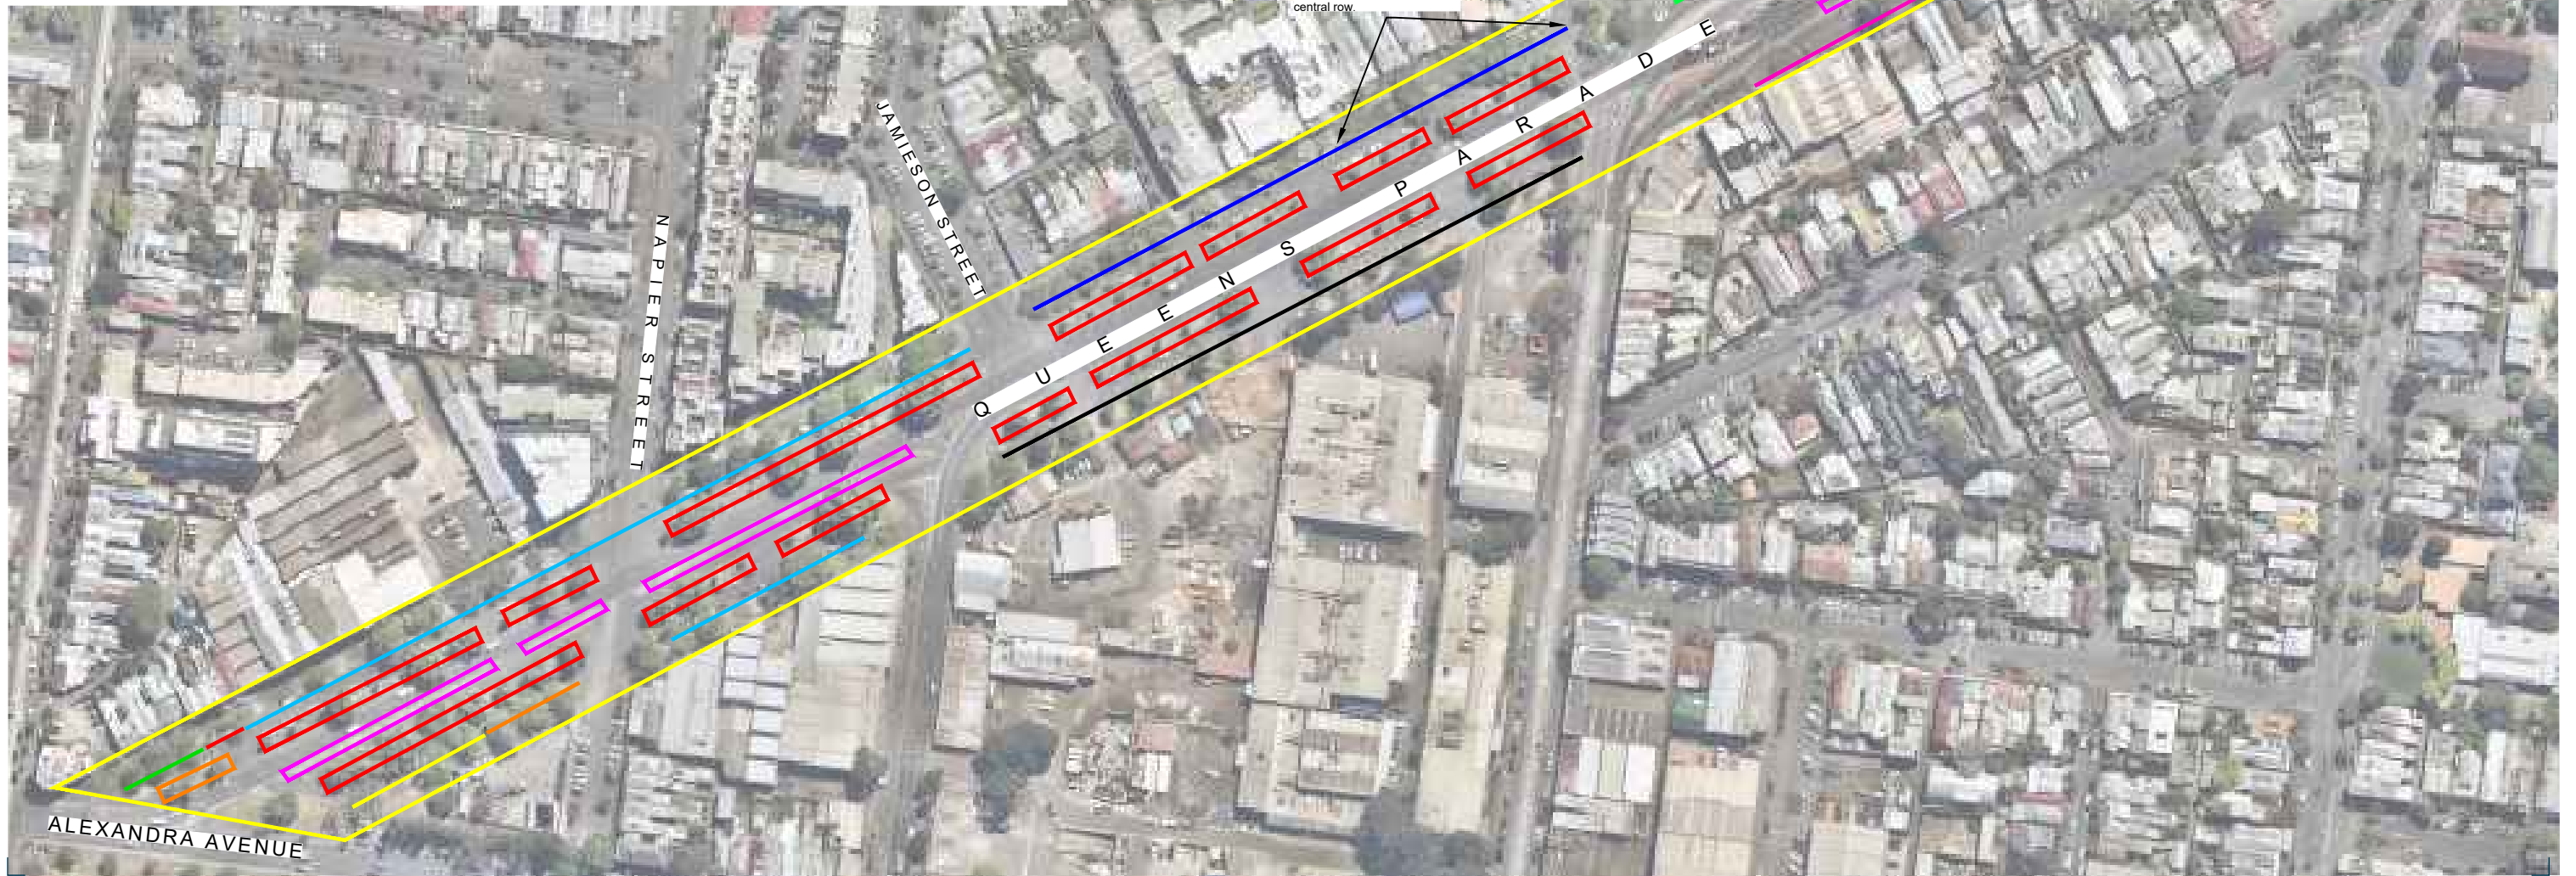
DRAWING
 Remnant Fabric
 (Man Made) Plan

The location and type of median border treatments is shown on the attached Remnant Fabric (Man Made) Plan, HS-02.

Inconsistency in the outer curb and drainage channel treatments was also noted along the length of Queens Parade within the study area, with eight types of curb and channel noted. These are shown on the attached Remnant Fabric (Man Made) Plan.
