Assessment of trees along Nicholson
Street as part of tramstop upgardes

Construction Impact Assessment

15 March 2017

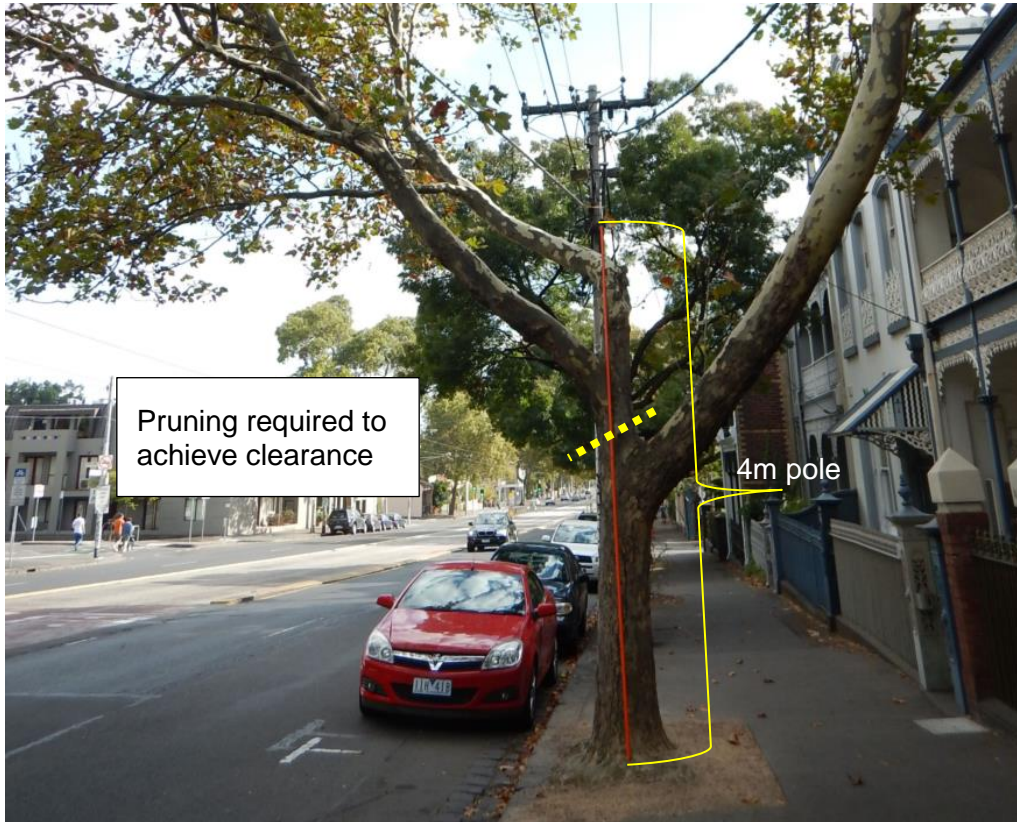
Figure 2: Pruning required to achieve 4.8m over the road. This tree will not remain viable (Tree 13).

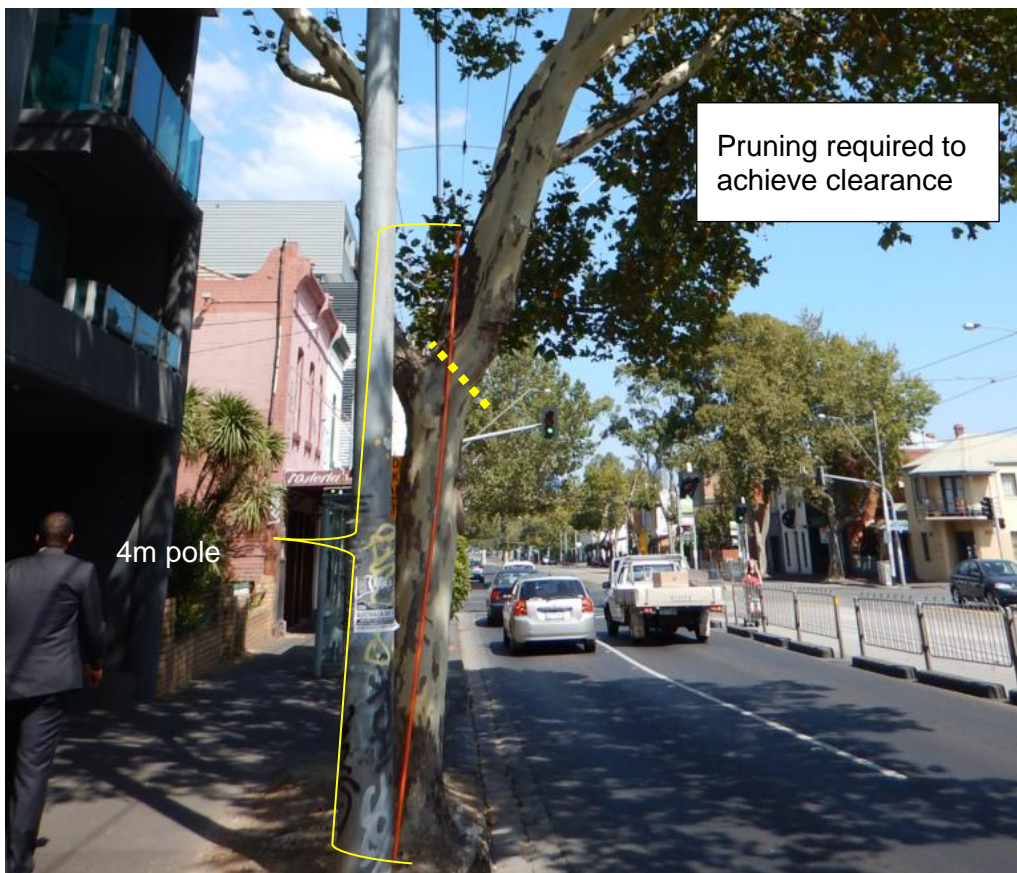
Figure 3: Pruning required to achieve 4.8m over the road. This tree will not remain viable (Tree 54).

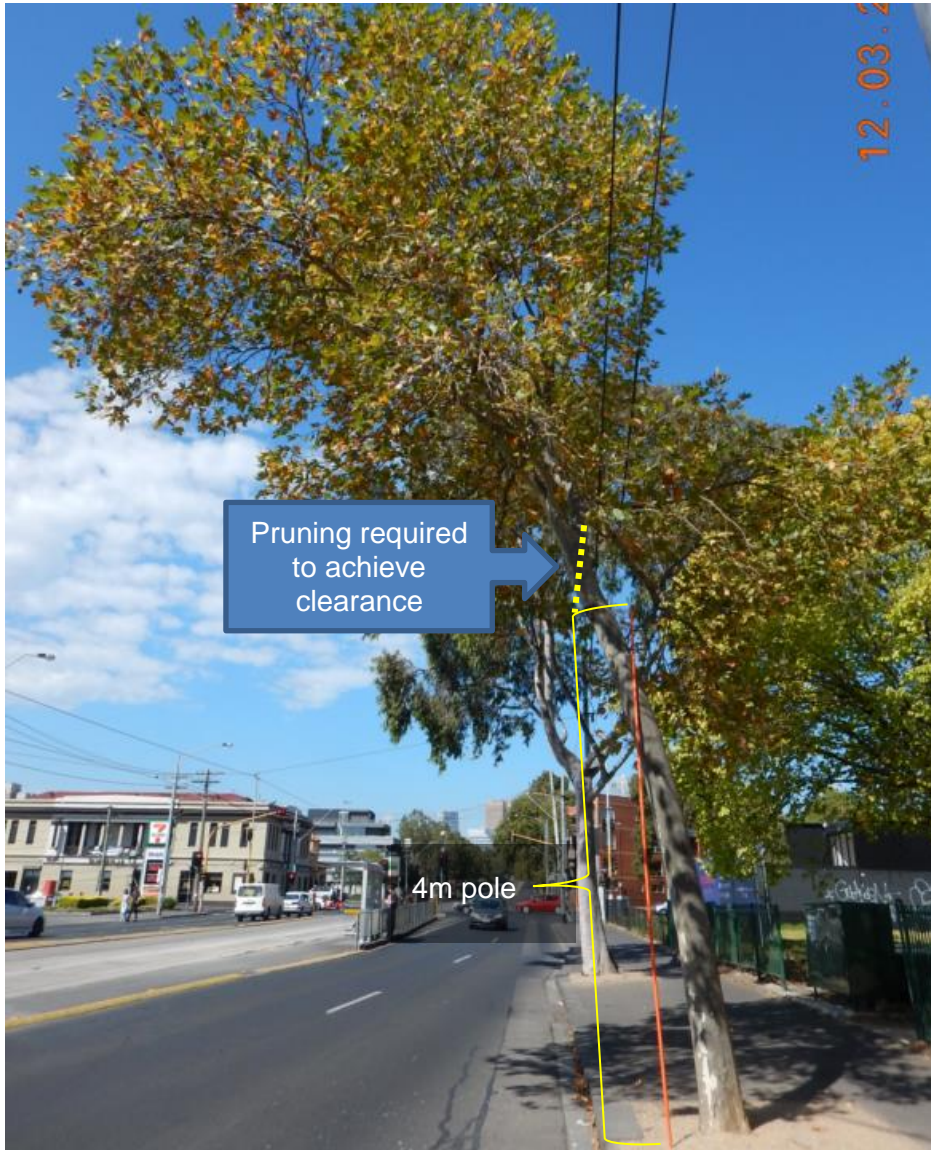
Figure 4: Example of where trunk removal is required to achieve clearance (Tree 21).

Common Name: London Plane
Origin: Exotic
Height (m): 9 **Health:** Good
Width (m): 6 **Structure:** Fair
DBH (cm): 26 **ULE:** 20+ years
Dia. @ base (cm): 33
Tree Significance | Retention: Moderately Significant | High
TPZ | SRZ Radius (m): 3.12 | 2.1
Minimum canopy clearance: ~4.5
Pruning required Whole of canopy to be removed as trunk leans over roadway
Likely Impact Tree will not remain viable
Comments: no design change.

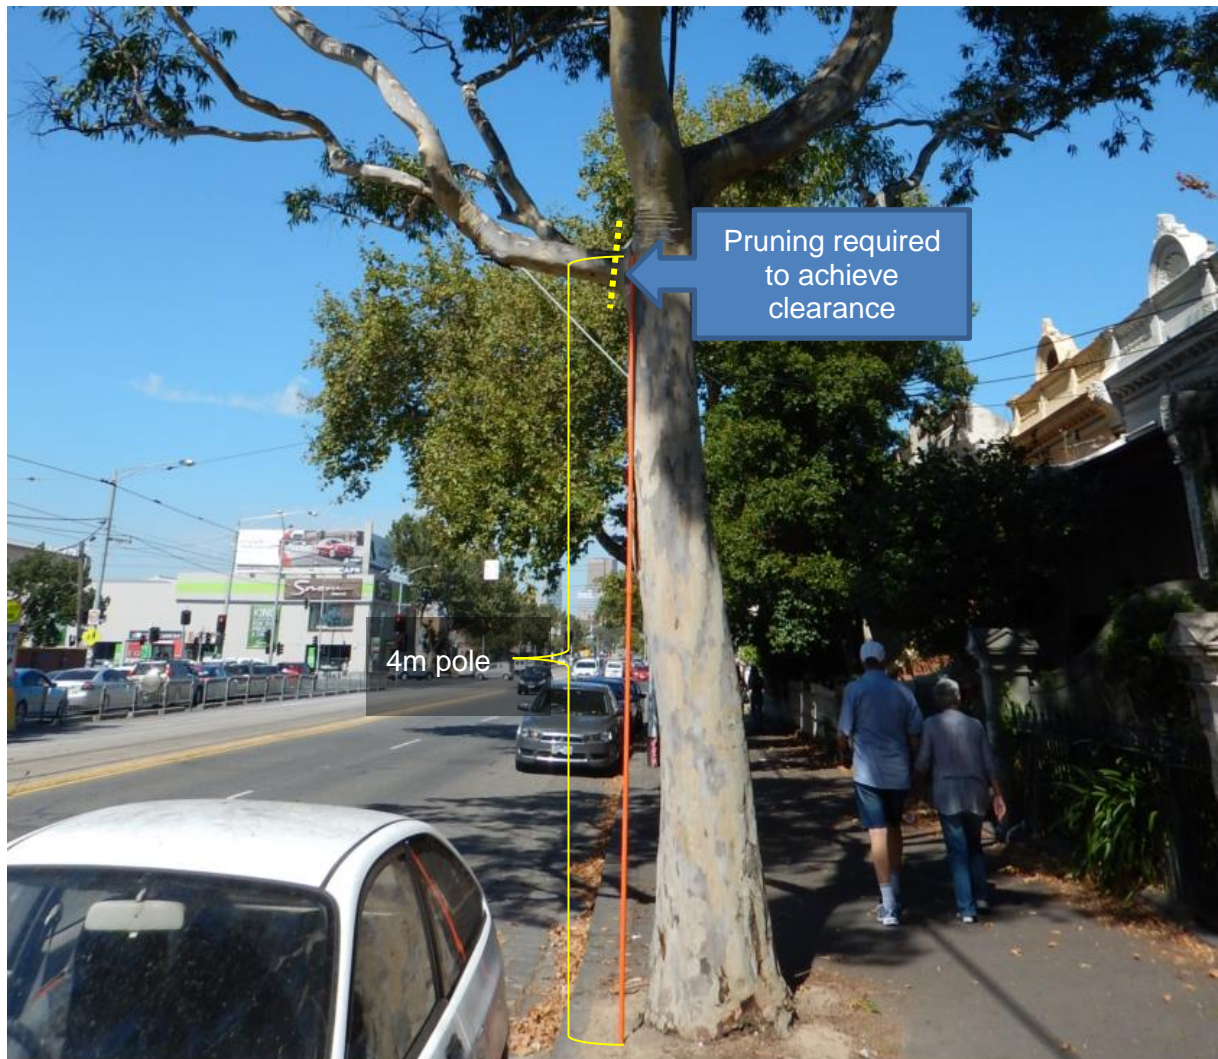
Figure 5: Example of a tree that will remain viable with pruning (Tree 34).

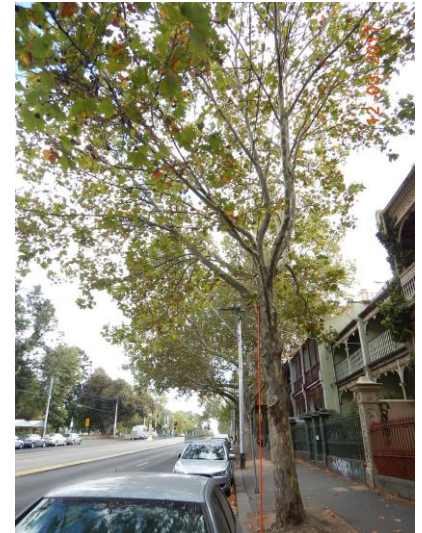
Tree ID: 4 **Botanical Name:** *Platanus Xacerifolia*

Common Name: London Plane
Origin: Exotic
Height (m): 14 **Health:** Good
Width (m): 8 **Structure:** Good
DBH (cm): 41 **ULE:** 20+ years
Dia. @ base (cm): 47
Tree Significance | Retention: Moderately Significant | High
TPZ | SRZ Radius (m): 4.92 | 2.4
Minimum canopy clearance: ~4
Pruning required 3 low branches over road, approx 25% canopy loss
Likely Impact Tree will remain viable
Comments:

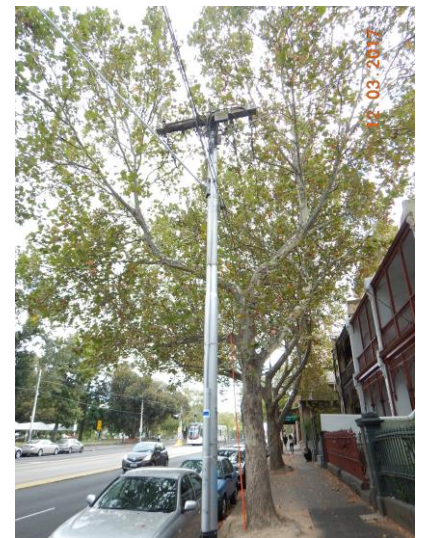
Tree ID: 6 **Botanical Name:** *Platanus Xacerifolia*

Common Name: London Plane
Origin: Exotic
Height (m): 16 **Health:** Good
Width (m): 12 **Structure:** Fair
DBH (cm): 57 **ULE:** 20+ years
Dia. @ base (cm): 68
Tree Significance | Retention: Moderately Significant | High
TPZ | SRZ Radius (m): 6.84 | 2.8
Minimum canopy clearance: ~4
Pruning required 1 large scaffold over road requires removal.
Likely Impact Tree will remain viable, possible reduction in ULE
Comments:

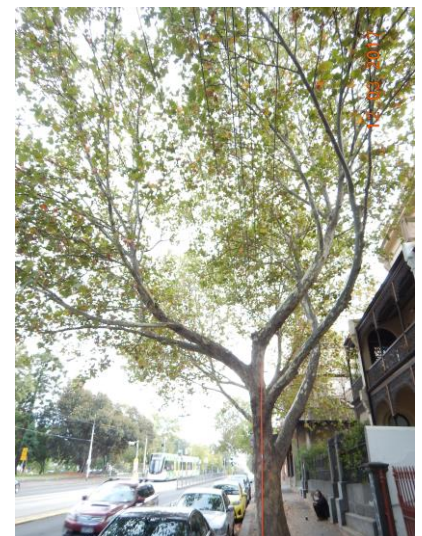
Tree ID: 7 **Botanical Name:** *Platanus Xacerifolia*

Common Name: London Plane
Origin: Exotic
Height (m): 15 **Health:** Good
Width (m): 10 **Structure:** Fair
DBH (cm): 54 **ULE:** 20+ years
Dia. @ base (cm): 64
Tree Significance | Retention: Moderately Significant | High
TPZ | SRZ Radius (m): 6.48 | 2.7
Minimum canopy clearance: ~4
Pruning required 1 scaffold over road requires removal.
Likely Impact Tree will remain viable, possible reduction in ULE
Comments: tree has already been pruned of several low, large branches.

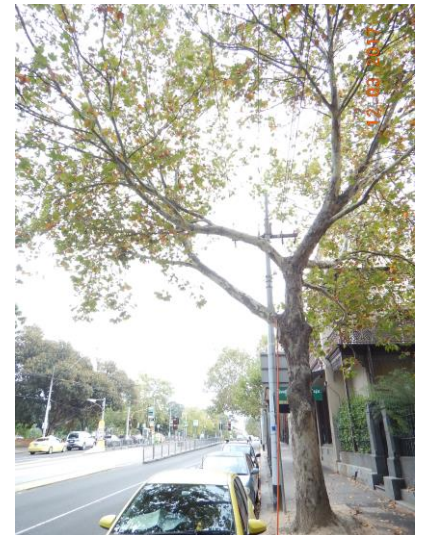
Tree ID: 8 **Botanical Name:** *Platanus Xacerifolia*

Common Name: London Plane
Origin: Exotic
Height (m): 8 **Health:** Good
Width (m): 5 **Structure:** Fair
DBH (cm): 16 **ULE:** 20+ years
Dia. @ base (cm): 20
Tree Significance | Retention: Low | Moderate
TPZ | SRZ Radius (m): 2 | 1.5
Minimum canopy clearance: ~3.5
Pruning required Small lower limbs to achieve clearance, but not for design changes.
Likely Impact Tree will remain viable
Comments: tree requires LV clearance.

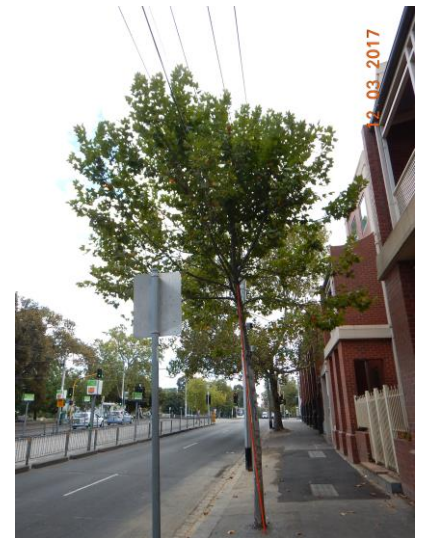
Tree ID: 9 **Botanical Name:** *Platanus Xacerifolia*

Common Name: London Plane
Origin: Exotic
Height (m): 15 **Health:** Good
Width (m): 10 **Structure:** Fair
DBH (cm): 50 **ULE:** 20+ years
Dia. @ base (cm): 61
Tree Significance | Retention: Significant | High
TPZ | SRZ Radius (m): 6 | 2.7
Minimum canopy clearance: ~4
Pruning required None for design, but 2 large low limbs to comply with 4.8m
Likely Impact Tree will remain viable, possible reduction in ULE
Comments:

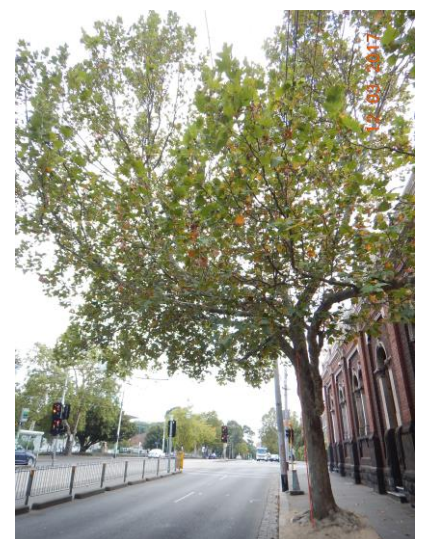
Tree ID: 10 Botanical Name: *Platanus Xacerifolia*

Common Name: London Plane
Origin: Exotic
Height (m): 9 **Health:** Good
Width (m): 7 **Structure:** Fair
DBH (cm): 32 **ULE:** 20+ years
Dia. @ base (cm): 39
Tree Significance | Retention: Moderately Significant | High
TPZ | SRZ Radius (m): 3.84 | 2.2
Minimum canopy clearance: ~3.75
Pruning required 3 branches growing over road, approx. 50% canopy loss
Likely Impact Tree will remain viable, possible reduction in ULE
Comments:

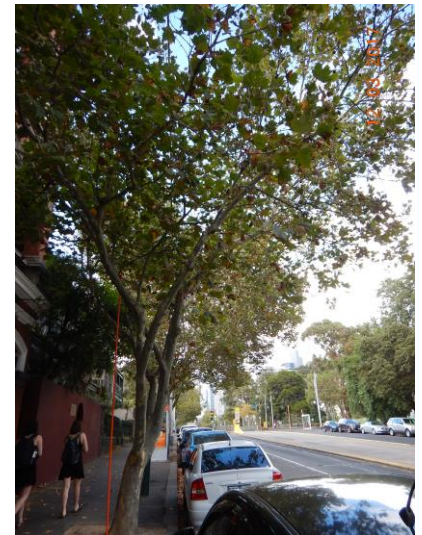
Tree ID: 11 Botanical Name: *Platanus Xacerifolia*

Common Name: London Plane
Origin: Exotic
Height (m): 16 **Health:** Good
Width (m): 10 **Structure:** Fair
DBH (cm): 48 **ULE:** 20+ years
Dia. @ base (cm): 57
Tree Significance | Retention: Moderately Significant | High
TPZ | SRZ Radius (m): 5.76 | 2.6
Minimum canopy clearance: ~3
Pruning required No significant branches, only small epicormics.
Likely Impact Tree will remain viable
Comments:

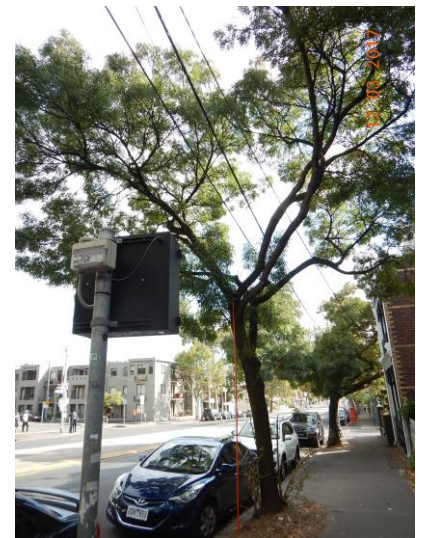
Tree ID: 15 Botanical Name: *Fraxinus 'Raywood'*

Common Name: Claret Ash
Origin: Exotic
Height (m): 10 **Health:** Fair
Width (m): 10 **Structure:** Fair
DBH (cm): 46 **ULE:** 10-20 years
Dia. @ base (cm): 55
Tree Significance | Retention: Moderately Significant | High
TPZ | SRZ Radius (m): 5.52 | 2.6
Minimum canopy clearance: ~3
Pruning required 3 stems over road, ~50% canopy loss
Likely Impact Tree will not remain viable
Comments:

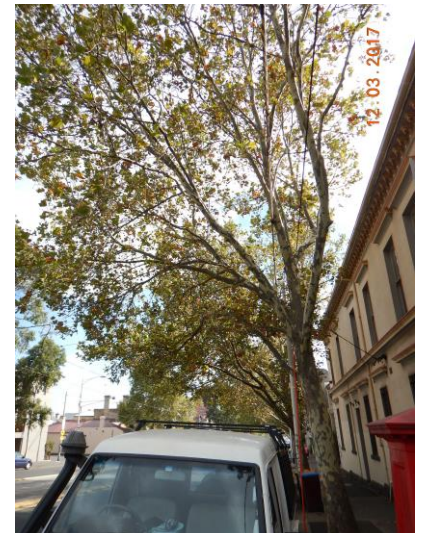
Tree ID: 16 Botanical Name: *Platanus Xacerifolia*

Common Name: London Plane
Origin: Exotic
Height (m): 14 **Health:** Good
Width (m): 9 **Structure:** Good
DBH (cm): 42 **ULE:** 20+ years
Dia. @ base (cm): 53
Tree Significance | Retention: Significant | High
TPZ | SRZ Radius (m): 5.04 | 2.5
Minimum canopy clearance: ~3.75
Pruning required 3-4 stems over road, ~30-40% loss
Likely Impact Tree will remain viable
Comments:

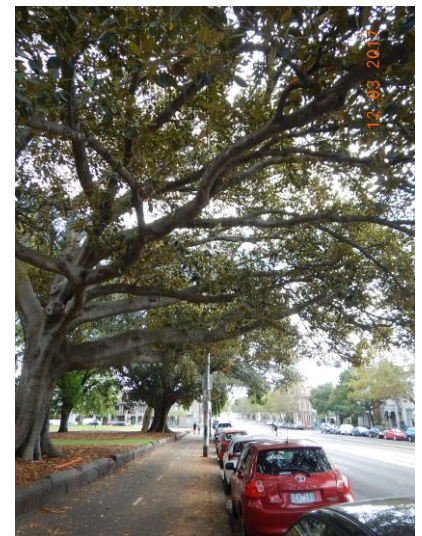
Tree ID: 18 Botanical Name: *Ficus macrophylla*

Common Name: Moreton Bay Fig
Origin: Native
Height (m): 18 **Health:** Good
Width (m): 26 **Structure:** Good
DBH (cm): 176 **ULE:** 20+ years
Dia. @ base (cm): 230
Tree Significance | Retention: Highly Significant | Very High
TPZ | SRZ Radius (m): 15 | 4.7
Minimum canopy clearance: ~4.5
Pruning required Only low hanging foliage.
Likely Impact Tree will remain viable
Comments: Tree located in Carlton Gardens

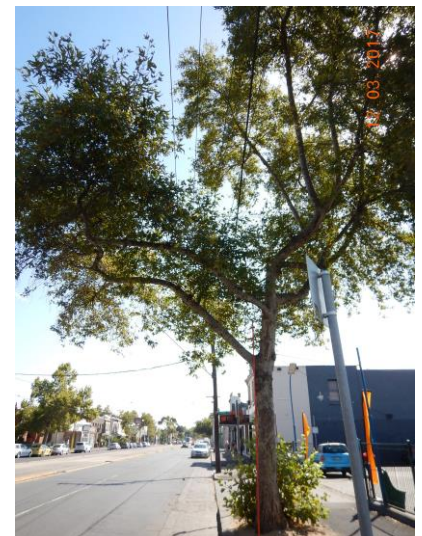
Tree ID: 27 Botanical Name: *Platanus Xacerifolia*

Common Name: London Plane
Origin: Exotic
Height (m): 8 **Health:** Good
Width (m): 8 **Structure:** Fair
DBH (cm): 33 **ULE:** 20+ years
Dia. @ base (cm): 42
Tree Significance | Retention: Moderately Significant | High
TPZ | SRZ Radius (m): 3.96 | 2.3
Minimum canopy clearance: ~3.5
Pruning required Whole stem over road, ~35% canopy
Likely Impact Tree will remain viable
Comments:

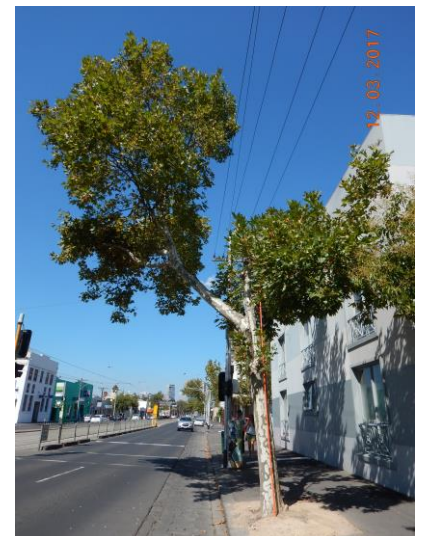
Tree ID: 30 Botanical Name: *Corymbia maculata*

Common Name: Spotted Gum
Origin: Native
Height (m): 15 **Health:** Good
Width (m): 10 **Structure:** Fair
DBH (cm): 50 **ULE:** 20+ years
Dia. @ base (cm): 58
Tree Significance | Retention: Moderately Significant | High
TPZ | SRZ Radius (m): 6 | 2.6
Minimum canopy clearance: ~5
Pruning required None
Likely Impact Tree will remain viable
Comments:

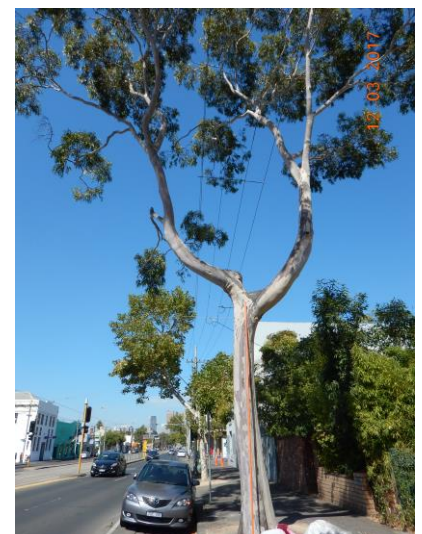
Tree ID: 31 Botanical Name: *Corymbia maculata*

Common Name: Spotted Gum
Origin: Native
Height (m): 14 **Health:** Good
Width (m): 8 **Structure:** Fair
DBH (cm): 35 **ULE:** 20+ years
Dia. @ base (cm): 43
Tree Significance | Retention: Moderately Significant | Moderate
TPZ | SRZ Radius (m): 4.2 | 2.3
Minimum canopy clearance: ~4
Pruning required None
Likely Impact Tree will remain viable
Comments: car space to remain, trunk hit by trucks multiple times.

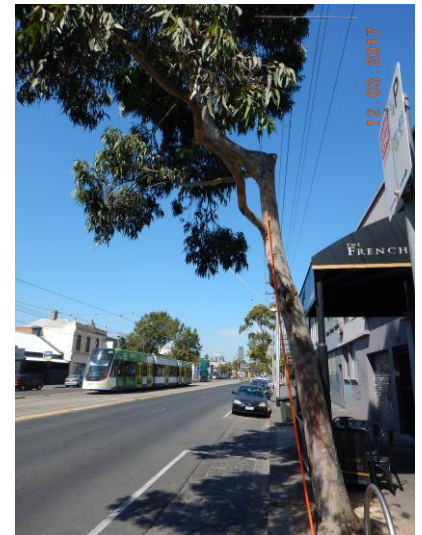
Tree ID: 32 Botanical Name: *Platanus orientalis*

Common Name: Plane
Origin: Exotic
Height (m): 8 **Health:** Good
Width (m): 7 **Structure:** Fair
DBH (cm): 27 **ULE:** 20+ years
Dia. @ base (cm): 33
Tree Significance | Retention: Moderately Significant | Moderate
TPZ | SRZ Radius (m): 3.24 | 2.1
Minimum canopy clearance: ~3.5
Pruning required None
Likely Impact Tree will remain viable
Comments: car space to remain, clearance not required.

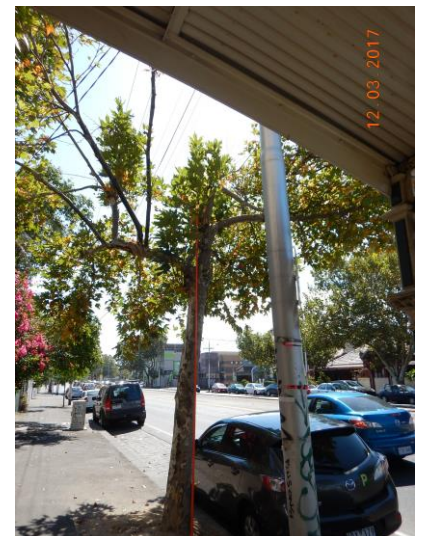
Tree ID: 33 Botanical Name: *Platanus orientalis*

Common Name: Plane
Origin: Exotic
Height (m): 17 **Health:** Good
Width (m): 12 **Structure:** Good
DBH (cm): 59 **ULE:** 20+ years
Dia. @ base (cm): 70
Tree Significance | Retention: Significant | High
TPZ | SRZ Radius (m): 7.08 | 2.8
Minimum canopy clearance: ~4
Pruning required Whole stem over road, ~40% canopy loss.
Likely Impact Tree will remain viable, possible reduction in ULE
Comments: car space to remain, clearance not required.

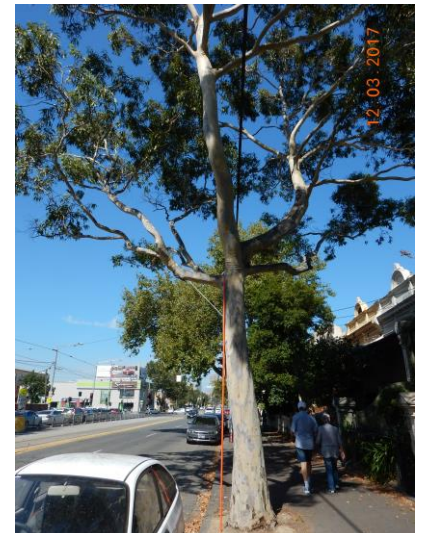
Tree ID: 34 Botanical Name: *Corymbia maculata*

Common Name: Spotted Gum
Origin: Native
Height (m): 15 **Health:** Fair
Width (m): 10 **Structure:** Fair
DBH (cm): 49 **ULE:** 20+ years
Dia. @ base (cm): 58
Tree Significance | Retention: Moderately Significant | High
TPZ | SRZ Radius (m): 5.88 | 2.6
Minimum canopy clearance: ~4
Pruning required 2 small branches over road, ~20% canopy loss.
Likely Impact Tree will remain viable
Comments:

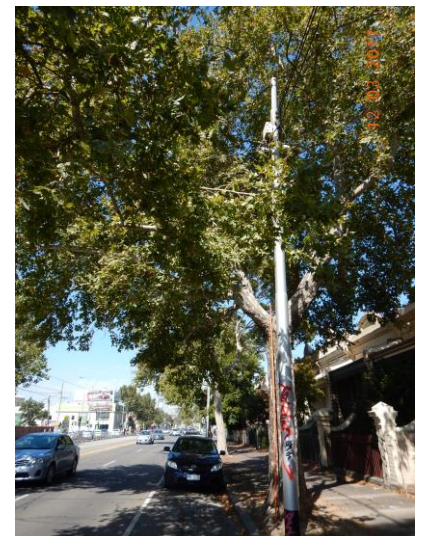
Tree ID: 36 Botanical Name: *Corymbia maculata*

Common Name: Spotted Gum
Origin: Native
Height (m): 16 **Health:** Good
Width (m): 12 **Structure:** Fair
DBH (cm): 72 **ULE:** 20+ years
Dia. @ base (cm): 85
Tree Significance | Retention: Significant | High
TPZ | SRZ Radius (m): 8.64 | 3.1
Minimum canopy clearance: ~4.8
Pruning required None
Likely Impact Tree will remain viable
Comments:

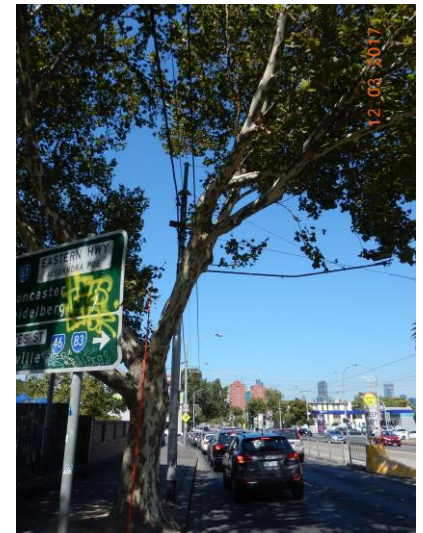
Tree ID: 38 Botanical Name: *Platanus Xacerifolia*

Common Name: London Plane
Origin: Exotic
Height (m): 14 **Health:** Fair
Width (m): 12 **Structure:** Fair
DBH (cm): 48 **ULE:** 20+ years
Dia. @ base (cm): 56
Tree Significance | Retention: Moderately Significant | High
TPZ | SRZ Radius (m): 5.76 | 2.6
Minimum canopy clearance: ~4
Pruning required Remove 2 branches over road, ~40% of canopy
Likely Impact Tree will remain viable, possible reduction in ULE
Comments: tree roots growing over kerb. canopy already asymmetrical.

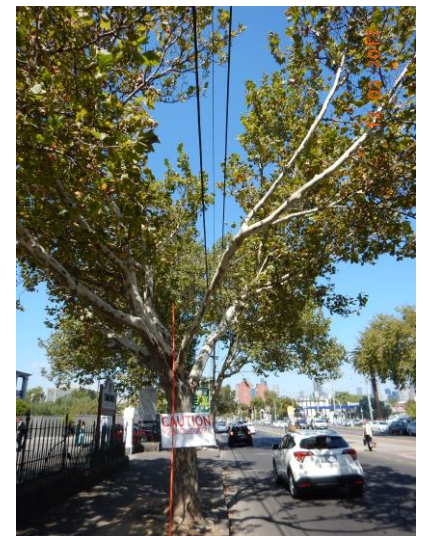
Tree ID: 39 Botanical Name: *Platanus Xacerifolia*

Common Name: London Plane
Origin: Exotic
Height (m): 14 **Health:** Fair
Width (m): 10 **Structure:** Fair
DBH (cm): 45 **ULE:** 10-20 years
Dia. @ base (cm): 52
Tree Significance | Retention: Moderately Significant | High
TPZ | SRZ Radius (m): 5.4 | 2.5
Minimum canopy clearance: ~3.5
Pruning required Remove 2 branches over road, ~60% of canopy
Likely Impact Tree will not remain viable
Comments:

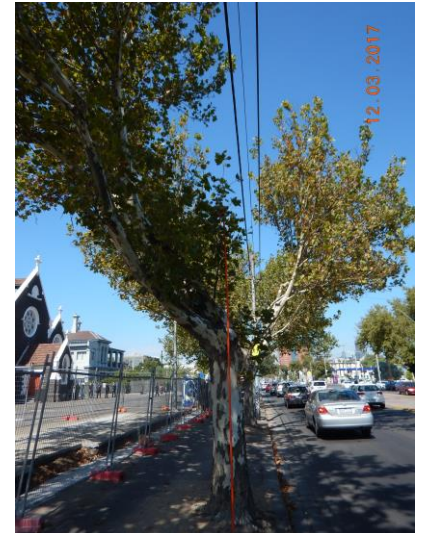
Tree ID: 40 **Botanical Name:** *Platanus Xacerifolia*

Common Name: London Plane
Origin: Exotic
Height (m): 14 **Health:** Fair
Width (m): 8 **Structure:** Fair
DBH (cm): 43 **ULE:** 10-20 years
Dia. @ base (cm): 49
Tree Significance | Retention: Moderately Significant | High
TPZ | SRZ Radius (m): 5.16 | 2.5
Minimum canopy clearance: >5
Pruning required None
Likely Impact Tree will remain viable
Comments: no canopy over road.

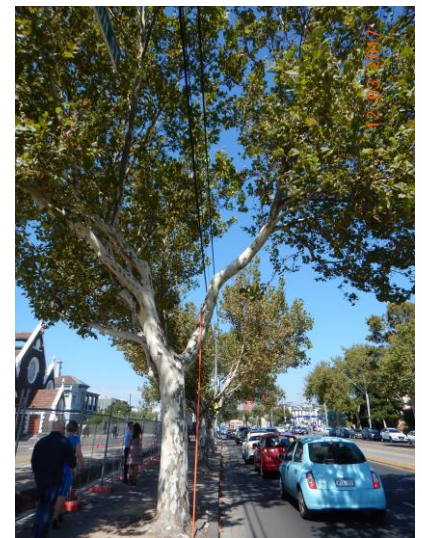
Tree ID: 41 **Botanical Name:** *Platanus Xacerifolia*

Common Name: London Plane
Origin: Exotic
Height (m): 13 **Health:** Good
Width (m): 10 **Structure:** Fair
DBH (cm): 50 **ULE:** 20+ years
Dia. @ base (cm): 58
Tree Significance | Retention: Moderately Significant | High
TPZ | SRZ Radius (m): 6 | 2.6
Minimum canopy clearance: ~4.7
Pruning required None
Likely Impact Tree will remain viable
Comments:

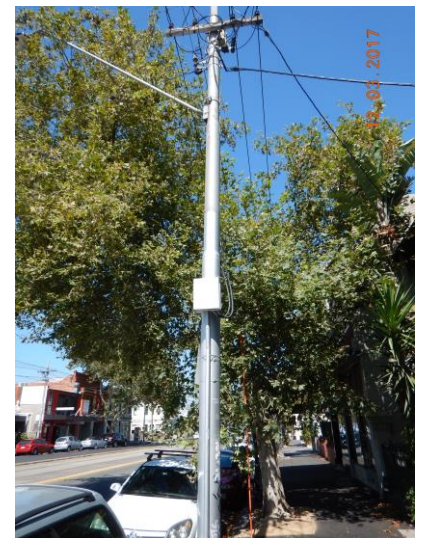
Tree ID: 45 Botanical Name: *Corymbia maculata*

Common Name: Spotted Gum
Origin: Native
Height (m): 15 **Health:** Good
Width (m): 10 **Structure:** Fair
DBH (cm): 52 **ULE:** 5-10 years
Dia. @ base (cm): 68
Tree Significance | Retention: Moderately Significant | High
TPZ | SRZ Radius (m): 6.24 | 2.8
Minimum canopy clearance: ~3.8
Pruning required Remove main trunk heading over road, ~60% canopy loss
Likely Impact Tree will not remain viable
Comments: decay in main stem, damage from vehicle impacts.

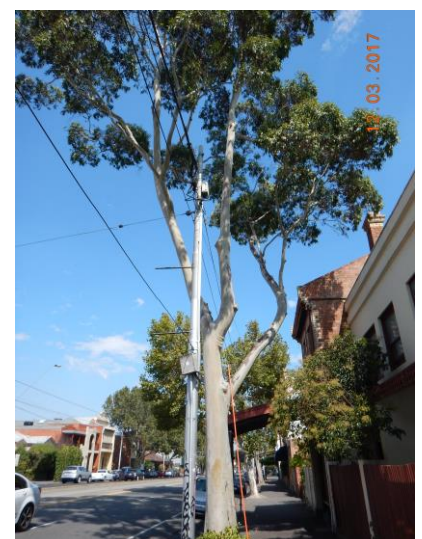
Tree ID: 48 Botanical Name: *Corymbia maculata*

Common Name: Spotted Gum
Origin: Native
Height (m): 15 **Health:** Good
Width (m): 10 **Structure:** Fair
DBH (cm): 67 **ULE:** 20+ years
Dia. @ base (cm): 77
Tree Significance | Retention: Significant | High
TPZ | SRZ Radius (m): 8.04 | 3.0
Minimum canopy clearance: >5
Pruning required None
Likely Impact Tree will remain viable
Comments:

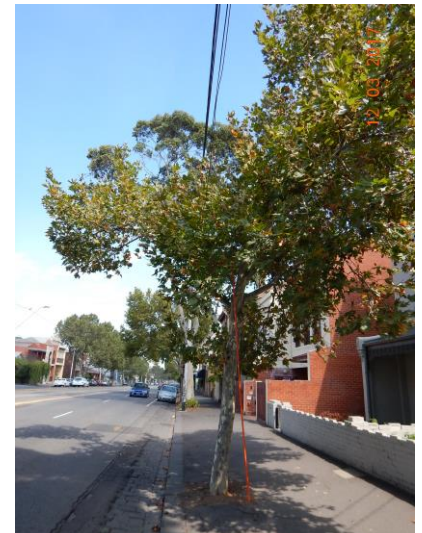
Tree ID: 49 **Botanical Name:** *Platanus Xacerifolia*

Common Name: London Plane
Origin: Exotic
Height (m): 9 **Health:** Good
Width (m): 6 **Structure:** Fair
DBH (cm): 25 **ULE:** 20+ years
Dia. @ base (cm): 30
Tree Significance | Retention: Moderately Significant | Moderate
TPZ | SRZ Radius (m): 3 | 2.0
Minimum canopy clearance: ~3
Pruning required 1 branch to be removed, ~20% of canopy.
Likely Impact Tree will remain viable
Comments:

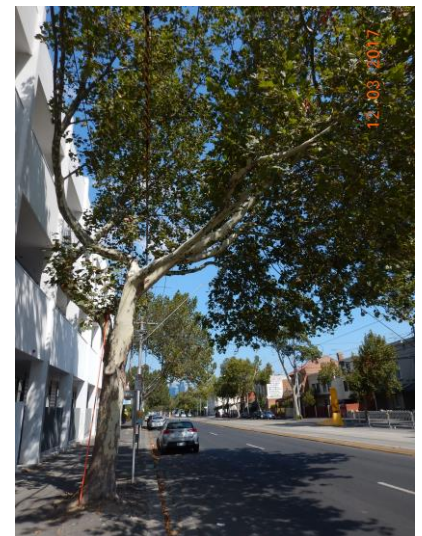
Tree ID: 53 Botanical Name: *Platanus Xacerifolia*

Common Name: London Plane
Origin: Exotic
Height (m): 16 **Health:** Good
Width (m): 10 **Structure:** Fair
DBH (cm): 54 **ULE:** 20+ years
Dia. @ base (cm): 62
Tree Significance | Retention: Moderately Significant | High
TPZ | SRZ Radius (m): 6.48 | 2.7
Minimum canopy clearance: ~4
Pruning required Only low hanging foliage
Likely Impact Tree will remain viable
Comments:

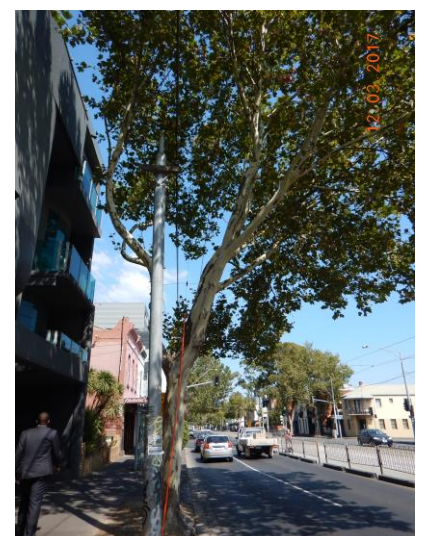
Tree ID: 54 Botanical Name: *Platanus Xacerifolia*

Common Name: London Plane
Origin: Exotic
Height (m): 15 **Health:** Good
Width (m): 10 **Structure:** Fair
DBH (cm): 48 **ULE:** 20+ years
Dia. @ base (cm): 59
Tree Significance | Retention: Moderately Significant | High
TPZ | SRZ Radius (m): 5.76 | 2.7
Minimum canopy clearance: ~3.5
Pruning required 2 main stems to be pruned
Likely Impact Tree will not remain viable
Comments:

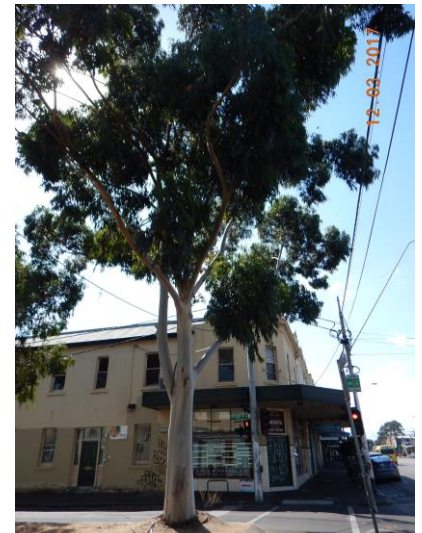
Tree ID: 64 Botanical Name: *Eucalyptus saligna*

Common Name: Sydney Blue Gum
Origin: Native
Height (m): 15 **Health:** Good
Width (m): 10 **Structure:** Good
DBH (cm): 50 **ULE:** 20+ years
Dia. @ base (cm): 58
Tree Significance | Retention: Moderately Significant | Moderate
TPZ | SRZ Radius (m): 6 | 2.6
Minimum canopy clearance: >5
Pruning required None
Likely Impact Tree will remain viable
Comments:

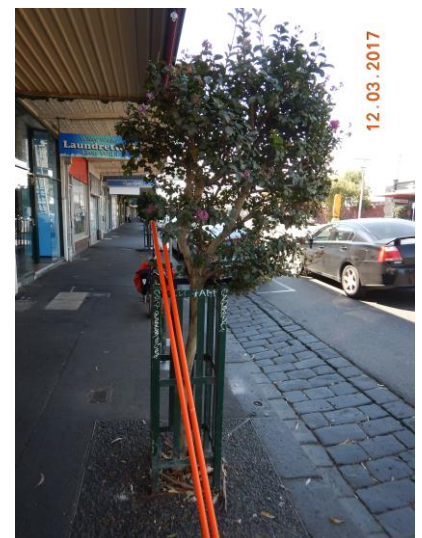
Tree ID: 65 Botanical Name: *Lagerstroemia indica*

Common Name: Crepe Myrtle
Origin: Exotic
Height (m): 3 **Health:** Good
Width (m): 1 **Structure:** Good
DBH (cm): 7 **ULE:** 20+ years
Dia. @ base (cm): 9
Tree Significance | Retention: Moderately Significant | Moderate
TPZ | SRZ Radius (m): 2 | 1.5
Minimum canopy clearance: >5
Pruning required None
Likely Impact Tree will remain viable
Comments:

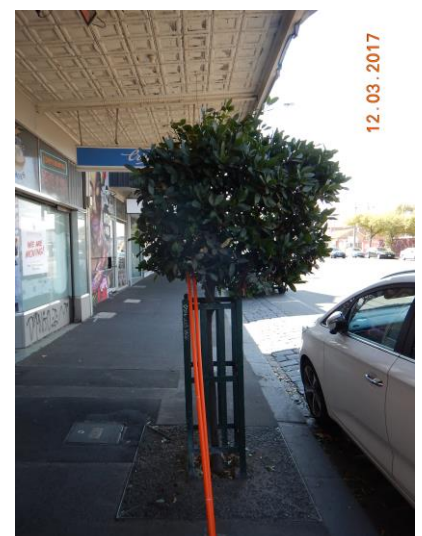
Tree ID: 66 Botanical Name: *Laurus nobilis*

Common Name: Bay Tree
Origin: Exotic
Height (m): 3 **Health:** Good
Width (m): 1 **Structure:** Good
DBH (cm): 7 **ULE:** 20+ years
Dia. @ base (cm): 9
Tree Significance | Retention: Moderately Significant | Moderate
TPZ | SRZ Radius (m): 2 | 1.5
Minimum canopy clearance: >5
Pruning required None
Likely Impact Tree will remain viable
Comments:

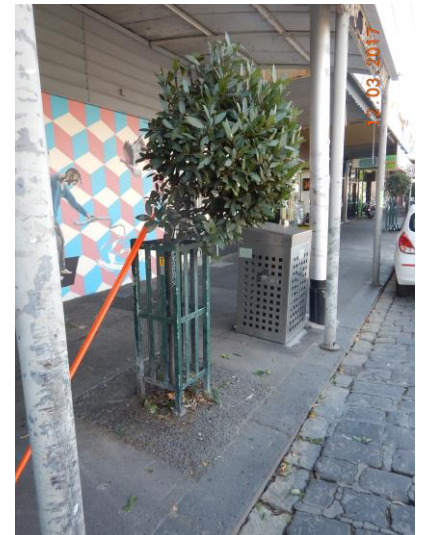
Tree ID: 67 Botanical Name: *Laurus nobilis*

Common Name: Bay Tree
Origin: Exotic
Height (m): 2 **Health:** Good
Width (m): 1 **Structure:** Good
DBH (cm): 5 **ULE:** 20+ years
Dia. @ base (cm): 6
Tree Significance | Retention: Moderately Significant | Moderate
TPZ | SRZ Radius (m): 2 | 1.5
Minimum canopy clearance: >5
Pruning required None
Likely Impact Tree will remain viable
Comments:

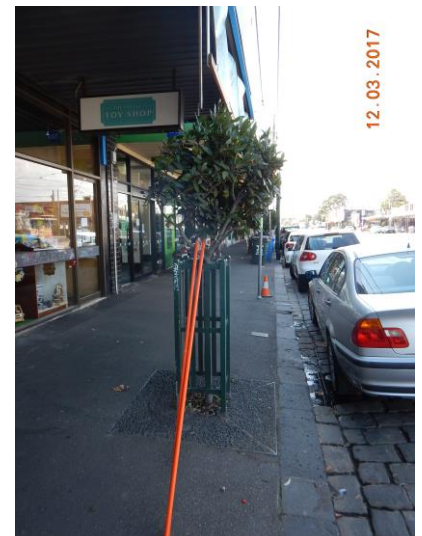
Tree ID: 68 Botanical Name: *Laurus nobilis*

Common Name: Bay Tree
Origin: Exotic
Height (m): 2 **Health:** Good
Width (m): 1 **Structure:** Good
DBH (cm): 5 **ULE:** 20+ years
Dia. @ base (cm): 6
Tree Significance | Retention: Moderately Significant | Moderate
TPZ | SRZ Radius (m): 2 | 1.5
Minimum canopy clearance: >5
Pruning required None
Likely Impact Tree will remain viable
Comments:

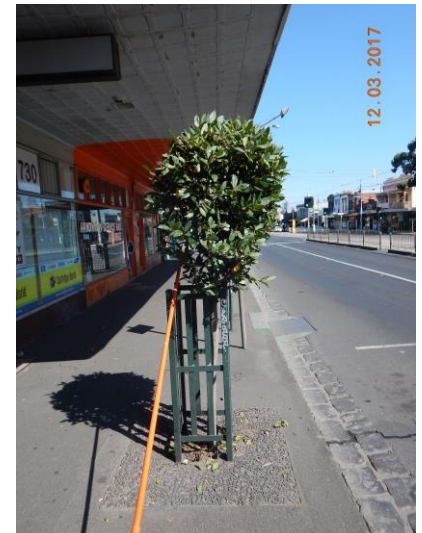
Tree ID: 70 Botanical Name: *Laurus nobilis*

Common Name: Bay Tree
Origin: Exotic
Height (m): 2 **Health:** Good
Width (m): 1 **Structure:** Fair
DBH (cm): 6 **ULE:** 10-20 years
Dia. @ base (cm): 8
Tree Significance | Retention: Moderately Significant | Moderate
TPZ | SRZ Radius (m): 2 | 1.5
Minimum canopy clearance: >5
Pruning required None
Likely Impact Tree will remain viable
Comments:

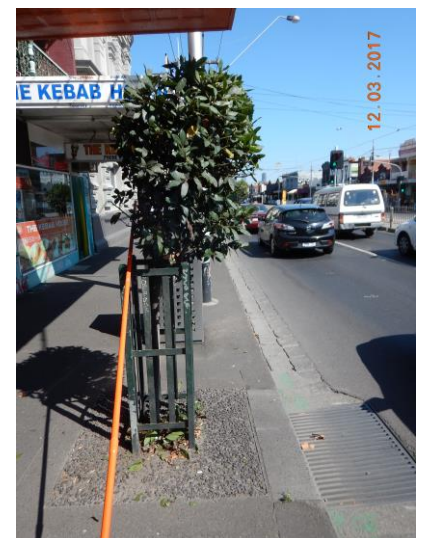
Tree ID: 71 Botanical Name: *Laurus nobilis*

Common Name: Bay Tree
Origin: Exotic
Height (m): 2 **Health:** Good
Width (m): 1 **Structure:** Fair
DBH (cm): 6 **ULE:** 10-20 years
Dia. @ base (cm): 8
Tree Significance | Retention: Moderately Significant | Moderate
TPZ | SRZ Radius (m): 2 | 1.5
Minimum canopy clearance: >5
Pruning required None
Likely Impact Tree will remain viable
Comments:

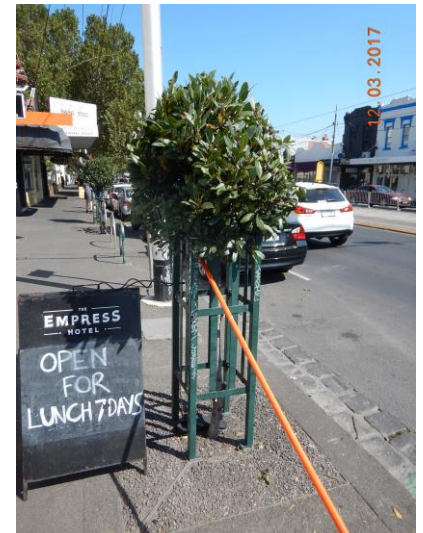
Likely Impact Tree will remain viable

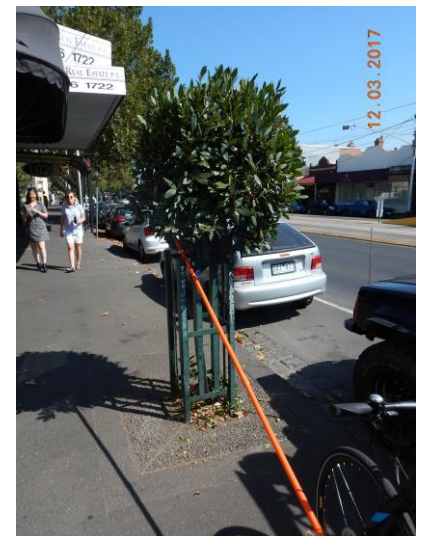
Tree ID: 74 **Botanical Name:** *Laurus nobilis*

Common Name: Bay Tree

Likely Impact Tree will remain viable

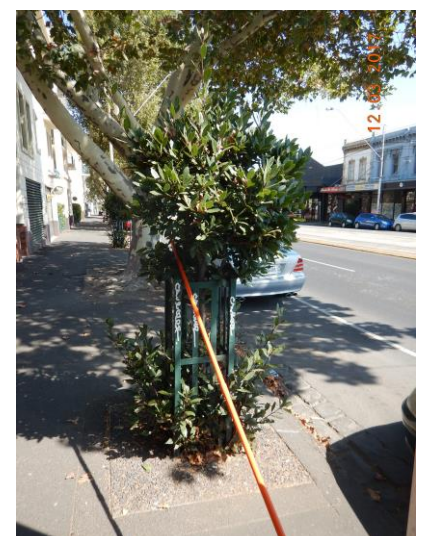
Tree ID: 75 **Botanical Name:** *Laurus nobilis*

Common Name: Bay Tree

Likely Impact Tree will remain viable

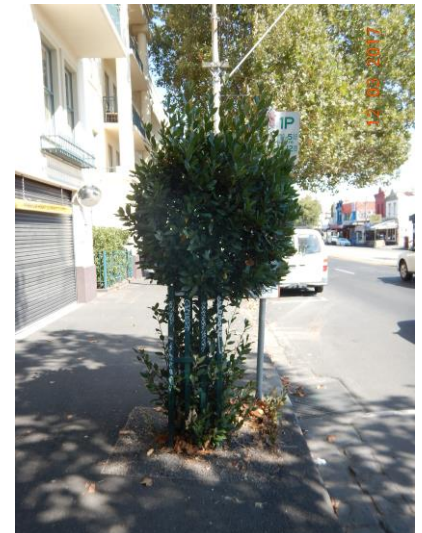
Tree ID: 76 Botanical Name: *Laurus nobilis*

Common Name: Bay Tree
Origin: Exotic
Height (m): 3 **Health:** Good
Width (m): 1 **Structure:** Fair
DBH (cm): 5 **ULE:** 10-20 years
Dia. @ base (cm): 6
Tree Significance | Retention: Moderately Significant | Moderate
TPZ | SRZ Radius (m): 2 | 1.5
Minimum canopy clearance: >5
Pruning required None
Likely Impact Tree will remain viable
Comments:

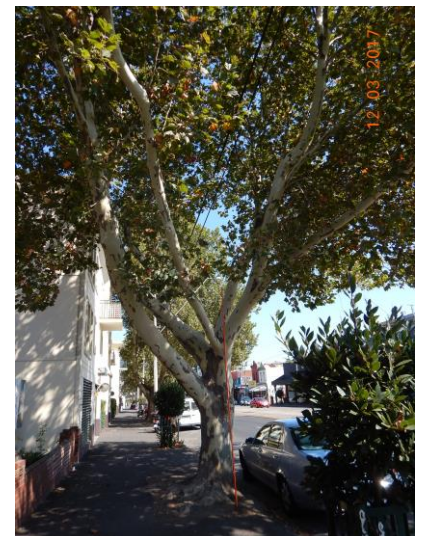
Tree ID: 77 Botanical Name: *Platanus Xacerifolia*

Common Name: London Plane
Origin: Exotic
Height (m): 16 **Health:** Good
Width (m): 14 **Structure:** Good
DBH (cm): 72 **ULE:** 20+ years
Dia. @ base (cm): 86
Tree Significance | Retention: Significant | High
TPZ | SRZ Radius (m): 8.64 | 3.1
Minimum canopy clearance: ~3.5
Pruning required 2 large branches over road, 50% canopy loss
Likely Impact Tree will not remain viable
Comments:

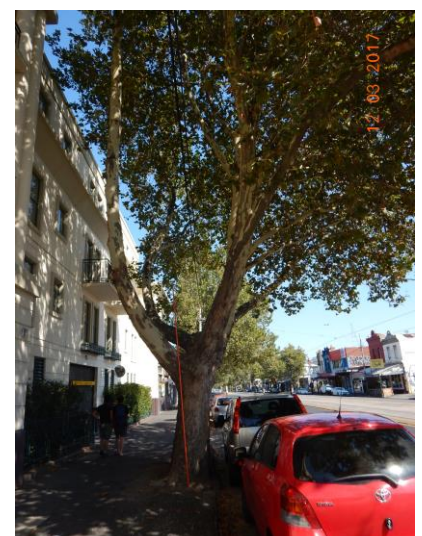
Tree ID: 78 Botanical Name: *Platanus Xacerifolia*

Common Name: London Plane
Origin: Exotic
Height (m): 16 **Health:** Good
Width (m): 14 **Structure:** Fair
DBH (cm): 86 **ULE:** 20+ years
Dia. @ base (cm): 96
Tree Significance | Retention: Significant | High
TPZ | SRZ Radius (m): ##### | 3.3
Minimum canopy clearance: ~3
Pruning required 3 main stems over road, 70% canopy loss
Likely Impact Tree will not remain viable
Comments:

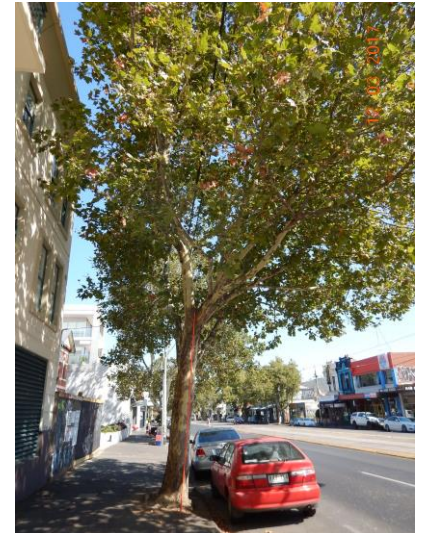
Tree ID: 79 **Botanical Name:** *Platanus Xacerifolia*

Common Name: London Plane

Likely Impact Tree will not remain viable

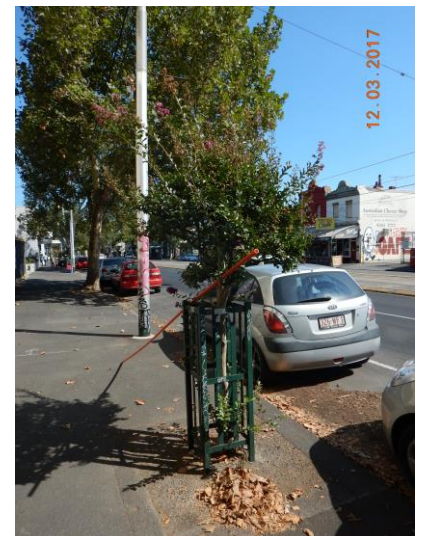
Tree ID: 80 **Botanical Name:** *Lagerstroemia indica*

Common Name: Crepe Myrtle

Likely Impact Tree will remain viable
