Attachment 1 - PLN17/0213 - 3 Park Crescent - ATTACHMENT 1 (Site Plan)

Attachment 2 - PLN17/0213 - 3 Park Crescent Alphington - Engineering comments 1 of 2

To: Michelle King
From: Artemis Bacani
Date: 25 January 2018
Subject: **Application No:** PLN17/0213
Description: Construction of a Second Dwelling and Works Associated with the Existing Dwelling
Site Address: 3 Park Crescent, Fairfield

Proposed Lower Floor Plan

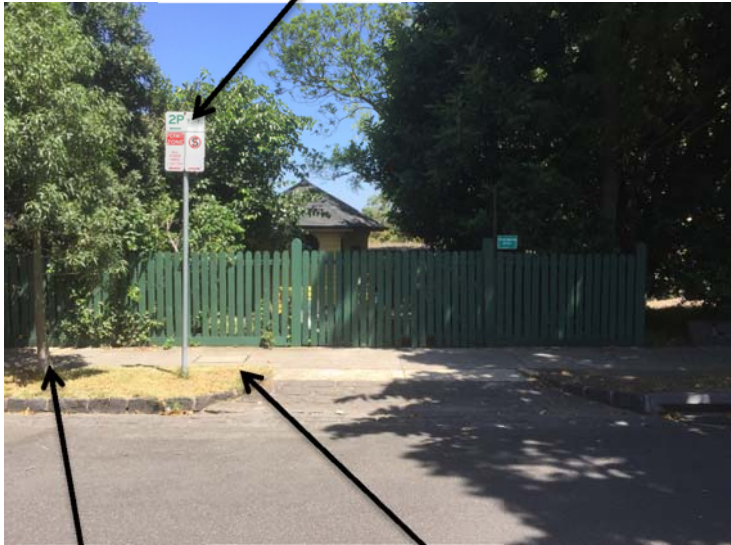
Item	Details
Telecommunications Pit - Park Crescent	<p>The widening of the existing vehicle crossing would require the applicant to obtain advice and consent from the relevant service authority in relation to the position of the telecommunications pit. A copy of written advice/consent from the service authority must be submitted to Council as part of the planning application.</p> <div style="text-align: center;"> <p>Parking sign</p>

<p>Street tree Telecommunications pit</p> </div>

Street Tree Protection – Park Crescent Road Frontage

The applicant must liaise with Council's Open Space unit regarding a street tree which appears to be in the area of the widened vehicle crossing. The applicant must obtain advice on the lateral clearance that is required for the new vehicle crossing. All costs associated with the relocation/removal of the tree will be the responsibility of the Permit Holder.

Removal, Adjustment, Changing or Relocation of Parking Restriction Signs

No parking restriction signs are to be removed, adjusted, changed or relocated without approval or authorisation from Council Parking Management unit and Construction Management branch.

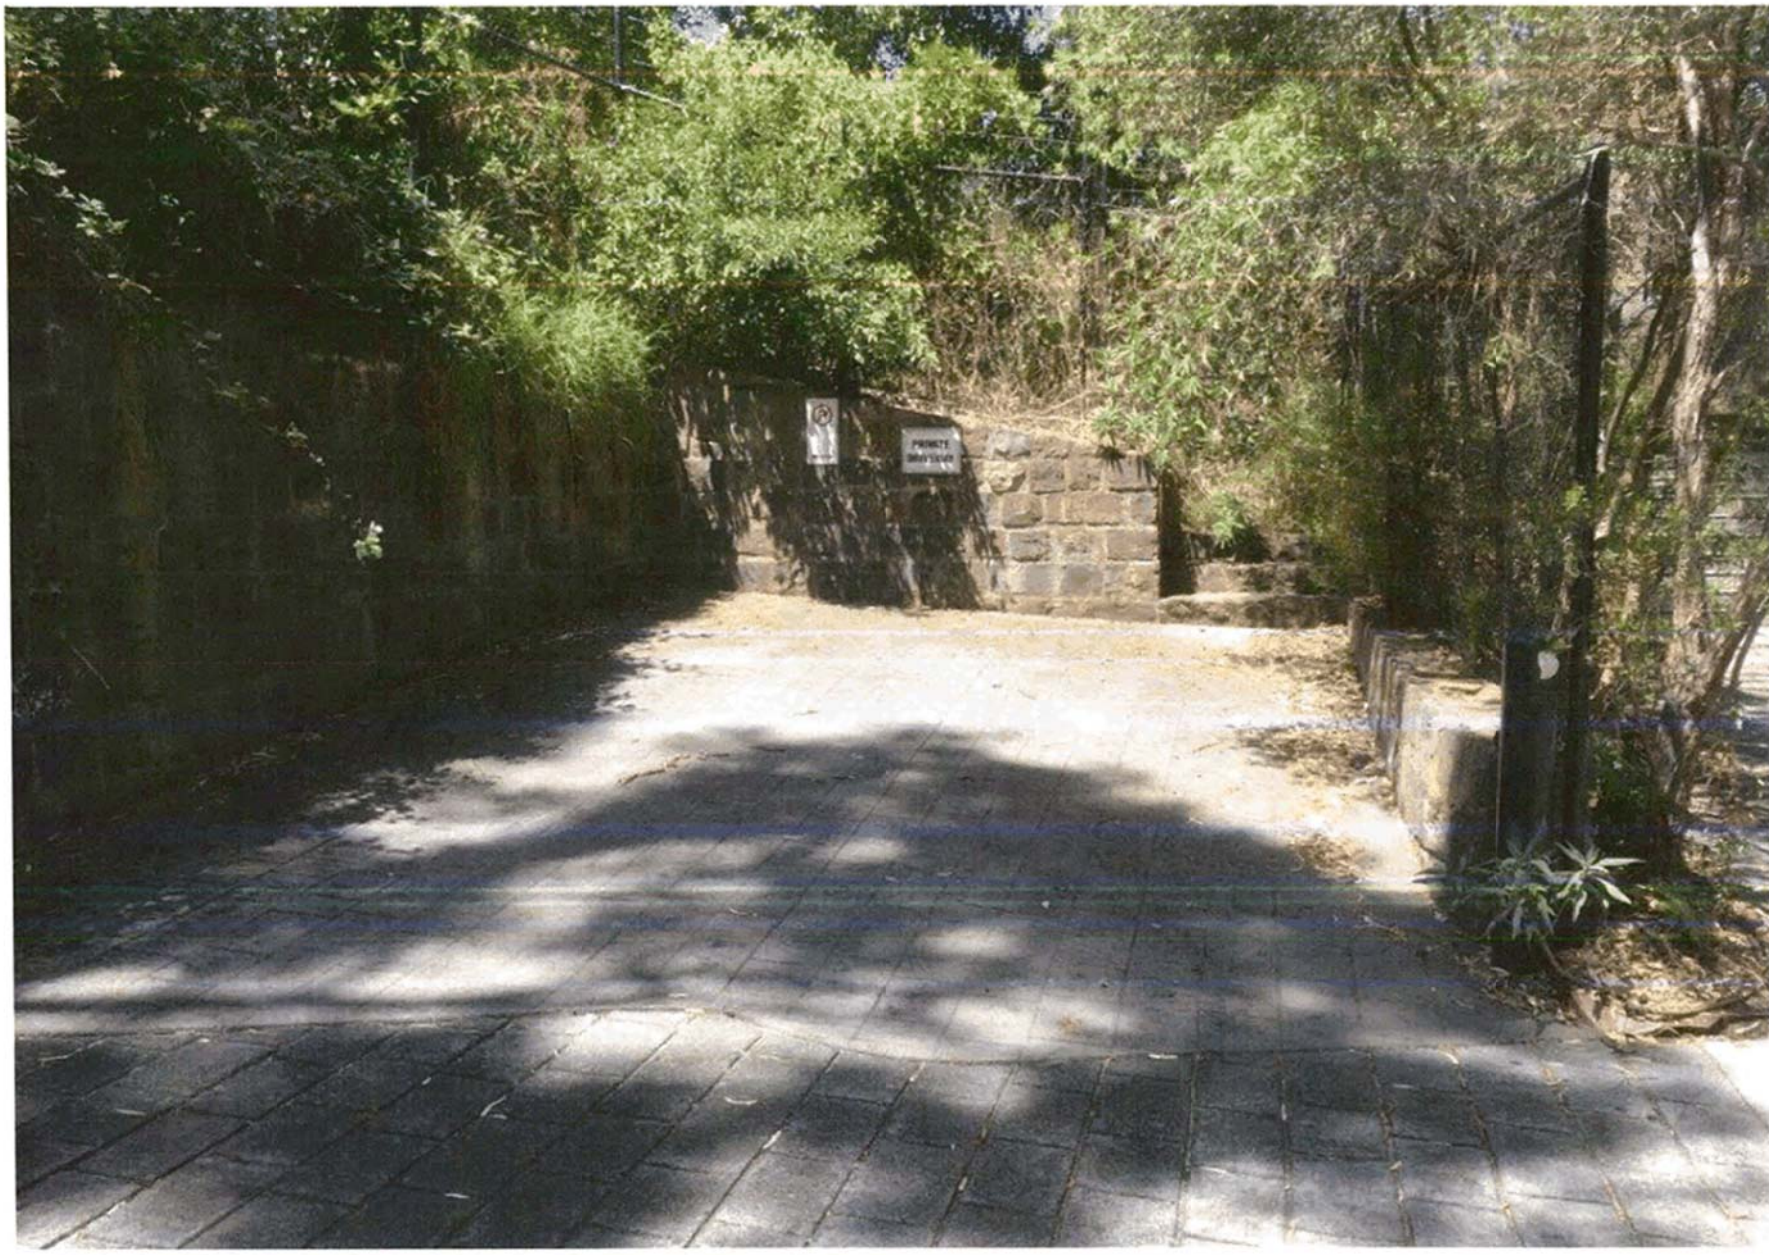
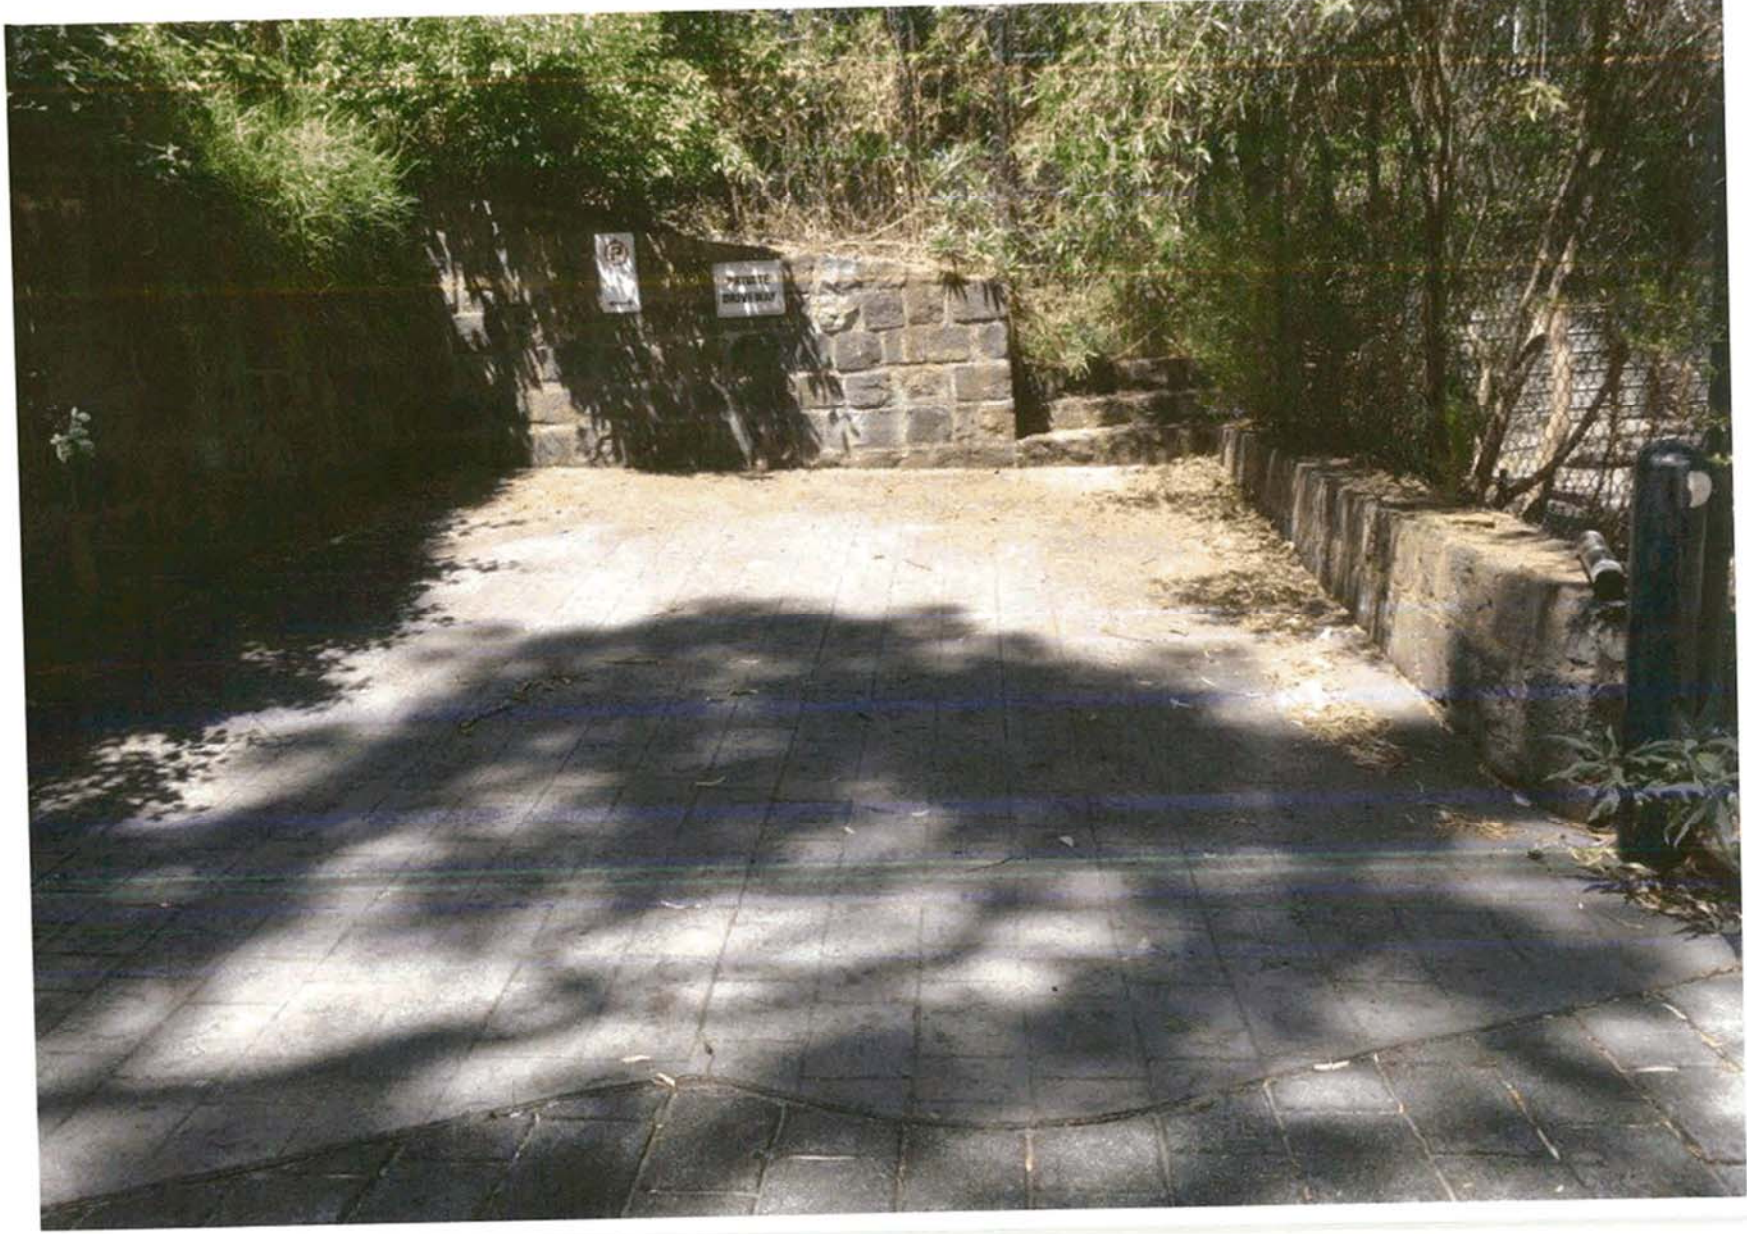
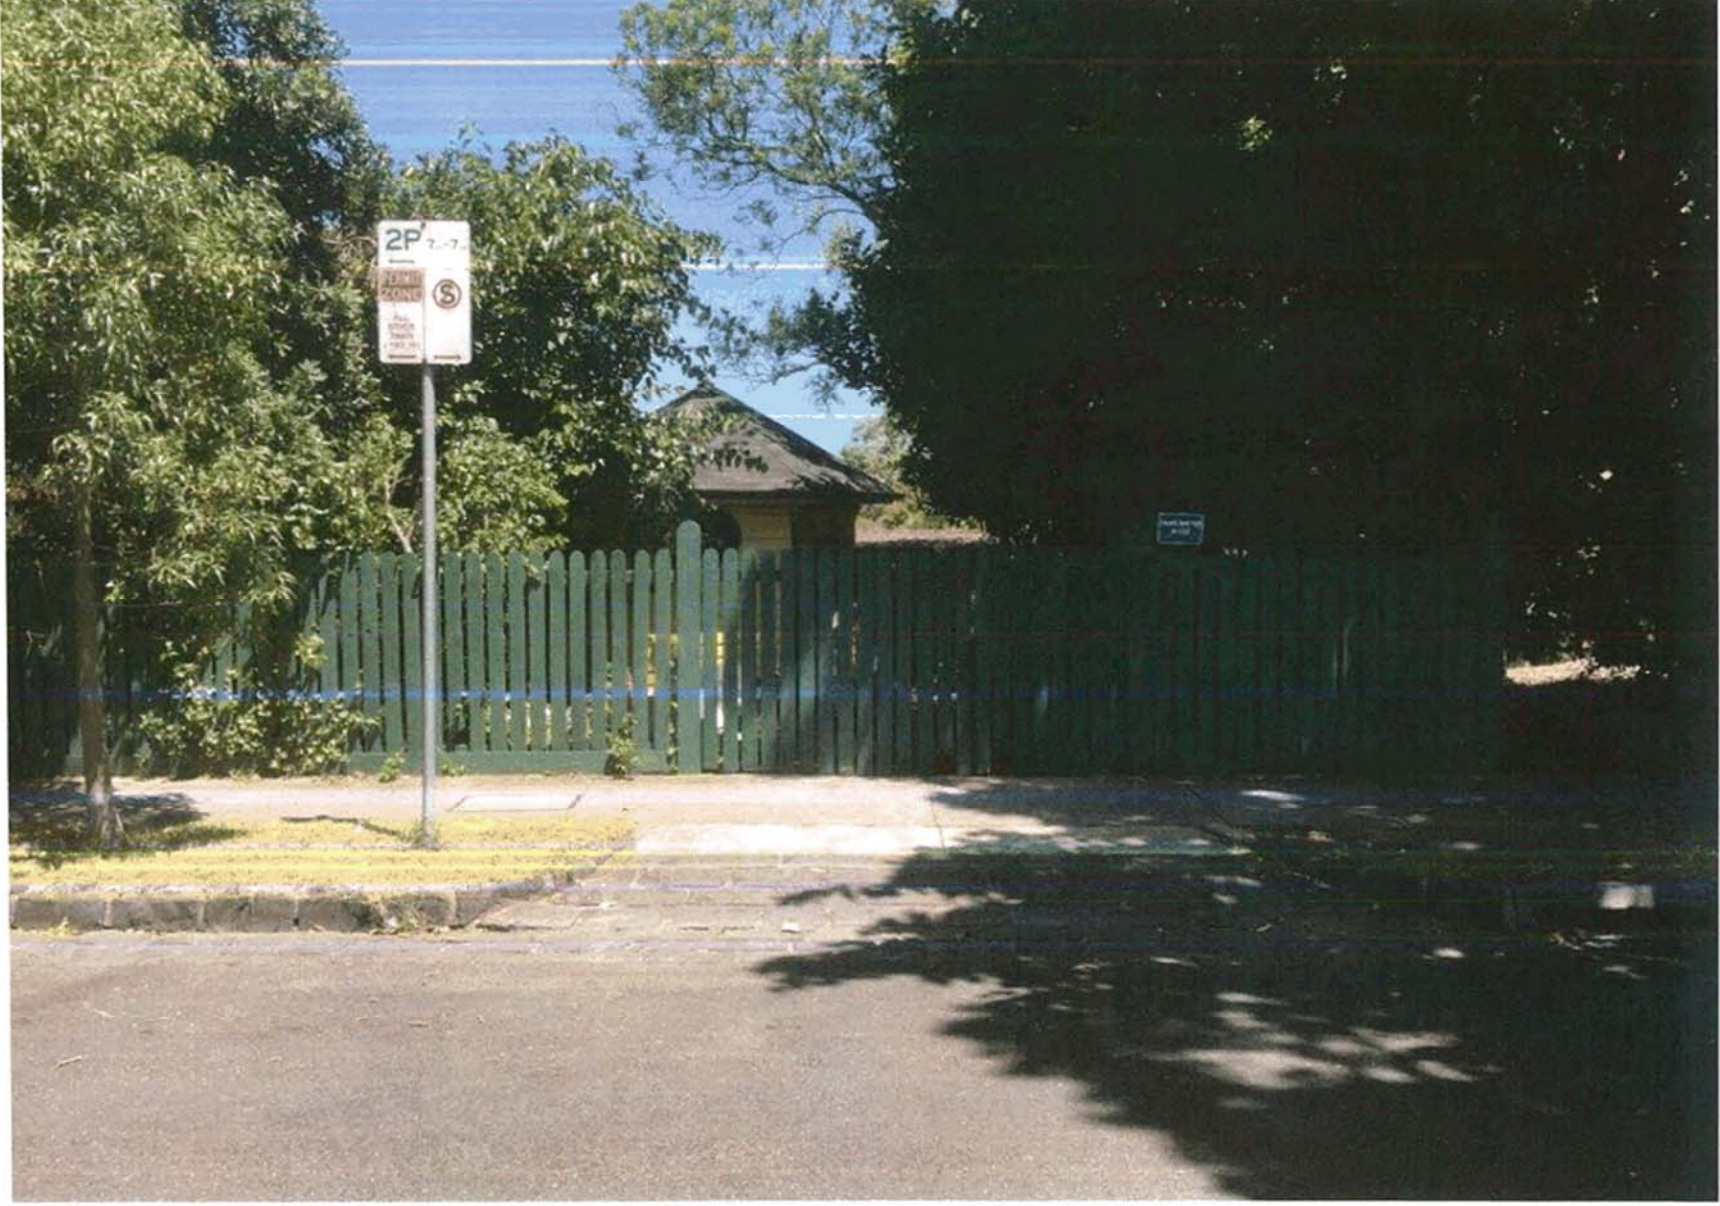
I inspected the property today and note that the two car spaces off Panther Place already exists (see attached photos).

As these spaces are currently being used, I would have no objections to their continued use.

At the Park Crescent road frontage, the applicant failed to show the existing parking sign, street tree, and service pit that is near the vehicle crossing.
