Road Safety Audit - Peer Review

**Proposed Vehicle Access
at
626 Heidelberg Road, Alphington**

**Prepared For
Yarra City Council**

Our Reference: G24706R-04A

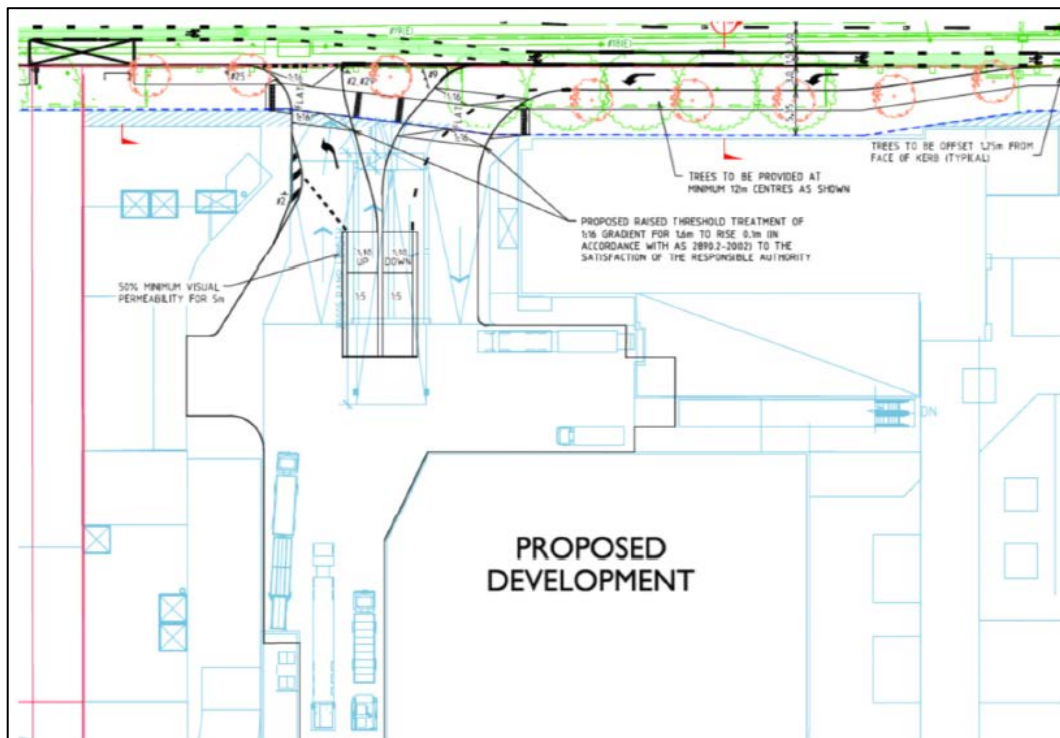
Figure 1: Proposed Access Arrangements

The proposal is for the construction of a left in / left out access point to Heidelberg Road, including a left turn deceleration lane. Internally, the proposed accessway splits into two (2) sections, one for vehicles to access a ramp to the internal carparking areas and one for trucks to the internal loading areas.

A shared path is provided along the Heidelberg Road frontage, with a raised crossing provided over the proposed access point.

A copy of the plan subject to the previous Road Safety Audit is provided in Figure 1 below.

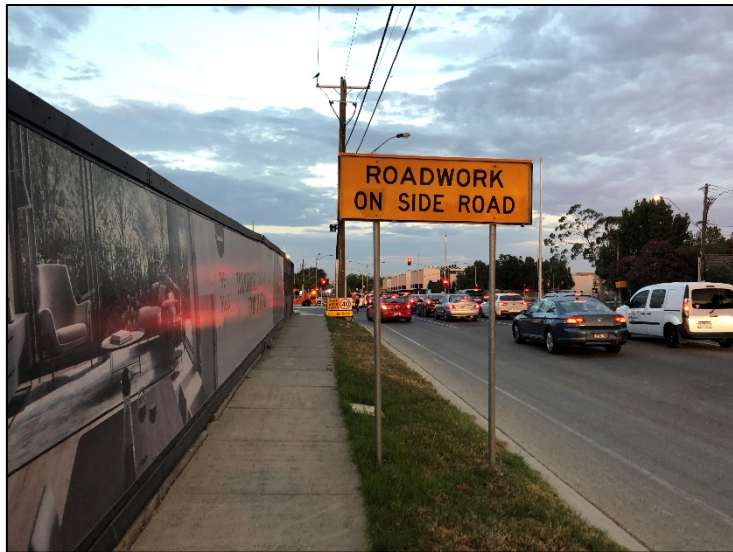
Photograph 1:

**Heidelberg Road –
East of Chandler
Highway**

View to West

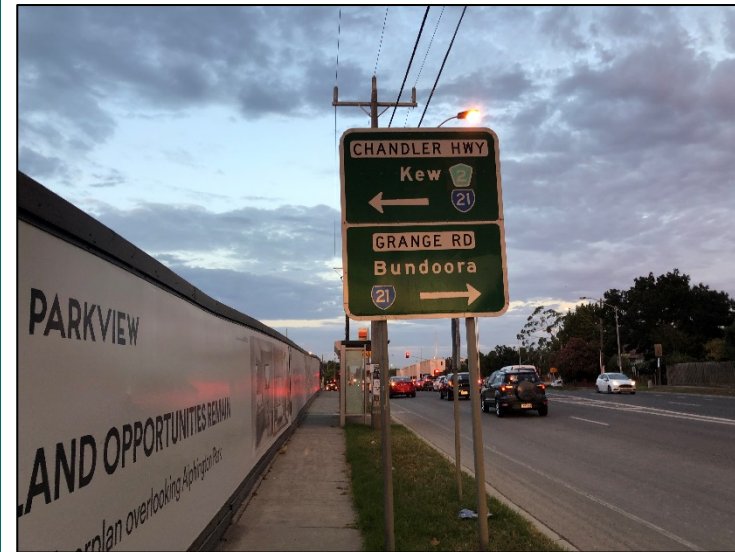
Photograph 2:

**Heidelberg Road –
Existing Bus Stop**

View to West

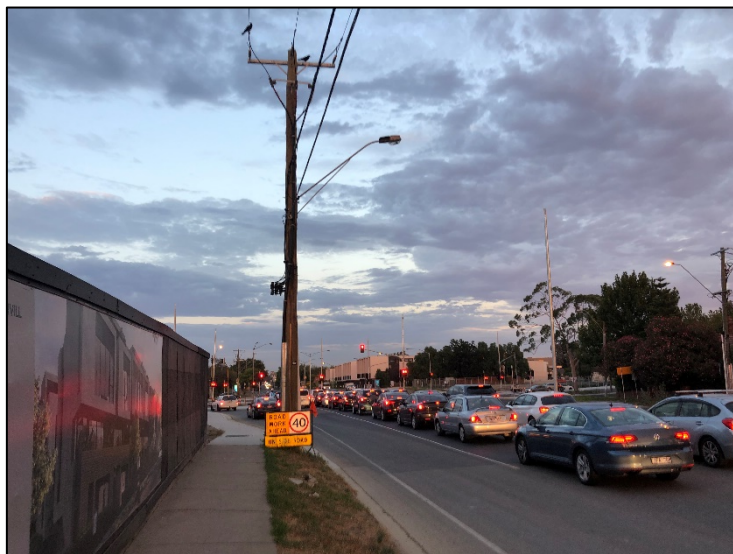
Photograph 3:

**Heidelberg Road –
East of Chandler
Highway**

View to West

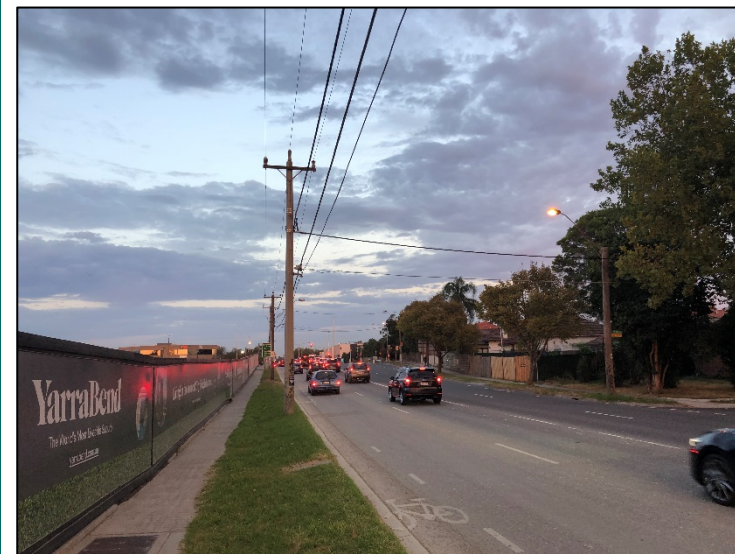
Photograph 4:

**Heidelberg Road
opposite Clive Street**

View to West

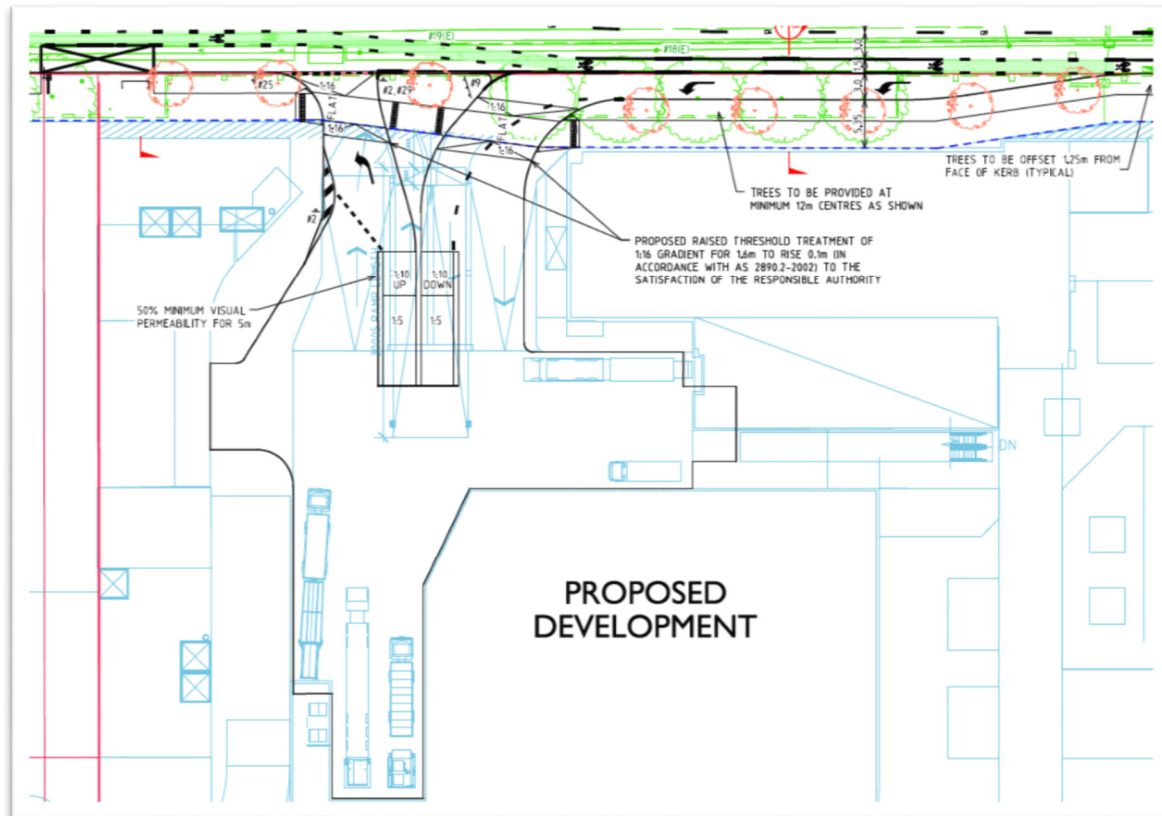
Figure 2: Design which is the subject of this audit

Since that time there have been a number of amendments that have occurred to this frontage, summarised as follows:

- The removal of the proposed pedestrian operated signals at this access due to an amended internal function that does not require loading trucks to cross the entry path for the public vehicles that the access. The design now requires trucks to circulate around the public access ramp, which has been set back from the Heidelberg Road as far as practical.
- The inclusion of trees along the Heidelberg Road frontage, noting that the updated VicRoads tree planting policy avoids the need for the use of barrier systems.
- VicRoads have granted in-principle approval to the functional layout and streetscape design comprising trees at 12m centres.

The revised plan is shown in Figure 2.

The left-in left-out intersection will not be signalised and will incorporate raised threshold treatments with a level grade for shared path users and 1:16 ramps for road traffic.

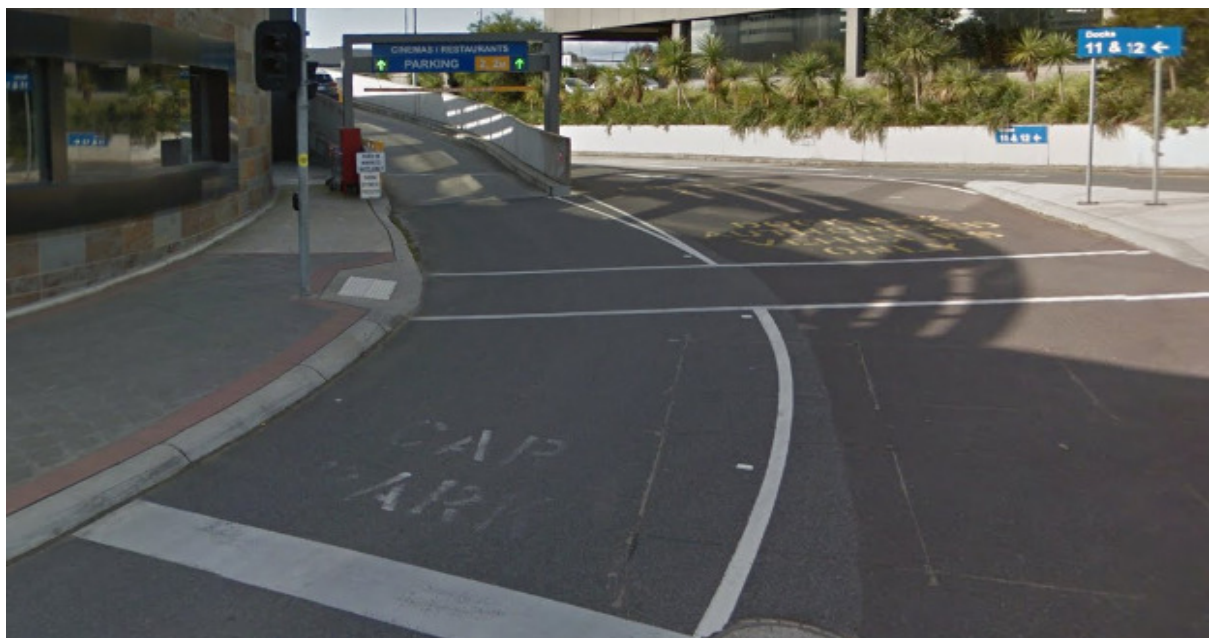
Figure 3: Westfield Doncaster - Doncaster Road/Frederick Street public car park / loading dock entry

The layout will function somewhat similarly (in principle) to the arrangement for Westfield Doncaster at the Doncaster Road/Frederick Street (Figure 3).

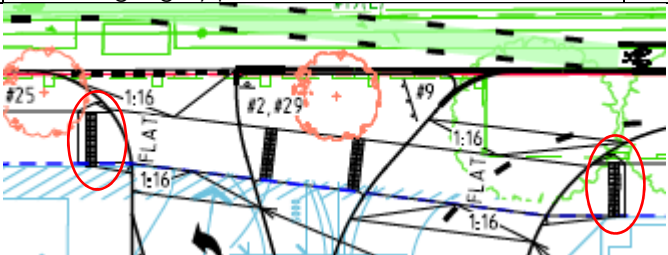
Point No.	Issue	Suggestion	Response	
			Accept / Reject	Comment / Status
3.	TGSIs <ol style="list-style-type: none"> Some of the TGSIs are shown perpendicular to approach paths rather than crossing alignment (red circles). TGSIs can be skidding hazards for cyclists. Some projects get constructed with white TGSIs on light grey paths. 	<ol style="list-style-type: none"> Realign these TGSIs. Specify TGSIs with similar friction characteristics to the surrounding path. Ensure good contrast is provided. 	Accept	The functional layout plan can be updated to include a realignment of the TGSI's.

Road Safety Audits Pty – Identified Safety Issues		Traffix Group Review	
		Agree/ Disagree	Comments
3	<u>Issue:</u> TGSIs '1. Some of the TGSIs are shown perpendicular to approach paths rather than crossing alignment (red circles). 2. TGSIs can be skidding hazards for cyclists. 3. Some projects get constructed with white TGSIs on light grey paths.'	Agree	The warning TGSIs should align with the path of travel. The currently arrangement would direct vision impaired pedestrians onto the ramp associated with the raised crossing.
	<u>Suggestion:</u> <ul style="list-style-type: none"> • 'Realign these TGSIs. • Specify TGSIs with similar friction characteristics to the surrounding path. • Ensure good contrast is provided.' 	Agree	The TGSIs should be updated to reflect the relevant Australian Standard.
	<u>Status:</u> No ranking provided	-	The previous Road Safety Audit doesn't provide a risk ranking for this item. Our ranking for this item is as follows: <u>Probability:</u> Improbable <u>Severity:</u> Minor <u>Risk Rating:</u> Low

RSA Issue	Project Manager Response (GTA Consultants)		Traffix Group Review
	Accept / Reject	Comments / Status	
<p>3 <u>Issue:</u> TGSIs</p> <p>'1. Some of the TGSIs are shown perpendicular to approach paths rather than crossing alignment (red circles).</p> <p>2. TGSIs can be skidding hazards for cyclists.</p> <p>3. Some projects get constructed with white TGSIs on light grey paths.'</p> <p><u>Suggestion:</u></p> <ul style="list-style-type: none"> • 'Realign these TGSIs. • Specify TGSIs with similar friction characteristics to the surrounding path. • Ensure good contrast is provided.' 	Accept	The functional layout plan can be updated to include a realignment of the TGSI's.	<p>The project manager has accepted the suggestion to realign the pram ramps. However, both the architectural plans and functional layout provided in the GTA report do not show the pram ramps being realigned.</p> <p>Recommendation: Seek plans from the proponent showing the suggested improvements.</p>

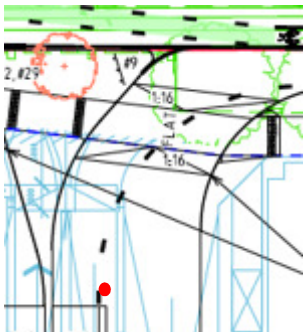
4.	Wall hazard <p>If a wall is present between entering trucks and cars, it would be a roadside hazard (although speeds will be low).</p>	Consider incorporating a shock absorbing bollard as shown.	Accept	The functional layout plan can be updated to include the bollard as suggested.

Road Safety Audits Pty – Identified Safety Issues		Traffix Group Review	
		Agree/ Disagree	Comments
	<u>Issue:</u> Wall Hazard <i>If a wall is present between entering trucks and cars, it would be a roadside hazard (although speeds will be low).</i>	Agree	Whilst it is agreed that the wall does present a blunt end adjacent to the possible travel paths, the vehicle speeds within the site would be expected to be very low (i.e. carpark speeds).
	<u>Suggestion:</u> <i>Consider incorporating a shock absorbing bollard as shown.</i>	Agree	An energy absorbing bollard would address the issue of the wall hazard. Furthermore, improved delineation as described in Item 1 would assist with alignment of vehicles into the carpark access.
4	<u>Status:</u> No ranking provided	-	<p>The previous Road Safety Audit doesn't provide a risk ranking for this item. Our ranking for this item is as follows:</p> <p><u>Probability:</u> Improbable</p> <p><u>Severity:</u> Minor</p> <p><u>Risk Rating:</u> Low</p> <p>Whilst no ranking has been provided, we are of the view that this item has a low risk rating.</p>

<p>4 <u>Issue:</u> Wall Hazard</p> <p>If a wall is present between entering trucks and cars, it would be a roadside hazard (although speeds will be low).</p> <p><u>Suggestion:</u></p> <p>Consider incorporating a shock absorbing bollard as shown.</p>	Accept	The functional layout plan can be updated to include a bollard as suggested.	<p>The project manager has accepted the suggestion to include a bollard in front of the wall. However, bot the architectural plans and functional layout provided in the GTA report do not show the bollard included.</p> <p>Recommendation: Seek plans from the proponent showing the suggested improvements.</p>

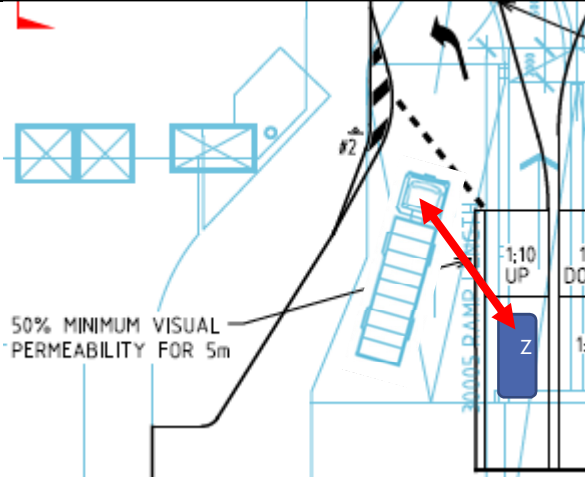
Point No.	Issue	Suggestion	Response	
			Accept / Reject	Comment / Status
5.	Sightlines between vehicles approaching Heidelberg Rd The wall between trucks and cars will obstruct sightlines between drivers of vehicles with conflicting movements. While a give way line is shown, truck drivers can only give way if they can see the vehicles they have to give way to.	50% visual permeability is specified. Ensure this visual permeability is relevant to the angles of viewing required.	Accept	The wall between trucks and cars will be 50% permeable for exiting cars/trucks at this location.

Road Safety Audits Pty – Identified Safety Issues		Traffix Group Review	
		Agree/ Disagree	Comments
5	<u>Issue:</u> Sight Lines Between Vehicles Approaching Heidelberg Road <i>The wall between trucks and cars will obstruct sightlines between drivers of vehicles with conflicting movements. While a give way line is shown, truck drivers can only give way if they can see the vehicles they have to give way to.</i>	Agree	Whilst the plans do reference 50% visual permeability, it is agreed that further detail regarding the wall openings should be provided at future design stages.
	<u>Suggestion:</u> <i>50% visual permeability is specified. Ensure this visual permeability is relevant to the angles of viewing required.</i>	Agree	The plans already specify 50% visual permeability.
	<u>Status:</u> No ranking provided	Partial	The previous Road Safety Audit doesn't provide a risk ranking for this item. Our ranking for this item is as follows: <u>Probability:</u> Occasional <u>Severity:</u> Minor <u>Risk Rating:</u> Medium Given the medium ranking, this item should be given the appropriate weighting.

RSA Issue	Project Manager Response (GTA Consultants)		Traffix Group Review
	Accept / Reject	Comments / Status	
<p>5 <u>Issue:</u> Sight Lines Between Vehicles Approaching Heidelberg Road</p> <p>The wall between trucks and cars will obstruct sightlines between drivers of vehicles with conflicting movements. While a give way line is shown, truck drivers can only give way if they can see the vehicles they have to give way to.</p> <p><u>Suggestion:</u></p> <p>50% visual permeability is specified. Ensure this visual permeability is relevant to the angles of viewing required.</p>	Accept	The wall between trucks and cars will be 50% permeable for exiting cars/trucks at this location.	<p>The plans provided as part of the previous RSA included text for the wall to be 50% clear of visual obstructions. This action would address the identified safety issue.</p> <p>The plans provided as part of the planning permit submission do not show this note. It is important that this design detail is not lost at the detailed design stage.</p> <p>Recommendation: Ensure that the note for 50% permeability is provided</p>
