Former AMCOR Papermill Site

***Groundwater Management Plan – Amcor Site Yarra
Riverfront***

Prepared by Alphington Developments Pty Ltd (Glennville)

dated 14 April 2020

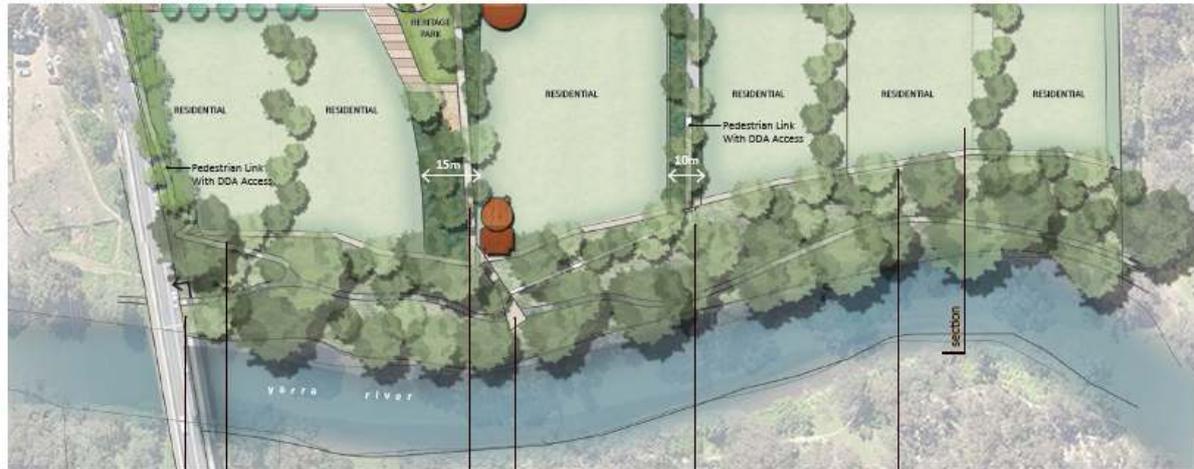
FIG. 60: THE RIVER PARK PLAN

Potential Access via stairs to Chandler Hwy Bridge shared path (to future detailed design)

Pedestrian link to Industrial Heritage Precinct via steps
Formalise existing trail, width and materials to align with existing at east and west interfaces

Access to Riverpark via steps. Connection to existing trails.

Existing track connection

1.8m path along crest line

The following Figures 60 & 61 are extracted from the approved Development Plan:
