**CITY OF YARRA
HERITAGE REVIEW**

LANDSCAPE CITATIONS

VOLUME 4

July 1998

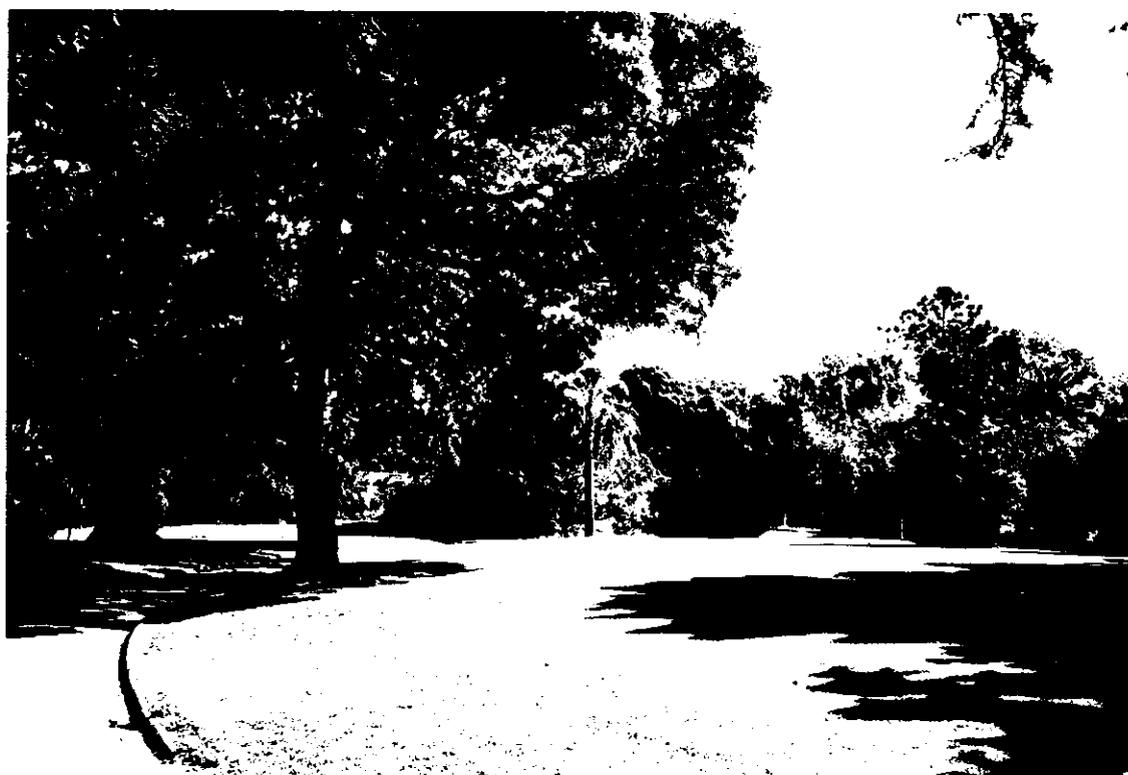
Site:	Burnley Gardens	Significance:	A
Address:	The Boulevard, Burnley	Map Ref:	45 A12
Access:	Unrestricted	Survey Date:	6/4/98

Intactness:
 E [] G [] F [x] P []

Condition:
 E [x] G [] F [] P []

The Burnley Gardens are an extensive 19th century gardens associated with the University of Melbourne, Burnley Campus. The gardens were opened in 1863 by the Horticultural Society of Victoria for fruit tree trials. The site also contained pleasure gardens accessible to the public. In 1891 the site became the School of Agriculture, administered by the Department of Agriculture. At some stage after his appointment as principal in 1897, Charles Bogue Luffmann implemented his own plan for the gardens, some of which survives today. Many of the trees on the site predate Luffmann's tenure as principal. The garden has undergone further design changes since the turn of the century, including some by Millie Gibson in the 1940s. The courtyard garden behind the library was established in 1987-88 by Steve Mullany. James Hitchmough, former Senior Lecturer at Burnley College, and Robert Boyle, Landscape Designer, established a large native garden and pool area in the southwestern section of the site in 1989-90. The ornamental gardens cover approximately 4 hectares, with 3 hectares of fruit trees and experimental plots in the southeastern section of the site.

Burnley Gardens are of Regional significance as a substantially intact example of a late Victorian garden. They have been used for over one hundred years as a teaching garden, and were important in the development of the Victorian orchard industry. The garden reflects the input of a number of important Australian landscape designers, most notably Charles Bogue Luffmann and Millie Gibson.

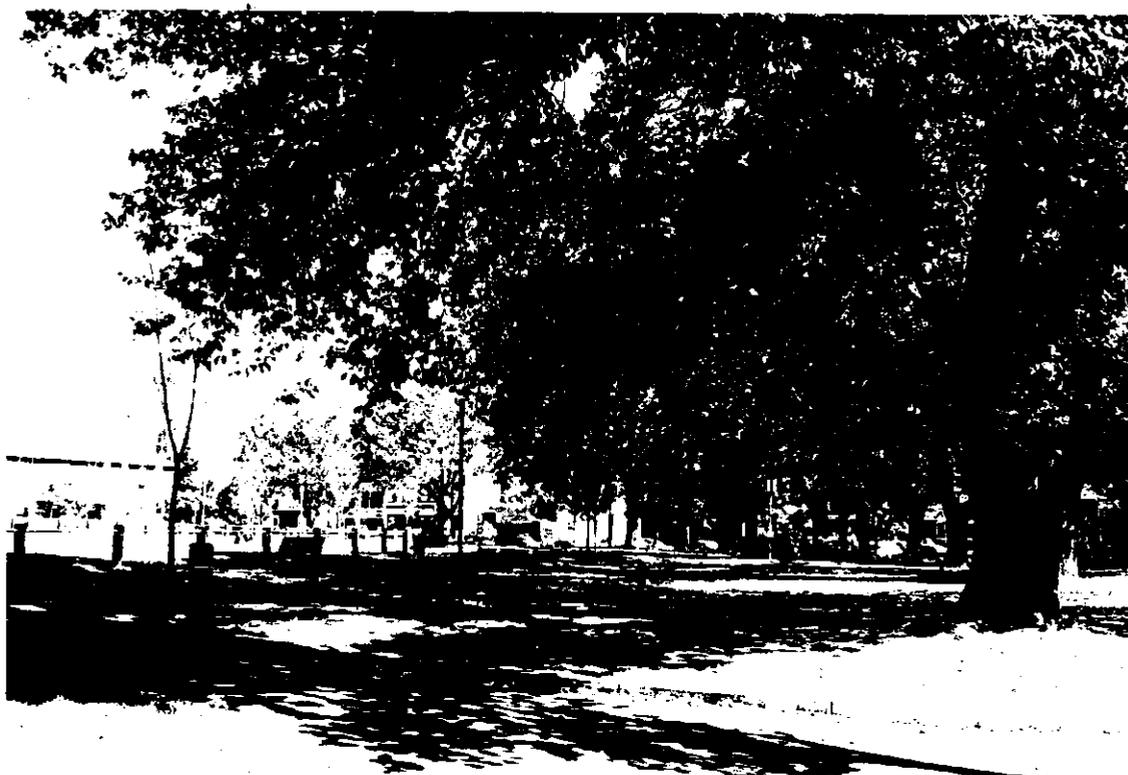
Site:	City Reserve	Significance:	C
Address:	Cnr Highett Street and Church Street, Richmond	Map Ref:	2H B5
Access:	Unrestricted	Survey Date:	6/4/98

Intactness: E [] G [] F [x] P []	Condition: E [] G [] F [x] P []
---	--

The site is dominated by a number of mature Dutch Elms (*Ulmus x hollandica*) at the northwestern corner of the site, and another group on the eastern boundary. Some of the trees in this section of the site are in very poor condition, apparently due to recent construction works within their root zones.

Failure to replace senescent trees with the same species. Failure to protect tree roots during future construction works.

Prepare a management plan outlining a maintenance and replacement strategy for these trees to ensure their amenity value is continued for as long as possible. The plan would outline suitable alternatives for tree replacement if the Dutch Elm Disease (*Ceratocystis ulmi*) becomes established in Australia.

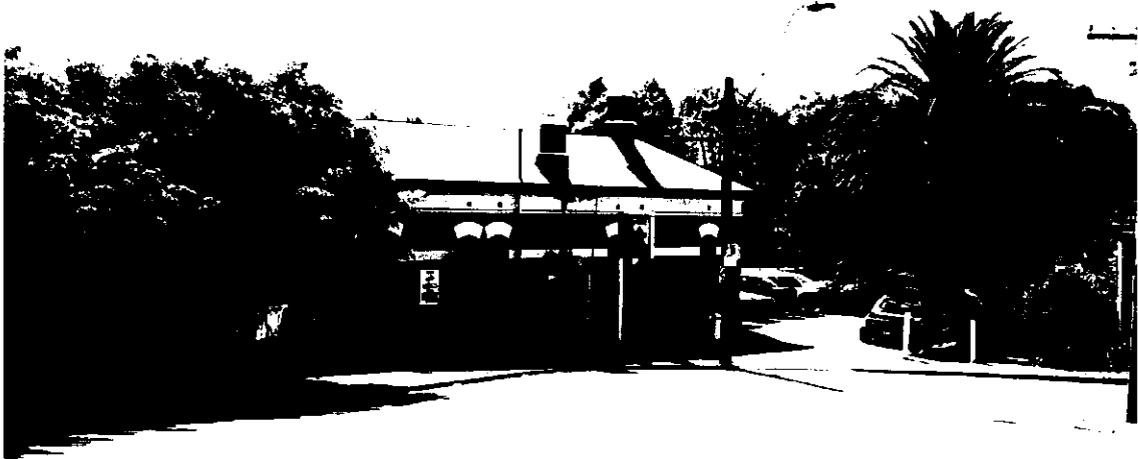
Site:	West Richmond Station	Significance:	C
Address:	Muir Street, Richmond	Map Ref:	2G H4
Access:	Unrestricted	Survey Date:	6/4/98

Intactness: E <input type="checkbox"/> G <input type="checkbox"/> F <input checked="" type="checkbox"/> P <input type="checkbox"/>	Condition: E <input type="checkbox"/> G <input type="checkbox"/> F <input checked="" type="checkbox"/> P <input type="checkbox"/>
--	---

Failure to replace senescent specimens with the same species, eroding the heritage character of the site. Planting trees in close proximity to the palms, obscuring their fine forms.

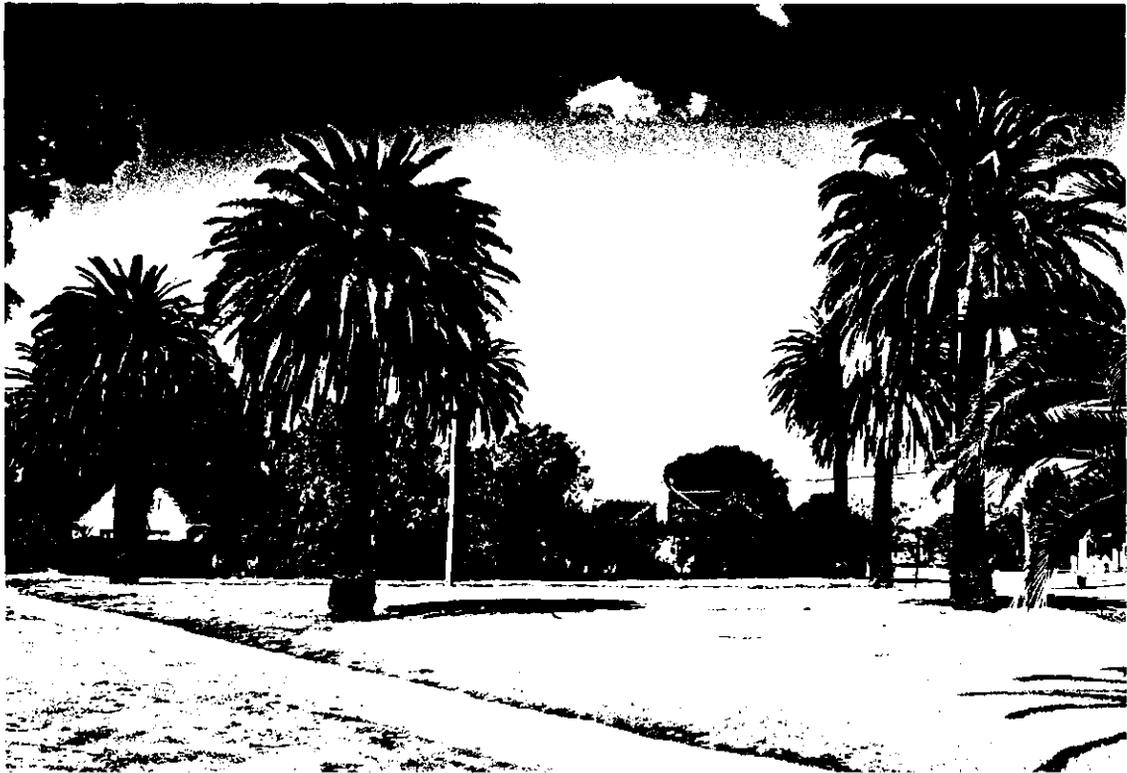
Site:	Baston Reserve	Significance:	C
Address:	Rushall Crescent, Fitzroy North, adjacent Rushall Station	Map Ref:	30 D11
Access:	Unrestricted	Survey Date:	14/4/98

Intactness:	Condition:
E [] G [] F [x] P []	E [] G [x] F [] P []

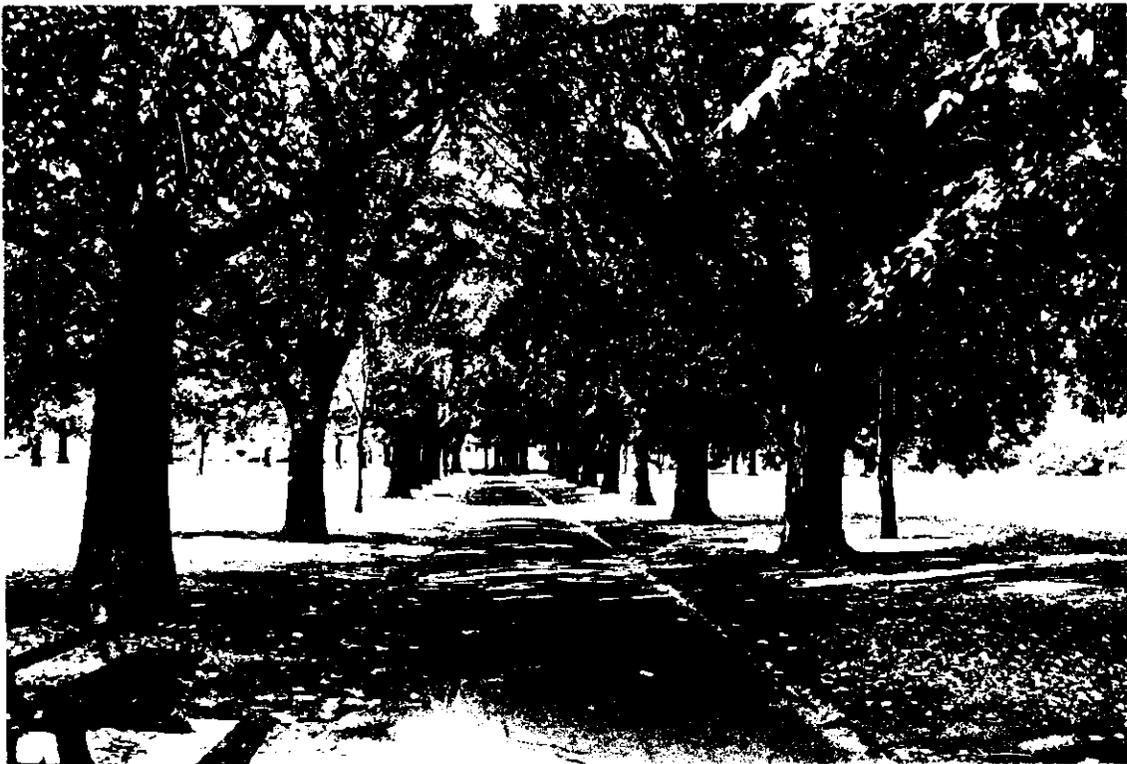
Site:	Darling Gardens	Significance:	B
Address:	Between North Terrace and South Terrace, Clifton Hill	Map Ref:	2C H3
Access:	Unrestricted	Survey Date:	9/4/98

Intactness:	Condition:
E [] G [] F [x] P []	E [] G [] F [x] P []

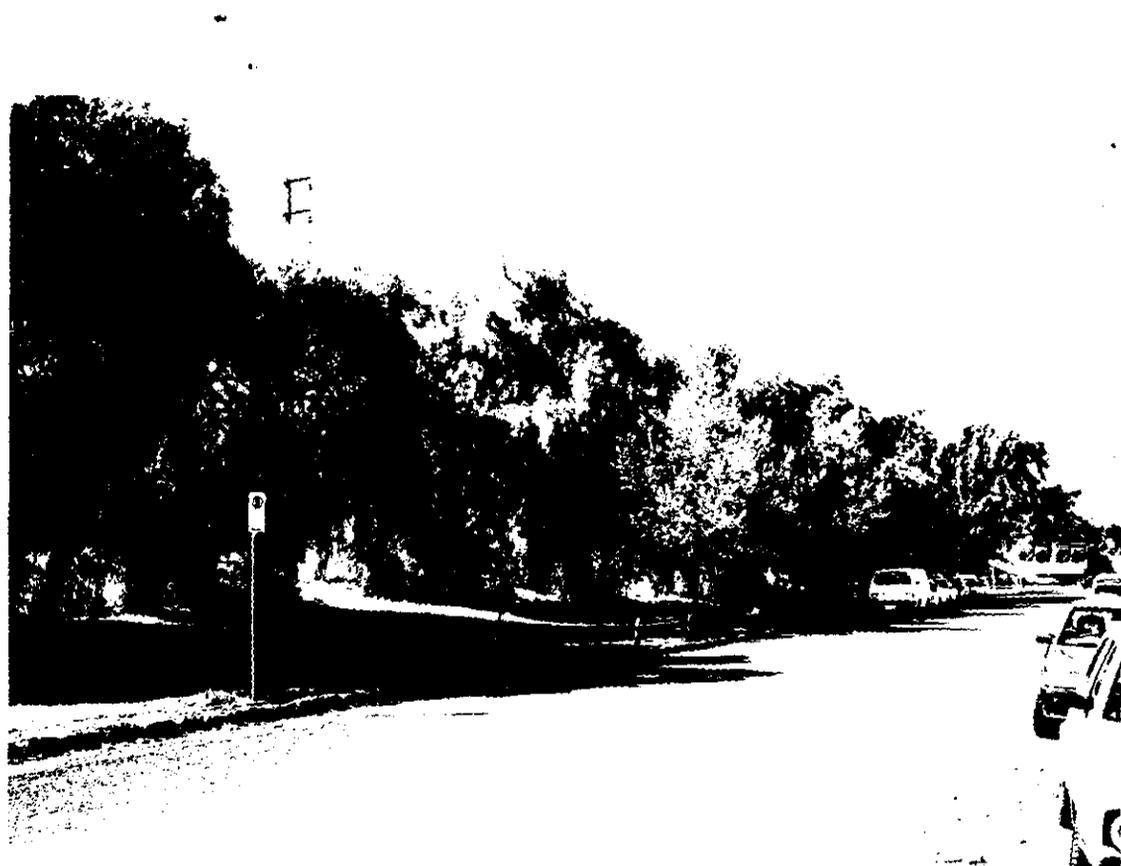
Site:	Railway Reserve	Significance:	C
Address:	Between Rushall Station & Queens Pde, Fitzroy North	Map Ref:	30 D11
Access:	Unrestricted	Survey Date:	14/4/98

Intactness:	Condition:
E [] G [x] F [] P []	E [] G [x] F [] P []

Mechanical damage to trunks from cars. Failure to maintain the trees at an appropriate level, reducing their potential amenity value.

The trees grow in a particularly hostile environment, the root zones compacted and covered with asphalt, and the trunks liable to mechanical damage from cars. It is essential these trees be considered by a tree management policy for significant trees within the City of Yarra, which will ensure an appropriate level of maintenance. It will also include guidelines for the replacement of trees as they enter decline, as well as alternative species if Dutch Elm Disease (*Ceratocystis ulmi*) becomes established in Australia.

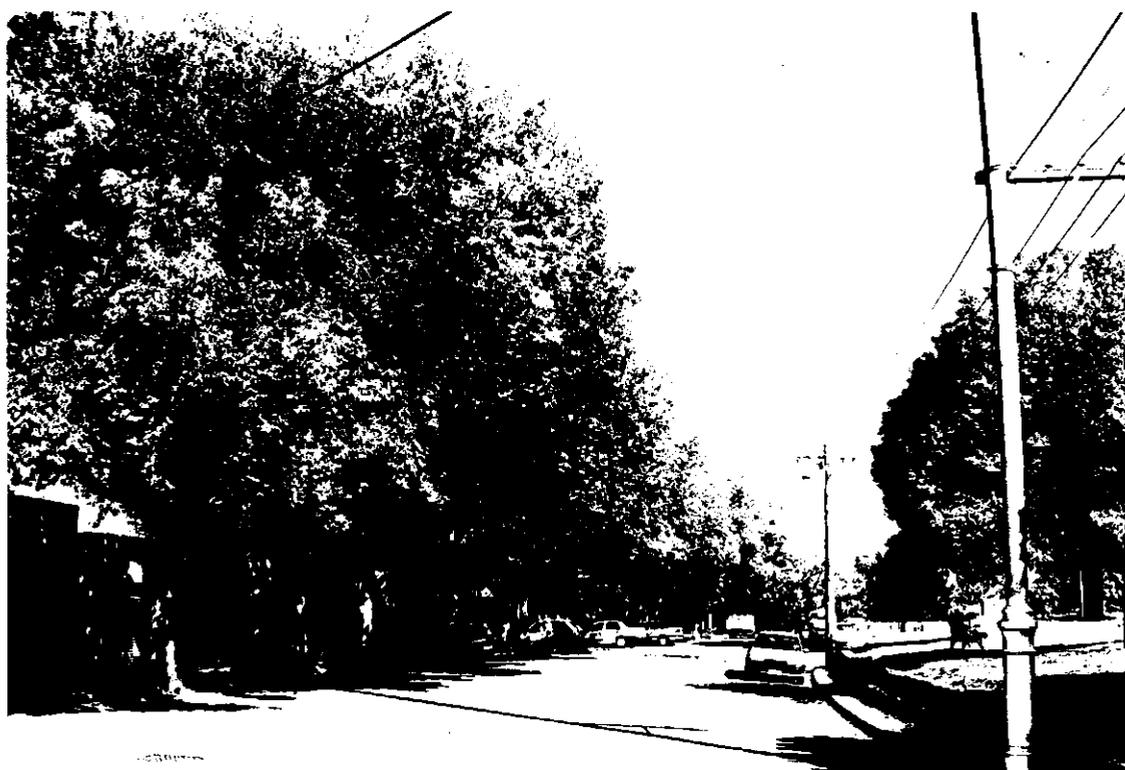
Site:	Street Trees	Significance:	C
Address:	Alfred Crescent, b/w Grant & Jamieson Sts, Fitzroy North	Map Ref:	2C D2
Access:	Unrestricted	Survey Date:	14/4/98

Intactness:	Condition:
E [] G [] F [x] P []	E [] G [] F [x] P []

Failure to replace senescent specimens with the same species. Interplanting of gaps between pairings with other species, which would destroy the formality of the median planting.

Preparation of a detailed management policy for the trees on the site, which would include details for regular maintenance as well as appropriate guidelines for the replacement of senescent specimens. These would be included in an overall tree management policy for significant trees within the City of Yarra.

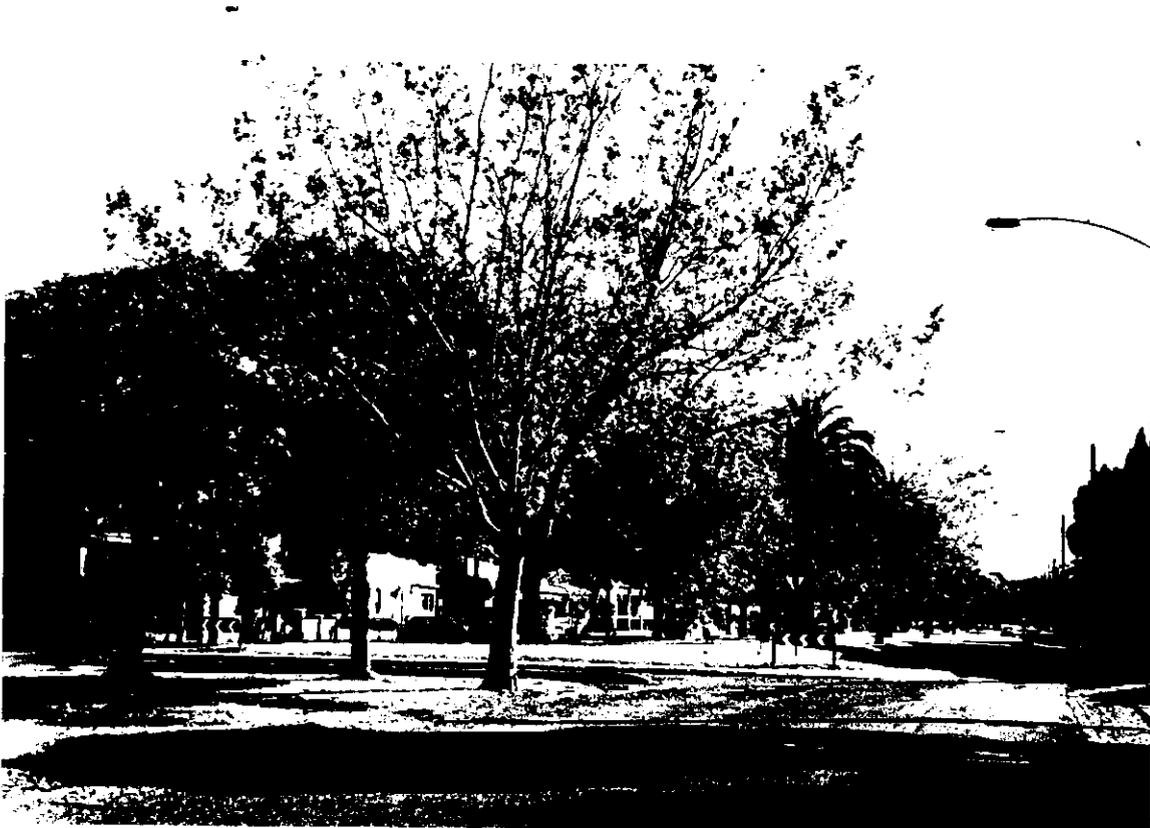
Site:	Median Planting	Significance:	B
Address:	Pigdon Street b/w Lygon St & Bowen Cres, Carlton North	Map Ref:	29 H11
Access:	Unrestricted	Survey Date:	20/4/98

Intactness:
E [] G [x] F [] P []

Condition:
E [] G [x] F [] P []

Failure to replace senescent trees with the same species, or failure to maintain the existing trees to a standard that will ensure a long amenity life. Inter-planting of the area between specimens with shrubs or trees, which would alter the character of the planting dramatically.

Preparation of a detailed management policy for the trees on the site, which would include details for regular maintenance as well as appropriate guidelines for the replacement of senescent specimens. These tree management guidelines should be included in an overall document for significant trees within the City of Yarra

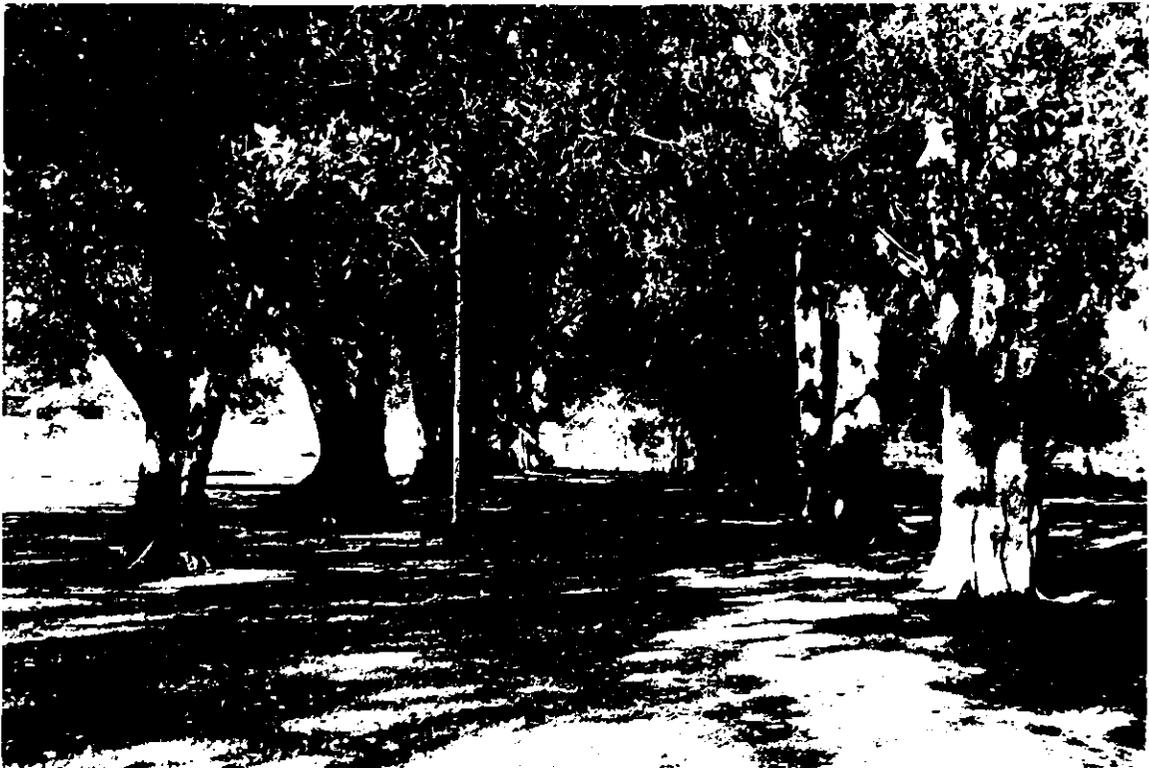
Site:	Curtain Square	Significance:	C
Address:	Bounded by Curtain, Newry, Rathdowne & Canning Streets, North Carlton.	Map Ref:	2B J2
Access:	Unrestricted	Survey Date:	20/4/98

Intactness:
 E [] G [] F [x] P []

Condition:
 E [] G [] F [x] P []

Removal of senescent specimens and failure to replace them with the same species, eroding the heritage character of the place. Failure to maintain the mature trees on the site to a level that would ensure a long amenity life.

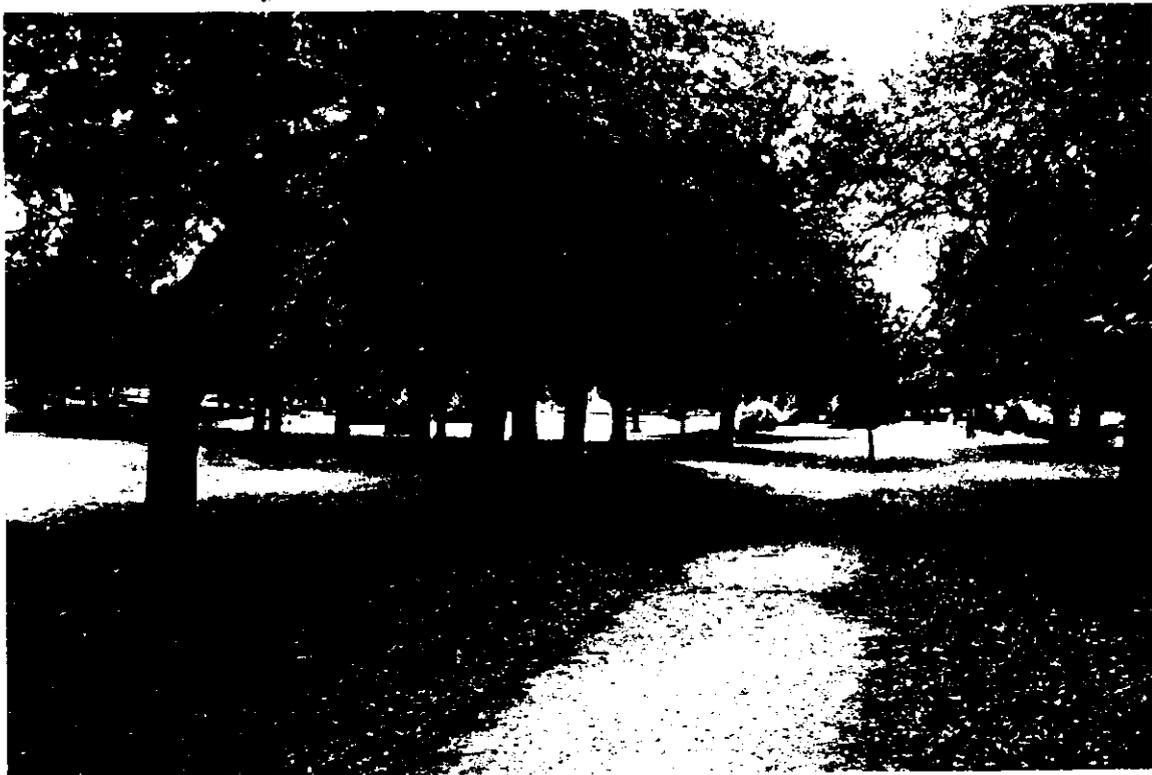
Site:	Barkly Gardens	Significance:	C
Address:	Bounded by Barkly Ave, Madden Gve, Coppin & Mary Sts, Richmond	Map Ref:	2H B11
Access:	Unrestricted	Survey Date:	27/4/98

Intactness:	Condition:
E [] G [] F [x] P []	E [] G [] F [x] P []

The site features extensive plantings throughout, both remnant riparian vegetation and introduced exotic species. Of particular note is a dead River Red Gum (*Eucalyptus camaldulensis*) scar tree, associated with the Wurundjeri Aboriginal group in the area occupied by Burnley Oval. Other remnant River Red Gums are scattered throughout the parklands. More recent plantings include various Oaks (*Quercus* sp.), Elms (*Ulmus* sp.) and Canary Island Date Palms (*Phoenix canariensis*) along The Boulevard. Dense overgrown shrubberies also line the thoroughfare, many of the species being self-sown weeds.

The site in certain areas is derelict, particularly the shrubberies along The Boulevard. Further degeneration of these plantings will impact significantly on the heritage value of the site, particularly the failure to replace senescent specimens with the same species. Further introduction of inappropriately detailed constructed elements, particularly in relation to sporting facilities, which will further challenge the heritage character of the area.

The site requires the preparation of a detailed master plan and management policy that should attempt to unify the various disparate elements throughout the extensive site, and reinforce the heritage character of the place. The plan should address maintenance and replacement strategies for vegetation, and appropriate detailing of hard landscaping. It should seek to encourage increased use of the site as a passive recreational area.

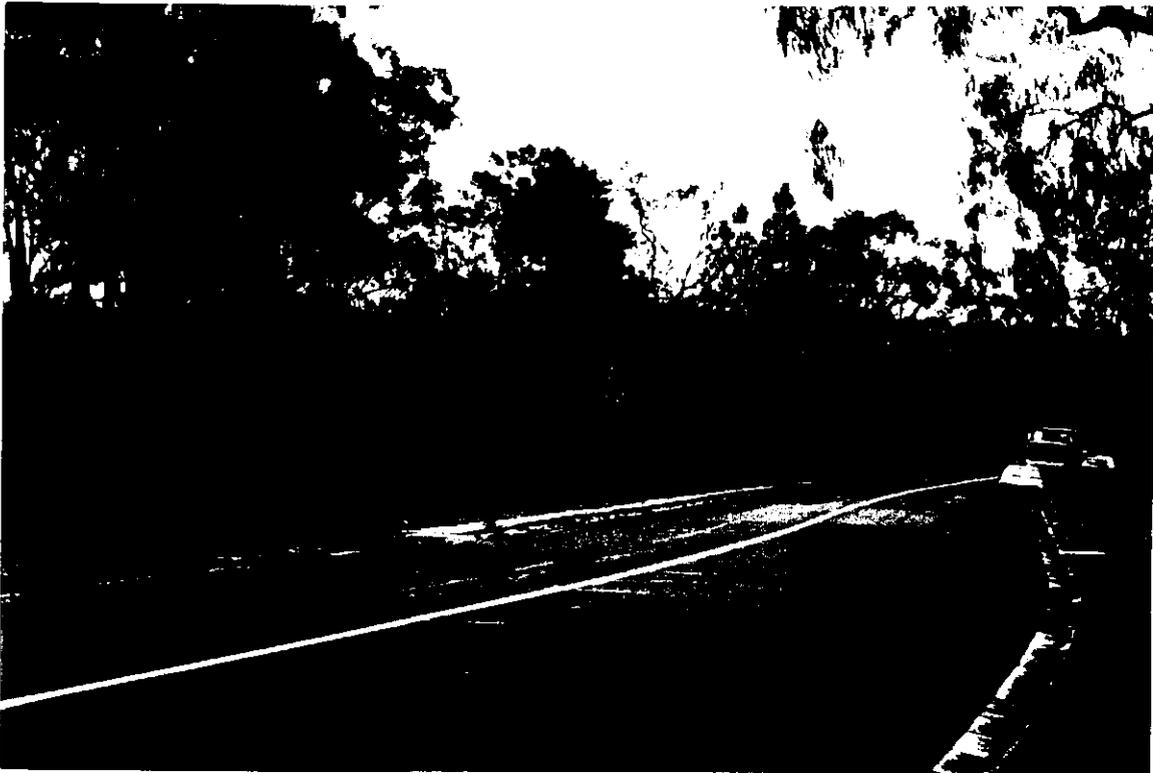
Site:	The Boulevard Parklands	Significance:	B
Address:	The Boulevard, Richmond	Map Ref:	2H H10
Access:	Unrestricted	Survey Date:	27/4/98

Intactness: E [] G [] F [x] P []	Condition: E [] G [] F [x] P []
---	--

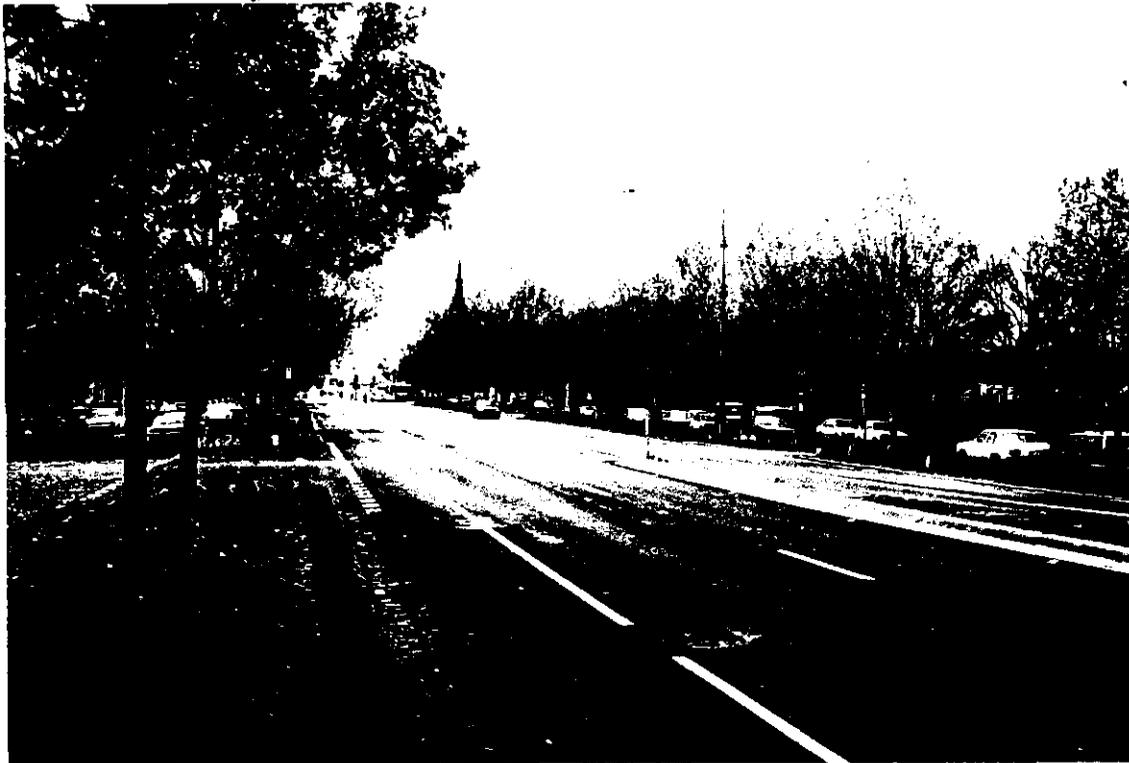
Site:	Street Trees	Significance:	B
Address:	Queens Parade, between Alexandra Parade & Delbridge Street, Clifton Hill	Map Ref:	44 B2
Access:	Unrestricted	Survey Date:	7/5/98

Intactness:	Condition:
E [] G [x] F [] P []	E [] G [] F [x] P []

Failure to replace senescent specimens with the same species. Lopping of major limbs.

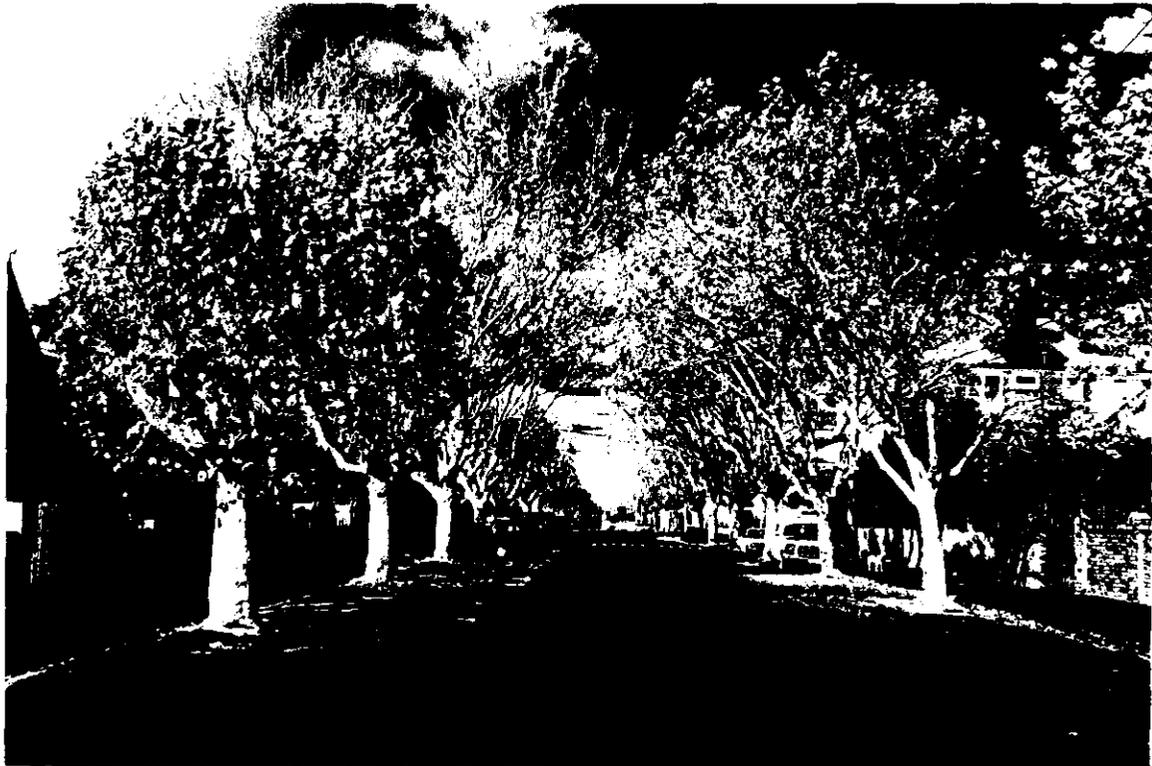
Site:	Street Trees	Significance:	C
Address:	Barkly Street, Fitzroy North, between Nicholson St & St Georges Rd	Map Ref:	30 B10
Access:	Unrestricted	Survey Date:	11/5/98

Intactness: E <input type="checkbox"/> G <input type="checkbox"/> F <input checked="" type="checkbox"/> P <input type="checkbox"/>	Condition: E <input type="checkbox"/> G <input type="checkbox"/> F <input checked="" type="checkbox"/> P <input type="checkbox"/>
--	---

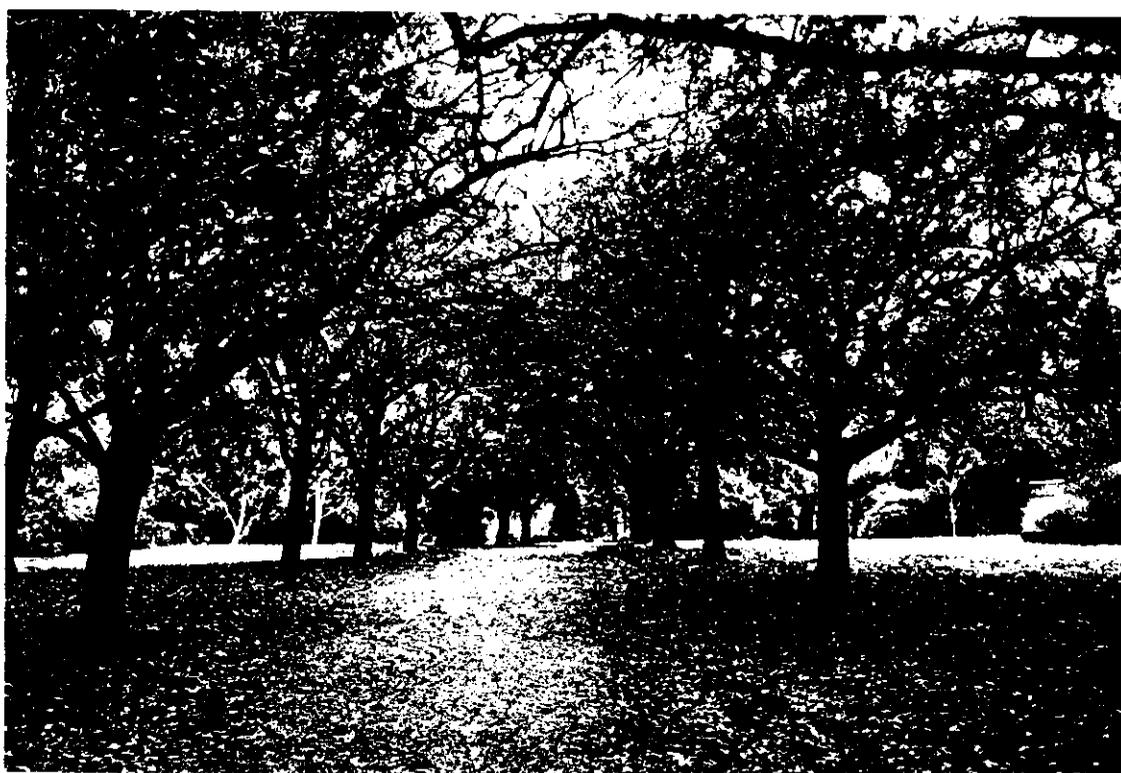
Site:	Coate Park	Significance:	C
Address:	Coate Avenue, Alphington	Map Ref:	31 A12
Access:	Unrestricted	Survey Date:	18/5/98

Intactness: E [] G [x] F [] P []	Condition: E [] G [] F [x] P []
---	--

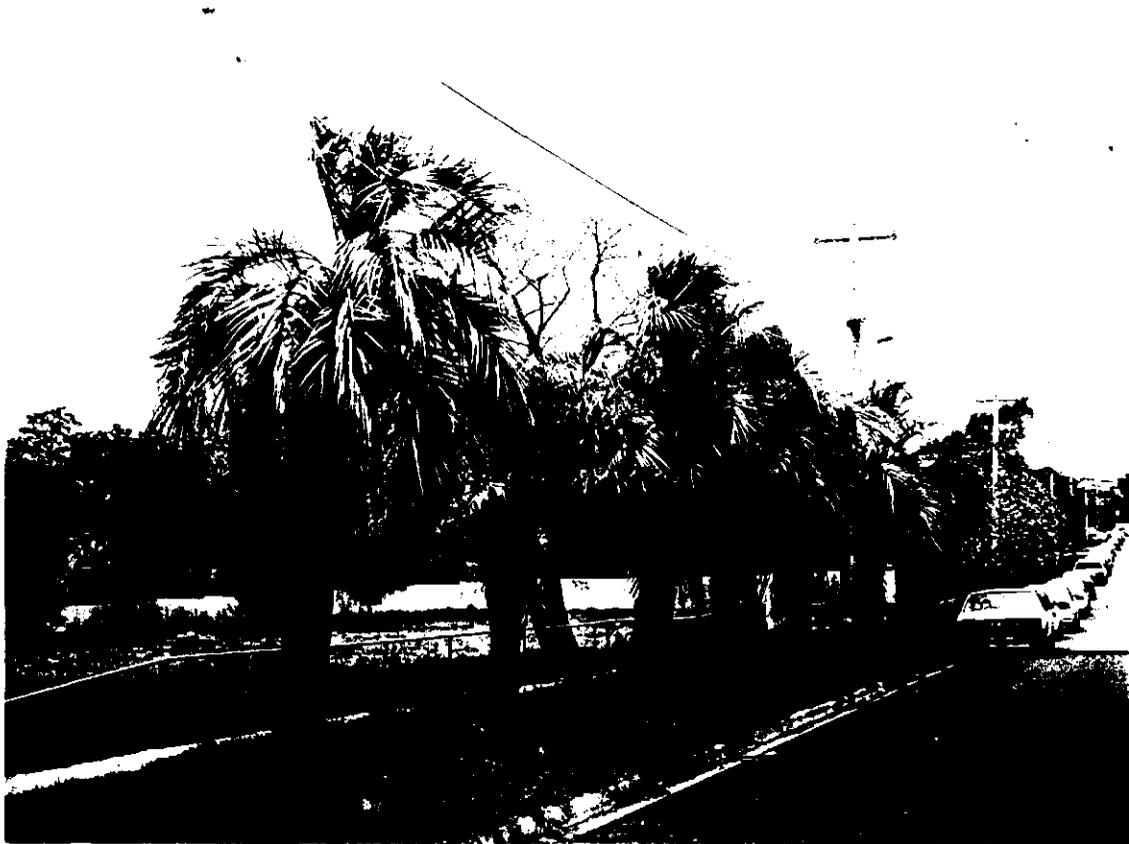
Site:	Median Planting	Significance:	C
Address:	Coate Street, Alphington	Map Ref:	31 A12
Access:	Unrestricted	Survey Date:	18/5/98

Intactness:	Condition:
E [] G [x] F [] P []	E [] G [x] F [] P []

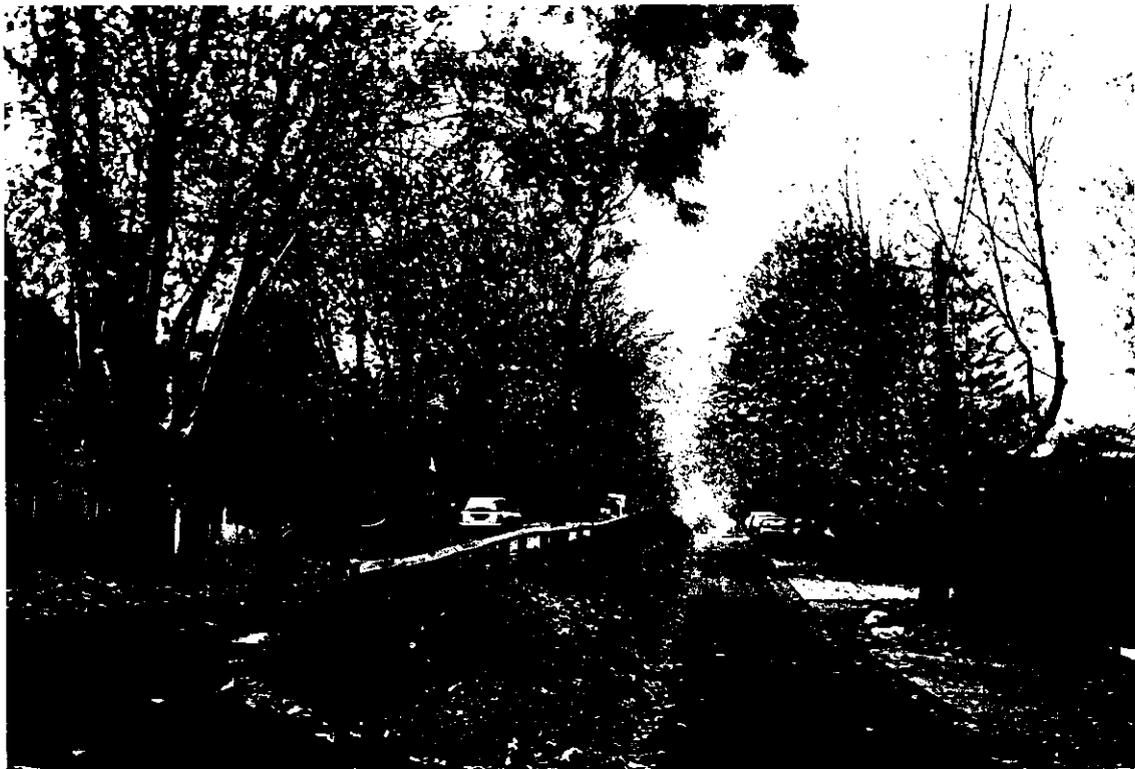
Site:	Street Trees	Significance:	C
Address:	Yarraford Avenue, Alphington	Map Ref:	31 A12
Access:	Unrestricted	Survey Date:	18/5/98

Intactness:	Condition:
E [] G [x] F [] P []	E [] G [x] F [] P []

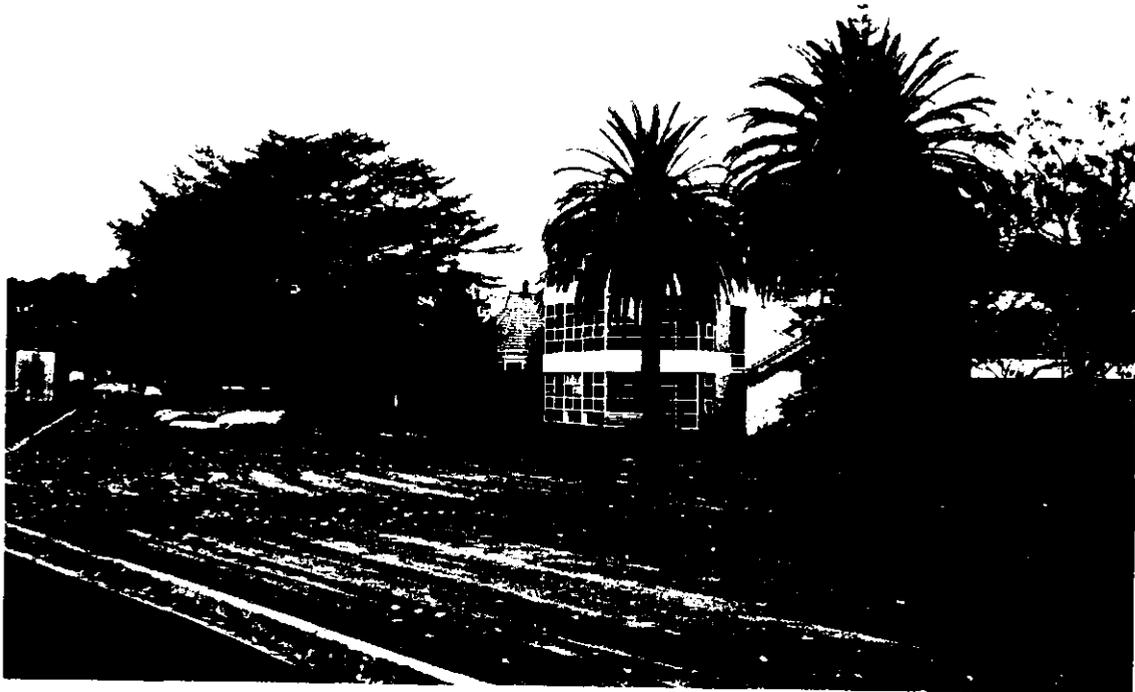
Site:	Fairfield Hospital	Significance:	B
Address:	Yarra Bend Road, Yarra Bend	Map Ref:	2D G2
Access:	Restricted	Survey Date:	19/5/98

Intactness:
 E [] G [] F [x] P []

Condition:
 E [] G [x] F [] P []

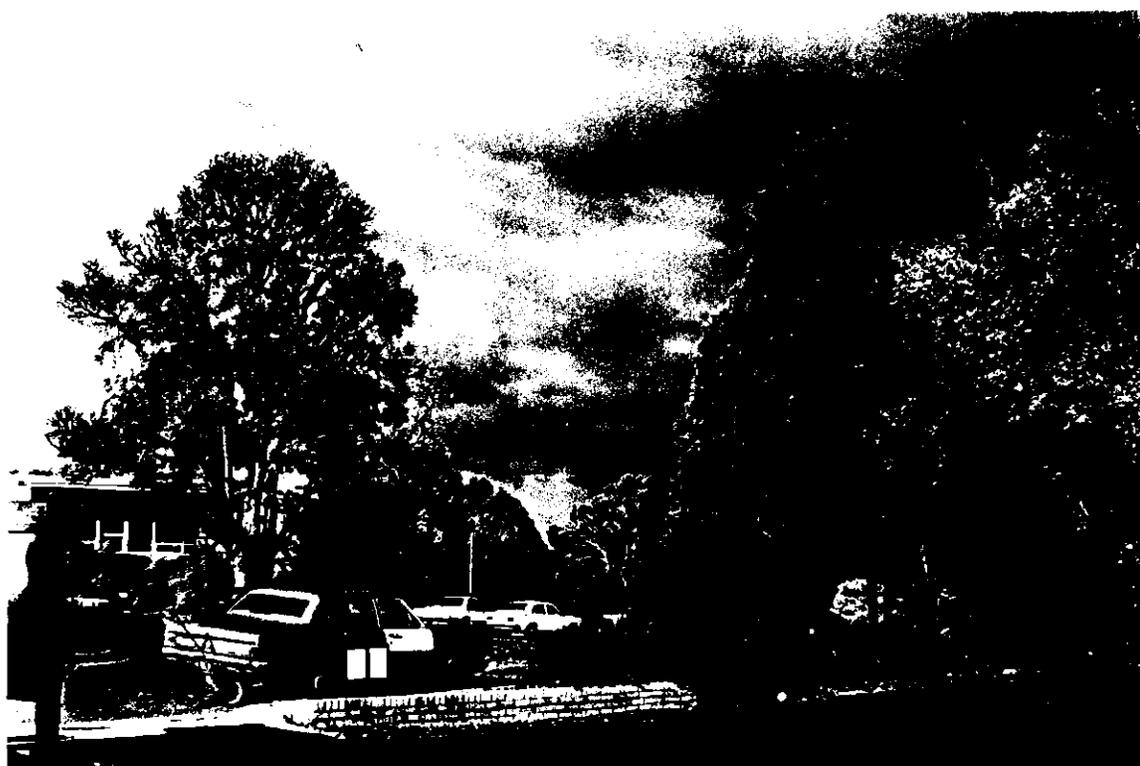
Site:	Latrobe Golf Club	Significance:	C
Address:	Farm Road, Alphington	Map Ref:	31 D12
Access:	Restricted	Survey Date:	21/5/98

Intactness: E <input type="checkbox"/> G <input type="checkbox"/> F <input type="checkbox"/> P <input checked="" type="checkbox"/>	Condition: E <input type="checkbox"/> G <input checked="" type="checkbox"/> F <input type="checkbox"/> P <input type="checkbox"/>
--	---

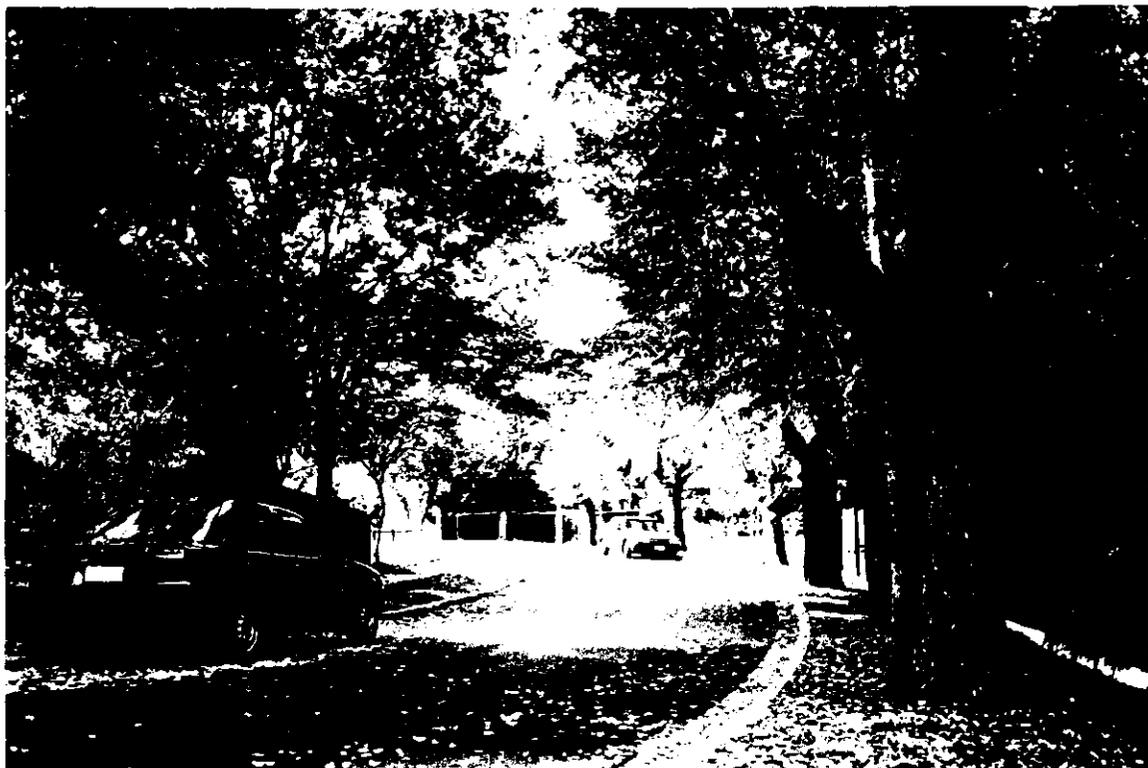
Site:	Street Trees	Significance:	C
Address:	Roemer Crescent, Alphington	Map Ref:	31 C12
Access:	Unrestricted	Survey Date:	22/5/98

Intactness:
E [] G [] F [x] P []

Condition:
E [] G [] F [x] P []

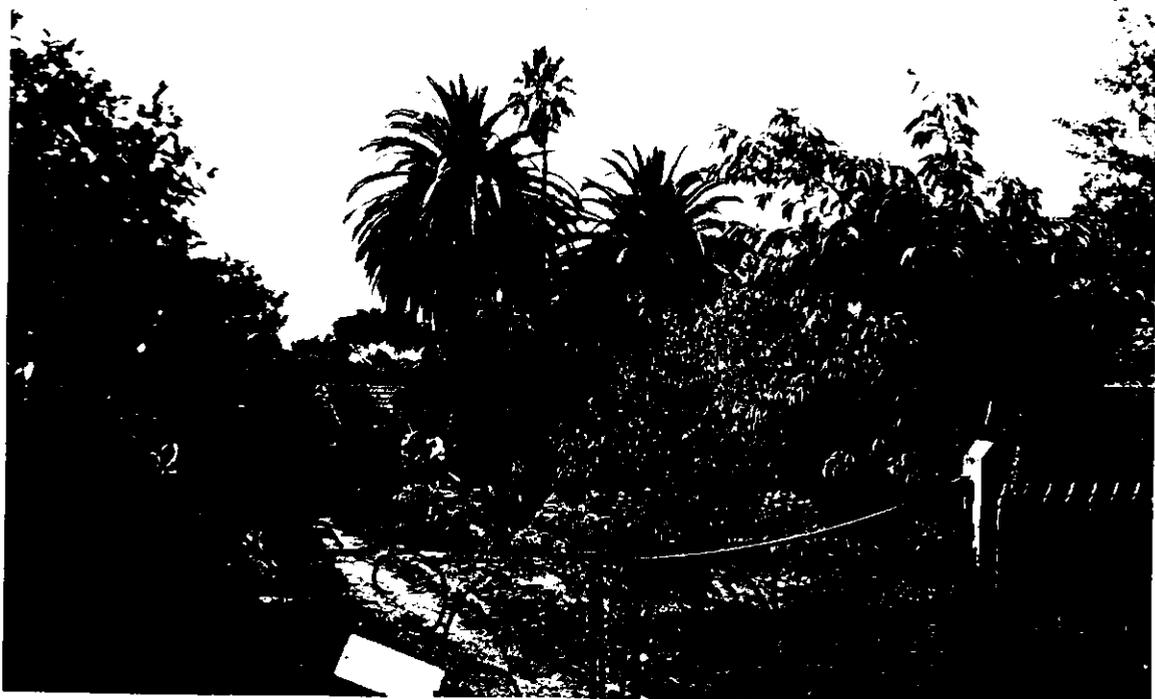
Site:	Residential Garden	Significance:	C
Address:	52 Lucerne Crescent, Alphington	Map Ref:	31 D12
Access:	Restricted	Survey Date:	25/5/98

Intactness:	Condition:
E [] G [] F [x] P []	E [] G [] F [x] P []

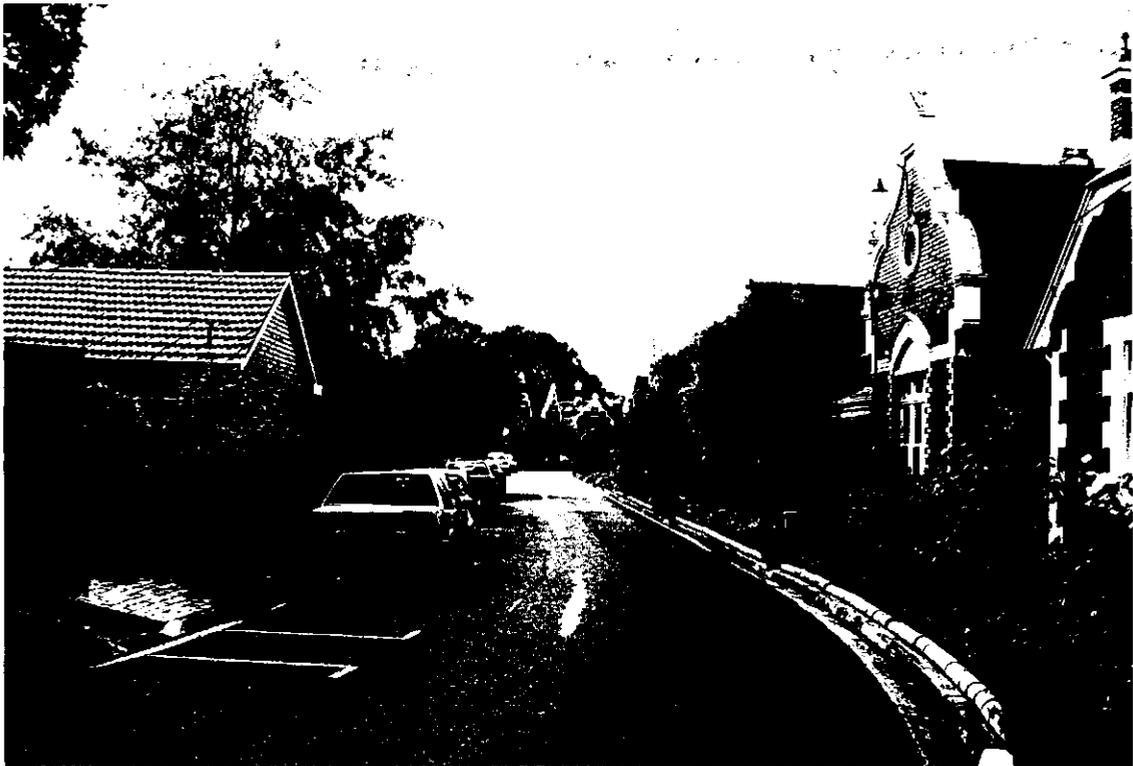
Site:	Rushall Park Old Colonists' Cottages	Significance:	A
Address:	Rushall Crescent, Fitzroy North	Map Ref:	30 D12
Access:	Restricted	Survey Date:	25/5/98

Intactness:
E [] G [x] F [] P []

Condition:
E [] G [x] F [] P []

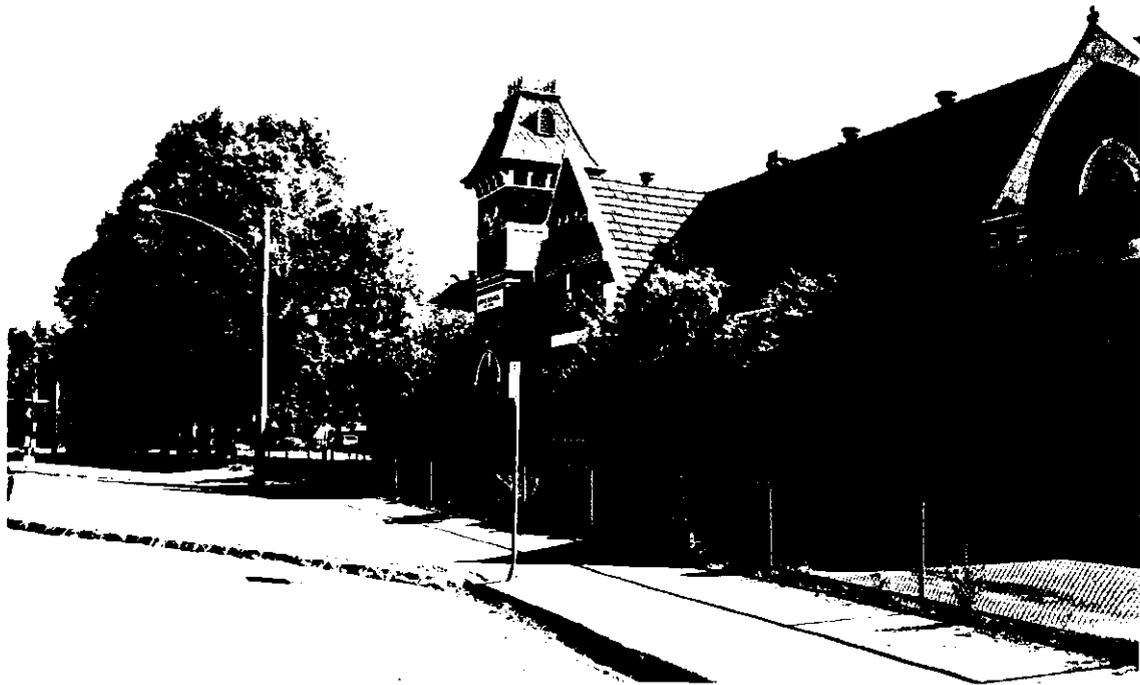
Site:	Fitzroy North Primary School	Significance:	C
Address:	Cnr Alfred Crescent & Best Street, North Fitzroy	Map Ref:	30 B12
Access:	Restricted	Survey Date:	28/5/98

The site features a number of mature exotic trees. Specimens include Pepper Tree (*Schinus molle*), Desert Ash (*Fraxinus oxycarpa*), English Elm (*Ulmus procera*) and a short row of Dutch Elm (*Ulmus x hollandica*) on the southern boundary of the site. An unusual oak tree, which appears to be a Common Oak (*Quercus robur*) hybrid is located in the south western section of the site. All the trees are in reasonable condition. Most of the significant trees are located in the vicinity of the old wing of the school, and native trees and shrubs are planted elsewhere, forming an effective landscape scheme.

The mature exotic trees at North Fitzroy Primary School are of local interest as early plantings associated with an important local building. The trees contribute significantly to the heritage character of the site and the surrounding precinct, and to the amenity of the neighbourhood generally.

Intactness:	Condition:
E [] G [] F [x] P []	E [] G [x] F [] P []

Removal of senescent specimens and failure to replace them with the same species, particularly introduction of native trees to the south western section of the site..

Preparation of a management plan for the mature exotic trees on the site that would outline a regular maintenance program for the trees, and ensure senescent specimens are replaced with the same species, maintaining some degree of heritage character to the site.
