Ordinary Meeting of Council Agenda

**to be held on Tuesday 27 August 2019 at 7.00pm
Richmond Town Hall**

Attachment 1 - Alluvium Stage 1 Interim Report 20 August 2019

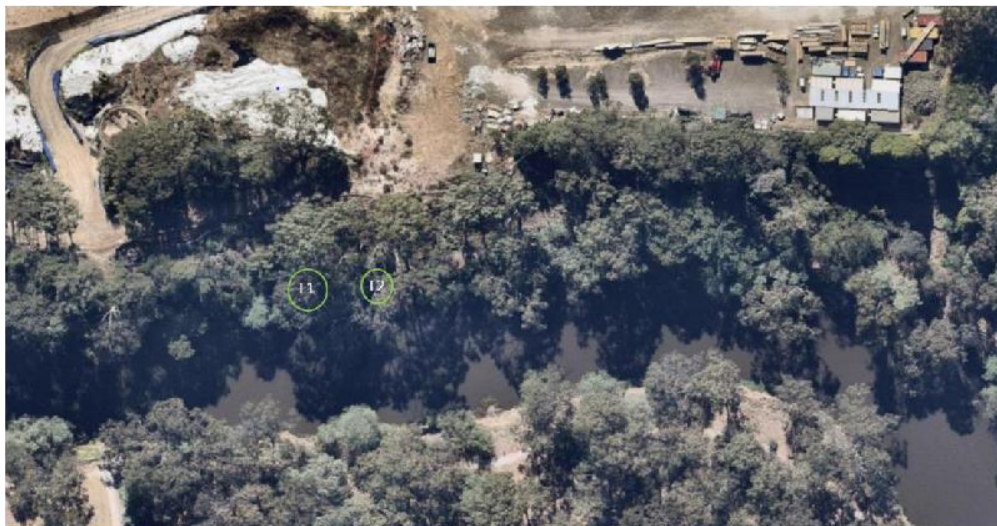
Figure 1. Location of trees assessed at bank slump zone

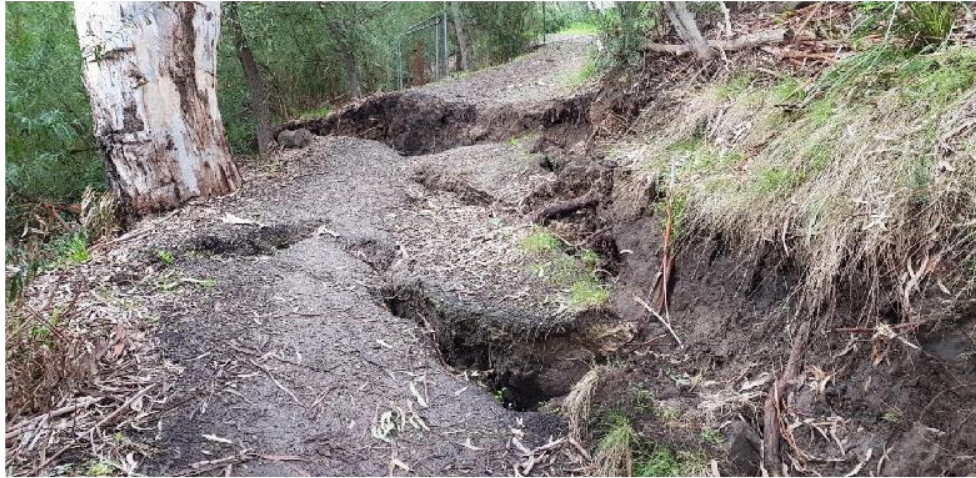
Figure 2. *Tree (T1) and bank slump site visit by Alluvium*

The two trees at risk of collapse are shown in Figure 2 and figure 3.

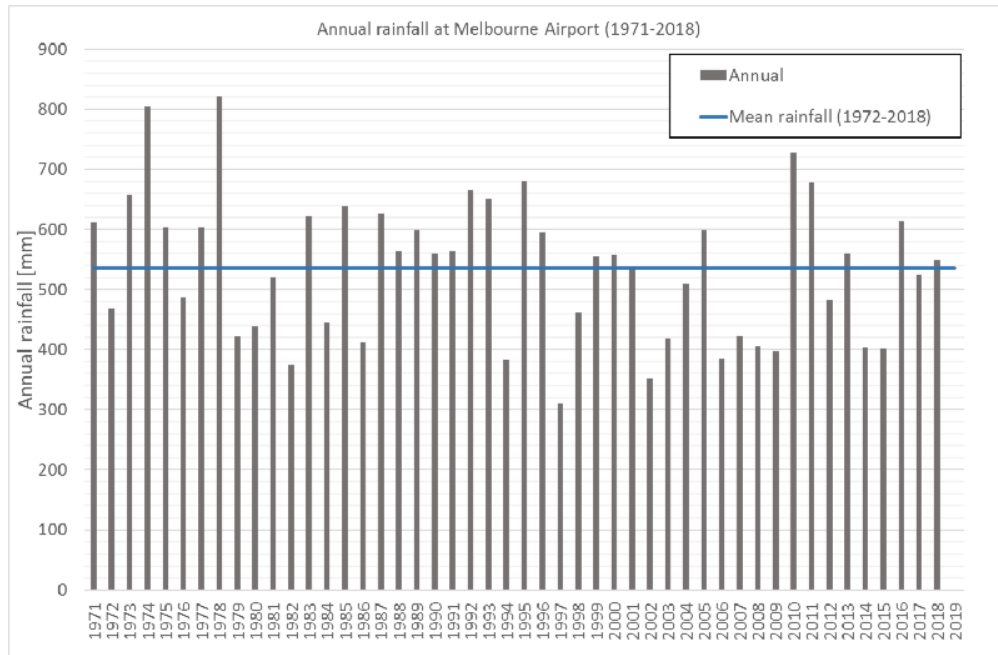
Figure 4 Rainfall records for Melbourne Airport 1971-2018

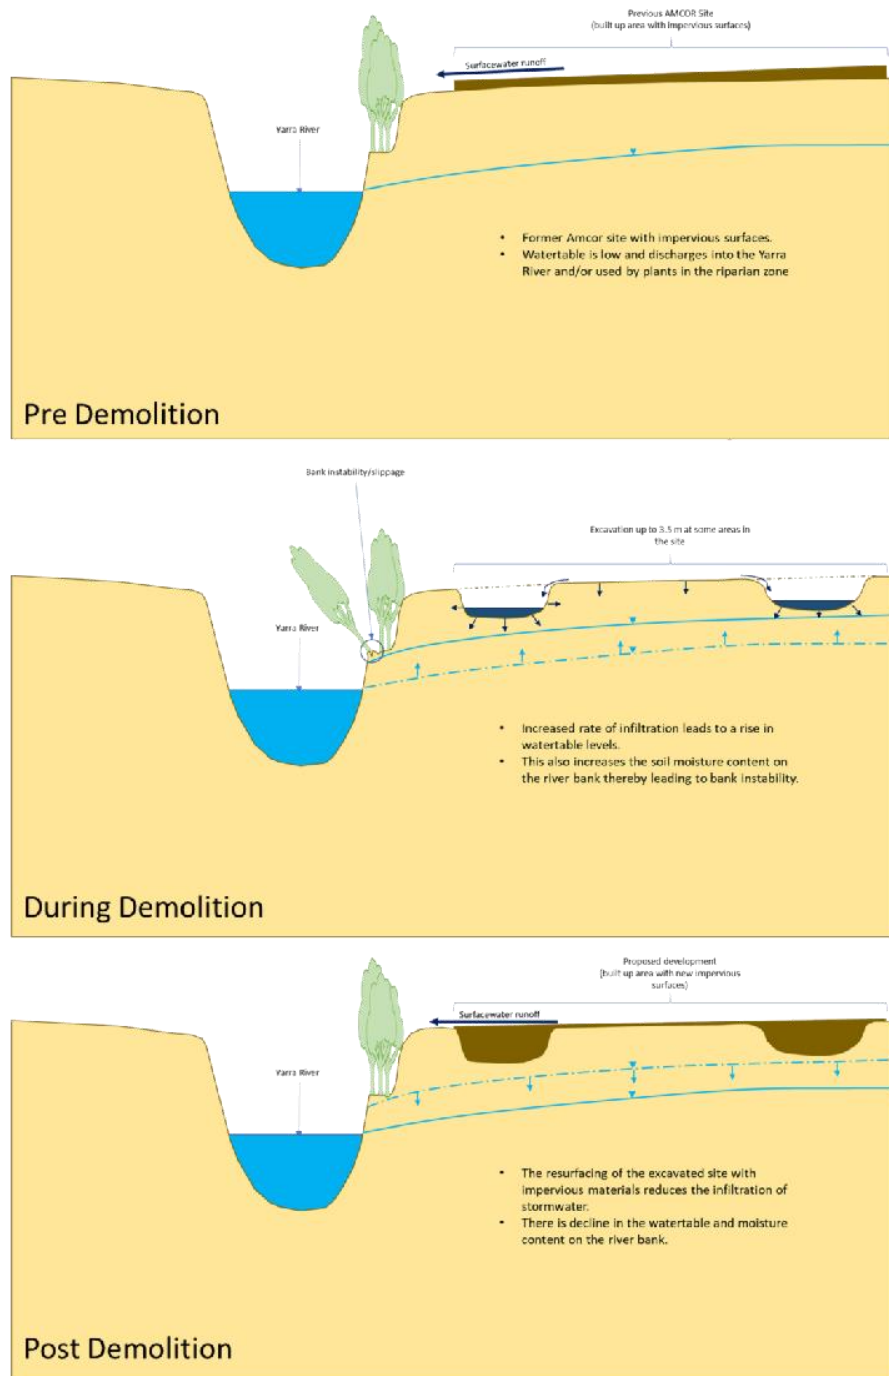
Figure 6 Conceptual model of possible changes to groundwater levels at the subject site (source CDM Smith refer appendix B)

14. Based on the information available, the expert panel is of the opinion that the most likely source of the elevated groundwater is a change to the rate of surface water infiltration at the subject site. Ongoing bank collapse (instability) will continue to occur at the site until groundwater issues are addressed and bank stability threatens trees on the river bank.

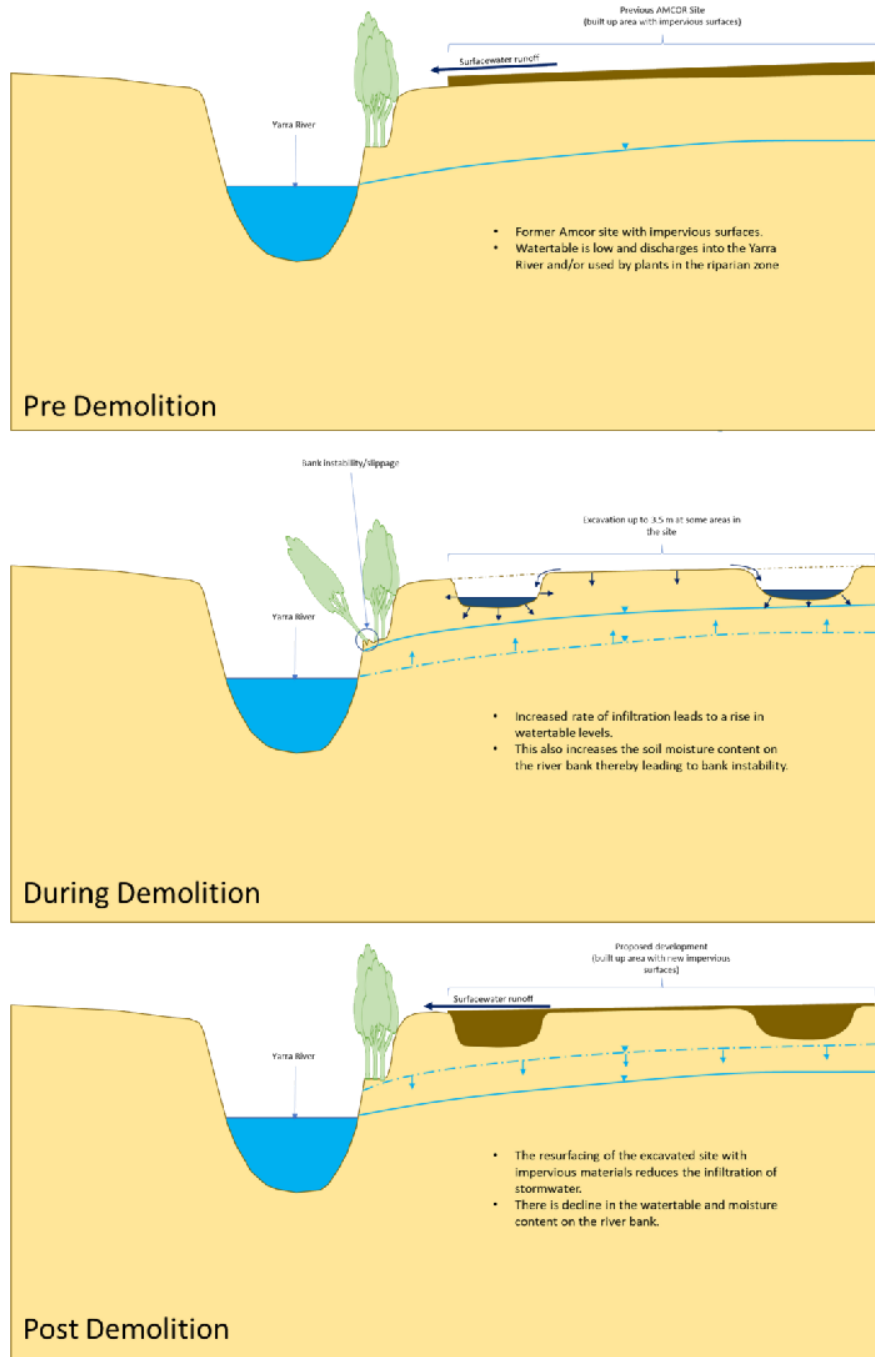
Figure 6-6 Conceptual site model

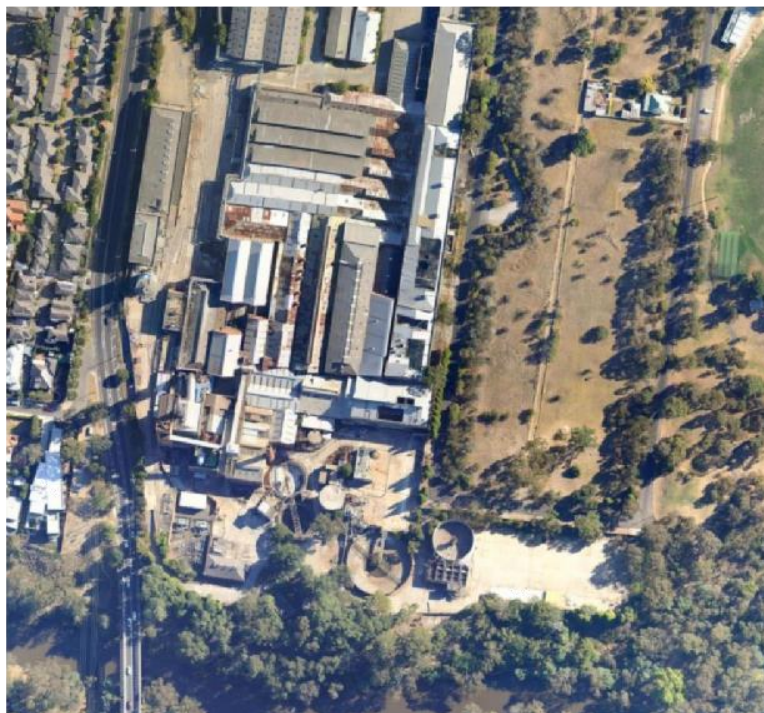
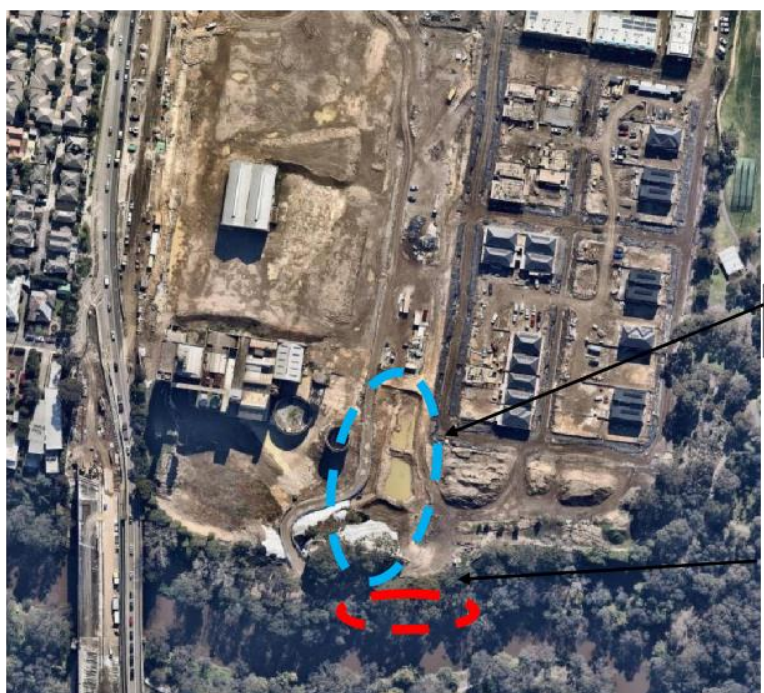
Figure 1 – Aerial photo of the site. March 2014 (top image), August 2018 (bottom image)

As shown in Figure 1, the stripping and demolition of the site removed all of the original underground drainage systems. Rainfall that falls on the site under these circumstances lands on exposed earth, where it runs along the surface to a swale drain or pools on the surface. During bulk earthworks, it is standard practice (and a permit requirement) to manage stormwater runoff to mitigate potential erosion and sediment laden water from entering the downstream receiving environment (i.e. the Yarra River). Therefore, as you would expect a "Construction Management Plan" was prepared by CSC Civil Constructions. One element of this plan included information on the protection measures to control stormwater runoff, which involved the use of swale drains or cut-off drains and a sediment pond (refer to Figure 2).

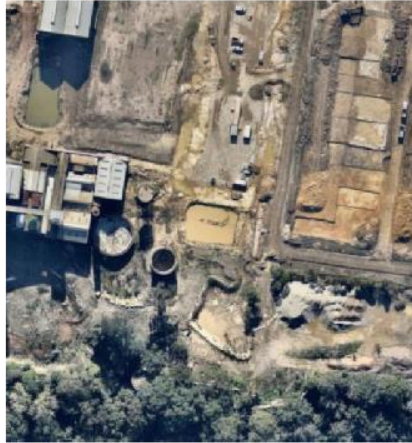
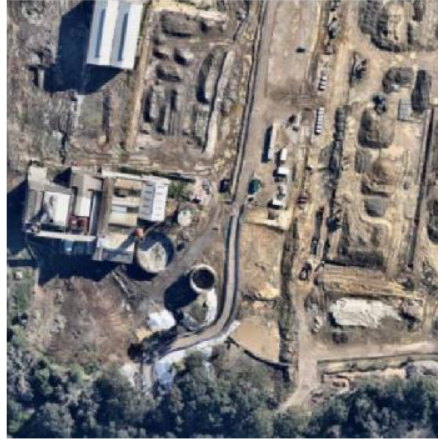
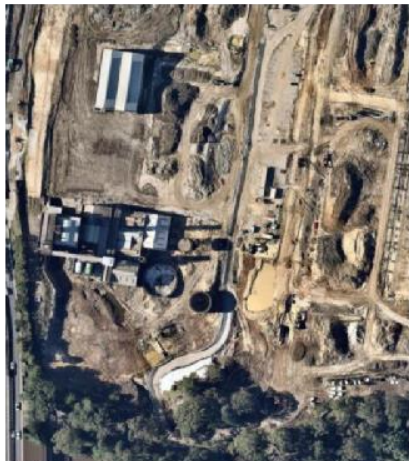
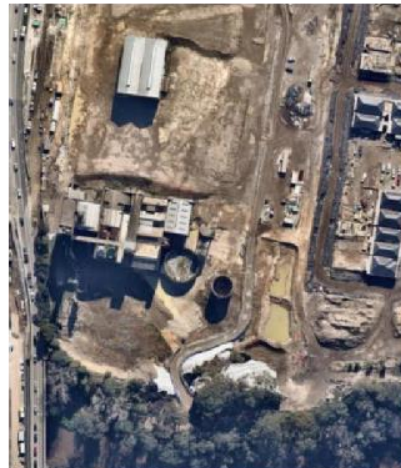
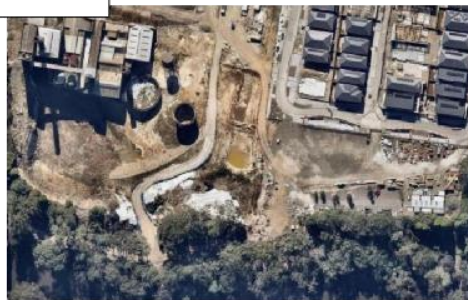
Figure 3 – Images showing the change in sediment pond location over time

From an examination of aerial images, it is clear that the location of the surface water management sedimentation ponds has moved over time (see Figure 3).

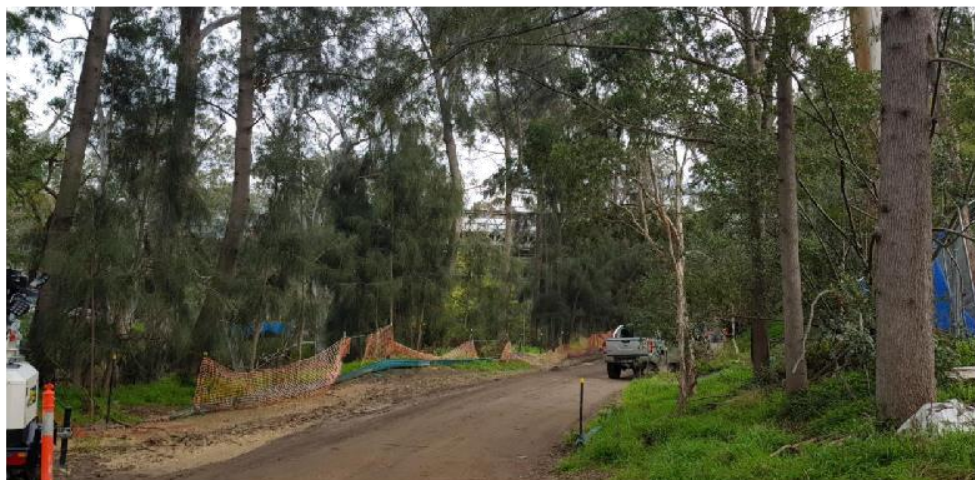
Figure 8: Riparian planting west of slump area -River Red Gums occur along the riverbank. The waterway corridor is predominately planted with non-indigenous natives. Newer plantings are local indigenous plants.

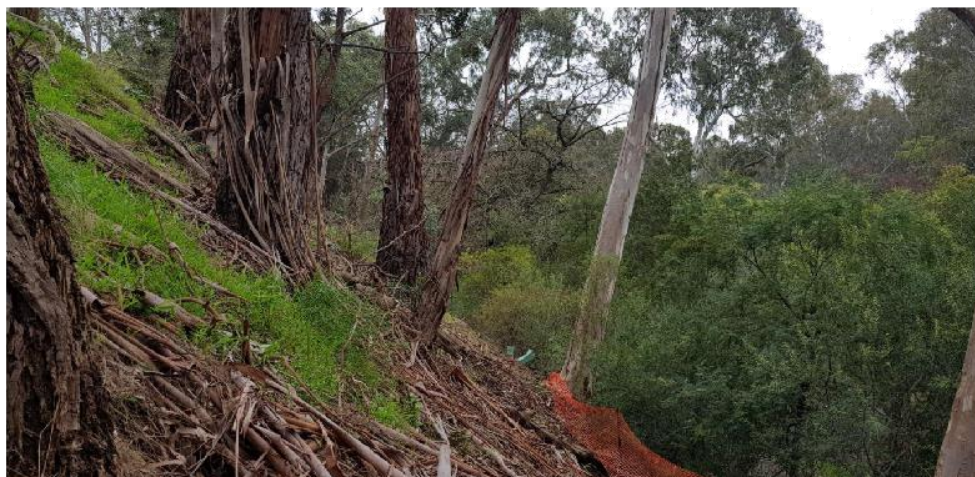
Figure 9: Planted trees on embankment - Trees on the embankment are 20+ year old non-indigenous natives. The trees on the embankment are growing at different angles to each other. Investigate for slumping or ground heaving to determine stability of the trees.

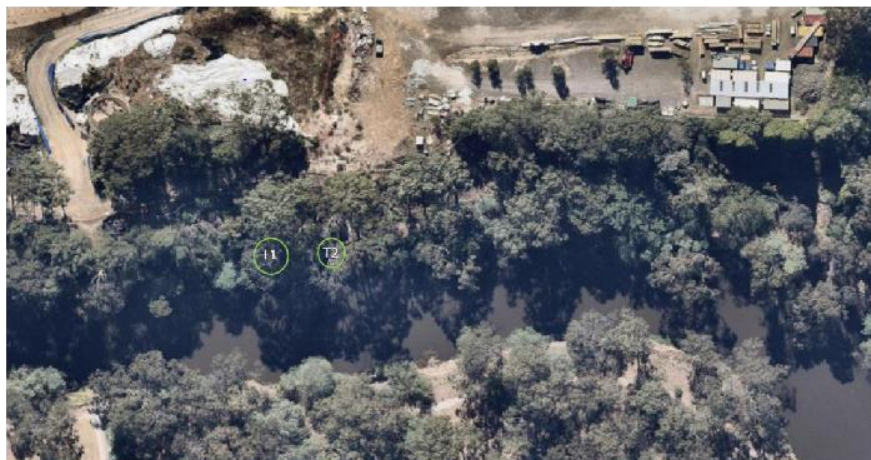
Figure 10. Location of trees assessed at bank slump zone

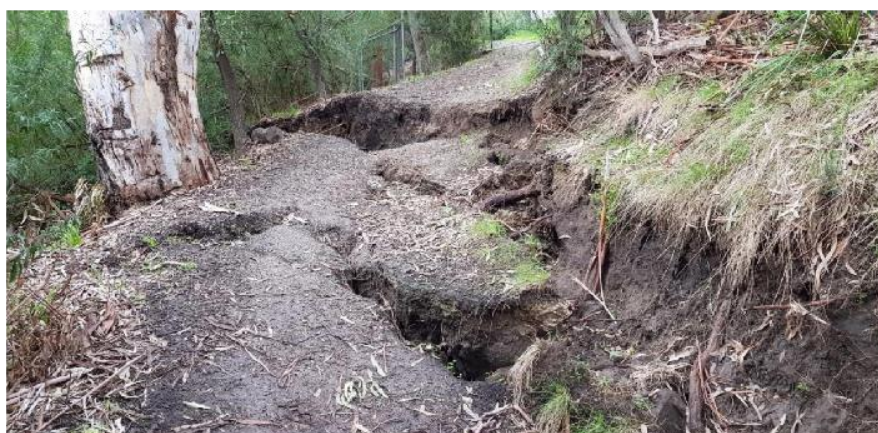
Figure 11: Tree (T1) and bank slump site visit by Alluvium

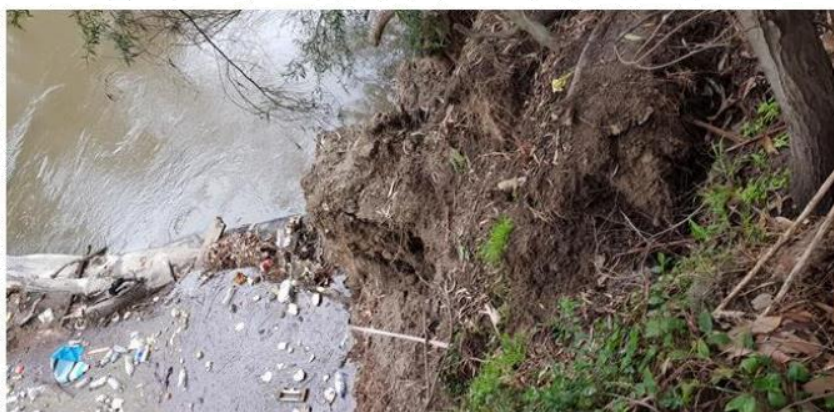
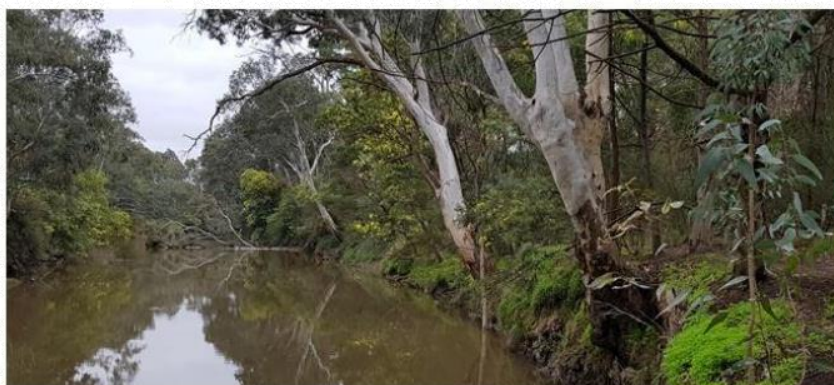
Figure 13: *Tree in slump which has fallen into river*

The tree which has fallen into the river (see Figure 13) is firmly held into the riverbank and has not swung around with the river current. This suggests that the tree had a healthy root system prior to falling.

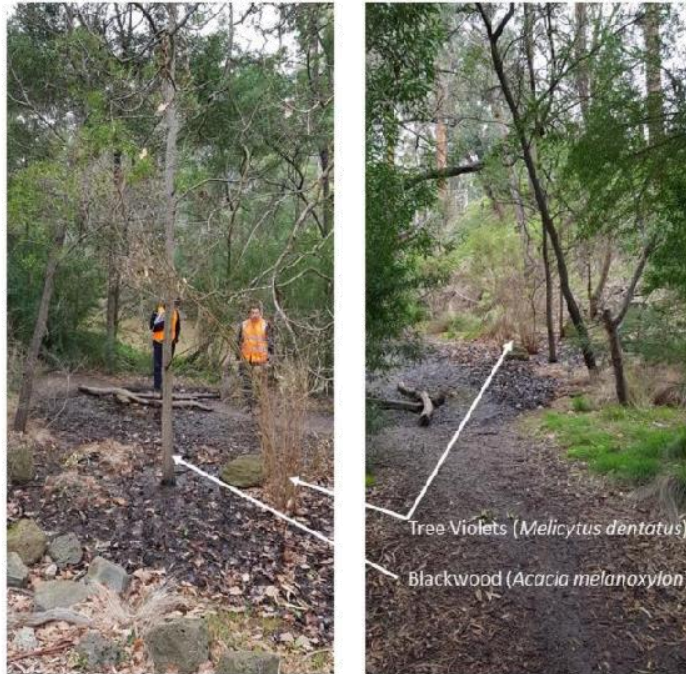
Areas of the lower terrace adjacent to the riverbank were observed to be waterlogged with the vegetation in those areas showing stress or death consistent with waterlogging.

Figure 14: *Dead native plants in waterlogged area*

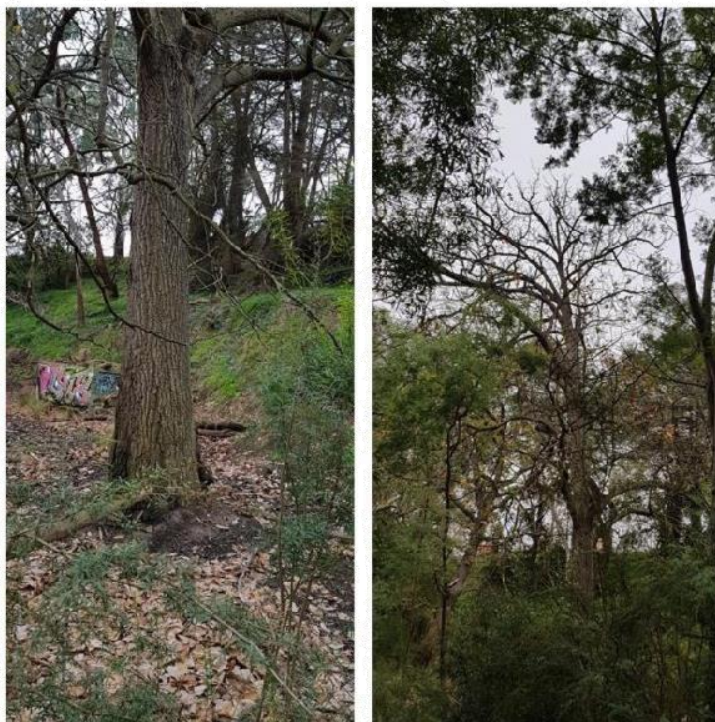
Figure 15: *Oak in waterlogged area*

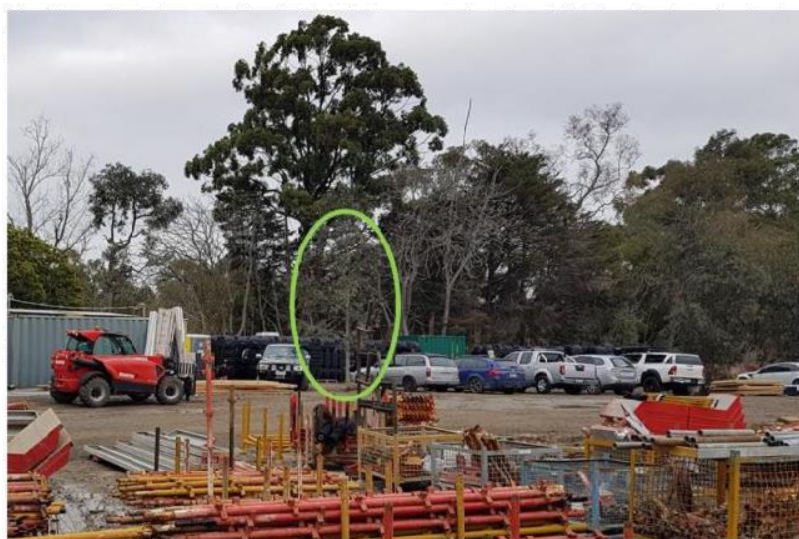
Figure 16: Juvenile tree in carpark - old logistics hardstand

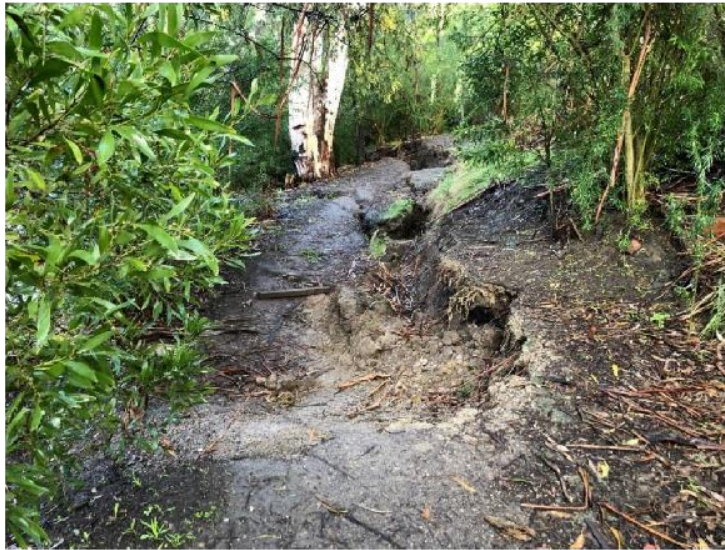
Tree T1 on and related bank slump 12 August 2019

However, the subject tree in its current form threatens the bank stability. Council officers, have advised that the subject riverbank has undergone significant further movement over the weekend (10 and 11 August 2019), refer figure below. The subject bank is active. Further bank slumping can be expected over the forthcoming days and weeks.

The loss of the lower terrace and steep upper bank would result in significant loss of property including the walking path, with accompanying adverse outcomes for the Yarra River including release of uncontrolled historic fill material. Removal of the tree T1, to reduce the mass of the tree, and the uncontrolled collapse of the tree would meet the requirements of emergency works to protect the riverbank.

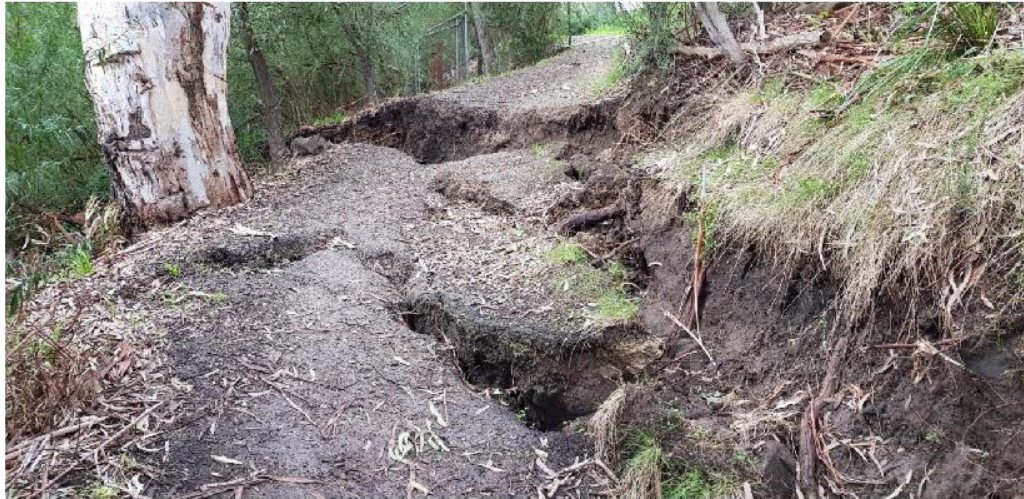
Figure 18. *Tree collapse site*

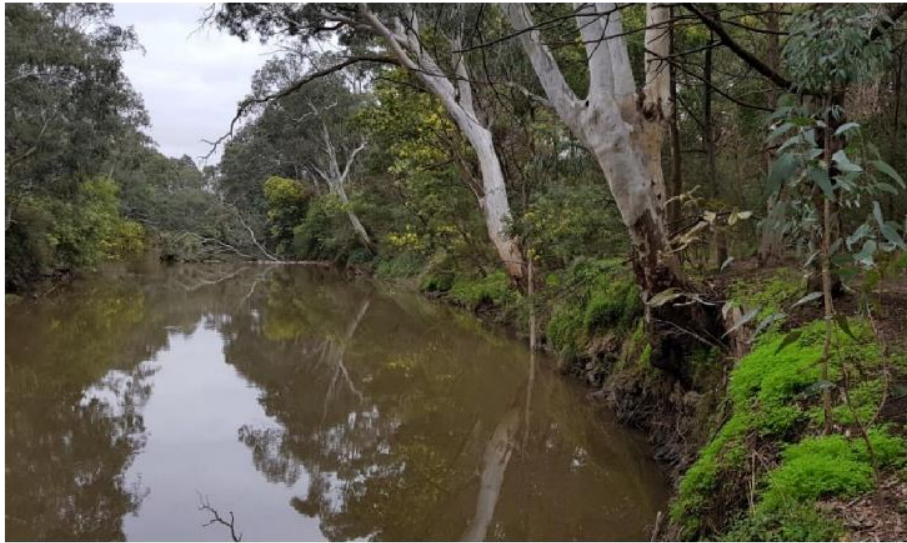
Figure 19. Root material along bank of Yarra River at subject site

The lower terrace and steep embankment have been revegetated with non-indigenous native trees. However, the edge of the riverbank comprises indigenous river red gums, likely to be from natural regeneration. The root material from the river red gums provide a matting within the clays and fine silts making up the riverbank material.

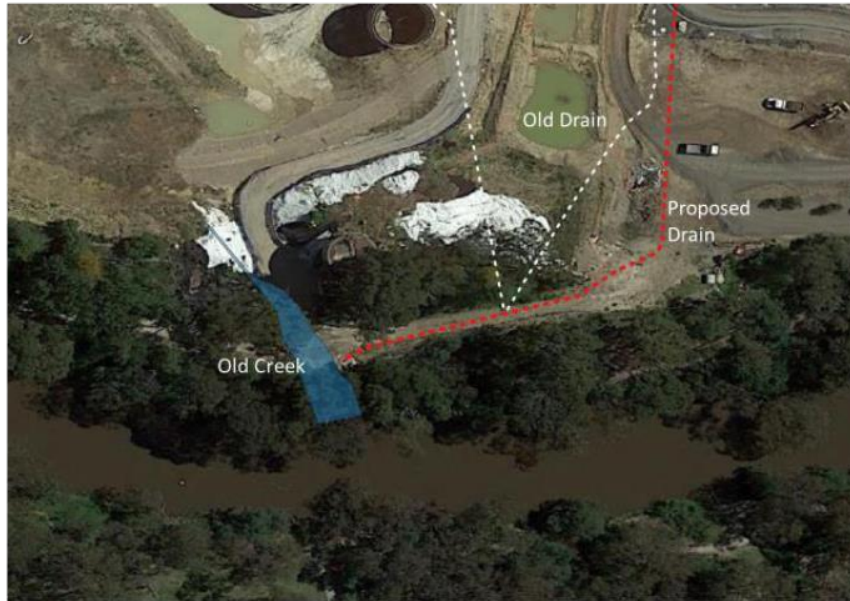
Figure 21. Indicative location of creek in current landscape

As set out above there is evidence of fill material on the lower terrace. Figure 20 illustrates provides an extract of a MMBW Historic Survey Plans (1910-1911) (refer Douglas Partners 2019) of a creek on entering the Yarra River through the now lower terrace of riverbank. Figure 21 sets out an indicative location of the creek in the current landscape. We are aware of a stormwater pipe located in the area of the old creek, however there is limited surface evidence of this creek in the current landscape, suggesting that the creek and its confluence with the Yarra River have been infilled.

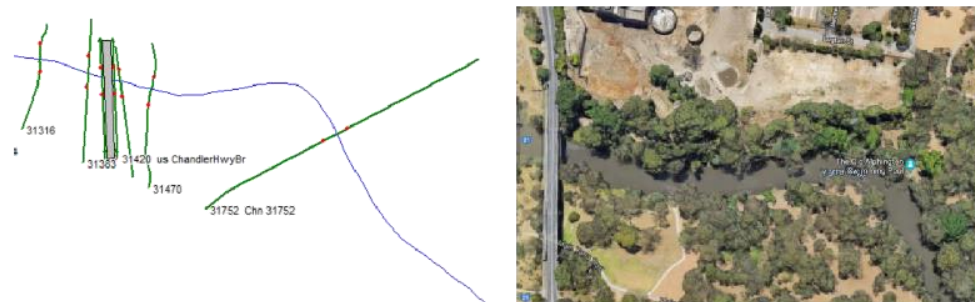
Figure 22. Cross section survey and aerial view of site

Figure 22 demonstrates the riverbank site lies between CH 31752 and CH 31470 of HECRAS model. The bank slumps and tree collapse site are located between these two cross sections. The shear stress for the subject site has been assessed at both these cross sections. The results are set out in Table 3.

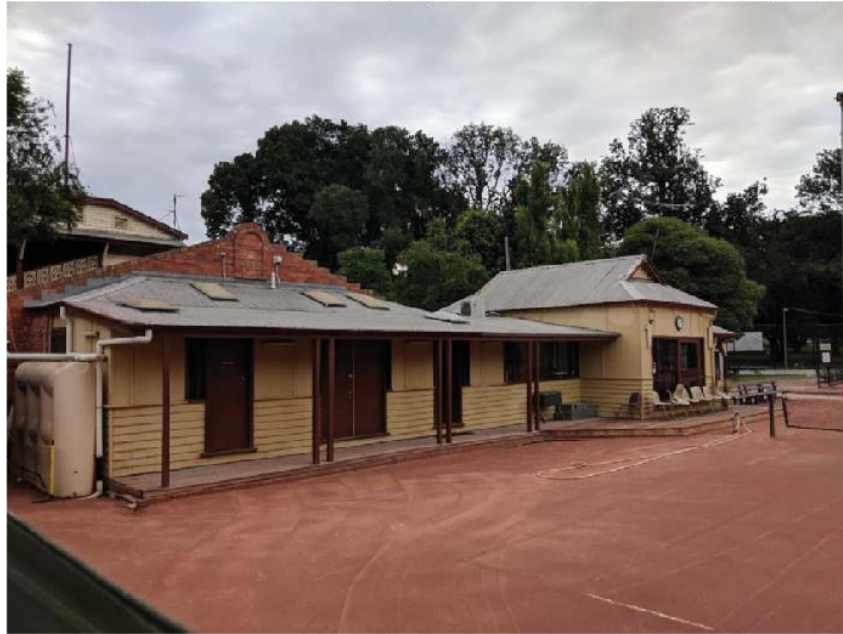
The perimeter court fencing is relatively new and in good condition. Line marking, nets and net posts are in good condition and fit for purpose. Hose bibs, drinking fountains and sprinklers in the vicinity of the net posts is a hazard to players and should be located outside the court runoff zone or below ground.

Figure 9 Tennis Club room and amenities, viewed from within the courts.

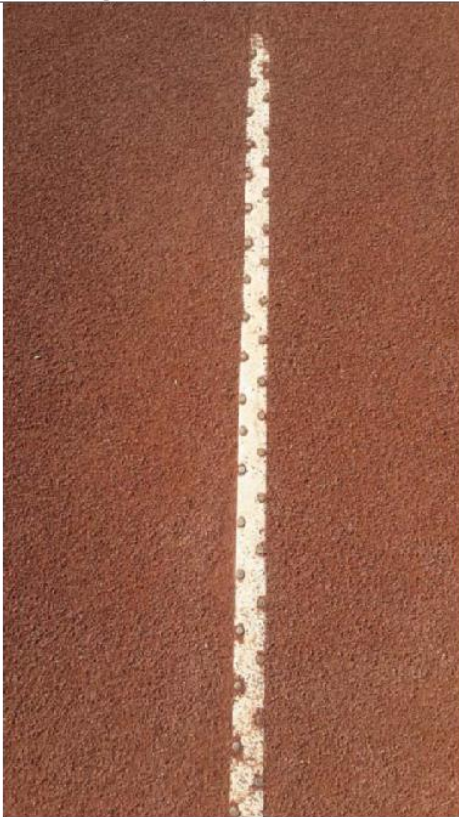
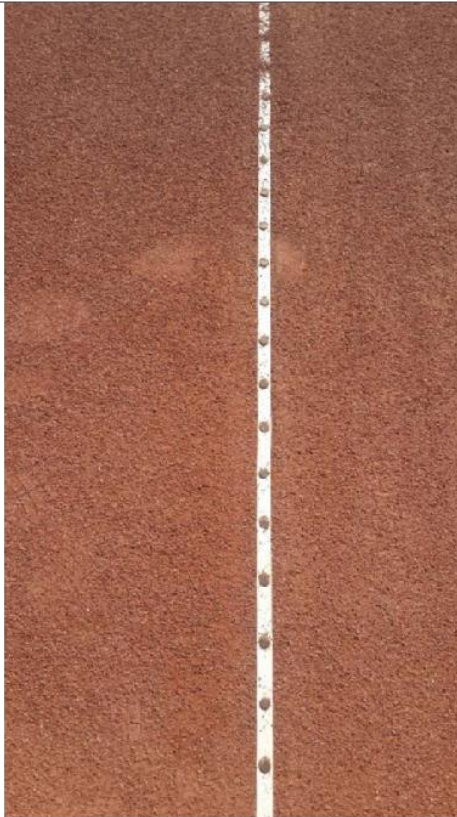
BASELINE COURT 1	SIDELINE COURT 1

Linemarking – Court 1	
Line marking description	Tennis only lines
Linemarking rating	Good
Linemarking condition notes	The lines are standard for red porous courts and there are no obvious signs of breakages.
Linemarking condition photos

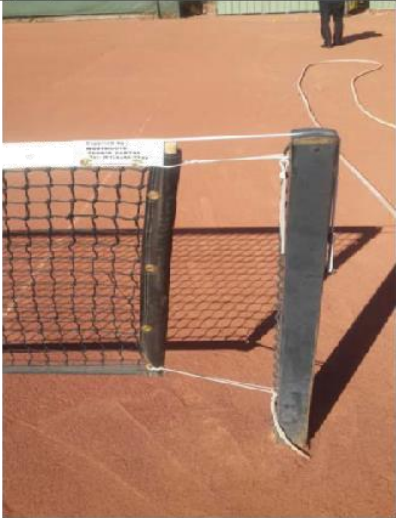
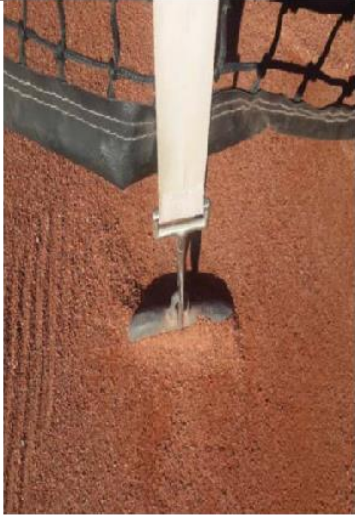
NET & POST COURT 1	CENTRE NET ATTACHMENT COURT 1

Net Posts – Court 1	
Net post type	Square powder coated steel installed directly into pavement.
Net post condition	Good, posts straight
Net post winders	Collapsible winders
Net condition	Good
Net structure	Net tethered to posts and centre strap fitted.
Net post life span	6-10 years
Net life span	6-10 years
Net/post notes	Posts and nets are generally in good condition.
Net/post photos

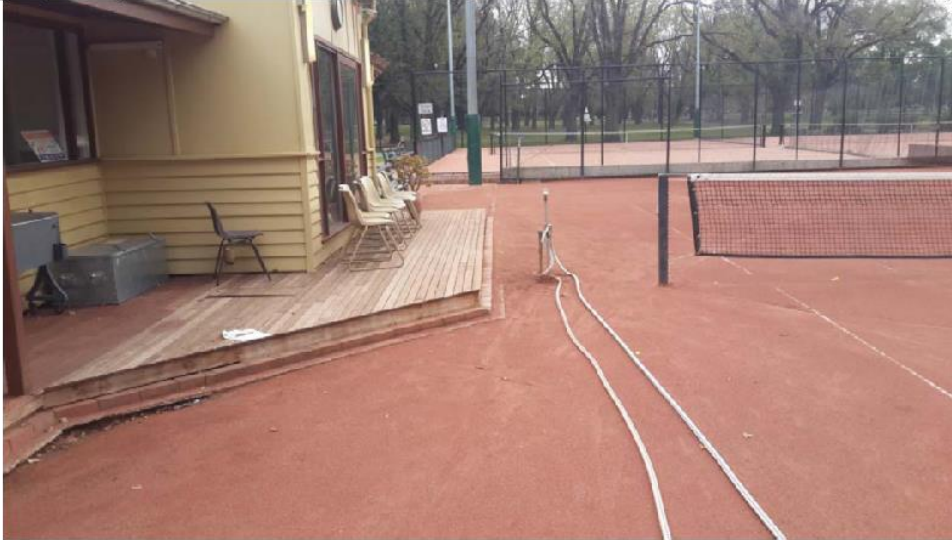
Court Compliance – Court 1	
Is the court runoff compliant	North: 4.94m to fence South: 4.91m to fence East: 2.80m to Court 2 West: 2.62m N end, 5.06m S end
Could the court be made compliant	No. Due to existing infrastructure (ie mounds to the south, and trees, drainage channel and footpath to the east) this would not be recommended due to considerable cost in both tree loss and expenditure.
Is the court to the standard dimensions	Yes
Court orientation	North south
Are netball goal posts outside tennis court run of areas?	Not applicable
Are lockable post hole covers fitted and safe	No
Compliance notes	The court runoffs do not meet the minimum requirements for Club/recreation use. On the east side a timber deck encroaches into the runoff area. This could be removed to achieve compliance.
Compliance photos

<p>ENCROACHMENTS INTO RUNOFF ZONE WEST SIDE COURT 1</p>

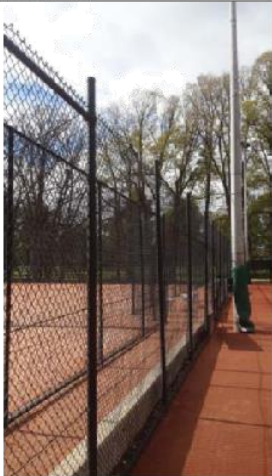
Fencing – Court 1	
Fence type	N end - black PVC chainwire, S end - galvanized chainwire.
Fence height	2.85m N end, 3.50m S end
Fence rails	Top & bottom rails NW end 2 panels only.
Fence attachments	2.20m high green site screen S end.
Fence condition rating	N end - good, S end - fair -.
Fence lifespan	N end – 10+ years, S end 5-7 years
Fence notes	N end fencing is relatively new and should provide long maintenance free life. S end fencing is serviceable and is fit for purpose.
Fencing photos

<p>FENCING ALONG NORTH END COURT 1</p>

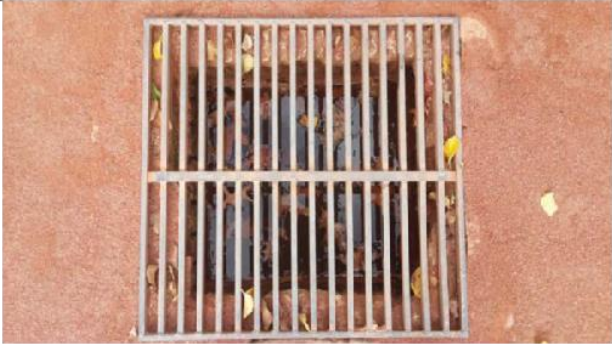
Drainage – Court 1	
Drainage infrastructure	Formed
What type of drainage is in place?	Grated pits with PVC drainage pipes.
Are drains, pits or other drainage infrastructure within runoff areas?	Yes, GP at S end.
Drainage condition	Fair. GP holding water
Drainage notes	GP is holding water. Cleanout SW pipe and pit to improve drainage. Check invert levels to determine if SW pipe fall is sufficient.
Drainage photos

GRATED DRAINAGE PIT SOUTH END COURT 1

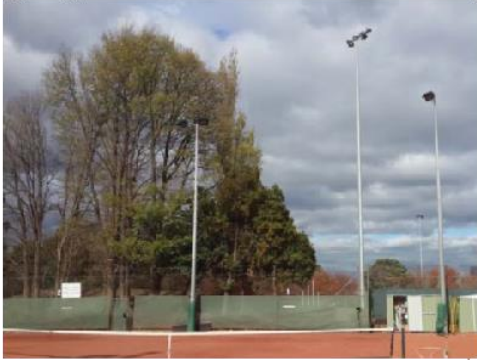
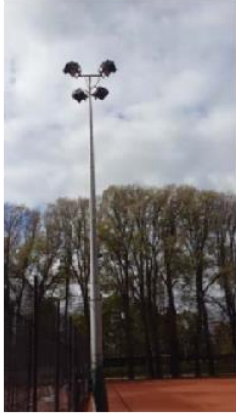
Lighting – Court 1	
Does the enclosure have lighting?	Yes
Total number of lit courts per enclosure	3
Lighting infrastructure type	Galvanized steel poles
Lighting infrastructure location	N & S corners and mid enclosure N & S ends.
Light fittings	Varies, 1 per SW cnr tower, 2 per S mid enclosure tower, 2 per NW cnr tower, 4 per NE mid enclosure tower.
Lighting infrastructure design	Fair, position of mid enclosure lights unlikely to achieve required lux levels.
Lighting infrastructure rating	Fair
Lighting infrastructure life span	5+ years
Lighting notes	Light towers covered with padding to 2m. A lighting lux level test should be undertaken to determine if lux levels are appropriate.
Lighting photos

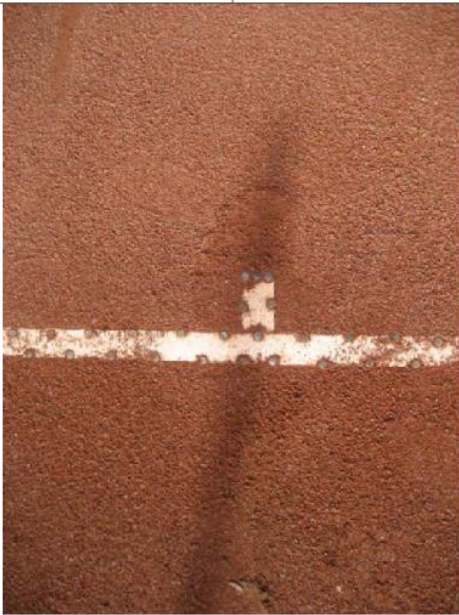
BASELINE COURT 2

Linemarking – Court 2	
Line marking description	Tennis only lines
Linemarking rating	Good
Linemarking condition notes	The lines are standard for red porous courts and there are no obvious signs of breakages.
Linemarking condition photos

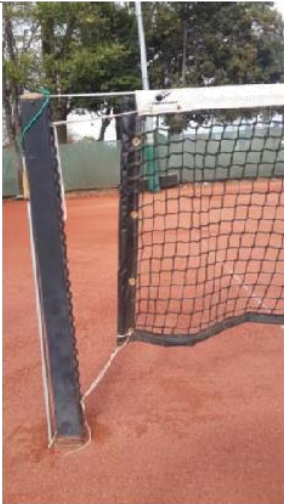
<p>NET POST COURT 2</p>

Net Posts – Court 2	
Net post type	Square powder coated steel installed directly into pavement.
Net post condition	Good, posts straight
Net post winders	Collapsible winders
Net condition	Good
Net structure	Net tethered to posts and centre strap fitted.
Net post life span	6-10 years
Net life span	6-10 years
Net/post notes	Posts and nets are generally in good condition.
Net/post photos

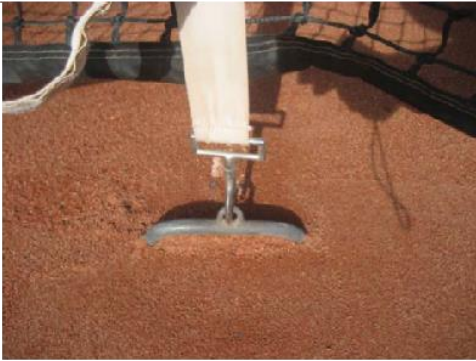
<p>CENTRE NET ATTACHMENT COURT 2</p>

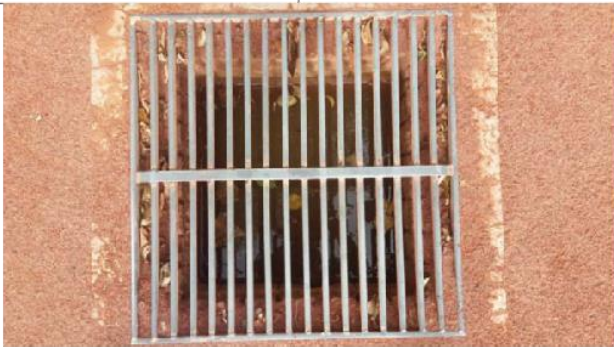
Drainage – Court 2	
Drainage infrastructure	Formed
What type of drainage is in place?	Grated pits with PVC drainage pipes.
Are drains, pits or other drainage infrastructure within runoff areas?	Yes, GP at S end.
Drainage condition	Fair. GP holding water
Drainage notes	GP is holding water. Cleanout SW pipe and pit to improve drainage. Check invert levels to determine if SW pipe fall is sufficient.
Drainage photos

GRATED DRAINAGE PIT AT SOUTH END OF COURT 1

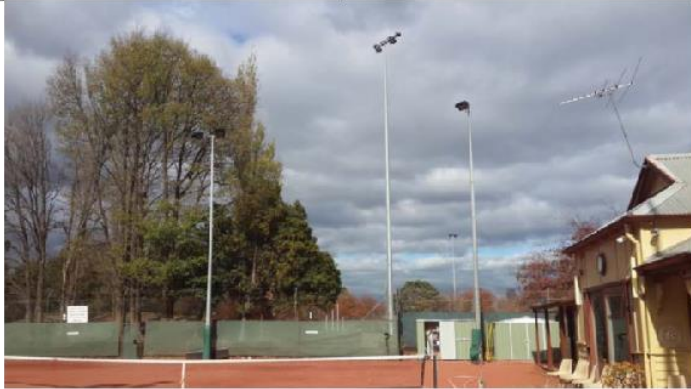
Lighting – Court 2	
Does the enclosure have lighting?	Yes
Total number of lit courts per enclosure	3
Lighting infrastructure type	Galvanized steel poles
Lighting infrastructure location	N & S corners and mid enclosure N & S ends.
Light fittings	Varies. 1 per SE cnr tower, 2 per S mid enclosure tower, 2 per NE cnr tower, 4 per N mid enclosure tower.
Lighting infrastructure design	Fair, position of mid enclosure lights unlikely to achieve required lux levels.
Lighting infrastructure rating	Fair
Lighting infrastructure life span	5+ years
Lighting notes	Light towers covered with padding to 2m. A lighting lux level test should be undertaken to determine if lux levels are appropriate.
Lighting photos

<p>VIEW FROM NW CORNER OF COURT 1 LOOKING SOUTH</p>   <p>NORTH END MID ENCLOSURE 1 LIGHT TOWER</p>

<p>NORTHERN GATE ACCESS TO COURT 2</p>	
Maintenance & Risk management	
Court	Continue to maintain good court surface coverage.
Drainage	Investigate why GP's are holding water.
Infrastructure	Generally good. Southern boundary fence will need replacement in 5-7 years.
Lighting	Conduct a lighting lux level test
Safety issues	
Are there any critical safety Issues	Yes. Relocate existing sprinklers (located next to net posts) either outside court runoffs or install in below ground valve box. Drinking fountains should be relocated outside court runoffs

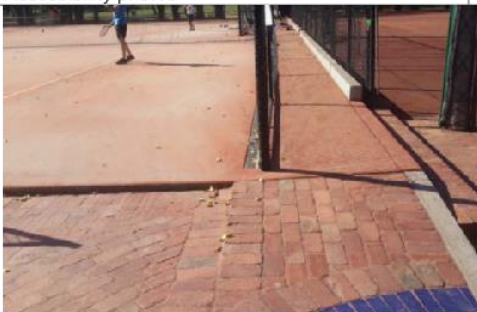
Accessibility – Court 2	
Court enclosure accessibility	Access to the enclosure via formed paths. No trip hazards observed. Ramped access no required.
Path material	Brick
Main gate dimensions	1050mm
Accessibility notes	The enclosure can be accessed from brick paving leading to red porous surface. A brick/concrete edge, at paving level, separates courts from adjacent paving. The court can also be access via the passageway between Enclosures 1 & 2.
Accessibility photos

<p>NORTHERN ACCESS TO COURTS 2-3</p>

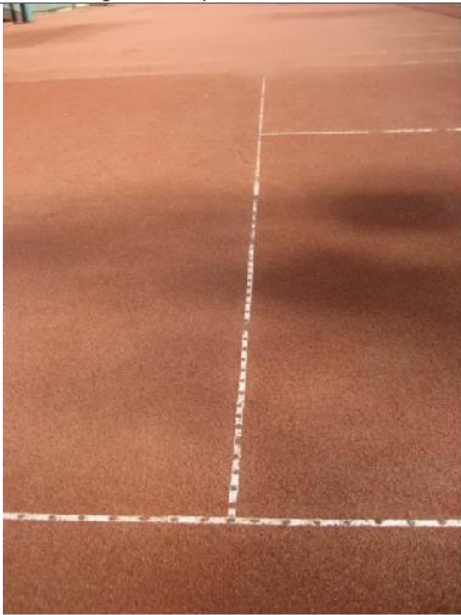
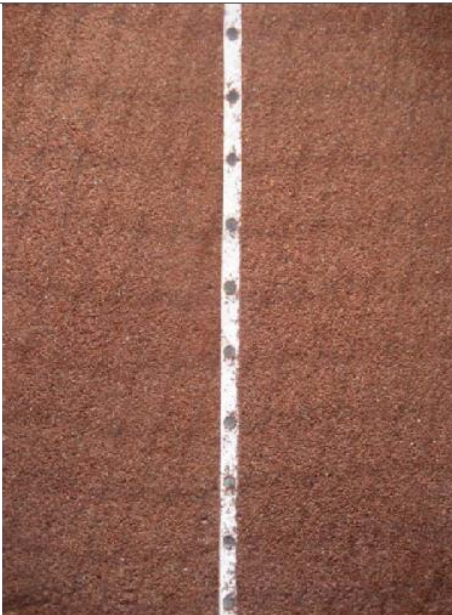
Linemarking – Court 3	
Line marking description	Tennis only lines
Linemarking rating	Good
Linemarking condition notes	The lines are standard for red porous courts and there are no obvious signs of breakages.
Linemarking condition photos

SERVICE LINE LINEMARKING COURT 3 SOUTH END	CENTRE SERVICE LINE COURT 3

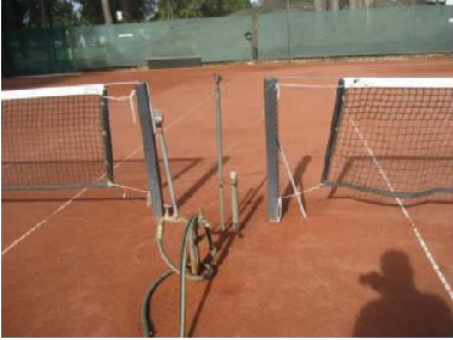
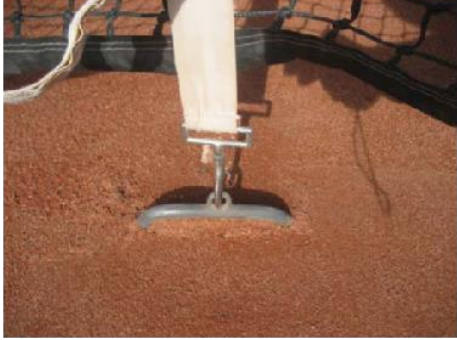
Net Posts – Court 3	
Net post type	Square powder coated steel installed directly into pavement.
Net post condition	Good, posts straight
Net post winders	Collapsible winders
Net condition	Good
Net structure	Net tethered to posts and centre strap fitted.
Net post life span	6-10 years
Net life span	6-10 years
Net/post notes	Posts and nets are generally in good condition.
Net/post photos

NET & POSTS WITH SPRINKLER & HOSE BIBS BETWEEN COURTS 2 & 3	CENTRE NET ATTACHMENT COURT 3

Lighting	Conduct a lighting lux level test
Safety issues – Court 3	
Are there any critical safety Issues	Yes. Relocate existing sprinklers (located next to net posts) either outside court runoffs or install in below ground valve box. Drinking fountains should be relocated outside court runoffs.
Enclosure recommendations

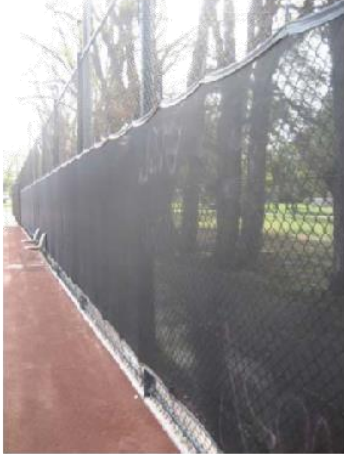
Fencing – Court 3	
Fence type	N end - black PVC chainwire, S end - galvanized chainwire.
Fence height	2.85m N end, 3.50m S end
Fence rails	Top & bottom rails NW end 2 panels only.
Fence attachments	2.20m high green site screen S end.
Fence condition rating	N end - good, S end - fair.
Fence lifespan	N end – 10+ years, S end 5-7 years
Fence notes	N end fencing is relatively new and should provide long maintenance free life. S end fencing is serviceable and is fit for purpose.
Fencing photos

<p>EAST SIDE FENCE COURT 3</p>

<p>NORTHERN GATE ACCESS TO COURT 3 NOTE LIP RESTRICTING EGRESS</p> </div> </div>	
Maintenance & Risk management – Court 3	
Court	Continue to maintain good court surface coverage.
Drainage	Investigate why GP's are holding water.
Infrastructure	Generally good. Southern boundary fence will need replacement in 5-7 years.

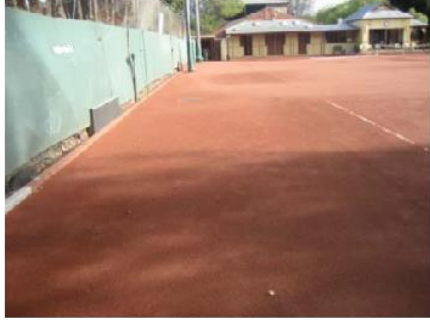
<p>SOUTH END FENCE COURT 3</p>

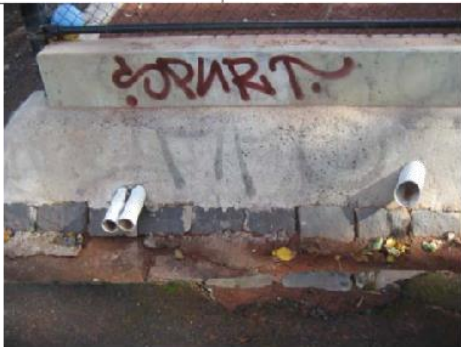
Drainage – Court 3	
Drainage infrastructure	Formed
What type of drainage is in place?	Grated pits with PVC drainage pipes.
Are drains, pits or other drainage infrastructure within runoff areas?	Yes, GP at S end.
Drainage condition	Fair. GP holding water
Drainage notes	GP is holding water. Cleanout SW pipe and pit to improve drainage. Check invert levels to determine if SW pipe fall is sufficient.
Drainage photos

OUTFALL TO COURTS 1-3 DRAINAGE INFRASTRUCTURE (EAST SIDE)

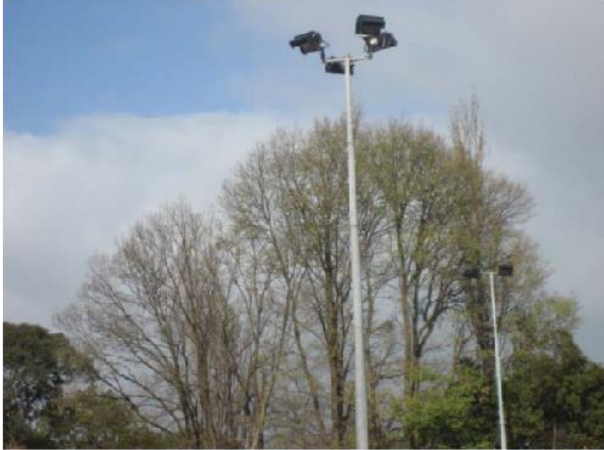
Lighting – Court 3	
Does the enclosure have lighting?	Yes
Total number of lit courts per enclosure	3
Lighting infrastructure type	Galvanized steel poles
Lighting infrastructure location	N & S corners and mid enclosure N & S ends.
Light fittings	Varies. 1 per SE cnr tower, 2 per S mid enclosure tower, 2 per NE cnr tower, 4 per N mid enclosure tower.
Lighting infrastructure design	Fair, position of mid enclosure lights unlikely to achieve required lux levels.
Lighting infrastructure rating	Fair
Lighting infrastructure life span	5+ years
Lighting notes	Light towers covered with padding to 2m. A lighting lux level test should be undertaken to determine if lux levels are appropriate.
Lighting photos

<p>MID ENCLOSURE 1 NORTH LIGHT TOWER</p>

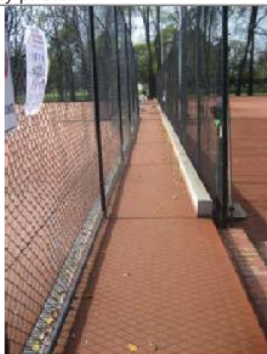
Accessibility – Court 3	
Court enclosure accessibility	Access to the enclosure via formed paths. No trip hazards observed. Ramped access no required.
Path material	Brick
Main gate dimensions	1050mm
Accessibility notes	The enclosure can be accessed from brick paving leading to red porous surface. A brick/concrete edge, at paving level, separates courts from adjacent paving. The court can also be access via the passageway between Enclosures 1 & 2.
Accessibility photos	
<div style="display: flex; justify-content: space-around;"> <div style="text-align: center;">

<p>NORTHERN ACCESS TO COURT 3</p> </div> <div style="text-align: center;">

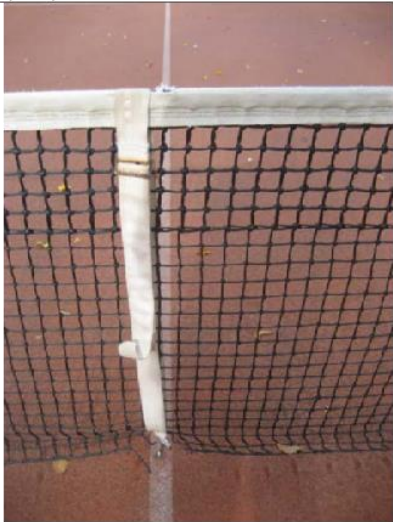
Net Posts – COURT 4	
Net post type	Square powder coated steel installed directly into pavement.
Net post condition	Good, posts straight
Net post winders	Collapsible winders
Net condition	Good
Net structure	Net tethered to posts and centre strap fitted.
Net post life span	10+ years
Net life span	10+ years
Net/post notes	Posts and nets are generally in good condition.
Net/post photos

<p>NET COURT 4</p>

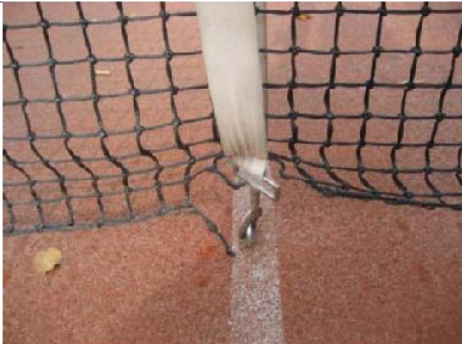
<p>CENTRE NET ATTACHMENT COURT 4</p>
