Ordinary Meeting of Council Agenda

**to be held on Tuesday 27 August 2019 at 7.00pm
Richmond Town Hall**

Attachment 1 - Alluvium Stage 1 Interim Report 20 August 2019

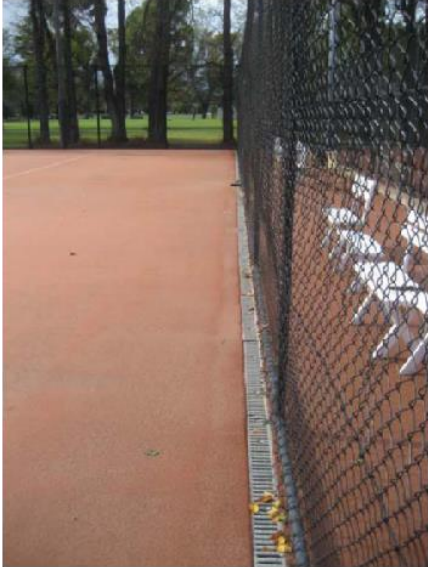
Drainage – COURT 4	
Drainage infrastructure	Formed
What type of drainage is in place?	Trench grate South end.
Are drains, pits or other drainage infrastructure within runoff areas?	No.
Drainage condition	Good
Drainage notes	Trench grating is intact, level and in good condition. Trench grating channel not holding water.
Drainage photos

TRENCH GRATE ALONG SOUTH END COURTS 4-6

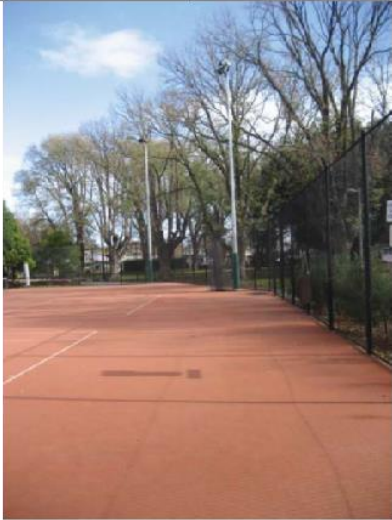
Lighting – COURT 4	
Does the enclosure have lighting?	Yes
Total number of lit courts per enclosure	3
Lighting infrastructure type	Powder coated steel poles
Lighting infrastructure location	N & S corners and mid enclosure N & S ends.
Light fittings	Varies, 2 per SW cnr tower, 4 per S mid enclosure tower, 1 per NW cnr tower, 2 per NE mid enclosure tower.
Lighting infrastructure design	Fair, position of mid enclosure S end lights unlikely to achieve required lux levels.
Lighting infrastructure rating	Good
Lighting infrastructure life span	10+ years
Lighting notes	Light towers covered with padding to 2m. A lighting lux level test should be undertaken to determine if lux levels are appropriate.
Lighting photos

LIGHTING NORTH END COURTS 4 & 5

<i>LIP RESTRICTING ACCESS TO COURT 4</i>	<i>ACCESS TO COURTS 4-6</i>
Maintenance & Risk management	
Court	Undertake regular maintenance of courts including mould/mildew removal.
Drainage	Nil
Infrastructure	Improve access to court by removing lip and providing ramp at court entrance.
Lighting	Conduct a lighting lux level test
Safety issues	
Are there any critical safety Issues	Yes. Relocate existing drinking fountains/hose bibs (located next to net posts) outside court runoffs.
Enclosure recommendations

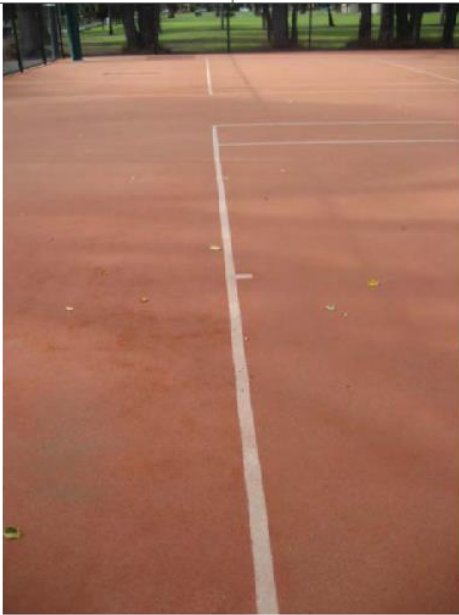
Linemarking – COURT 5	
Line marking description	Tennis only lines
Linemarking rating	Good
Linemarking condition notes	The lines are standard for synthetic courts and are clearly visible with sharp edges.
Linemarking condition photos

<i>NORTH END LINEMARKING LOOKING EAST</i>

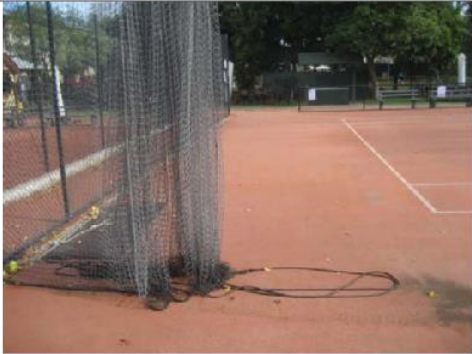
Fencing – COURT 5	
Fence type	Black PVC chainwire, netting to E side.
Fence height	3.60m N end, 3.00m S end, 1.0m W side, 2.5m E side.
Fence rails	Top & bottom rails.
Fence attachments	Nil.
Fence condition rating	Good.
Fence lifespan	10+ years
Fence notes	Fencing is relatively new and should provide long maintenance free life for 10+ years.
Fencing photos	
  <p>SOUTH END FENCING COURT 5</p>

<p>NETTING BETWEEN COURTS 4 & 5</p>

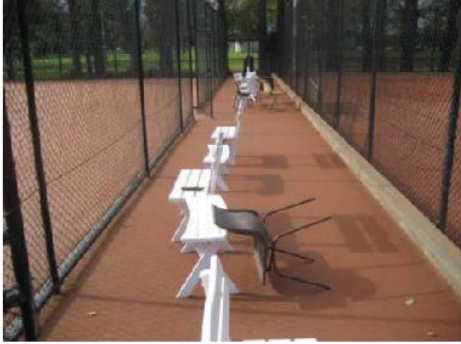
Accessibility – COURT 5	
Court enclosure accessibility	Access to the enclosure via formed paths. No trip hazards observed. Ramped access not required.
Path material	Brick/synthetic grass.
Main gate dimensions	1450mm
Accessibility notes	The enclosure can be accessed from brick paving leading to synthetic grass surface passageway. Maintain clear passageway for disabled access by fixing furniture in place.
Accessibility photos

<p>ACCESS TO COURTS 4-6</p>	
  <p>ACCESS GATE TO COURTS 4-6</p>	
Maintenance & Risk management	
Court	Continue to maintain good court surface coverage.
Drainage	Investigate why GP's are holding water.
Infrastructure	
Lighting	Conduct a lighting lux level test
Safety issues	
Are there any critical safety Issues	Yes. Relocate existing drinking fountains/hose bibs (located next to net posts) outside court runoffs.
Enclosure recommendations

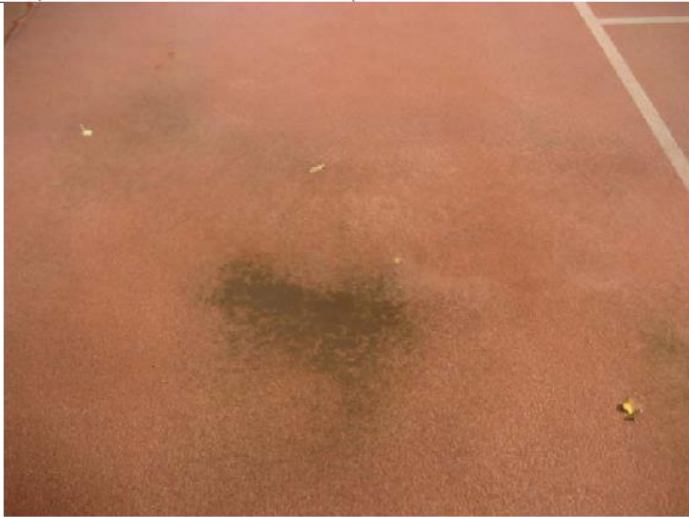
Enclosure 2	
Court 6	
Surface Condition	
Surface type	Synthetic grass.
Surface condition rating	Fair. Mildew/mould spotting in parts of the court.
Surface life span	10+ years
Court condition notes	The court is in fair condition. Regular maintenance of courts recommended including mould/mildew removal. There are no apparent worn areas.
Court condition photos

COURT 6 SOUTH END

ACCESS RESTRICTIONS TO COURTS 4 - 6 DUE TO SEATING	
Maintenance & Risk management – COURT 6	
Court	Undertake regular maintenance of courts including mould/mildew removal.
Drainage	Nil
Infrastructure	Improve access to court by maintaining a clear passageway to the access gate.
Lighting	Conduct a lighting lux level test.
Safety issues – COURT 6	
Are there any critical safety Issues	Yes. Relocate existing drinking fountains/hose bibs (located next to net posts) outside court runoffs.

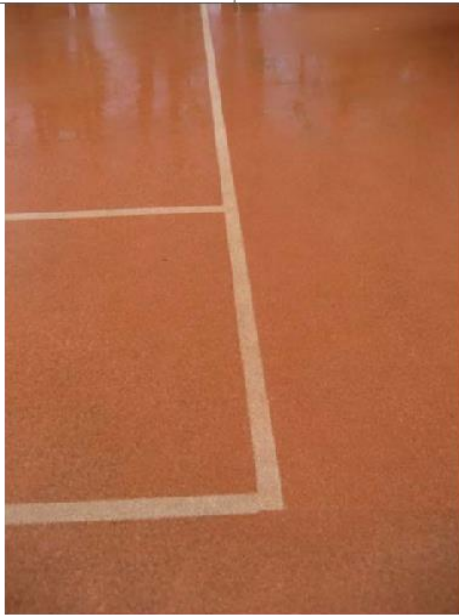
Linemarking – COURT 6	
Line marking description	Tennis only lines
Linemarking rating	Good
Linemarking condition notes	The lines are standard for synthetic courts and are clearly visible with sharp edges.
Linemarking condition photos

<p style="text-align: center;">BASELINE COURT 6</p>

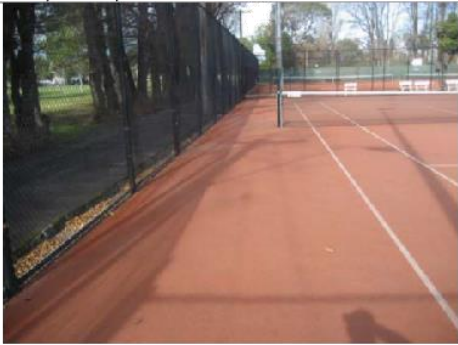
Court Compliance – COURT 6	
Is the court runoff compliant	North: 5.65m to fence. South: 5.60m to fence. East: 3.13m to fence. West: 3.75m to Court 5.
Compliance notes	The court runoffs meet the minimum requirements for Club/recreation use.
Could the court be made compliant	Not applicable.
Is the court to the standard dimensions	Yes
Court orientation	North south
Are netball goal posts outside tennis court run of areas?	Not applicable.
Are lockable post hole covers fitted and safe	No
Compliance photos

<p>EAST SIDE COURT 6 RUNOFF</p>

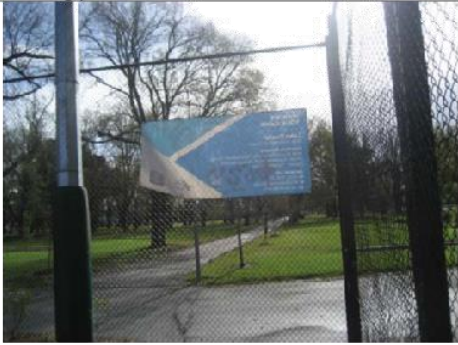
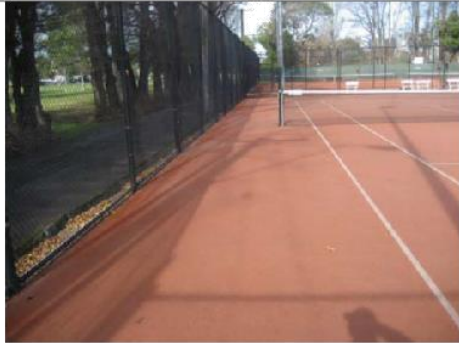
Fencing – COURT 6	
Fence type	Black PVC chainwire.
Fence height	3.60m N end, 3.00m S end, 3.6m E side.
Fence rails	Top & bottom rails NW end
Fence attachments	2.20m high black site screen E side and small advertising screen to NE corner..
Fence condition rating	Good.
Fence lifespan	10+ years
Fence notes	Fencing is relatively new and should provide long maintenance free life for 10+ years.
Fencing photos

FENCING NE CORNER COURT 6	FENCING EAST SIDE COURT 6

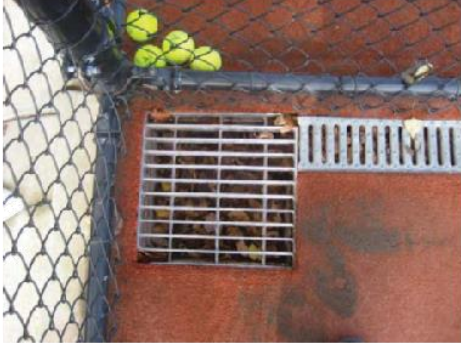
Drainage – COURT 6	
Drainage infrastructure	Formed
What type of drainage is in place?	Trench grate South end
Are drains, pits or other drainage infrastructure within runoff areas?	No
Drainage condition	Good
Drainage notes	Trench grating is intact, level and in good condition. Trench grating channel not holding water.
Drainage photos

<p>GRADED DRAINAGE PIT & TRENCH GRATE SE CORNER COURT 6</p>

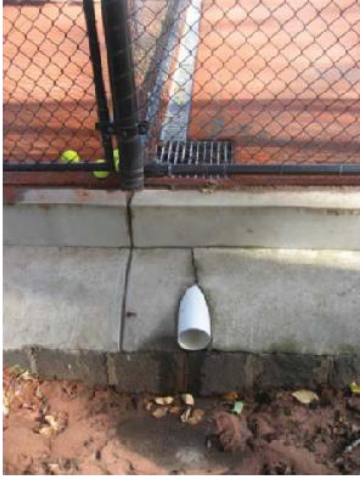
<p>COURTS 4-6 DRAINAGE OUTFALL SE CORNER COURT 6</p>

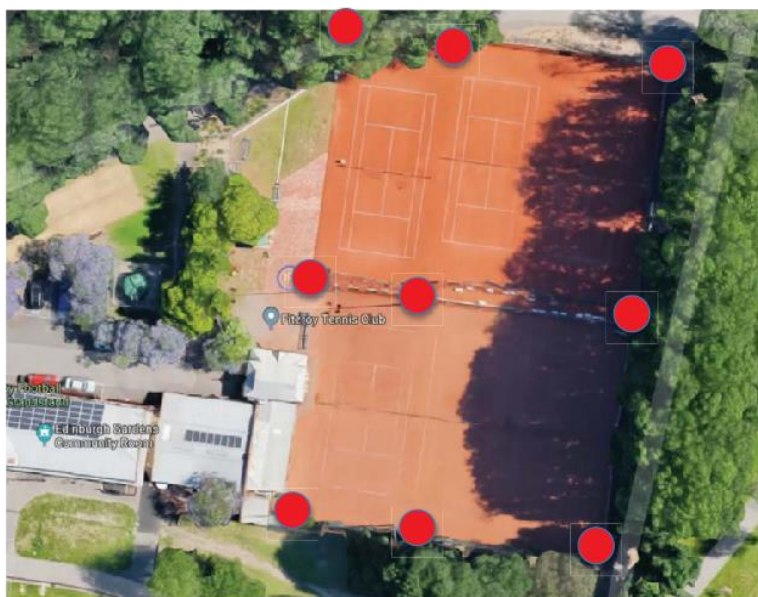
Endura Light was contracted to assess the current light level at the tennis Courts in Fitzroy's Edinburgh Gardens as a preliminary step toward planning a lighting upgrade for the site. Endura Light visited the site and conducted light level assessments from 5.45pm on 1st July 2019.

Lighting for the courts is provided from 9 poles with positions as marked by the red dots below.
