APPENDIX 3

Appraisal Data

The research data presented below features information from community appraisal of disability access at railway stations in the City of Yarra. Records about each station are presented in individual tables with description of the current level of compliance, suggested improvements and other commentaries and images, which are referenced against the eight accessibility categories (TGSi, shelter at WAP, ramp gradient, ramp width, WAP, handrails, signs, accessible parking bays) and against potential hazards. In some instances an additional row is added as 'other improvements', when more opportunities for better accessibility, beyond the listed categories, has been observed. For terminology and abbreviations please refer to *Section 2 Key Findings* and to *Appendix 2 Glossary* in the main report (pp. 6 and 16).

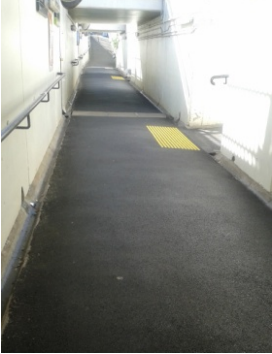
Ramp Gradient	Ramp gradient 0/3	<ul style="list-style-type: none"> Non-compliant access ramps gradient 3/3 P1 & P2 = 1:8 P3 & P4 = 1:8 Other 1:8 	
Ramp Width	Ramp width compliant 3/3		
WAP	WAP compliant 4/4 P 1 = 4m P 2 = 4.1m P3 & P4 = 10.6 combined platform width		
Handrails	Handrails 3/3 Compliant Hand Rail in Tunnel	<ul style="list-style-type: none"> Some parts of the tunnel do not have handrails. 	Handrails missing.

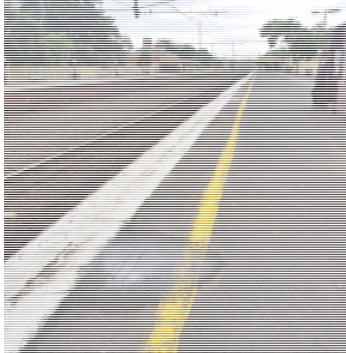
TABLE 2. CLIFTON HILL STATION APPRAISAL RECORD			
Category	Compliant	Needs Improvement	Image/Commentary
TGSI	TGSI 0/2 on Platforms' edge TGSI 0/2 at entrance TGSI ramps 0/4	<ul style="list-style-type: none"> Clifton Hill is a transfer point railway station, frequently used by many. Install TGSI on both Platform 1 & 2, and at the station entrances. 	<p>Platforms 1 and 2 require installation of TGSI along the platforms' edge.</p>

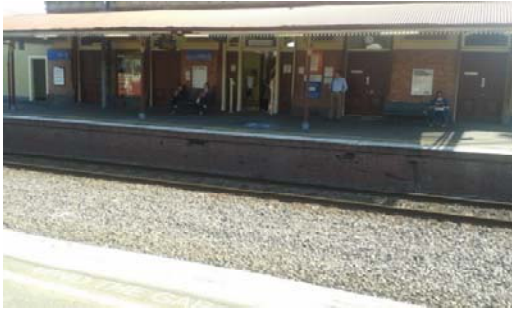
<p>TGSI need to be installed at Platform 2 railway station entrance both on footpath and on platform.</p>

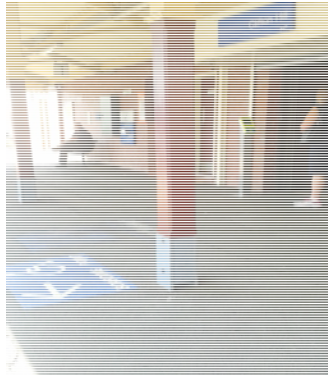
TABLE 2. CLIFTON HILL STATION APPRAISAL RECORD			
Category	Compliant	Needs Improvement	Image/Commentary
			<p>TGSI need to be installed at Platform 1 railway station entrance both on footpath and on platform entrance.</p>

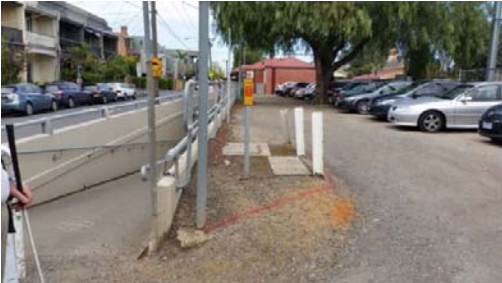
Ramp Gradient	0 out of 4 ramps	<ul style="list-style-type: none"> • Non-compliant access ramps gradient 4/4. Examples: P1 = 1:10 (and 1:12 at some points) P2 = 1:9 • On northern side of Clifton Hill Station, P1 & P2 have extra space where the ramps can be extended to be more accessible. 	<p>This is the northern side of P1.</p>

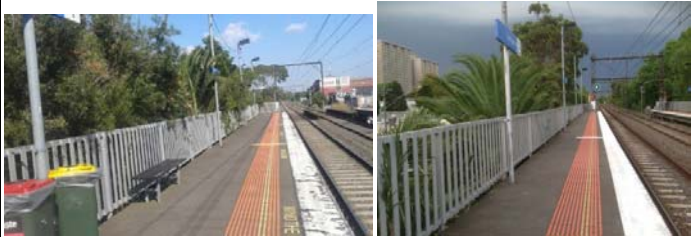
Shelter at WAP	Compliant 0/2	<ul style="list-style-type: none"> Requires shelter at WAP on P1 & P2 	<p>Having a Shelter at WAP means that commuters who need assistance boarding the train are sheltered from the sun, rain and wind. It also means less time for driver to wait for commuter to board train. Photo indicates no shelter on P1 and P2 at Collingwood Station.</p>

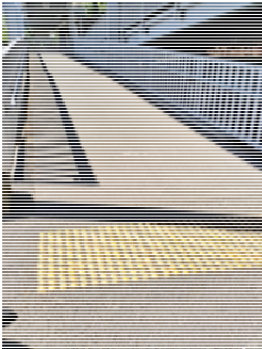
TABLE 3. COLLINGWOOD STATION APPRAISAL RECORD			
Category	Compliant	Needs Improvement	Image/Commentary
			Platform 1 Platform 2
Ramp Gradient	Compliant 0/2	<ul style="list-style-type: none"> • Non-compliant access ramps 2/2 • P1 = 1 : 10 and 1:12 at other points. • P2 = 1 : 10 	<p>Very steep ramps make access difficult for manual wheelchairs, people on crutches or walking aids and people with shopping buggies. They are steep and quite high resulting in a lengthy ramp. Ramps need to be a maximum grade of 1:6 or less. The installation of an elevator is also an option to consider (see over page).</p>

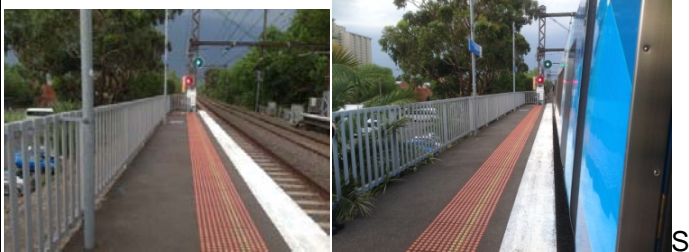
Ramp Width	Compliant 2/2 P1 & P2 = 2.2		
WAP	Compliant 1/2 P1 = 3.2	<ul style="list-style-type: none"> • Non-compliant 1/2 • P2 = 2.5 	Platform 2 is too narrow.

<p>Please refer to Case Study (Appendix 4 Community Appraisal of Disability Access Report) describing harm endured by a commuter when using electric powered wheelchair at this very point.</p>
Handrails	Handrails 2/2		
Signs	WAP sign on platform 2/2 WAP sign on entrance 2/2	<ul style="list-style-type: none"> Larger station signs would be advantageous. 	<p>Photo shows station name signs which can be larger text and illuminated for night reading.</p>

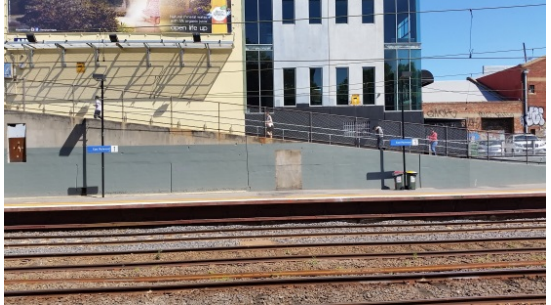
TABLE 4. EAST RICHMOND STATION APPRAISAL RECORD			
Category	Compliant	Needs Improvement	Image/Commentary
Shelter at WAP	Shelter 1/2 P2 has at shelter	<ul style="list-style-type: none"> • Non-compliant 1/2 • P 1 requires shelter 	<p>Photo of P1 demonstrates lack of shelter.</p>

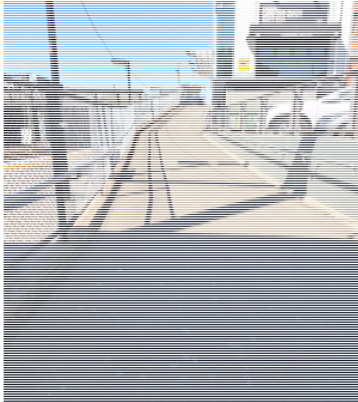
Ramp Gradient	Compliant 0/2	<ul style="list-style-type: none"> • Non-compliant access ramps 2/2 P1 = 1:8 P2 = 1:8 and 1:15 at other points of ramp. • Ramps need to be a maximum grade of 1:6 or less. The installation of an elevator is also an option to consider. There is a significant issue for people walking up this ramp, particularly if you could not walk far,, you had to carry your shopping, or push a pram up on a daily basis 	<p>This photo indicates how steep and long the ramp is on P1. Steep ramps make access difficult for manual wheelchairs, people on crutches or walking aids and people with shopping buggies. They are also quite high resulting in a lengthy ramp.</p>

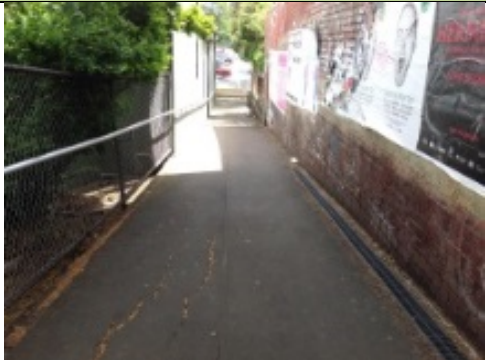
Ramp Width	Compliant 2/2 P1 = 2.4 P2 = 2.2	<ul style="list-style-type: none"> • Non-compliant 0/2 	
WAP	Compliant 2/2 P 1 = 390mm or 3.9 metre P 2 = 460 mm or 4.6 metre	<ul style="list-style-type: none"> • Non-compliant 0/2 	
Handrails	Handrails compliant at 1/2 platforms. P1 has a handrail	<ul style="list-style-type: none"> • Non-compliant 1/2 • Handrail required on P2 ramp on side of the brick wall. 	Handrail missing. Add a hand rail on right hand wall of access ramp/pathway to railway station.

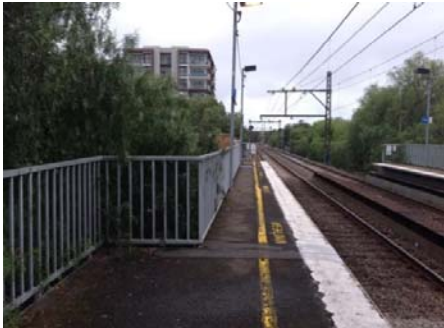
TABLE 5. NORTH RICHMOND STATION APPRAISAL RECORD			
Category	Compliant	Needs Improvement	Image/Commentary
TGSI	TGSI on Platform 0/2 TGSI on entrance 0/2 TGSI on Ramps 0/4 TGSI on Stairs N/A	<ul style="list-style-type: none"> TGSI is required on P1 & P2 at both platforms, ramps and at entrance. 	<p>Photo shows that P1 requires TGSI along platform.</p>

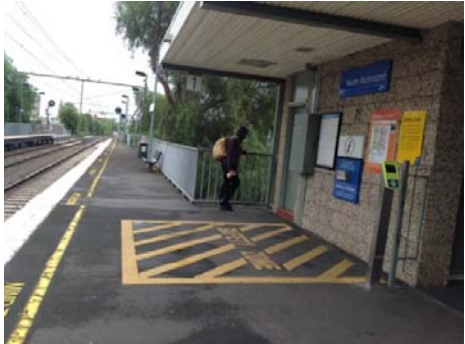
<p>This photo indicates absence of TGSI on P2 and at main entrance.</p>

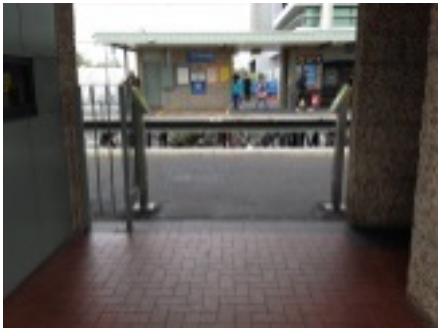
<p>This photo shows that P2 requires TGSI along platform and at entrance of railway station.</p>

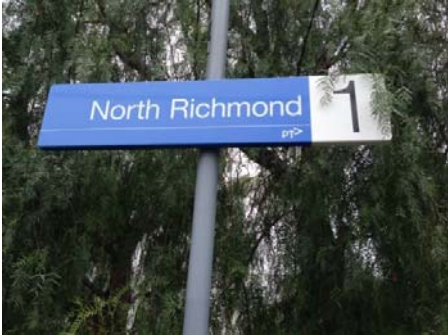
TABLE 5. NORTH RICHMOND STATION APPRAISAL RECORD			
Category	Compliant	Needs Improvement	Image/Commentary
			https://www.dropbox.com/sh/c4n1396z1uyhgaz/AAAnASQZ4RF11EPP-HqX6u33a?dl=0
Handrails	Handrails 4/4. Both P1 & 2 have handrails		
Signs	WAP Sign on Platform 2/2 WAP sign on Entrance 2/2	<ul style="list-style-type: none"> Larger font on station name sign is required. 	<p>Writing on North Richmond sign could be larger in print and bolder.</p>

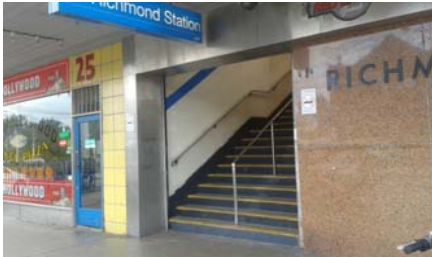
TABLE 6. RICHMOND STATION APPRAISAL RECORD			
Category	Compliant	Needs Improvement	Image/Commentary
		<p>high colour contrast TGSi</p> <ul style="list-style-type: none"> Stewart Street entrance ticket validation machine entrance from ramp and stairs - install TGSi. Install TGSi at Customer Service desk and directional TGSi along entrance to platforms. Install TGSi at Ticket Validation point at main entrance near customer service area. Install directional way finder TGSi from subway entrance, corridor to platforms. 	<p>Swan Street stairs lack of TGSi at bottom of stairs.</p>

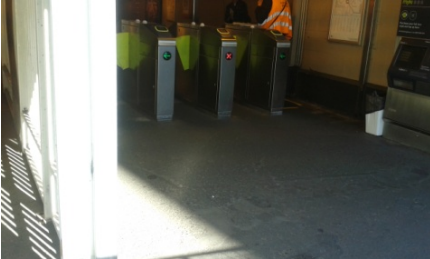
TABLE 6. RICHMOND STATION APPRAISAL RECORD			
Category	Compliant	Needs Improvement	Image/Commentary
			<p>Stewart Street entrance shows lack of TGSI at Ticket Validation machine.</p>

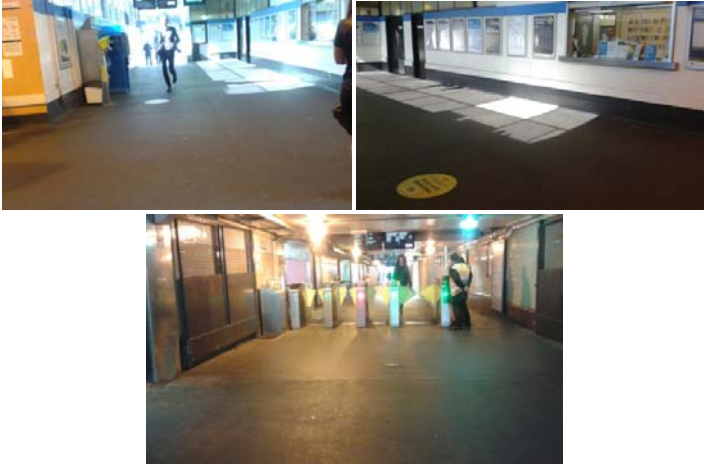
<p>The photos below show the lack of TGSI through the main area of Richmond station including amenities, Customer Service desk and pathway to platforms.</p>

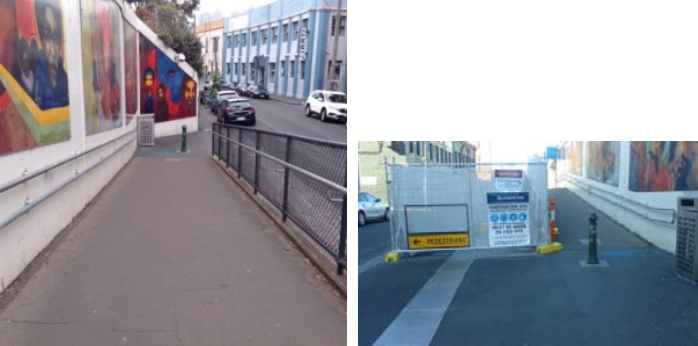
TABLE 6. RICHMOND STATION APPRAISAL RECORD			
Category	Compliant	Needs Improvement	Image/Commentary
Shelter at WAP	Shelter 10/10		
Ramp Gradient (external ramps)		<ul style="list-style-type: none"> • Non-compliant station access ramps 2/2 • Ramp gradient is 1:9 • Compliance could be feasible at Stewart and Swan Streets with extension. • Explore alternative to external ramps 	<p>External ramp too steep. Ramp has room to be extended for a better more accessible gradient.</p>

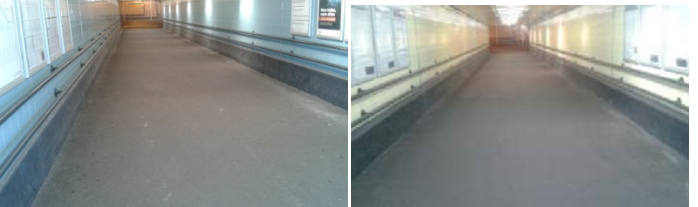
Ramp Gradient (internal ramps)	Both sides of the ramp walls leading from main area of station to individual platforms are different colours. This is a great example of colour coding.	<ul style="list-style-type: none"> • Non-compliant 10/10 • P 1 to P10 = ramp gradient 1:9 	<p>Photos show colour coding of ramps. Very effective.</p>

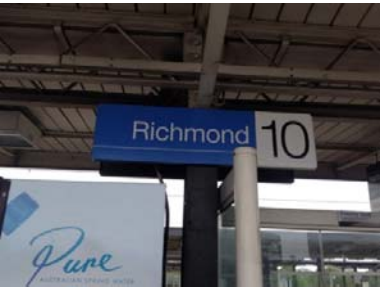
Signs	WAP signs platform edge 10/10 Trains heading into City leave from platforms 1, 3, 5, 7 & 8. WAP signs at entrance N/A due to layout of station. WAP entrance sign N/A	<ul style="list-style-type: none"> The written word on the Station name signs could be larger print and bold. 	<p>There is room on name sign to enlarge font and in bold letters. This would make sign easier to see for people with vision loss, elderly people and general public as well. Signs would be more visible if they were illuminated during the evenings.</p>

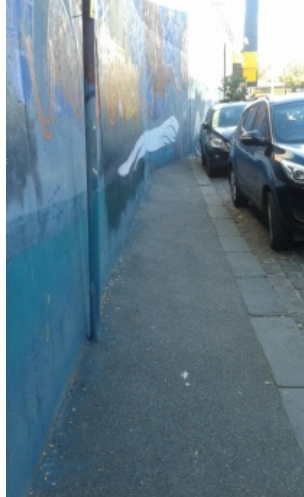
TABLE 6. RICHMOND STATION APPRAISAL RECORD			
Category	Compliant	Needs Improvement	Image/Commentary
Accessible Parking Bays	There are currently no accessible parking bays	<ul style="list-style-type: none"> Recommend two accessible parking bays installed near 25 Swan St Richmond. 	YCC to install 2 accessible parking bays near 25 Swan street Richmond.
Hazard		<ul style="list-style-type: none"> Footpath on Stewart Street stops and leads onto road. Hazard for people with little or no vision. 	<p>Footpath leads onto Stewart street road. Remove barrier wall and clear pathway.</p>

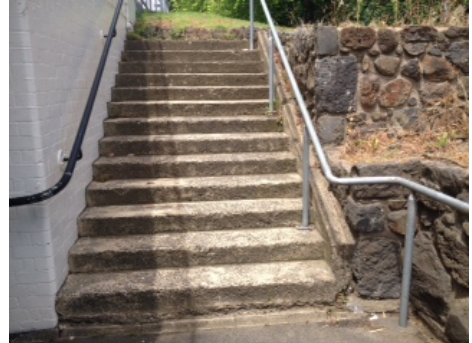
TABLE 7. RUSHALL STATION APPRAISAL RECORD			
Category	Compliant	Needs Improvement	Image/Commentary
TGSI	TGSI compliance 1/2 P2, TGSI on platform 2/2 P2 TGSI on entrance 2/2 TGSI on ramps 0/4 TGSI on stairs 0/1	<ul style="list-style-type: none"> • TGSI is required on P2 at top and bottom of stairs. • TGSI required at top and bottom of ramps. 	<p>Stairs on P2 side of station requires TGSI at top and bottom of stairs.</p>

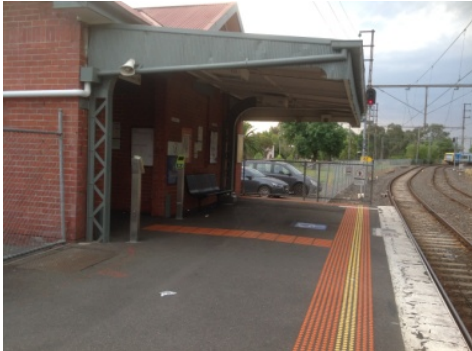
Shelter at WAP	Shelter 1/2 Shelter at WAP on P2	<ul style="list-style-type: none"> • 1/2 Shelter non-compliant • Shelter requires at WAP on P1. 	<p>Great shelter at WAP on P2.</p>

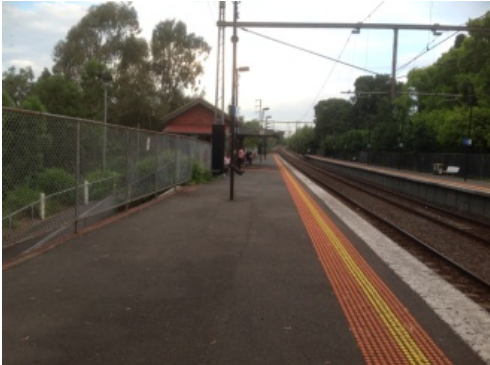
TABLE 7. RUSHALL STATION APPRAISAL RECORD			
Category	Compliant	Needs Improvement	Image/Commentary
			<p>Photo of P1 requires shelter at Wheelchair Access Point of platform to protect commuters from the weather.</p>

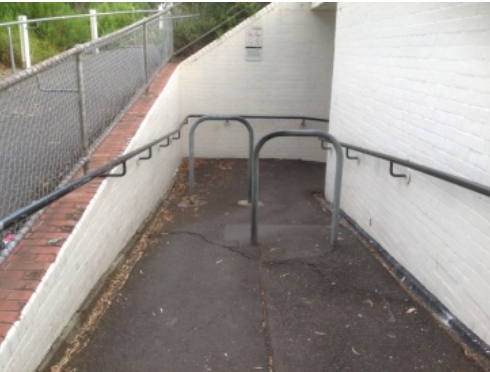
Ramp Gradient	External railway station access ramps 1/4 P2 – 1:6	<ul style="list-style-type: none"> • 2/3 non-compliant access ramps on P 1 & P2 • P1 South ramp is 1:8, and North ramp is 1:9 	<p>Ramp gradient too steep.</p>

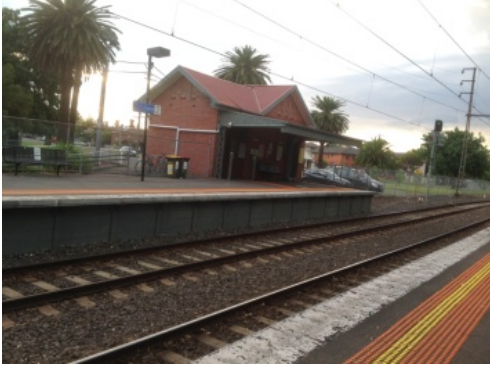
Ramp Width	Ramp width compliant 3/3 Flat in tunnel		
WAP	Compliant 2/2 P 1 = 3.2 P 2 = 4.9	<ul style="list-style-type: none"> 0/2 	
Handrails	Handrails 3 /3 compliant		
Signs	WAP Sign on platform 2/2 WAP sign on entrance 1/2	<ul style="list-style-type: none"> WAP sign at entrance required Sign- larger station name signs 	<p>There is room on current name sign to enlarge font and in bold letters. This would make your sign easier to see for people with vision loss, elderly people and general public as well.</p> <p>Signs would be more visible if they were illuminated during the evenings (see over page).</p>

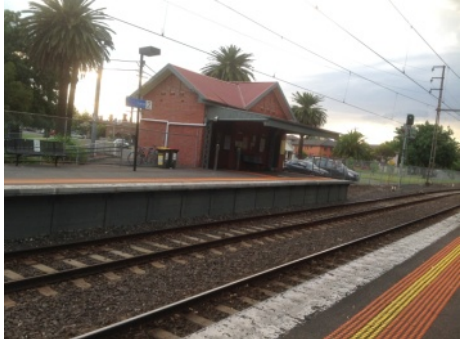
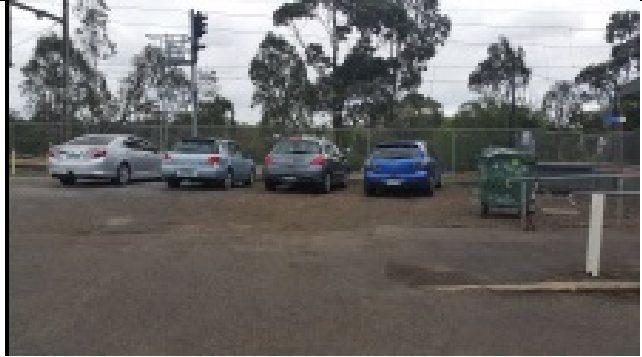
Accessible Parking Bays	There is currently no accessible parking bay.	<ul style="list-style-type: none"> • 4 disability access parking bays on the site of P2 could be installed. • 2 are PTV ownership. 	<p>The photos below and over page of P2 area currently gravel could be appropriate for the implementation of two accessible parking bays. Accessible parking bays are located very close to P2 entrance which has an accessible ramp.</p>

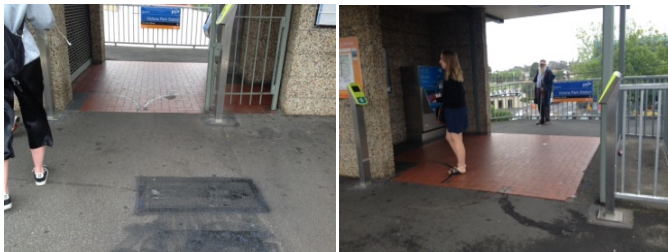
<p>Platform 1 Platform 1 Platform 2</p> <p>Platform 1 and P 2 requires the installation of directional TGSI at Station entrance</p>

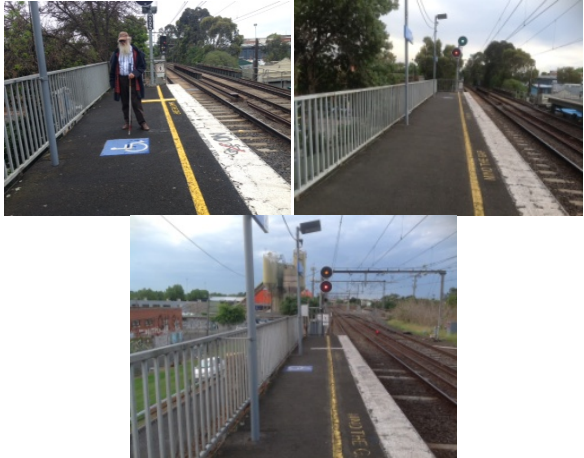
<p>Platform 1 Platform 2</p>
Shelter at WAP	0/2 shelter	<ul style="list-style-type: none"> Shelters requires at P1 & P2 	<p>The photos overpage show absence of shelter on P1 and 2. Recommen to instatll shelter.</p>

TABLE 8. VICTORIA PARK STATION APPRAISAL RECORD			
Category	Compliant	Needs Improvement	Image/Commentary
			<p>Having a shelter at WAP means that commuters who need assistance boarding the train are sheltered from the sun, rain and wind. Having a shelter at WAP also means less time for driver to wait for commuter to board train.</p>

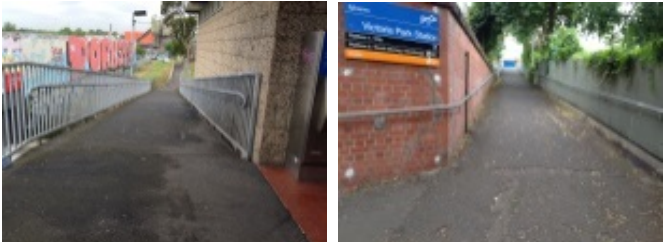
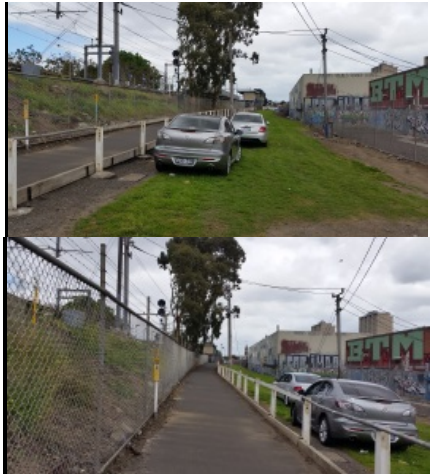
Ramp Gradient	Compliance 0/4	<ul style="list-style-type: none"> Non-compliant access ramps 4/4 P 1 = 1:12 P2 = 1:12 	<p>Both P1 and P2 ramps (4 of them) are too steep to navigate for people in wheelchairs, scooter and people with mobility difficulties</p>

TABLE 8. VICTORIA PARK STATION APPRAISAL RECORD			
Category	Compliant	Needs Improvement	Image/Commentary
			<p>The two photos below show both sides of Victoria Park Railway Station. It appears that ramps could be extended to achieve a better ramp gradient.</p>

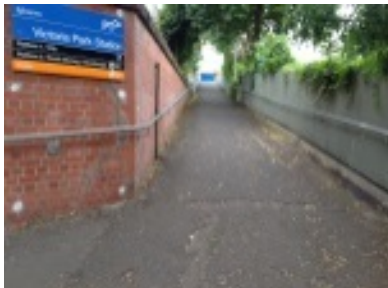
Ramp Width	Ramp width compliant 4/4 P1 = 3m P2 = 3m		<p>The widths of these ramps are 3 metres wide, compliant and ample space.</p>

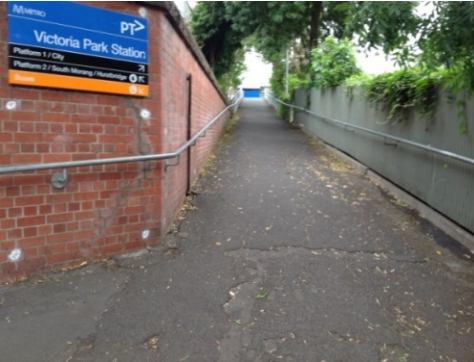
Handrails	Handrails 4/4 Handrails are present on all 4 ramps to station. They are a great help.		<p>The handrails wrap around the path. Excellent installation of handrails.</p>

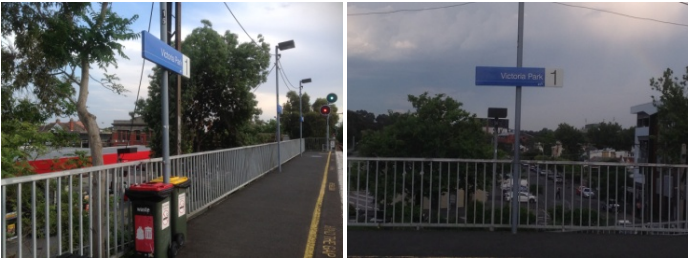
TABLE 8. VICTORIA PARK STATION APPRAISAL RECORD			
Category	Compliant	Needs Improvement	Image/Commentary
Signs	WAP signs on Platform 2/2 WAP sign on entrance 2/2	<ul style="list-style-type: none"> Signs – larger station name signs 	<p>Train station name signs could be larger text and illuminated for night time visibility.</p>

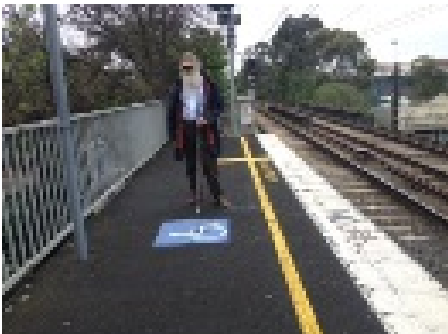
Accessible Parking Bays	There are currently no accessible parking bays.	<ul style="list-style-type: none"> Recommended 6 parking bays. There is ample space for parking and can accommodate many accessible parking bays. 	<p>City of Yarra and PTV (ownership). This station has plenty of space and is used by two major routes. It could be a good point to drive to and catch train from.</p>
Hazard		<ul style="list-style-type: none"> Pole near WAP on P1 is too close, which make it difficult to navigate a wheelchair. 	<p>Platform 1 has WAP point which is located very close to a pole allowing even less room to navigate a mobility aid. Recommend a wider platform and blue WAP sign to be located further away from pole.</p>

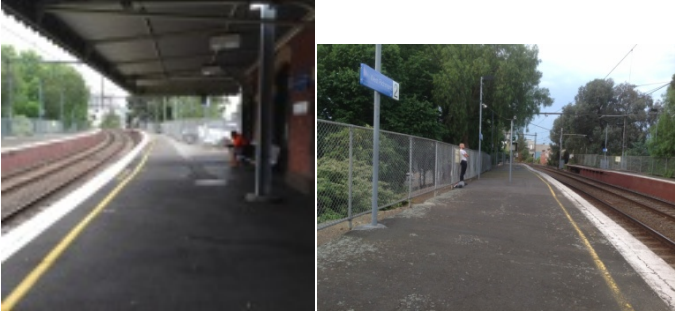
TABLE 9. WEST RICHMOND STATION APPRAISAL RECORD			
Category	Compliant	Needs Improvement	Image/Commentary
TGSI	TGSI on platform 0/2 TGSI on Entrance 0/2 TGSI on Ramps 0/1	<ul style="list-style-type: none"> TGSI required on P1 & 2 platform edge 0/2 Requires TGSI o P1 & 2 at entrance 0/2 	<p>Platform 1 & 2 requires the installation of TGSI along edge of platform.</p>

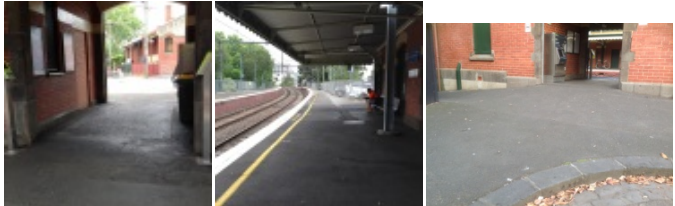
<p style="text-align: center;">Platform 1 Platform 2</p> <p>Platform1 & 2 requires the installation of TGSI at Station entrance.</p>

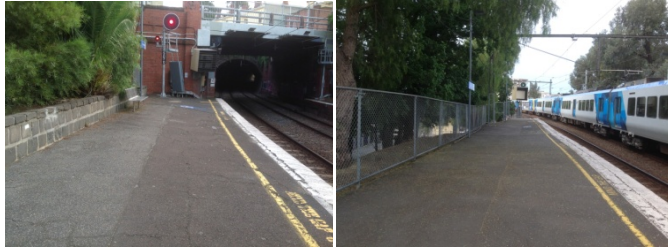
<p style="text-align: center;">Platform 1 Platform 1 Platform 2</p>
Shelter at WAP	Compliance 0/2	<ul style="list-style-type: none"> Shelter at WAP required on P1 & P2 	<p>Platform 1 & 2 require the installation of Shelter at WAP</p>

TABLE 9. WEST RICHMOND STATION APPRAISAL RECORD			
Category	Compliant	Needs Improvement	Image/Commentary
			<p>point. Having a Shelter at WAP means that commuters who need assistance boarding the train are sheltered from the sun, rain and wind. Having a shelter at WAP also means less time for driver to wait for commuter to board train.</p>

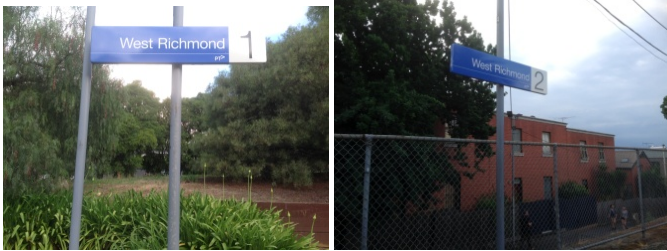
<p style="text-align: center;">Platform 1 Platform 2</p>
Ramp Gradient	Ramp gradient 0/1 External ramps P1 n/a	<ul style="list-style-type: none"> • P1 = N/A • P2 = 1 in 12 and also has a footpath 	<p>P1 has general footpath which leads to train station.</p> <p>P2 footpath access to railway station has too steep gradient.</p>
Ramp Width	Compliant 1/1 P2 = 2.2m		
WAP	Compliant 2/2 P 1 = 4.5 P 2 = 4.5		Both platforms have an excellent WAP.
Rails	Handrails 1/1 (i.e. on P2)		Handrail only required on P2 side of station and it already exists.
Signs	WAP signs on platform 2/2 WAP signs on entrance 2/2	<ul style="list-style-type: none"> • Sign- larger station name sign 	There is room on current name sign to enlarge text size and in bold letters. This would make your sign easier to see for people with vision impairment, elderly people and general public as well.

TABLE 9. WEST RICHMOND STATION APPRAISAL RECORD			
Category	Compliant	Needs Improvement	Image/Commentary
			<p>Signs would be more visible if they were illuminated during the evenings.</p>

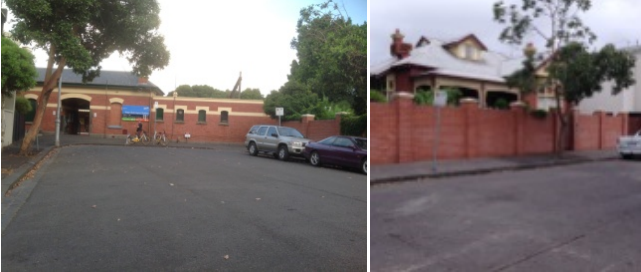
Accessible Parking Bays	There are currently no accessible parking bays	<ul style="list-style-type: none"> Two additional bays recommended: P2 Jika place – YCC’s ownership, and P1 & PTV ownership 	<p>On P2 side of station in Jika place there is a possibility to place an accessible parking bay in the street.</p>

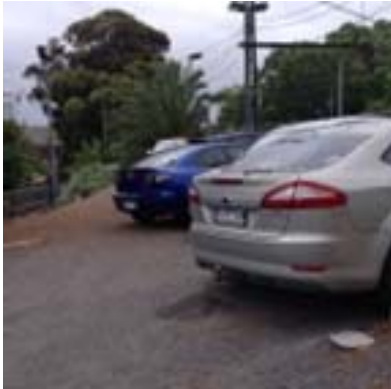
<p>It would be advantageous to place an accessible parking bay on P1 West Richmond..</p>

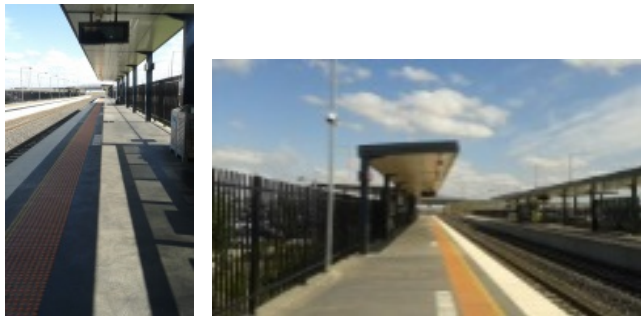
TABLE 10. TARNEIT STATION APPRAISAL RECORD			
Category	Compliant	Needs Improvement	Image/Commentary
TGSI	TGSI Compliant 2/2 TGSI also in front of lift, stairs, ramps and on platforms.	<ul style="list-style-type: none"> • GSI are different colours, it would be better to have consistency. • Directional TGSI in front of elevator requires is required linking to the other areas of train station. • The pathway through the main entrance at reception to platform requires TGSI to maintain a continuous pathway. Install TGSI on other side of double doors, directional TGSI externally from door to platform and internally across main entrance to double doors. The installation of TGSI in reception area may also be useful, • Install directional TGSI pathway from P 1 & P2 towards pathway to car park and bus stops, 	<p>TGSI on P 1 & P2 has great colour contrast along the platform edge.</p>

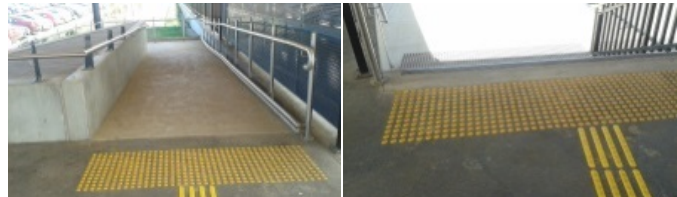
<p>TGSI have been placed at top and bottom of stairs and ramps indicating start and finish points. The photos also show the yellow directional TGSI which guides the way to platform.</p>

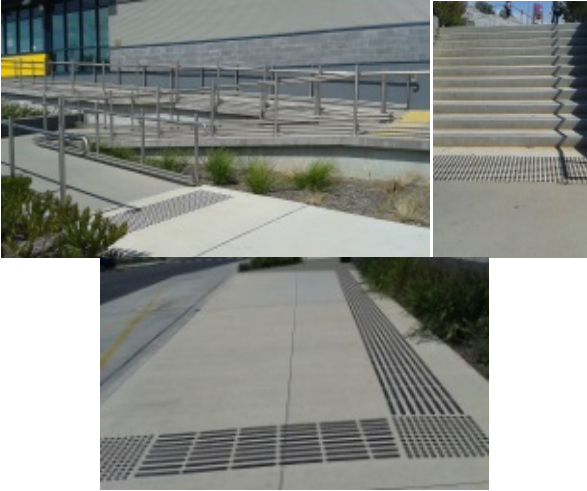
Category	Compliant	Needs Improvement	Image/Commentary
			<p>The photos below indicate the TGSi at top, bottom and middle landing of ramp and stairs. Some are yellow and some grey. Both grey and yellow TGSi have been used here. It is best to have continuity of colour.</p> <p>These photos also depict the vast difference in colour contrast when using yellow or grey TGSi. The yellow TGSi is more visible. The color difference is shown in the first set of photos (previous page).</p>

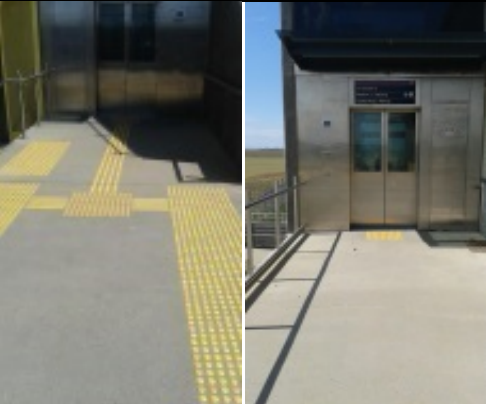
<p>The first photo overpage (left) has Yellow TGSi in front of the elevator and directional TGSi leading to platform. The second photo show the lack of TGSi in front of elevator and the directional TGSi are missing making it difficult to navigate to platform.</p>

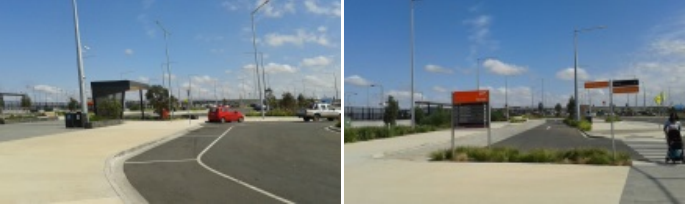
Category	Compliant	Needs Improvement	Image/Commentary
			<p>TGSI are absent at pick up points.</p>

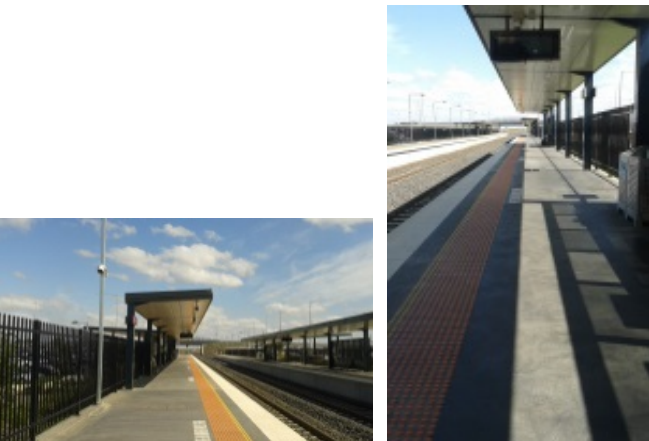
<p>Shelter at WAP</p>	<p>Shelter at WAP 2/2 Both, P 1 & P2 have shelter area on platform. Fully enclosed indoor waiting room as well.</p>		<p>Both Platform 1 and 2 have ample shelter from sun and rain at wheelchair access boarding points.</p>

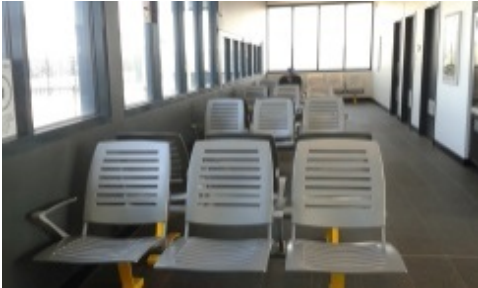
<p>The fully indoor waiting room is great protection from heat, cold weather and wind (see overpage).</p>

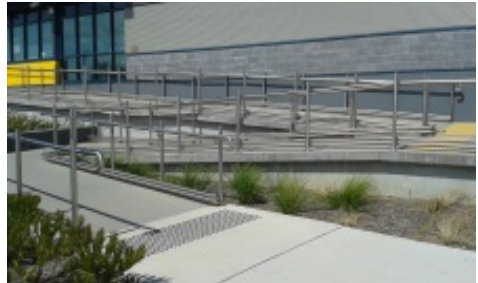
Ramp Gradient	External ramps Compliant 2/2 P 1 = 1 :12 P 2 = 1 :12

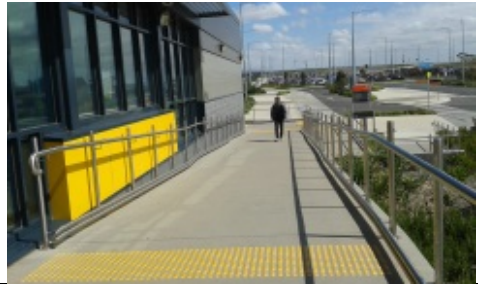
Ramp Width	Compliant 2/2 P 1 = 4 m P 2 = 4 m

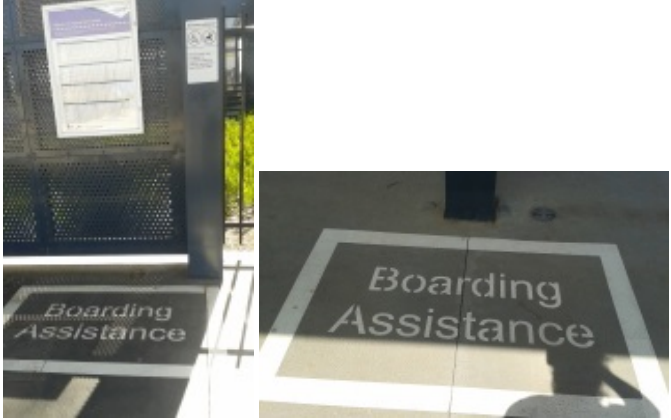
Category	Compliant	Needs Improvement	Image/Commentary
WAP	Compliant 2/2 WAP is replaced by Boarding Assistance sign on both platforms.	<ul style="list-style-type: none"> The Boarding Assistance sign is a new concept and not introduced as yet at railway stations in Yarra (or other inner city stations). On P1, the Boarding Assistance point is closer to front of train, however, on P 2 it is positioned at the end of train. Not sure how this works in relation to time allocated for boarding. 	<p>The WAP sign is replaced by the Boarding Assistance sign.</p>

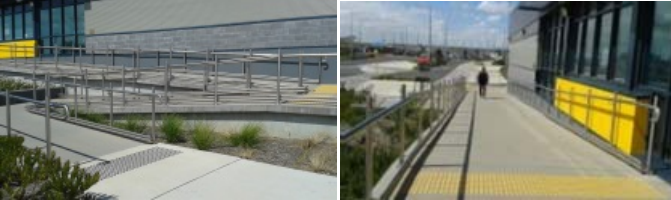
Handrails	Handrails 2/2		<p>The hand rails are placed in all the right places and very effective. They also extend a little past the end points at end of path/stair/ramp, which is great.</p>

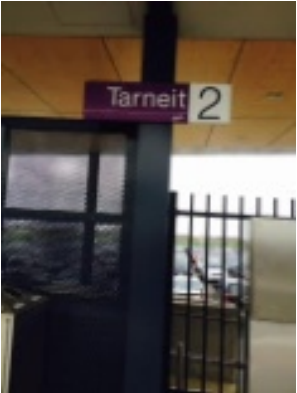
Category	Compliant	Needs Improvement	Image/Commentary
	<p>Signage on platforms and reception is excellent.</p>		<p>would be nice to have illuminated signs that could be read easily at the night.</p>

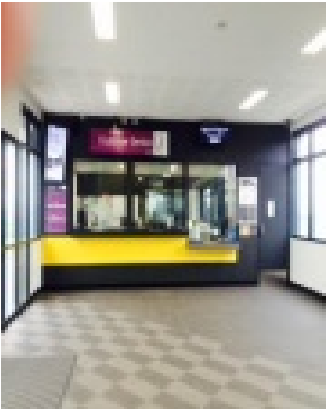
<p>The customer service signage is large enough for easy reading.</p>

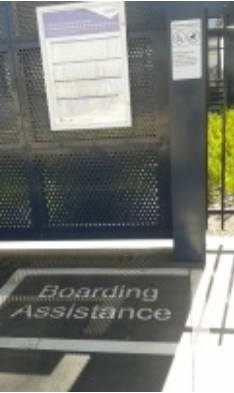
Category	Compliant	Needs Improvement	Image/Commentary
			<p>The boarding Assistance sign on the ground is large and clear. The sign on post is small and could be in larger print.</p>

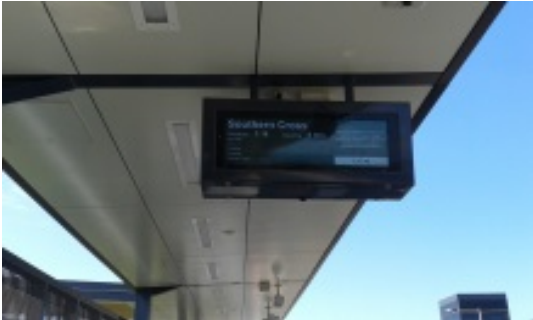
<p>The writing on the LED monitor display is small and difficult to read. Sunlight effects legibility making it harder to read. Larger display would be more beneficial.</p>

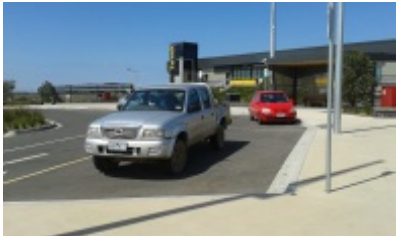
Category	Compliant	Needs Improvement	Image/Commentary
<p>Accessible Parking Bays</p>	<p>12 accessible bay (two very large accessible bay) They have direct access to platform. Excellent</p> <p>12 accessible bays (including two very large accessible bays) They have direct access to platform (on platform only???) Excellent positioning.</p>	<ul style="list-style-type: none"> There are 12 accessible parking bays out of 400 bays (3%). Increased percentage would be welcome. 	<p>Here are two very large bus size accessible parking bays. It is great to know they have been installed. Excellent idea.</p> <div style="display: flex; justify-content: space-around;">

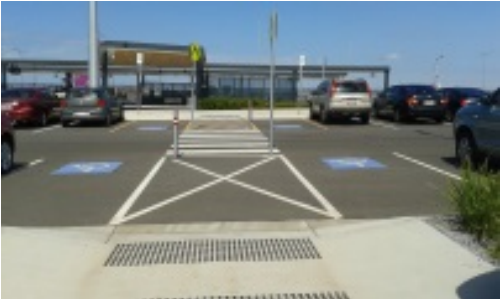
</div> <p>This photo shows 4 accessible parking bays close to platform entrance. A design like this with a walkway between them allows more options for people using wheelchairs, whether a passenger or a driver. The crossing point across roadway is direct, convenient and well thought out.</p>

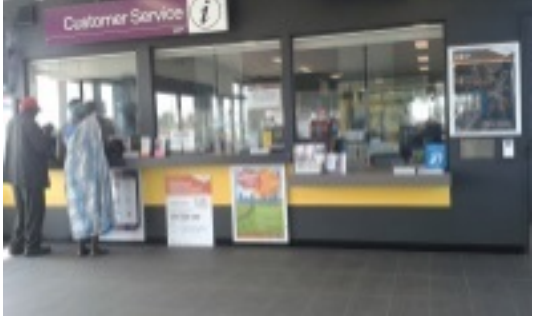
Category	Compliant	Needs Improvement	Image/Commentary
Hazards	There is a wheelchair accessible customer service desk which has plenty of space around it.	Ensure that wheelchair accessible window can be operational.
