INTERIM REPORT:

Tree collapse and bank slump investigation on Yarra River adjacent to former Amcor site at Alphington

August 2019

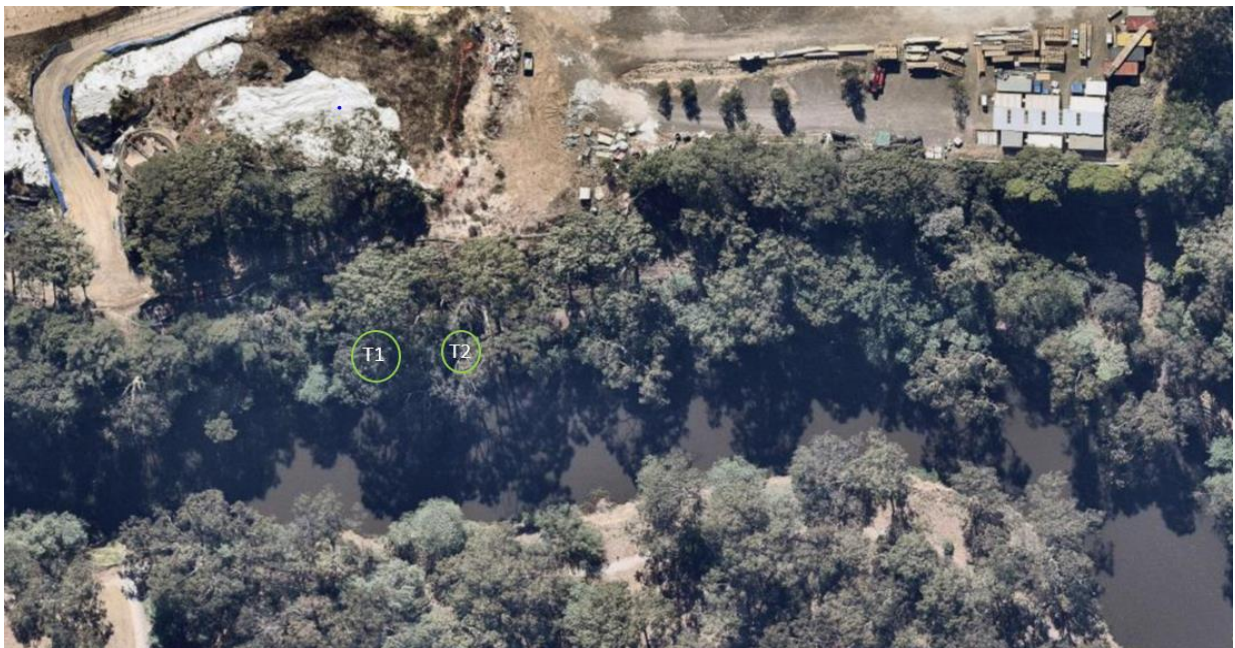
Figure 1. Location of trees assessed at bank slump zone

The issue of the tree collapse and management implications is confounded by the potential presence of asbestos on the lower bank in the vicinity of the subject trees. The expert panel were advised by Glenvill that the trees at risk of collapse may need to be removed as a component of the site remediation works. However, the panel was also advised that investigations into the presence of the asbestos or otherwise was nearing completion and the final program of asbestos remediation had not been finalised.

This memo was followed by a subsequent memo from Alluvium to City of Yarra dated 12 August 2019 that provided additional information and recommendations for the management of T1. This memo recommended urgent attention to fell T1. A copy of the memo is appended to this report. Tree T1 was felled on Friday 16 August 2019.

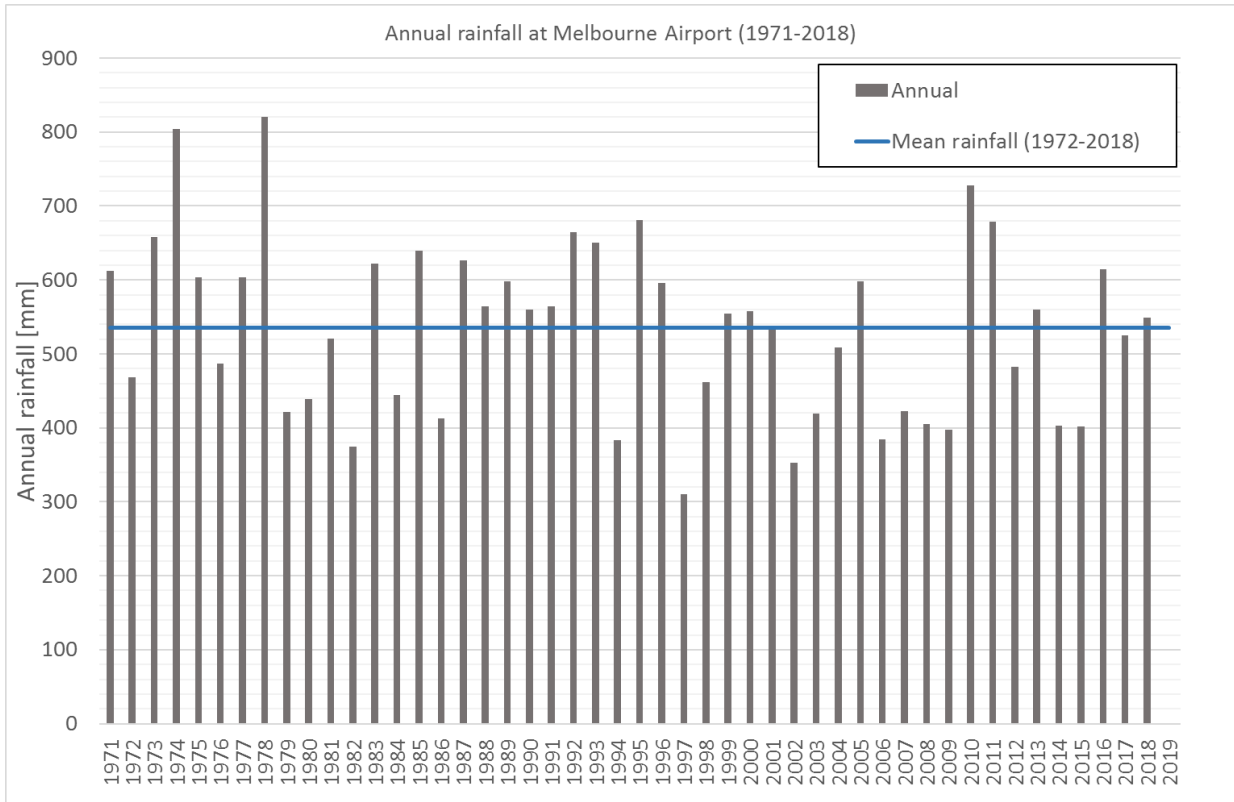
Figure 4 Rainfall records for Melbourne Airport 1971-2018

- **Natural processes:** We have not found any compelling evidence to suggest that the rise in groundwater is associated with natural process such as an increase in regional groundwater levels associated with any increased rainfall. The information currently available to the expert panel suggests that the issues are isolated to the subject site and has occurred over the period of recent changes at the site. The last 4 years have not been unusually wet (refer Figure 4) and it would be highly unusual for such a localised groundwater issue to be linked to broader scale natural processes.

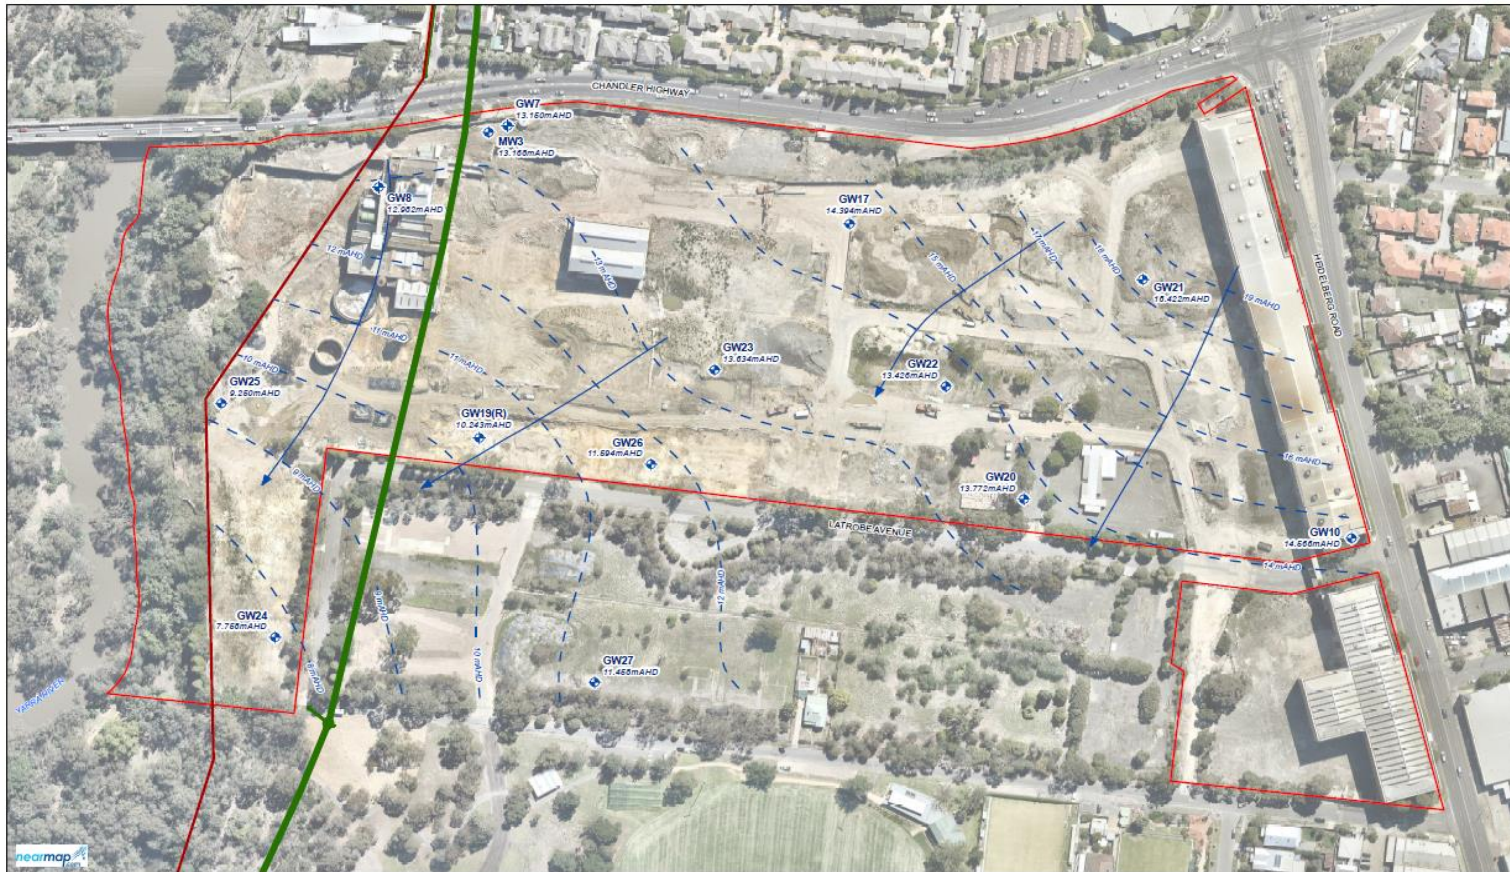
Figure 6-2 Groundwater flow direction based on GME 6 in 2016 (GHD 2016).

the Newer Volcanics and the siltstone indicated that the flow is south-eastwardly towards the Yarra River (Figure 6-4). The estimated gradient from one of the bores (GW25) to the Yarra River is 0.09.

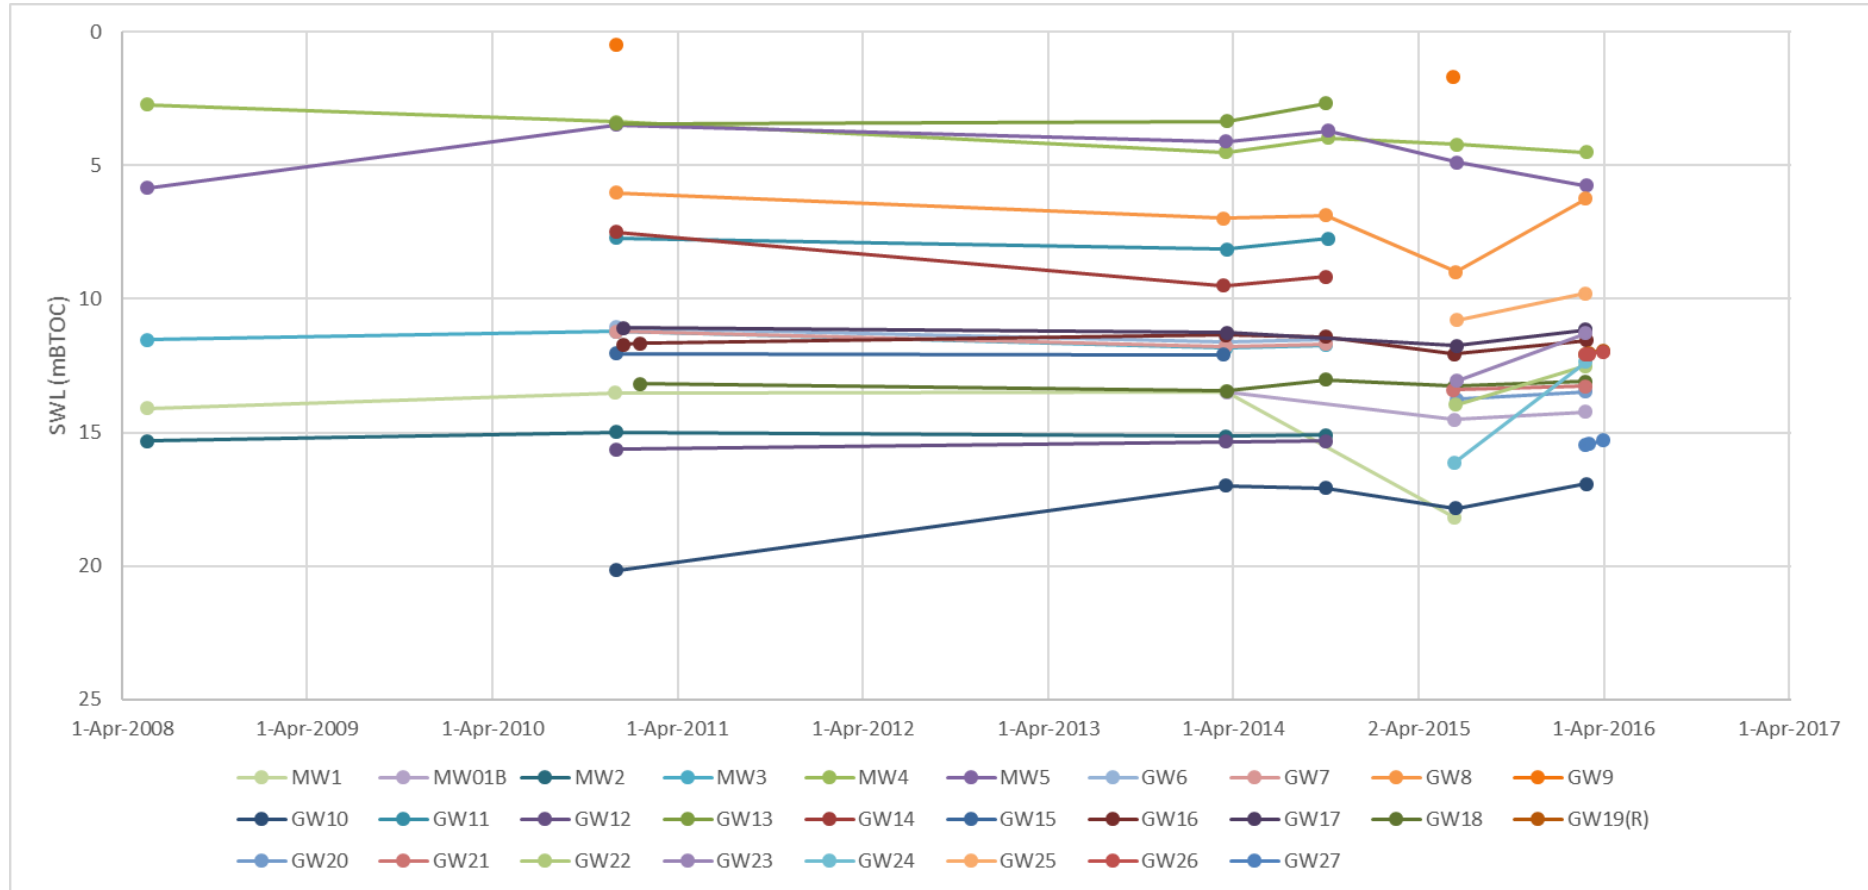
Figure 6-3 Standing Water Level data extracted from GHD 2016

The data collected during all the GMEs cannot be used to determine seasonal variations as the GMEs were irregular and the bores monitored varied considerably across all the GMEs (see Figure 6-3).

Standing water level (SWL) collected from these wells between 2008 and 2016 indicated that the SWL varied between 0.5 and 20 mBTC (as reported by GHD 2016). SWL were not reported as metres below ground level (mbgl) or metres Australia Height Datum (mAHD) (see Figure 6-3), thereby preventing the comparison between the river stages and the watertable.

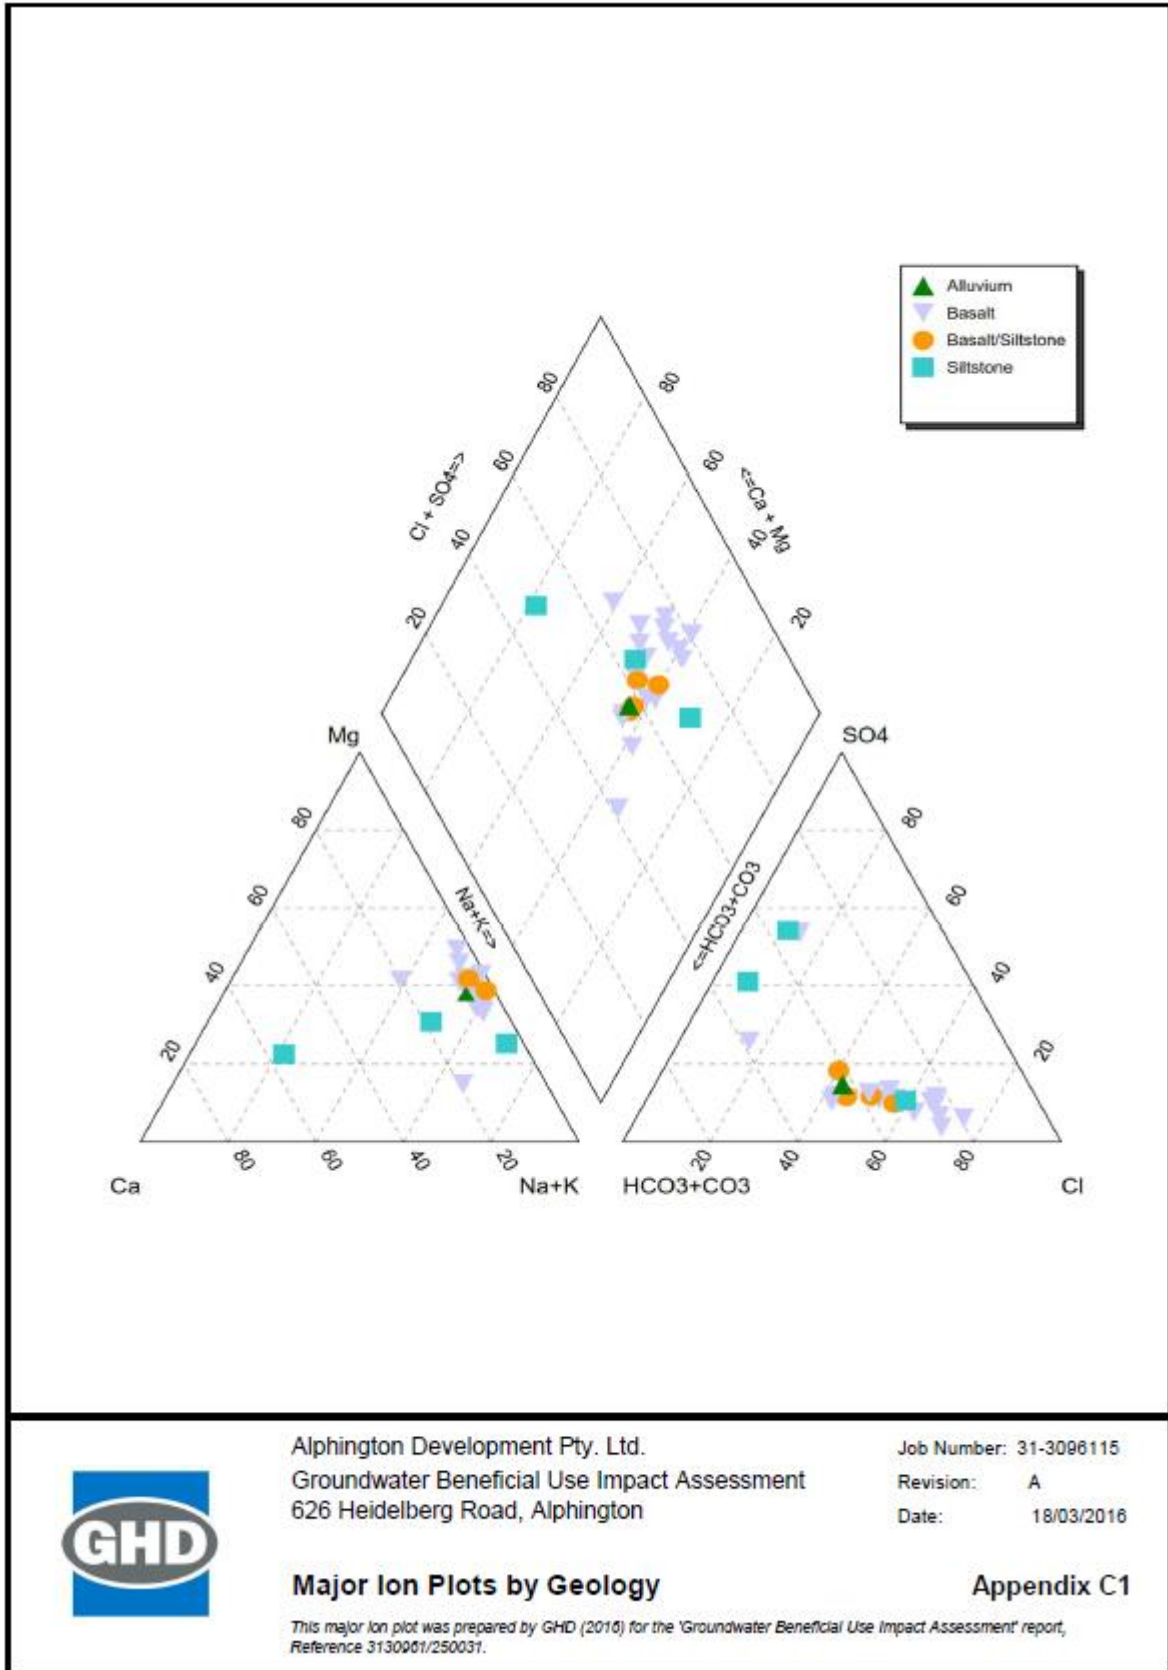
Figure 6-4 Major ions from GME 6 (GHD 2016)

The report also identified that the water type of most of the bores screened in the basalts were predominantly Na-Mg-Cl, which is typical of basalts in Victoria (Figure 6-4). The wells screened in siltstone showed diverse water types – reflecting possible interactions with basalt groundwater and/or impact from site activities. The ionic ratios were also consistent across the 6 GMEs.

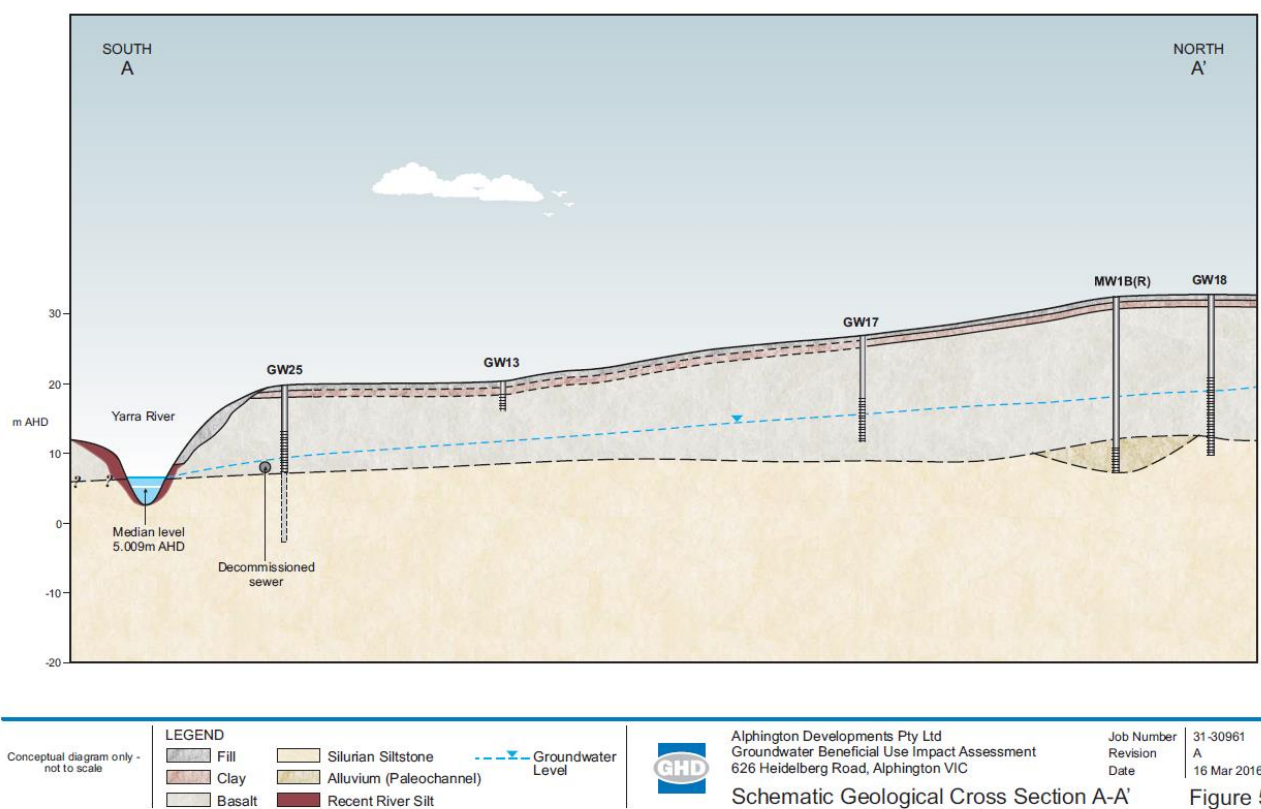
Figure 6-5 Geological Cross section of the site (GHD 2016)

27.	In the report Appendices GHD Figure 5 Schematic Geological Cross Section A-A. shows a clay layer above the Basalt layer through which the groundwater flows. With the remediation works clearing the site is there now greater seepage and subsequent salutation of the Basalt layer?	The removal of the clay cover over the fractured basalt is a potential pathway for increased surface water infiltration at the site. The extent to which this is the cause of the elevated groundwater levels in the lower terrace can only be resolved with the detailed stage 2 investigations as set out in the interim report

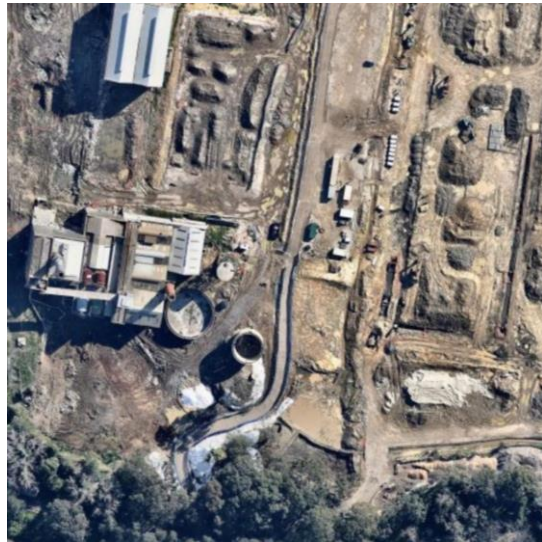
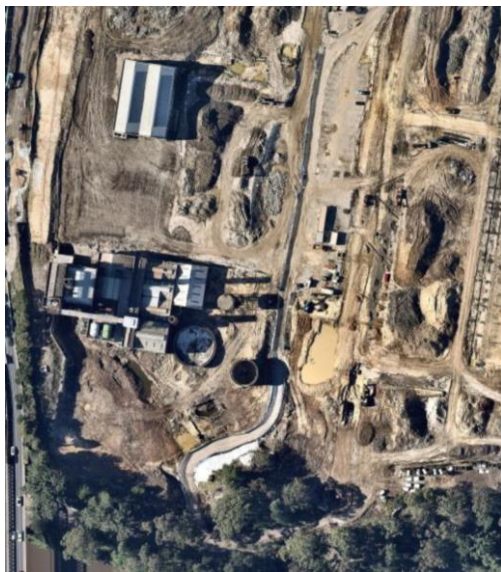
Figure 3 – Images showing the change in sediment pond location over time

From an examination of aerial images, it is clear that the location of the surface water management sedimentation ponds has moved over time (see Figure 3).

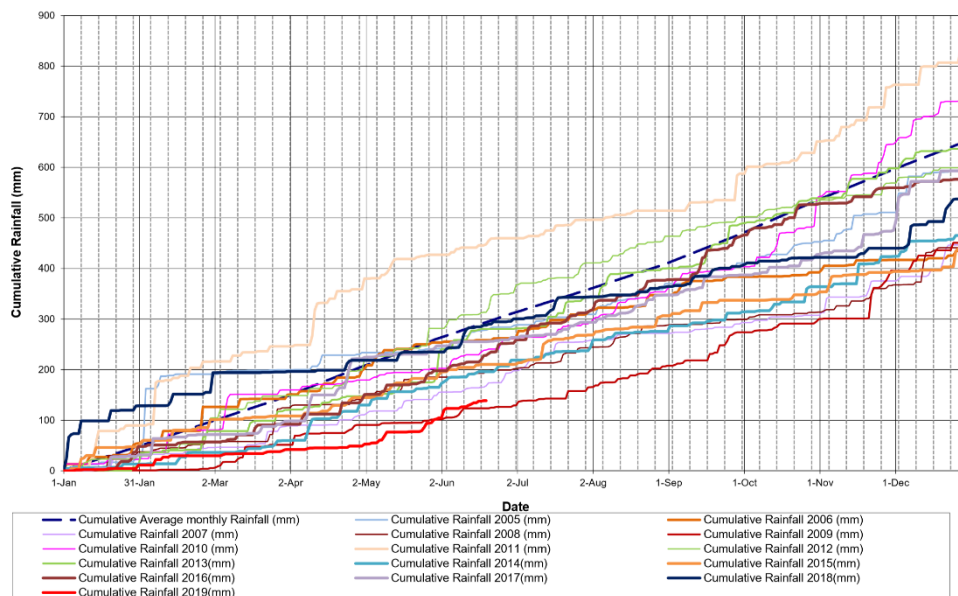
Figure 4 – Rainfall (source Douglas Partners report 3/7/19)

Over the 2017-2018 period the average annual rainfall was approximately 540mm (refer to Figure 4).

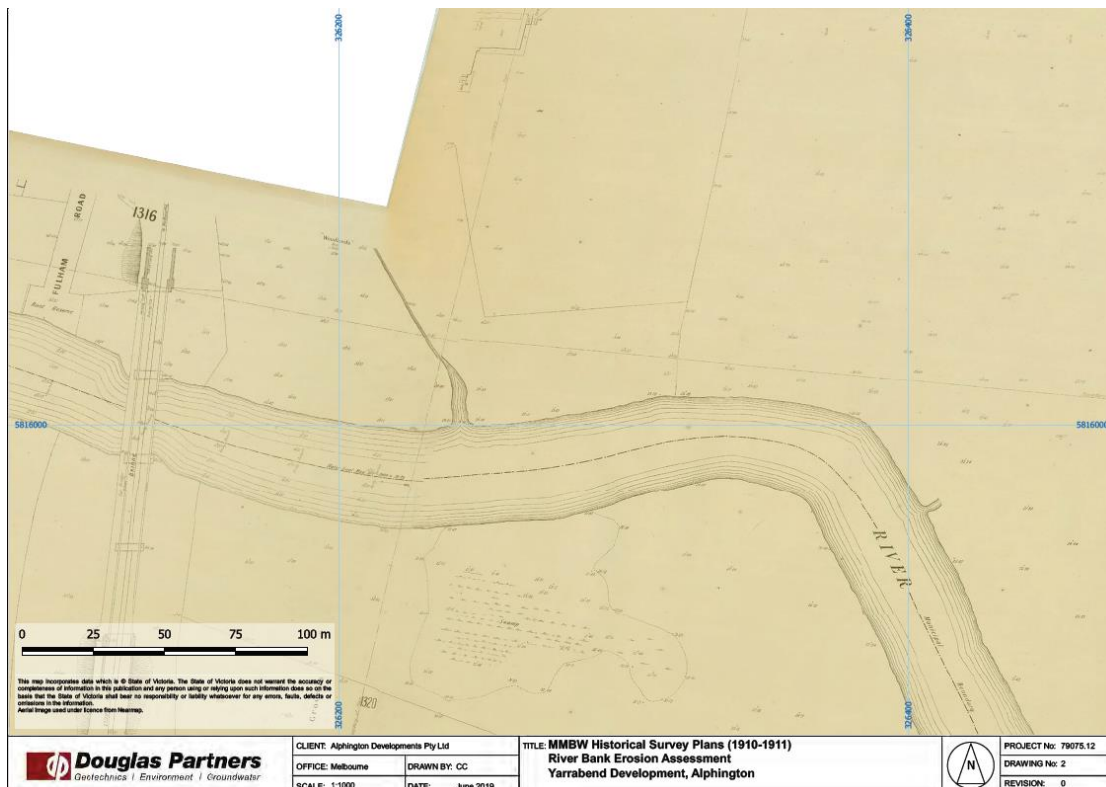
Figure 20. Old Creek location from historic survey

As set out above there is evidence of fill material on the lower terrace. Figure 20 illustrates provides an extract of a MMBW Historic Survey Plans (1910-1911) (refer Douglas Partners 2019) of a creek on entering the Yarra River through the now lower terrace of riverbank. Figure 21 sets out an indicative location of the creek in the current landscape. We are aware of a stormwater pipe located in the area of the old creek, however there is limited surface evidence of this creek in the current landscape, suggesting that the creek and its confluence with the Yarra River have been infilled.

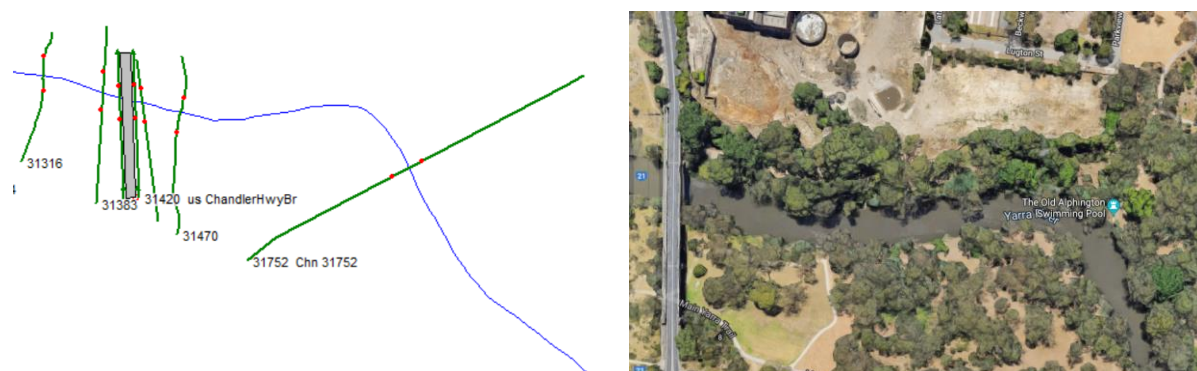
Figure 22. Cross section survey and aerial view of site

Figure 22 demonstrates the riverbank site lies between CH 31752 and CH 31470 of HECRAS model. The bank slumps and tree collapse site are located between these two cross sections. The shear stress for the subject site has been assessed at both these cross sections. The results are set out in Table 3.

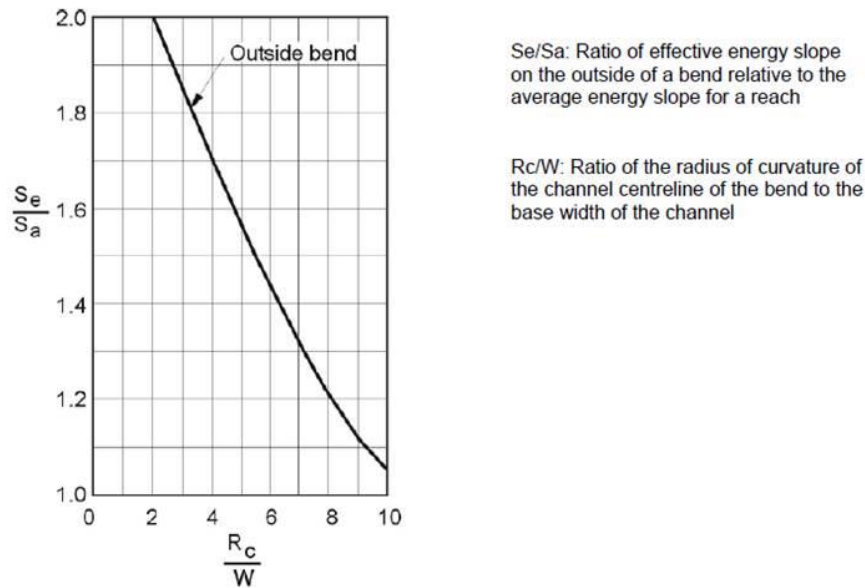
Figure 23. Effect of channel bend on effective energy slope (DSE 2007)

The method of adjustment was based on that set out in *Technical Guidelines for Waterway Management* (DSE, 2007), refer Figure 23. whereby the shear stress is scaled by a factor based on the radius of curvature (Rc) divided by the base width (W) of the channel (Rc/W). The resultant factor was used to factor up the cross-sectional shear stress value for the design events giving larger shear stress values on the outside of the bend.
