Report on Geotechnical Investigation and
Groundwater Study

Yarrabend: Riverfront Area
Heidelberg Road, Alphington

Prepared for
Alphington Developments Pty Ltd

Project 79075.12
R.012.Rev0
12 March 2020

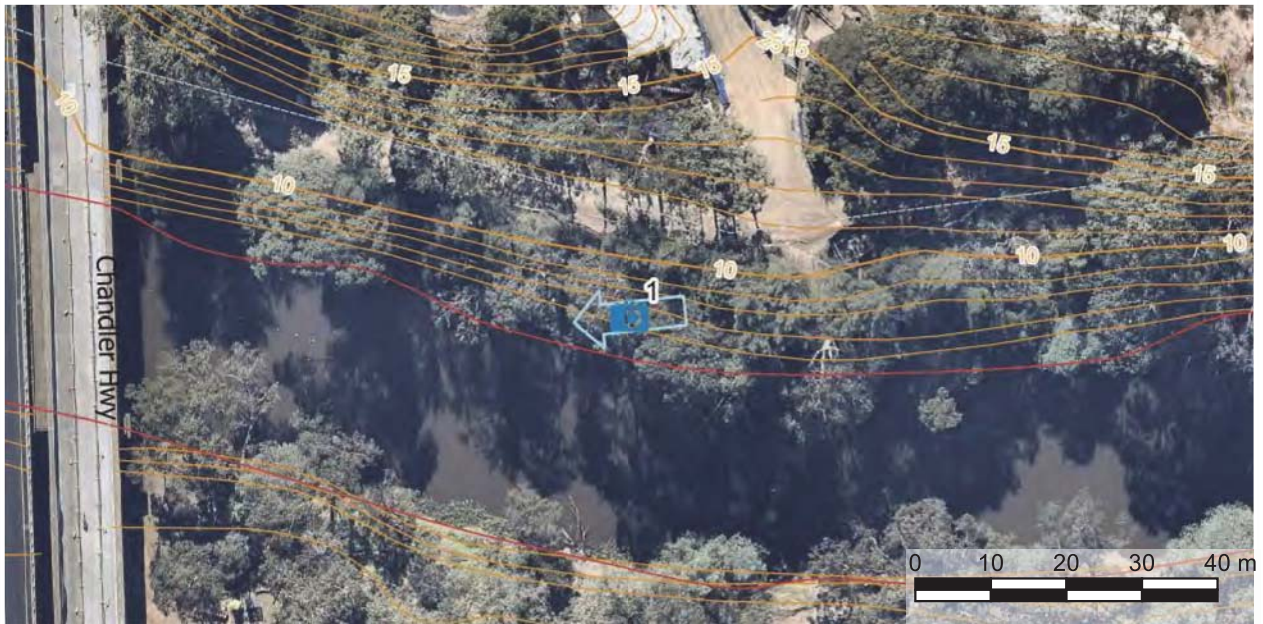
Site Photographs River Bank Erosion Assessment Yarrabend Development, Alphington	PROJECT: 79075.12
		DWG No.: Plate 1
		REV: 0
	CLIENT: Alphington Developments Pty Ltd	DATE: June 2019

a) stream bed lowering or infill	No information confirming this. Would require historical bathymetry data.
b) Rises in river levels, or inundation of bank soils followed by rapid drops in river levels	Probable contributing factor. Note that slumps B and C occurred after river level peaks, in December 2018 and May 2019. Consistent with fluctuating GW levels in standpipes near the river edge, historical and recent (MW5, MW4, DG4). Note that historical slumps are evident near these boreholes. See Plate 1 Appendix B, extracted from DP report -July 2019.

1 Old slump area, west of recent slump.

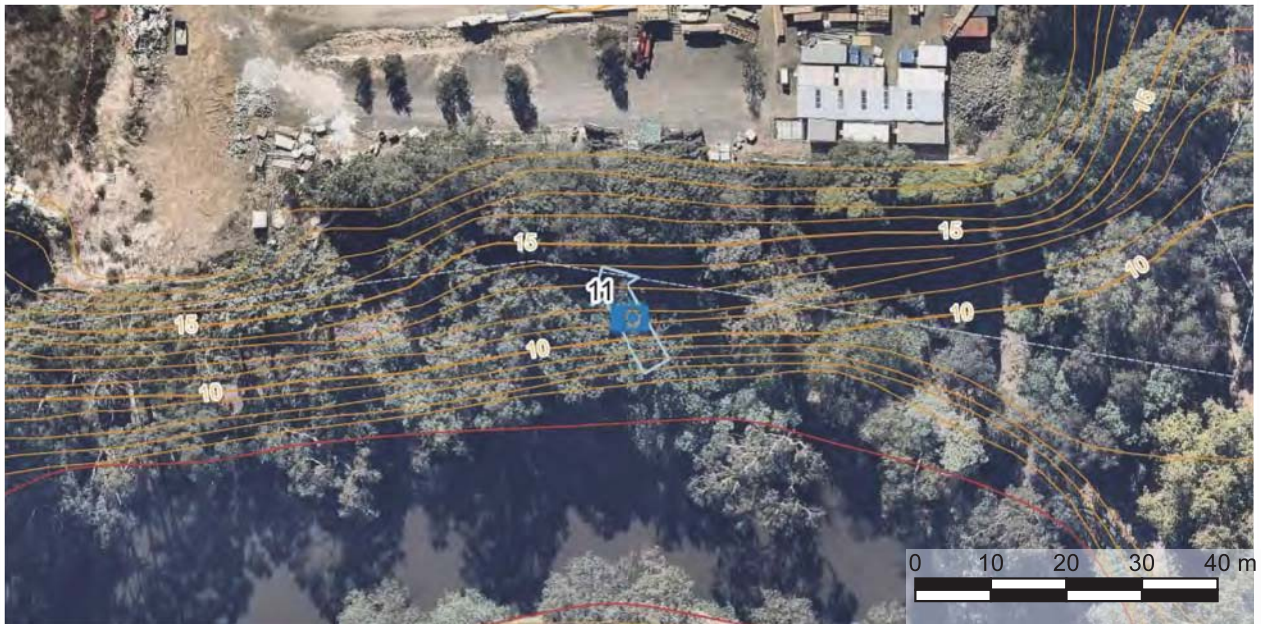
DWG.No: Plate 11

Seepage was reported in this area in January 2019. Tension cracks were observed by DP in June 2019. Wet ground was observed in this area at this time, consistent with prolonged poor drainage and intermittent wet ground, as shown in Plate 11 Appendix B (extract from of DP-July2019).

11 Terrace area.
