Cathedral Stone, 395 Johnston Street Abbotsford, Victoria 3065
Commercial Builder (Limited) CB-L 31787
ABN: 360 506 079 06

2nd October 2018

PROJECT **293 CHURCH STREET, RICHMOND (Lalor House)**
SUBJECT **HERITAGE FAÇADE INSPECTION and CONSERVATION SCHEDULE OF WORK**

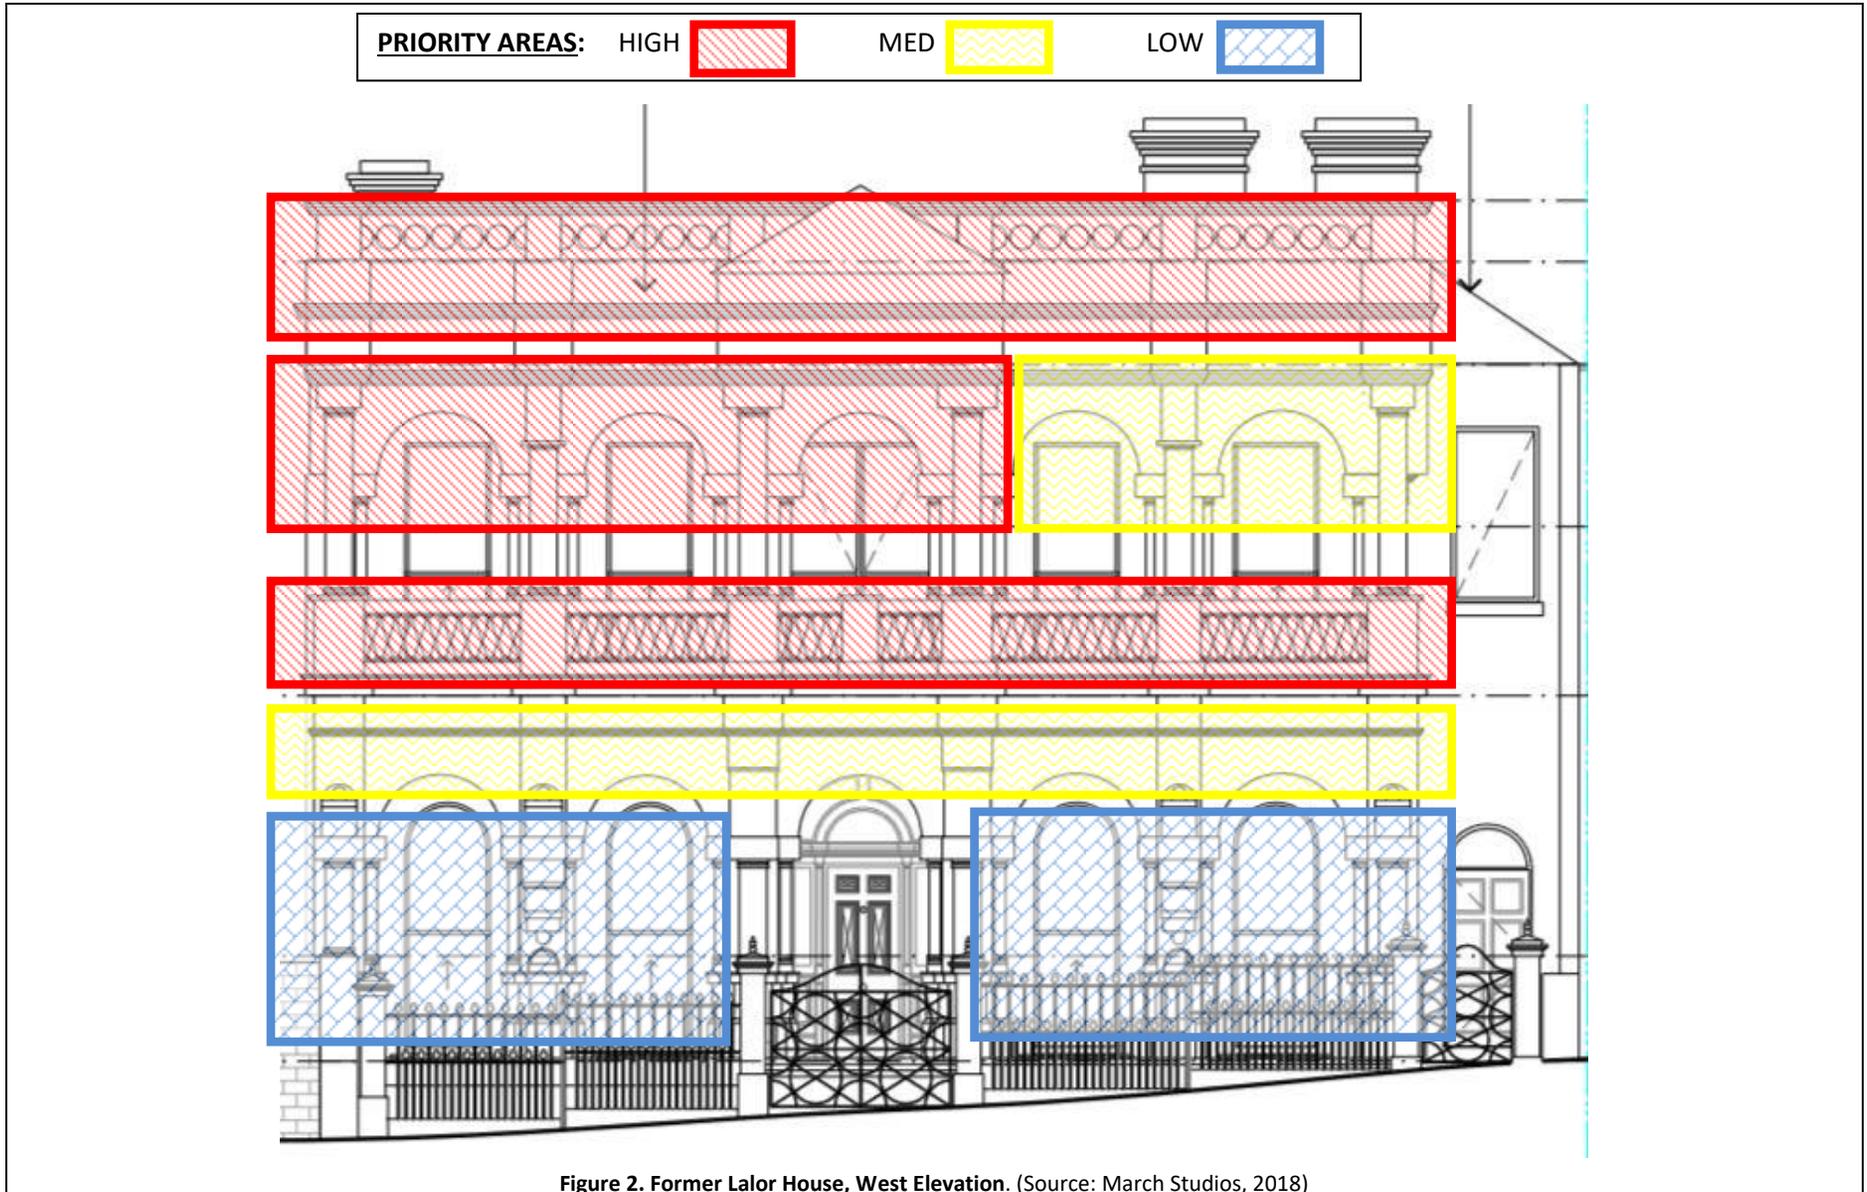
WEST ELEVATION – PARAPET BALUSTRADE and CORNICE

LOCATION: Roof (Parapet Coping)

- Extensive cracked, fretting and drummy render
- Vertical and horizontal stress fractures resulting in loss of material
- Corroded steel/iron lintels appear to retain most of their original profile and integrity
- Moderate efflorescence to soffit moulds

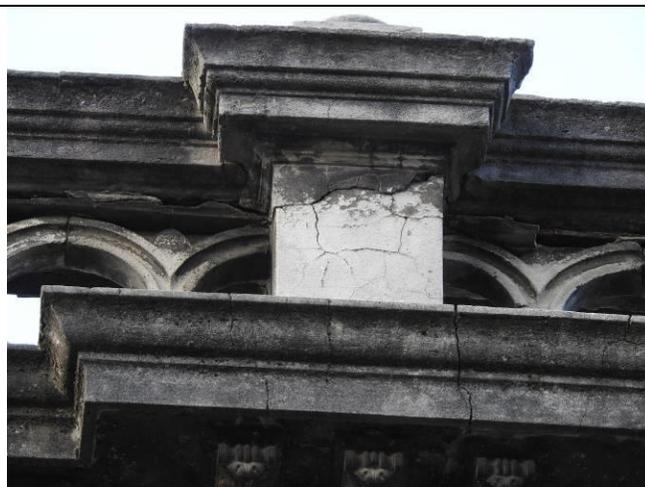
003

ITEM	DESCRIPTION	APPROX. DIMENSIONS	REPAIR CODE
001	Parapet and coping experiencing advanced cracking	2m ²	BIO, WSH, CRK, STR, STL, BRK, R1, R2, MLD
002, 003, 004, 005	Horizontal cracking through parapet and above coping. Rusting lintels	Several metres (requires elevated access to quantify)	BIO, WSH, CRK, STR, STL, BRK, R1, R2, MLD
006, 007, 008, 009	Horizontal and vertical cracking through cornice. Efflorescence observed.	As Above	DES, WSH, CRK, STR, STL, BRK, R1, R2, MLD

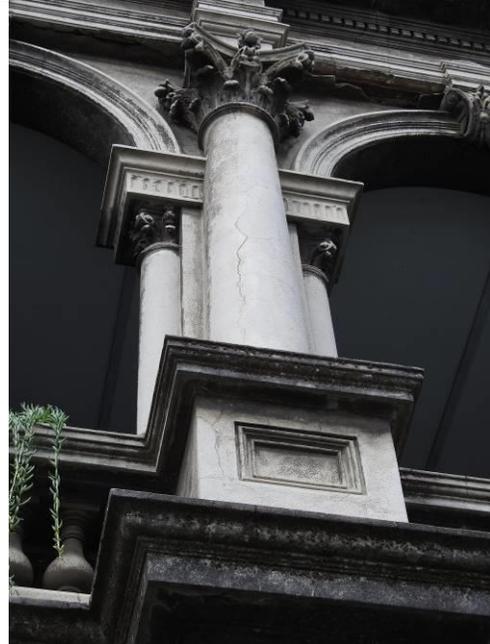
011

ITEM	DESCRIPTION	APPROX. DIMENSIONS	REPAIR CODE
010,011	Columns and pressed cement capitals display extensive crazing though structurally sound	2	WSH, Monitor, Inspect when scaffold erected
012, 013, 014, 015	Horizontal cracking through string course. Rusting lintels	Several metres (requires elevated access to quantify)	BIO, WSH, CRK, STR, STL, PIN, BRK, R1, R2, MLD

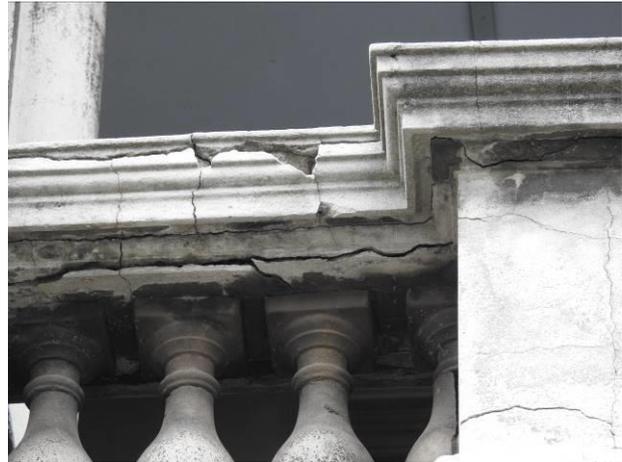
017

ITEM	DESCRIPTION	APPROX. DIMENSIONS	REPAIR CODE
016,017, 018, 019	Horizontal cracking through parapet and above coping. Rusting lintels. Efflorescence observed.	Several metres (requires elevated access to quantify)	DES, BIO, WSH, CRK, STR, STL, BRK, R1, R2, MLD,

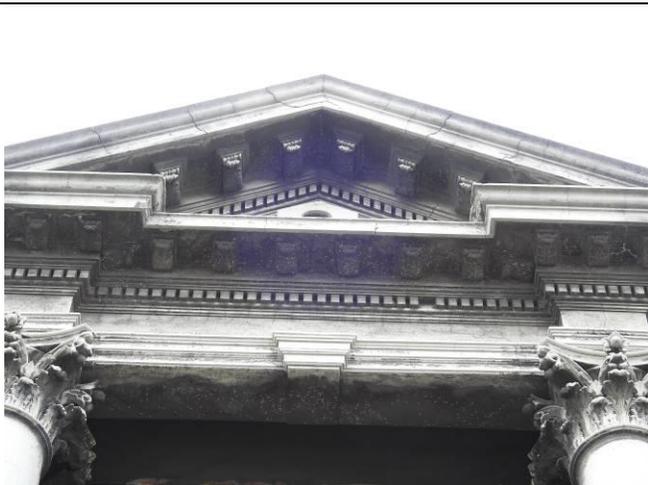
022

ITEM	DESCRIPTION	APPROX. DIMENSIONS	REPAIR CODE
020-027	Horizontal cracking through parapet and above coping. Rusting lintels. Efflorescence observed.	Several metres (requires elevated access to quantify)	DES, BIO, WSH, CRK, STR, STL, BRK, R1, R2, MLD,

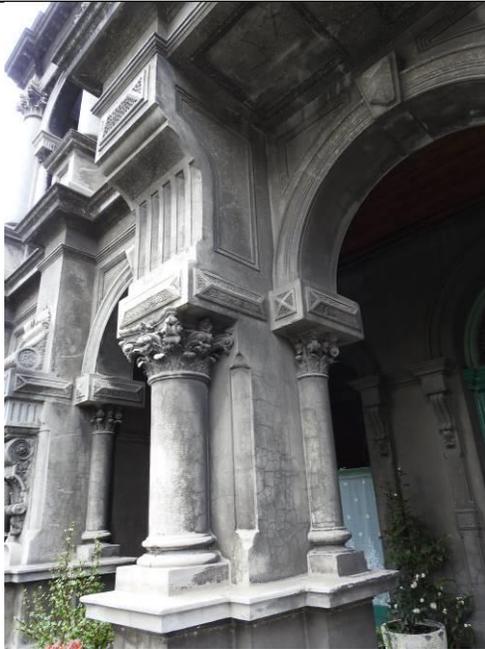
030

ITEM	DESCRIPTION	APPROX. DIMENSIONS	REPAIR CODE
028-031	Horizontal cracking through balustrade and above coping. Rusting lintels. Efflorescence observed.	Several metres (requires elevated access to quantify)	DES, BIO, WSH, CRK, STR, STL, BRK, R1, R2, MLD,

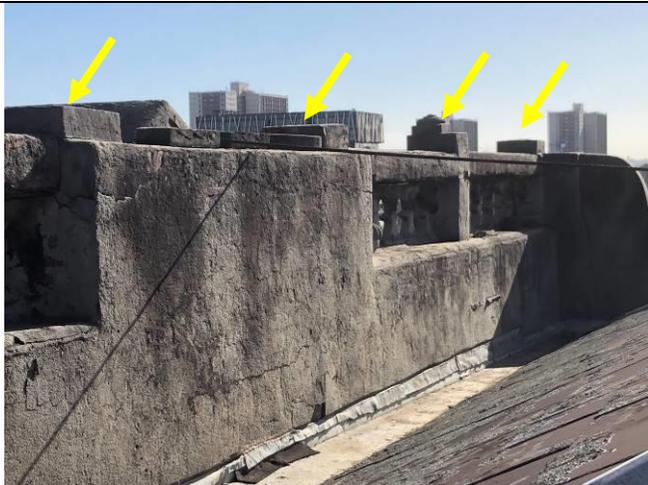
052

ITEM	DESCRIPTION	APPROX. DIMENSIONS	REPAIR CODE
050-053	Moderately drummy, extensive crazing, fatigued/eroded sand finish. Loss of Urns and Balls. Refer Figure 1, Section 8 of this Report.	20m ²	BIO, WSH, CRK, STR, STL, BRK, R1, R2, MLD. Replace missing decorations
