# **OUTER CIRCLE PRECINCT, ALPHINGTON**

## **DESKTOP ENVIRONMENTAL WIND ASSESSMENT**

**Report: 198-20-DE-EWA-00**

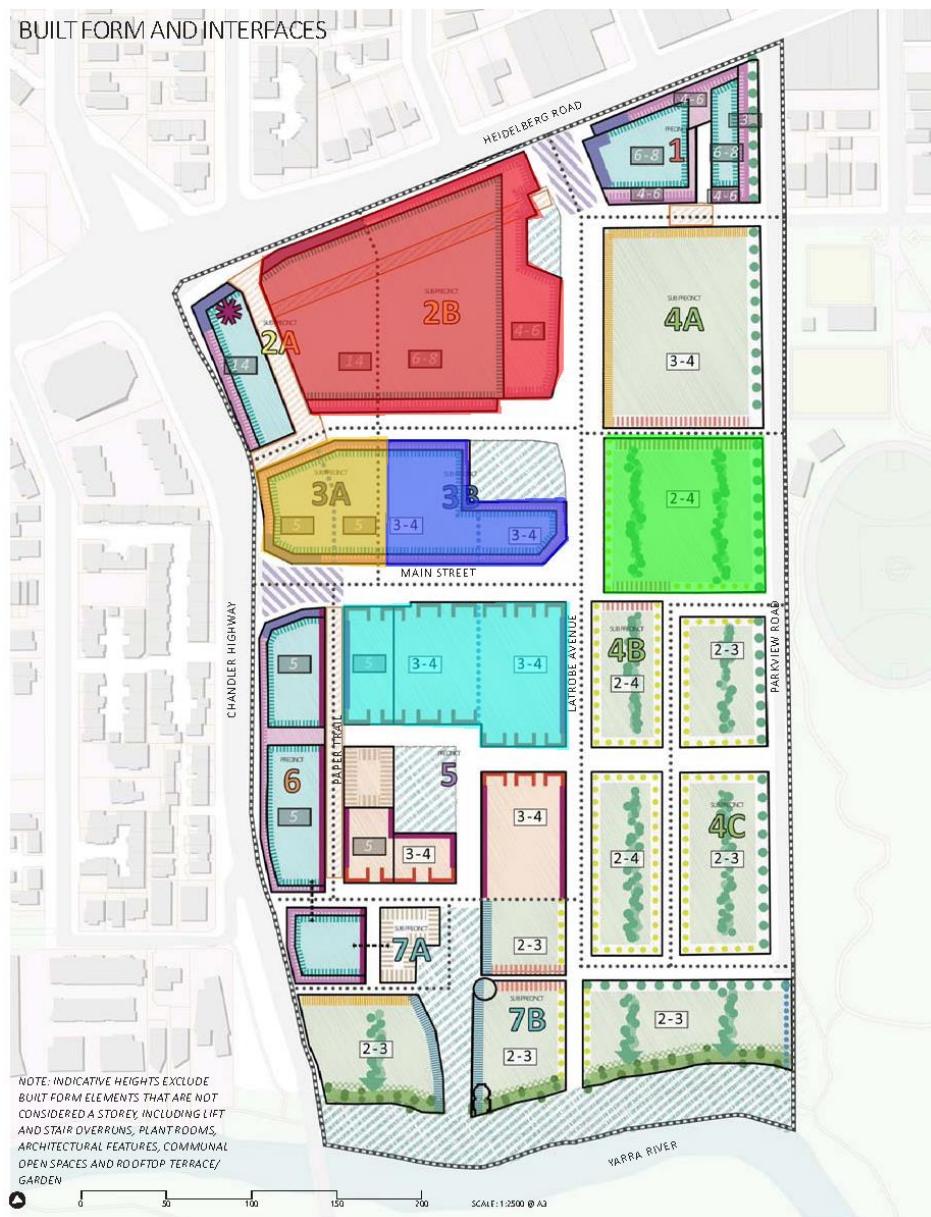
**Figure 1: Location of the Boiler House precinct (7A) within the masterplan context of the Alphington Paper Mill site.**

The proposed Boiler House Precinct in Alphington lies on the south-western extremity of the former Alphington paper mill site. The Boiler House precinct buildings (7A) lie immediately south of the Outer Circle and Wetlap buildings (6 and 5). Figure 1 shows the location of the development site within the masterplan context.

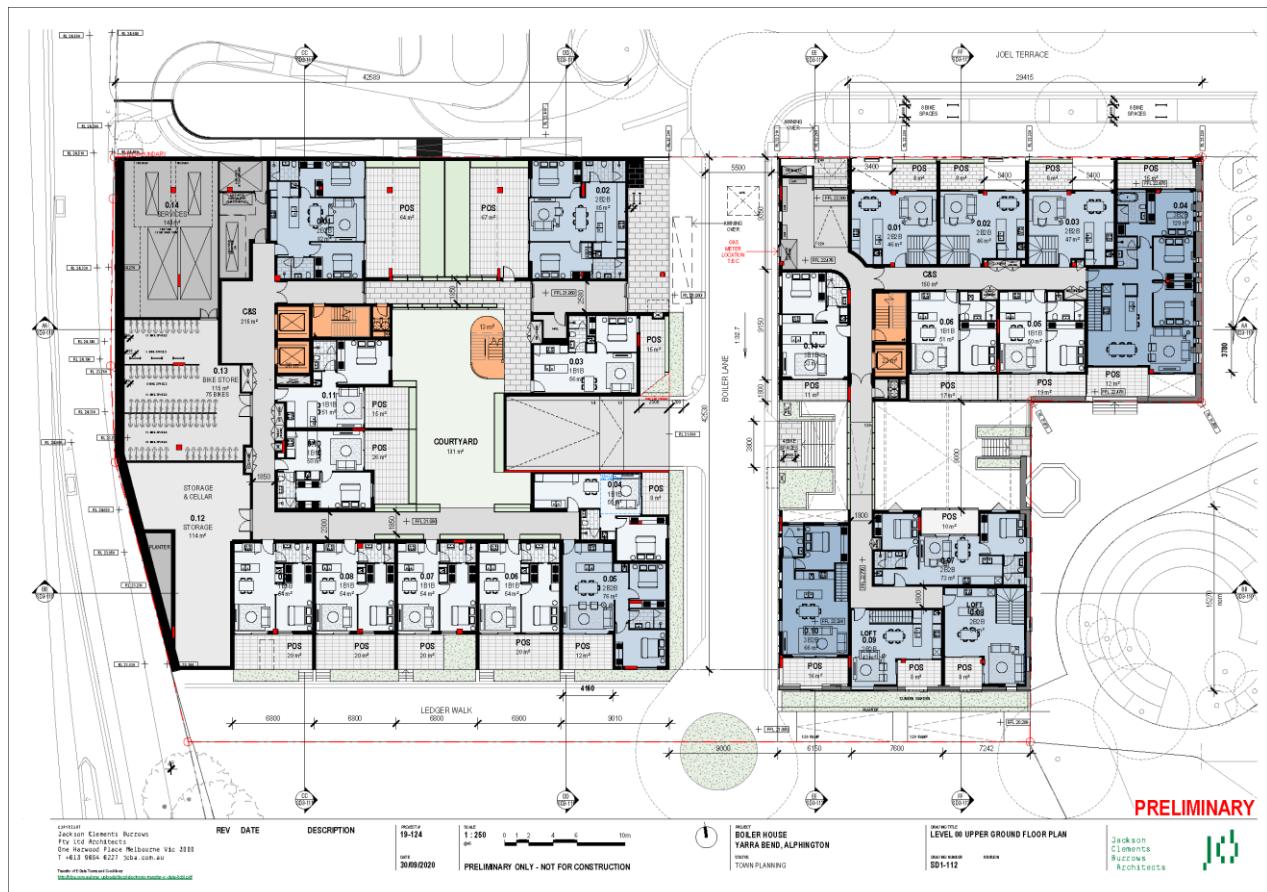
**Figure 2: Plan view of the proposed Boiler House buildings.**

The development will comprise two buildings; Boiler House east and Boiler House west. The west building will be taller, at 5 levels (with the south-west elevation up to 6 levels), and include rooftop terraces and communal spaces, while the east building will be 3 levels in height and retain some of the original building's features, such as the original chimney stack.

There will be new streets constructed to the north and south of the precinct. Between the two buildings will be an access way (Boiler Lane), with additional access ways to the north (Joel Terrace) and south (Ledger Walk). Access to each of the sites will be via these access ways. There will be individual apartment access off Chandler Highway to the western Level 1 apartments via the individual terraces.

The layout of the proposed development is shown in Figure 2.

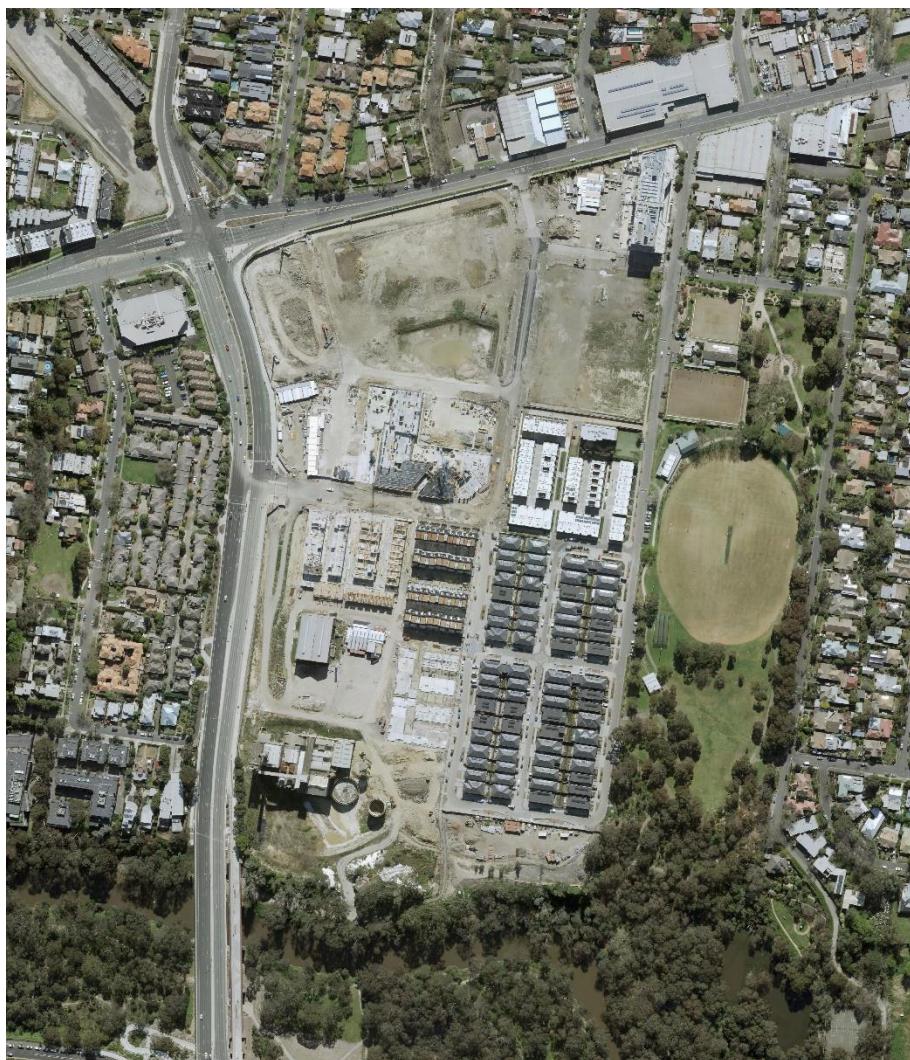
**Figure 2: View of the Paper Mill site (06/09/2020 : Metromap).**

The Boiler House precinct will have good shielding for north wind sector directions provided by all the buildings to its north. To the south the vegetation along the river will provide shielding to the lower levels as would any future buildings in the Riverfront precinct. Most of the direct wind exposure will be incident from the west sector. The Boiler House west building will provide shielding to the west wind sectors for the full height of the Boiler House east building, but will itself be exposed to the west wind directions and will be likely to induce additional wind flow to lower levels along Chandler Highway.
