**Nos. 18, 20 and 22 Derby Street
Collingwood**

**Nos. 10, 12, 14 and 16 Derby Street
Collingwood**

Heritage Assessment

June 2018

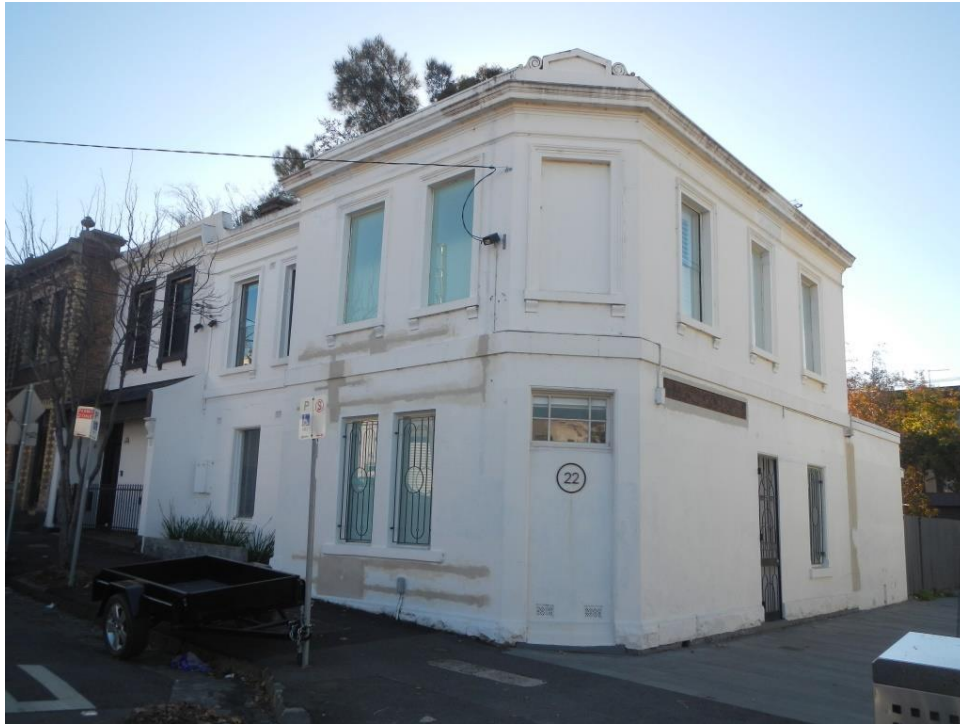
Figure 4 Nos. 18, 20 and 22 Derby Street, Collingwood. June, 2018.

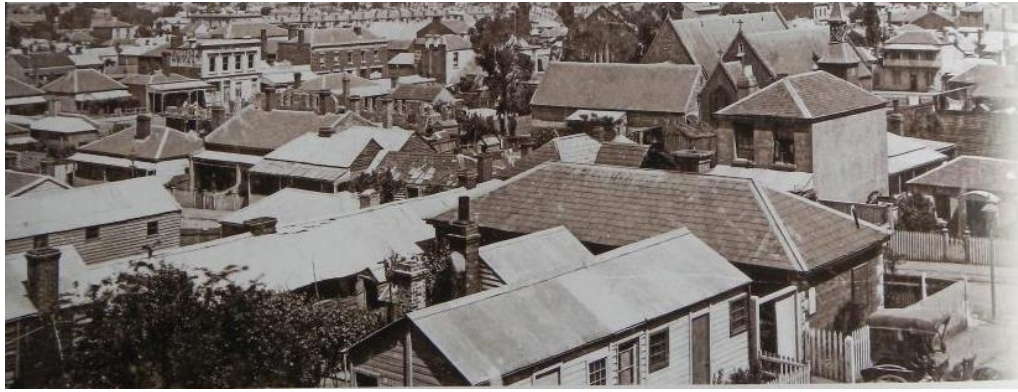
Figure 10 The Collingwood Slope c.1886.

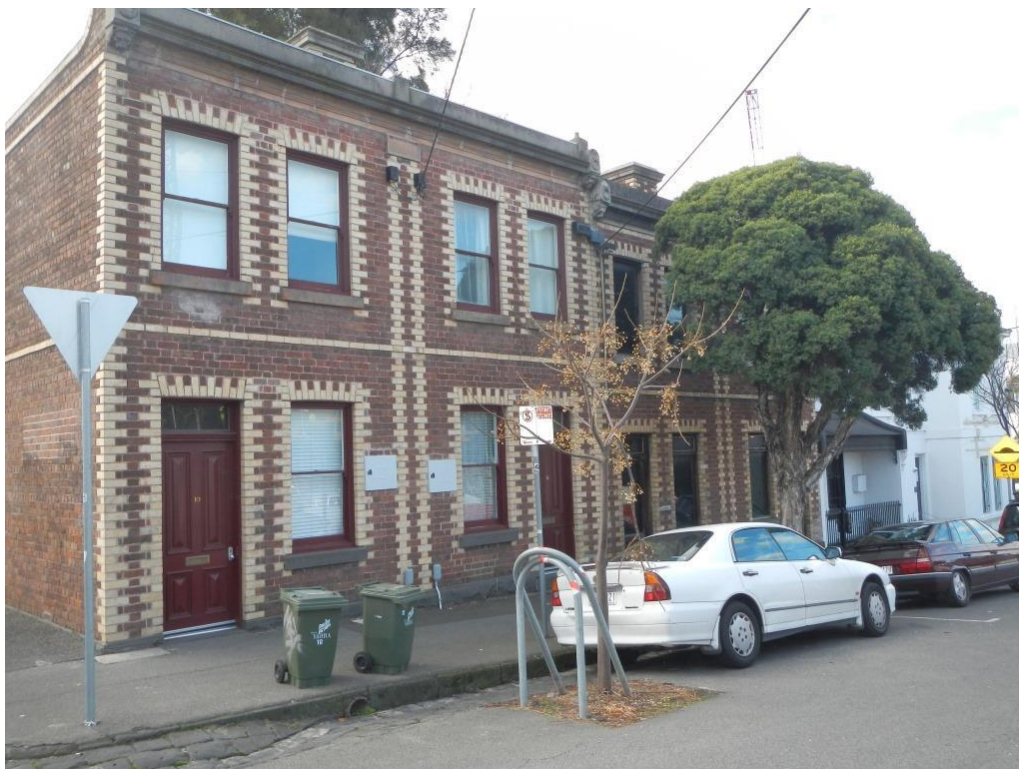
Figure 11 Nos. 10 – 16 Derby Street, Collingwood.

32. The terrace at 10-16 Derby Street, Collingwood, comprises four two storey attached bi-chromatic brick dwellings arranged as mirror-image pairs. The walls are of face brown brick, with cream brick dressings. Cream brick quoining at the buildings' corners, and between each dwelling combines with similar quoined window dressings to accentuate the unusual proportions, particularly of the ground floor facades, which are dominated by the large, off-centre openings. At ground floor level, each dwelling has a four-panel timber door with a multi-light highlight above and a single window opening to one side, whilst at first floor level there are two window openings. They originally contained typical timber-framed double-hung sash windows which have been removed at Nos. 14 and 16 Derby Street, evidently since the citation was updated in 2008. The sills are bluestone. The group did not have verandahs or balconies originally. The corrugated steel roof is concealed behind an unpainted rendered parapet which has a simple cornice and is decorated with urns, only one of which remains. The roof is penetrated by bi-chromatic brick chimneys with unpainted rendered caps.

33. There is a high degree of intactness with no obvious alterations being apparent other than for the loss of the window joinery to Nos. 14 and 16 Derby Street and which could be reinstated easily.

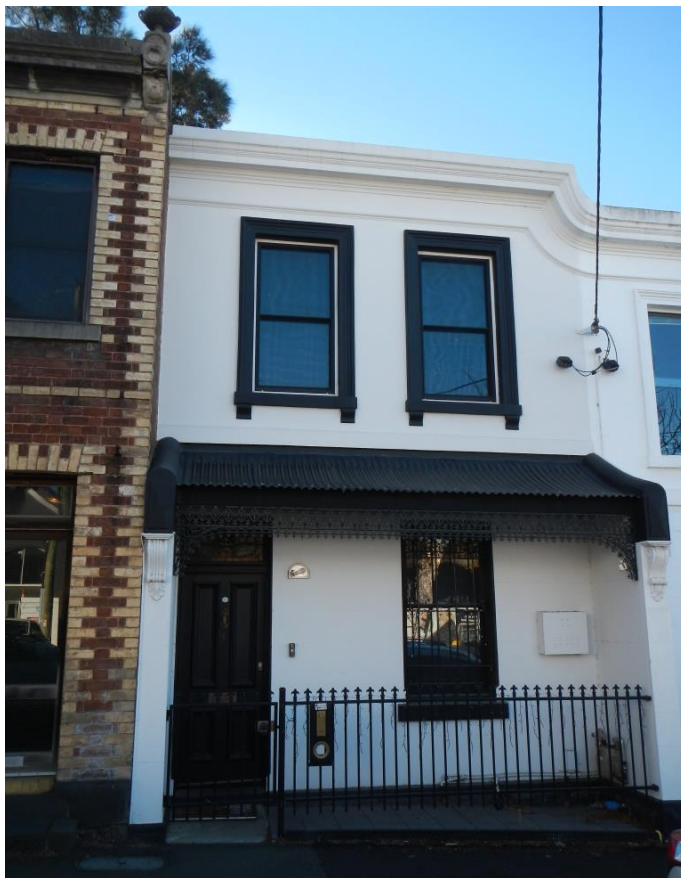
Figure 12 No. 18 Derby Street, Collingwood. June, 2018.

34. No. 18 Derby Street forms a pair with No. 20 as indicated by the curved and continuously moulded parapet. It is a double-storey rendered dwelling, with ruled ashlar, on a bluestone plinth, with a symmetrically-placed, pair of timber-framed, double-hung sash windows, surrounded by moulded rendered architraves, at the upper level. At the ground level is a centrally-located single typical Victorian window, with staff bead mouldings, a bluestone sill, and a four-panel timber door, with a highlight, to the west side. The staff bead is indicative of a date of 1860-70s. The verandah comprises a timber-framed corrugated steel roof and a cast iron valence set between end wing walls and supported on moulded consoles and with a pool fence balustrade and concrete tile paving. It appears to be a replacement for what was probably a timber-framed verandah. The main hipped roof is clad in corrugated steel and is penetrated by a rendered chimney with a moulded cap on the east side. From Langridge Street the rear upper level is visible and contains a single typical Victorian sash window opening.

35. There is a high degree of intactness with no obvious alterations being apparent other than for the non-original verandah and balustrade and original door highlight which could be reconstructed easily.

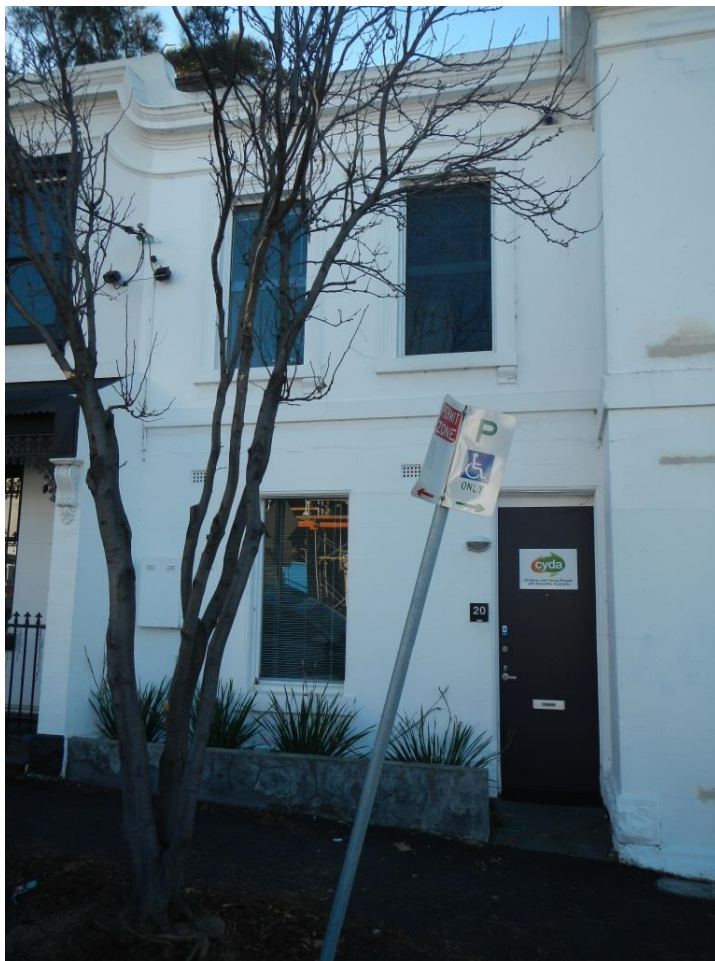
Figure 13 No. 20 Derby Street, Collingwood. June, 2018.

36. No. 20 Derby Street forms a pair with No. 18 as indicated by the curved and continuously moulded parapet. It is a double-storey rendered dwelling, with ruled ashlar, on a bluestone plinth. At the upper level is a symmetrically-placed, pair of typical vertically-oriented Victorian windows, surrounded by moulded rendered architraves and supported on small consoles on the east side only. The timber-framed sashes are lacking. At the ground level is a centrally-located typical Victorian window opening, with staff bead mouldings and a bluestone sill, and a non-original timber door to the east side. The staff bead is indicative of a date of 1860-70s. The verandah is lacking but the rendered string course indicates the location of its roof. It appears that the original verandah was timber-framed. A pair of terracotta waffle vent covers has been inserted into the façade. The main hipped roof is clad in corrugated steel and is penetrated by a rendered chimney with a moulded cap on the east side. From Langridge Street the rear upper level is visible and contains a single typical Victorian sash window opening.

37. The building has a high degree of intactness with no obvious alterations being apparent. The timber-framed window sashes, presumed original timber four-panel door, and verandah are lacking but this does not diminish the heritage value of this building. These elements are those which typically have been altered and they could be reinstated easily.

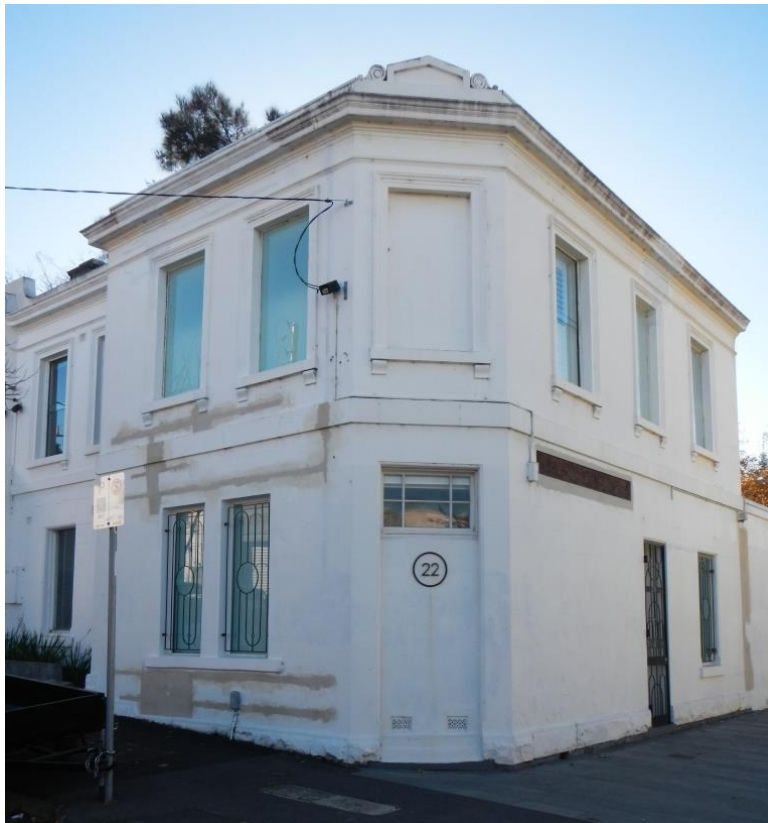
Figure 14 No. 22 Derby Street, Collingwood. June, 2018.

38. No. 22 Derby Street appears to form a group with Nos. 18 and 20 as indicated by the continuously moulded parapet. It is a double-storey rendered building, with ruled ashlar, on a bluestone plinth, with a splayed corner. It was a grocer's shop with a separate integral residence. A cellar is indicated on the MMBW plan in the south-east corner.

39. At the upper level are symmetrically-placed, typical vertically-oriented Victorian windows, surrounded by moulded rendered architraves and supported on small consoles. There are two on the Derby Street (south) elevation and three on the Oxford Street (east) elevation) on the east side only. At the ground level there is a pair of windows on the Derby Street elevation which appear to be an alteration which infilled the original larger shop window as indicated by the sill. On the Oxford Street elevation there is evidence of a similar infilling of a larger shop window and which is clearly indicated by the deliberately exposed timber lintol. On this elevation also is a single recessed door, slightly narrowed but with evidence of a staff bead moulding, and a single window which presumably were for the residential area. The staff bead is indicative of a date of 1860-70s. The door recess has a wrought iron security gate which incorporates "Circa 1872, Derby House". All the timber-framed sashes have been replaced with plain glass sashes as has occurred at Nos. 14 and 16 Derby Street. In the splayed corner is an infilled window opening at the upper level which probably was originally a blind window, possibly for advertising, and a door opening below. The fixed flush panel door and the multi-light highlight window above are not original. Vent covers have been inserted in the door panel at the bottom possibly to vent the cellar. The corner is surmounted by a small triangular pediment supported by moulded consoles on each side. No street verandah is indicated on the MMBW plan and there is no physical evidence of one. The main hipped roof is clad in corrugated steel and there is a chimney at the rear visible from Langridge Street. From Langridge Street the rear upper level is visible and contains a pair of single typical Victorian sash window openings, one being slightly altered. The single storey section at the rear is an addition.

40. The building has a high degree of intactness despite alterations to convert it from a shop to a residence. Even so this it is still readily recognizable as having been a shop. The exposed timber lintol is of interest. The timber-framed window sashes, presumed original timber four-panel and/or part-glazed door are lacking but none of these changes diminish the heritage value of this building. There is clear evidence of the dimensions of the shop windows, if not the fenestration details, and the timber-framed sashes are elements which typically have been altered. All of these could be reversed easily.

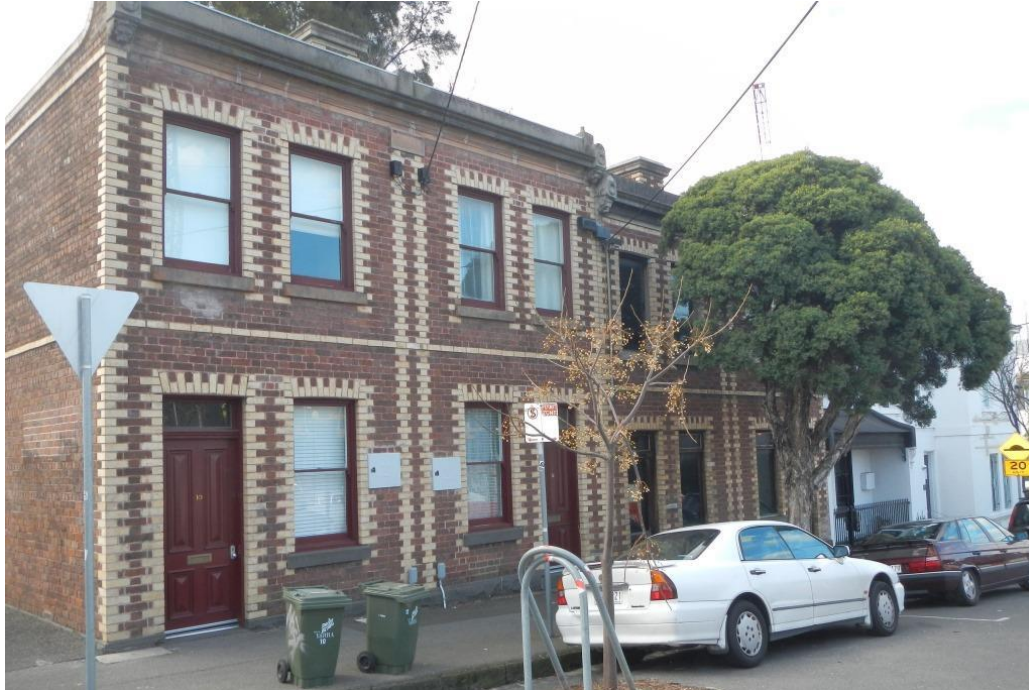
Figure 15 Nos. 10 - 16 Derby Street, Collingwood and Nos. 18 – 22 Derby Street to the right in the background. HO 102. June, 2018.

has a small half-round pediment bearing the date A.D. 1889. On the opposite (south-east) corner No. 62A Cambridge Street has a similarly-shaped brick pediment. Nos. 18, 20 and 22 Derby Street fit in to the precinct comfortably in terms of the pattern and era of development, architectural characteristics and general history of dwellings and local shops. There is also a degree of continuity of this type of development from the south end of Cambridge Street and then continuing west up Derby Street to Smith Street. In relation to Nos. 10 – 22 Derby Street, the comment in the *Collingwood Conservation Study Review May 1995* that Nos. 10 – 16 Derby Street “Forms a visual unit with adjoining Nos 18-20” is well-founded and illustrated below.

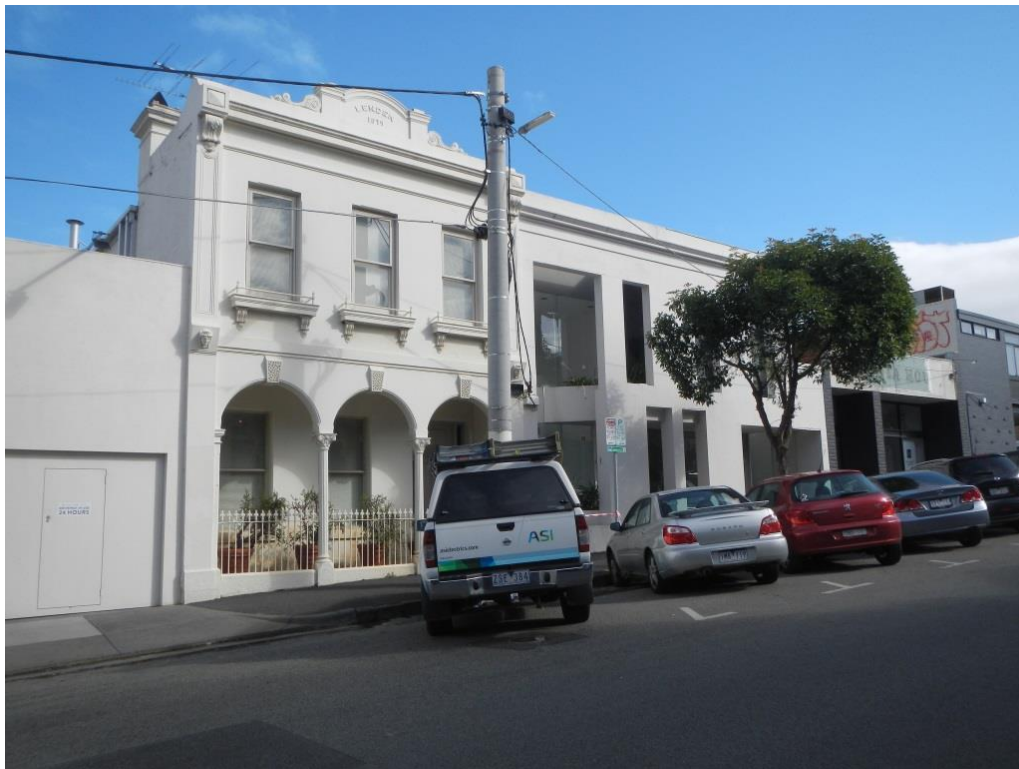
Figure 17 No. 33 Derby Street, Collingwood opposite Nos. 18 – 22 Derby Street. No. 33 Derby Street, is proposed to be included in HO 336, the Victoria Parade Precinct. June, 2018.

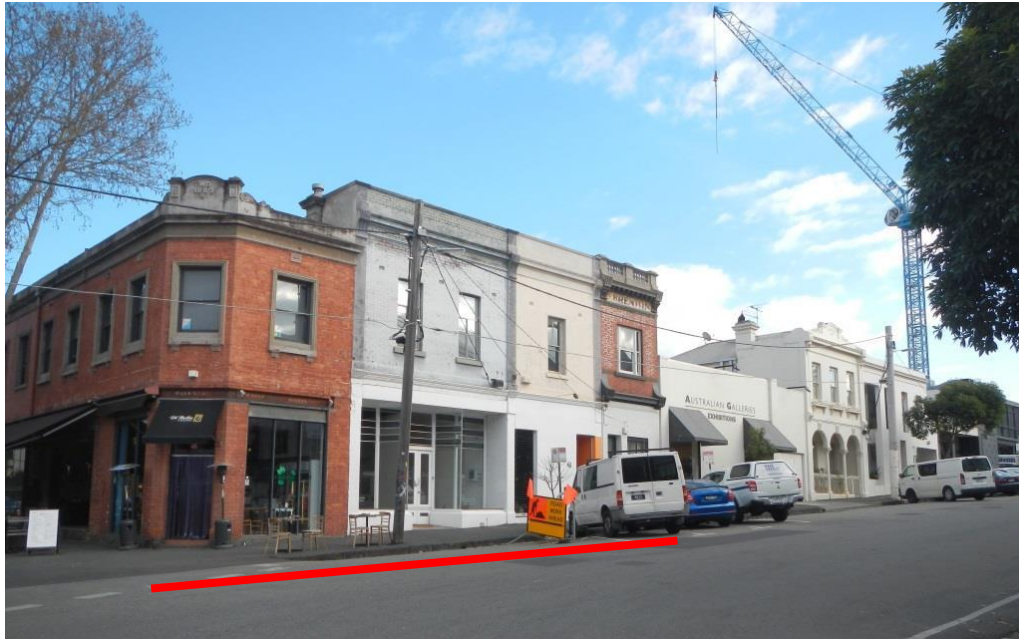
Figure 18 Nos. 45 - 39 Derby Street, Collingwood, east of Nos. 18 - 22 Derby Street. Nos. 45 - 39 Derby Street, are proposed to be included in HO 336, the Victoria Parade Precinct. June, 2018.

45. Historically, architecturally and physically these buildings provide a link between Cambridge and Derby Streets. They demonstrate the pattern of development of Derby Street as containing dwellings and some shops.

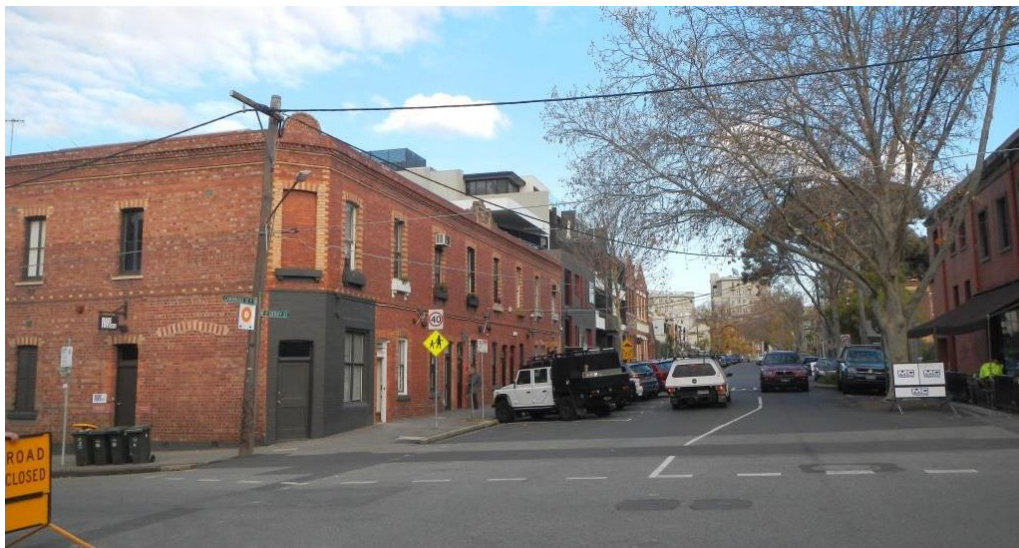
Figure 19 The Derby Street end of Cambridge Street, Collingwood, which are included in HO 336, the Victoria Parade Precinct. June, 2018.

46. In general form these buildings are similar to those in Derby Street. Historically and architecturally they link the buildings in both Cambridge and Derby Streets.

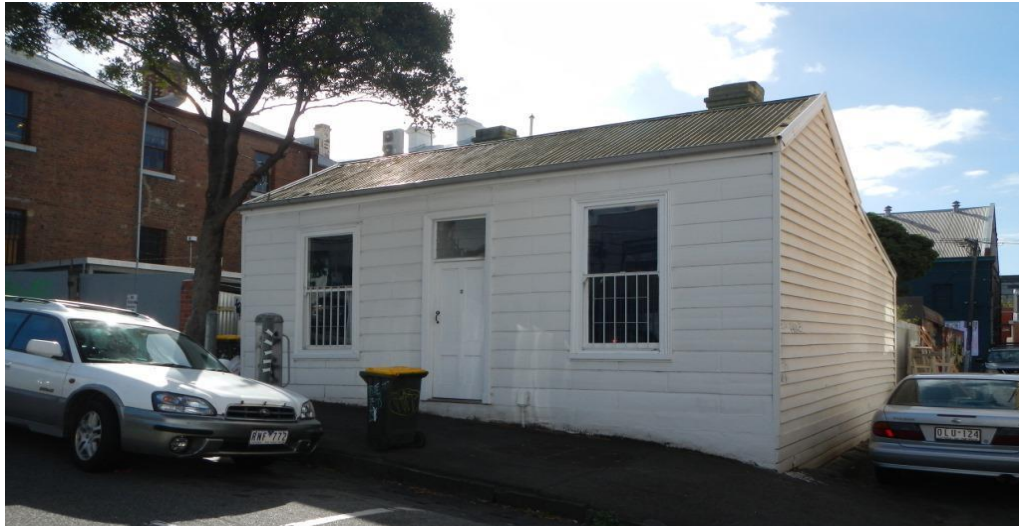
Figure 20 No. 2 Derby Street, Collingwood. HO 99. June, 2018.

47. This timber cottage is the last remaining wood building in Derby Street. It was in poor condition but has been refurbished recently. It appears to have been constructed c.1868, about the same time as Nos. 10 – 22 Derby Street and was occupied for decades by Peter Cooper, a carpenter and later retired as a gentleman. Collectively these buildings demonstrate an important part of the history and appearance of Derby Street at its formative time.

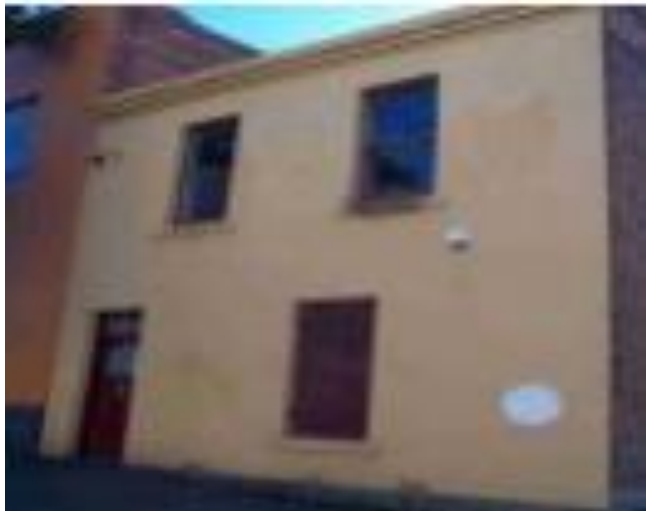
Figure 21 No. 8 Derby Street, Collingwood. HO 101. VHD citation.

48. According to the existing citation in the *Victorian Heritage Database* for the Johnston house at No. 8 Derby Street "John Johnston owned vacant land on this site by 1870 and the following year built this brick house. At least until 1892, he remained owner with tenants occupying the house." The Statement of Significance reads *Viz.*:
