Heidelberg Road Heritage Review (Stage 1) 2019

Stage 1 Report

City of Yarra

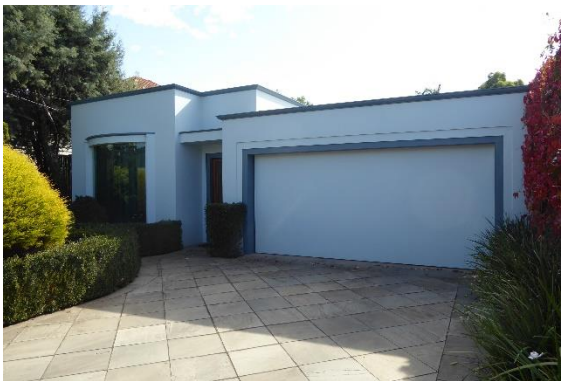
2 Killop Street is a single storey house constructed during the late 20th century and consists of a series of rendered cubic forms with a parapet concealing the roof. The colour palette is relatively plain and with teal accents to the trims

The house at 2 Killop Street is an anomaly at the edge of the Alphington East Precinct largely characterised by Victorian, Edwardian and Interwar houses with pitched, gabled or hipped roofs. Prevailing wall types include weatherboard, face pressed brick and stucco wall cladding. Street facing timber verandahs supported by timber posts are also common.⁴ 2 Killop Street was constructed during a latter period and varies greatly in style, form and materials to the graded building stock in the precinct. The building is not related to the significance of the precinct (HO362) and should be omitted.

2 Killop Street – façade/south elevation, included in HO362

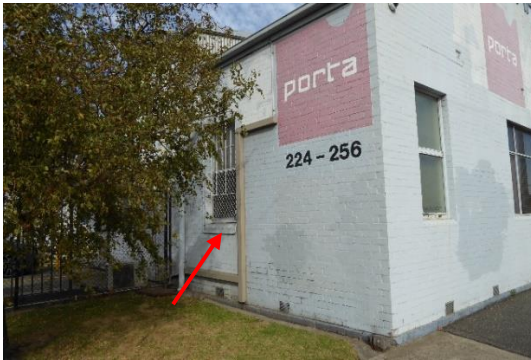
Retain single window, lintel and sill on east elevation

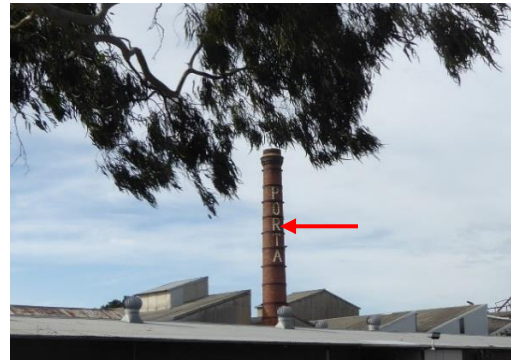
Retain view/sightline of integrated 'PORTA' sign on chimney from the street

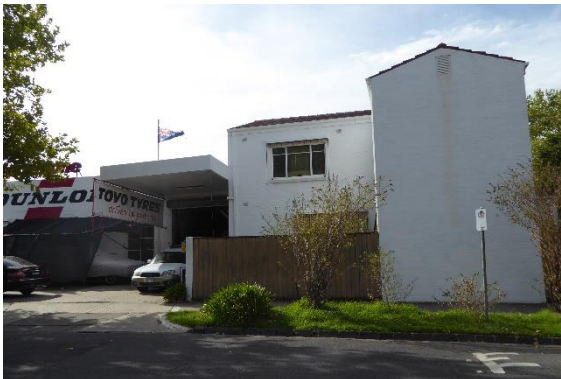
The two storey L-shaped house was built in two stages and consists of the rectangular east half of the building constructed circa late 1950s, and the subsequent west wing and entry porch. The parts are highly intact and integrated. The strong form of the building is most visible from Panther Place from the south and west, where the gable roofs and blank west wall are most evident. Openings and steel-framed windows on the south and west elevations are original elements.

Panther Place (west elevation) – building form and original openings

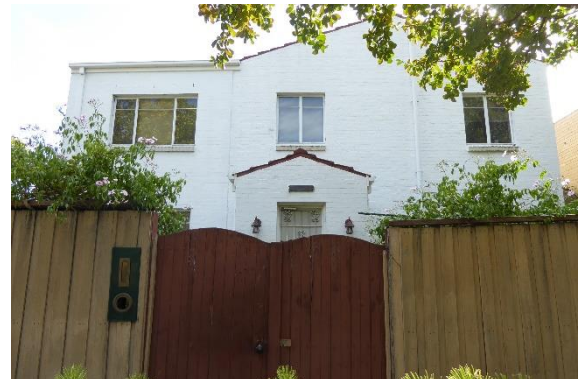
Park Crescent (south elevation) – original openings

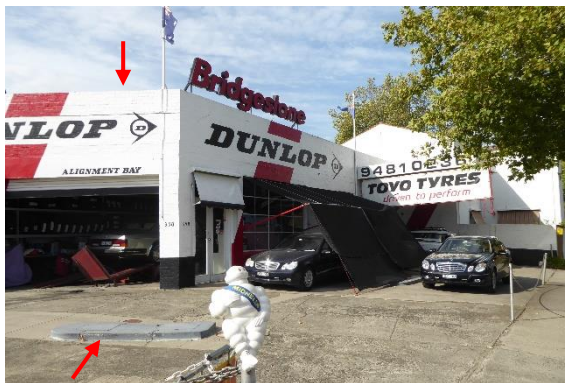
The single storey tyre outlet building is visible from the intersection of Heidelberg Road and Panther Place. The original parapet roof of the tyre outlet and prominent gable roof of the house are visible. On the north-east corner of the tyre outlet building is a chamfered brick corner with original raised street numbers. The upper section of the brick façade features brick courses in a header configuration and a horizontal, shallow recessed panel on the north façade.

Below this is an original garage opening and rendered concrete lintel. On the west façade of the tyre outlet is an original timber door and two large original steel windows. To the front of the site are the location of the petrol bowers is evident.

Heidelberg Road – original parapet roof, openings, doors and windows of tyre outlet. Original bowser pipes to front of site (indicated).

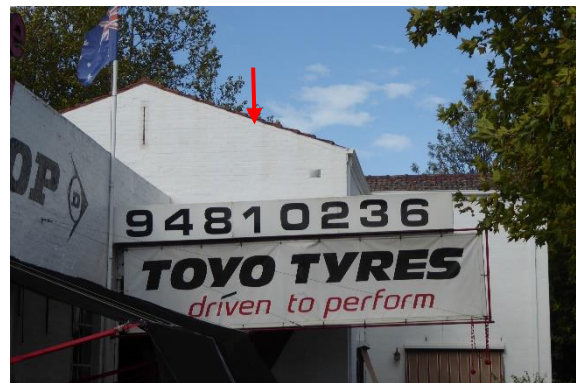
Heidelberg Road – original roof form of house is visible

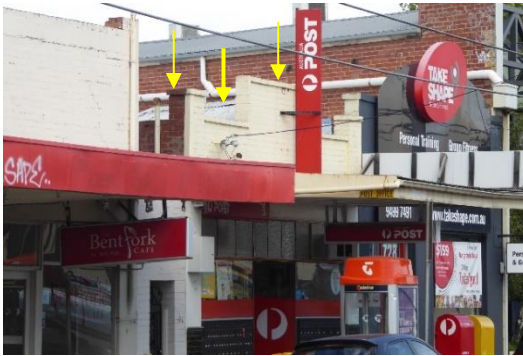
that have also been painted. A narrow walkway between no. 730 and no. 732 enables visibility of the east parapet return of no. 730 and the west parapet return of no. 732. The original red brick walls are also evident.

No. 730 – the original parapet, east return and hipped roof are visible from Heidelberg Road

- Retain brick parapets. Encourage paint removal to expose original red brick,
- Retain walkway/separation to front between no. 730 and no. 732 to maintain visibility of the east parapet return of no. 730 and the west parapet return of no. 732. Allow removal/replacement of the brick wall and door leading to the walkway.
- Retain original canopies.

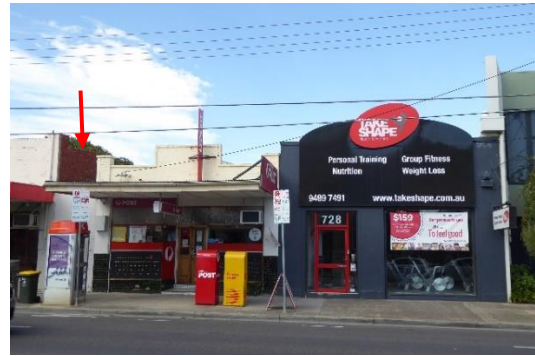
No. 732 – the original parapet and west return are visible from Heidelberg Road

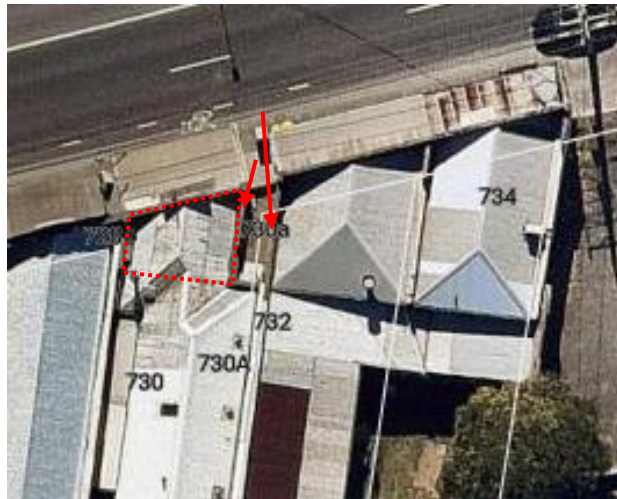
No. 730 – original section of roof visible from Heidelberg Road indicated by the dotted line. Visible parapet returns of nos 730 and 732 indicated by the red arrows (Source: Nearmap)

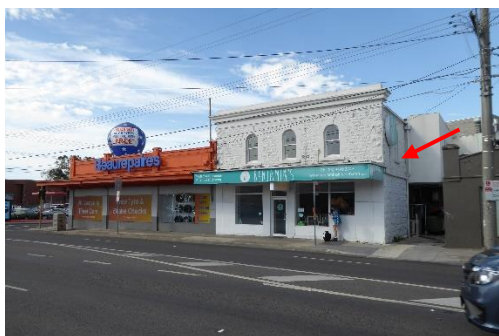
The building is located at the west end of Heidelberg Road and has a prominent street presence. This is partly due to the low scale massing of the adjacent buildings. The street façade, original parapet and hipped roof are widely visible from the street and the west (side) elevation remains exposed.

The entire west (side) elevation of the former Butcher Shop (HO71) remains exposed

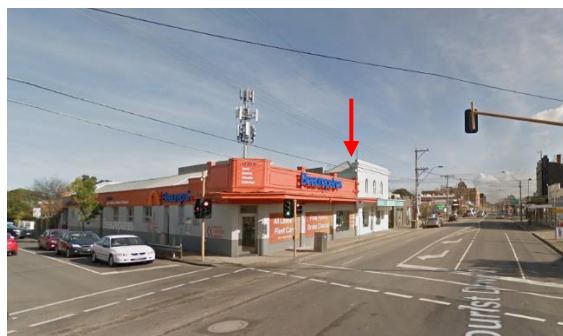
The prominence of the former Butcher Shop (HO71) is evident from the intersection of Heidelberg Road and Yarralea Street
(Source: googlemaps)

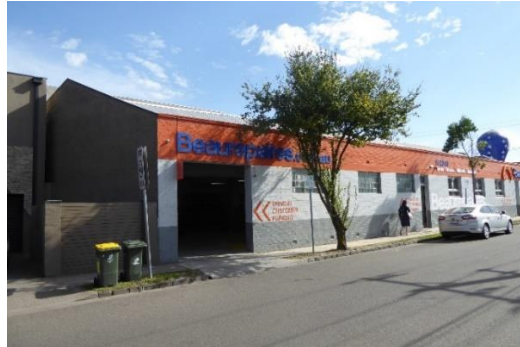
Original roof form and openings along Yarralea Street

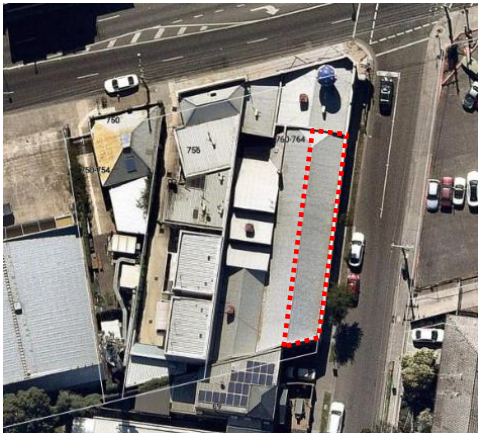
Retain eastern plane of narrow, gable roof
(Source: Nearmap)

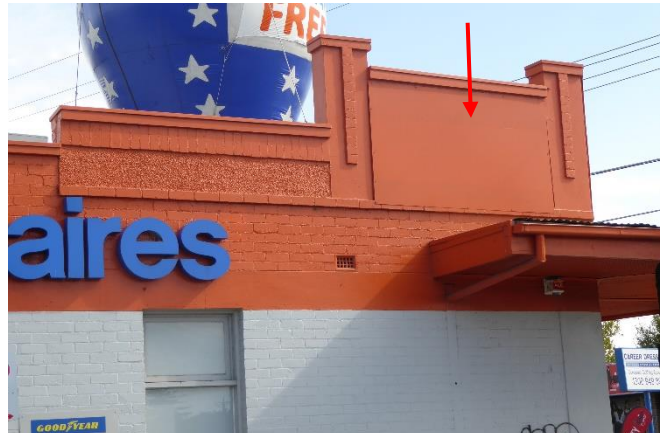
Encourage removal of paint and fixed rendered panels on parapet

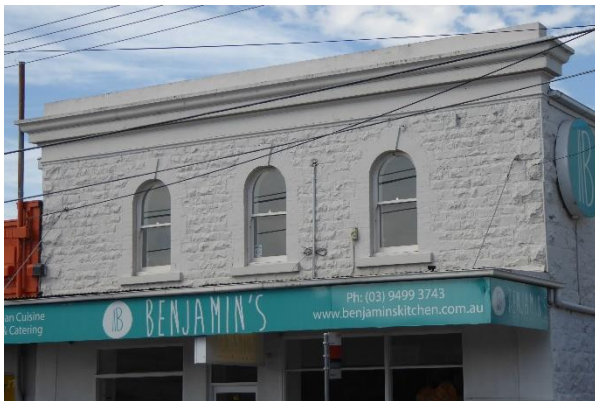
The Regency style refers to the era in the early 19th century when George IV was Prince Regent and is stylistically characterised by a simplified and restrained elegance. Facades were symmetrically composed and typically consisted of a parapet concealing the roof beyond. This is evident in the balanced arrangement of arched openings and prominent moulded cornice. While stucco was the main material, external masonry walls were often finished in face brickwork with refined and subtle brick detailing. This is reflected in the subtle projections of brick quoining to the windows and outer edges of the facade and visual contrast of brick (possibly cream) and basalt.

Symmetrical first floor features three original arched windows

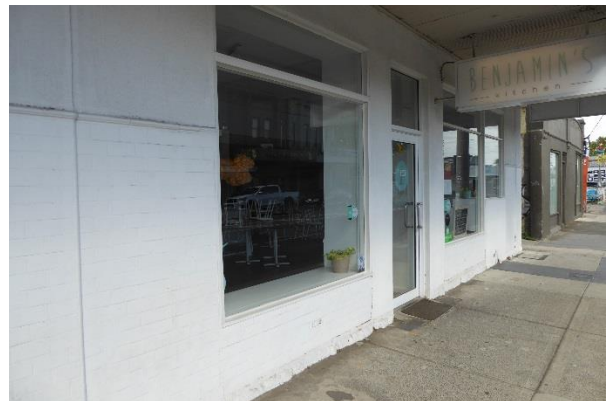
Shop front

The shop front of the subject building has undergone substantial alterations, probably multiple times. The entrance is off centre and there are large timber-framed windows to either side. The lower part of the wall consists of overpainted tiles dating from the early 20th century and the upper section has been rendered. A cantilevered canopy dating from the mid-20th century has replaced the earlier verandah.

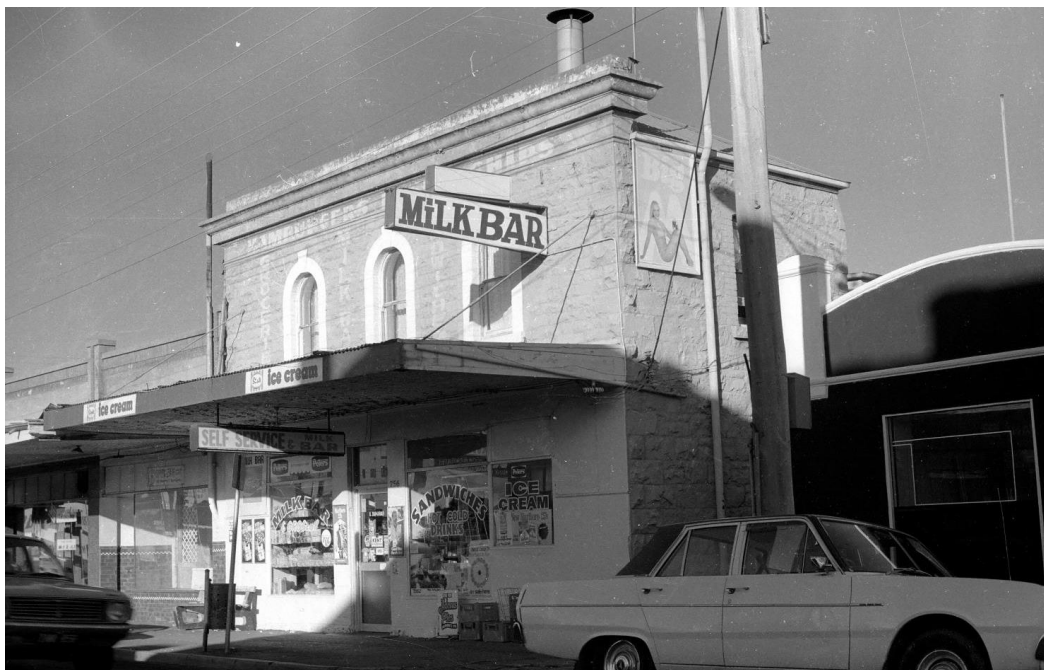
Photograph dated 1982
(Source: Darebin Archives LHRN3652)

By the 1980s, the front verandah had been replaced with a cantilevered canopy and the basalt walls had been painted. Between 2013 and 2016, the rear part of the site behind the basalt building was redeveloped.

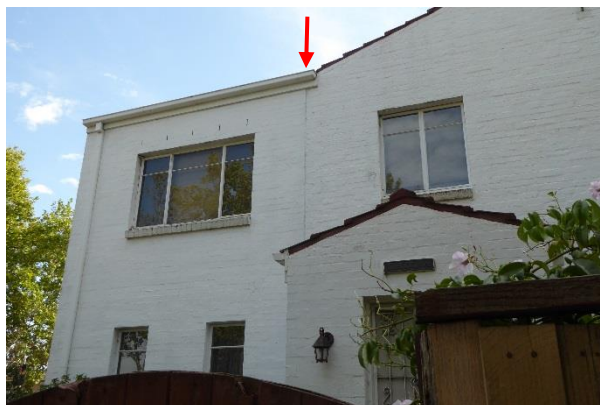
House – Park Crescent (primary) façade
Junction between original (right) and additions (left)

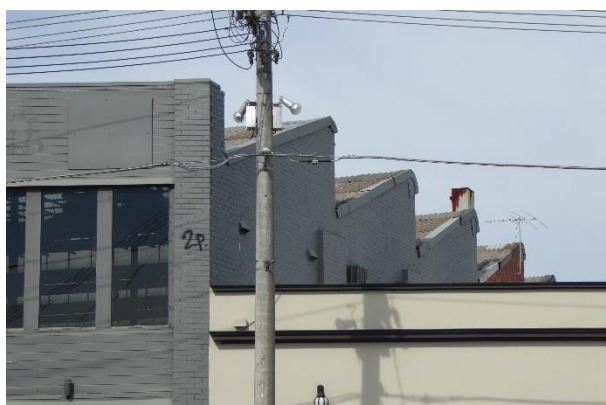
Sawtooth roof forms from Heidelberg Road

- The sawtooth roofs are highly visible and highlight the function of the building, and is unusual in this largely suburban context.
- Condition: poor fair good

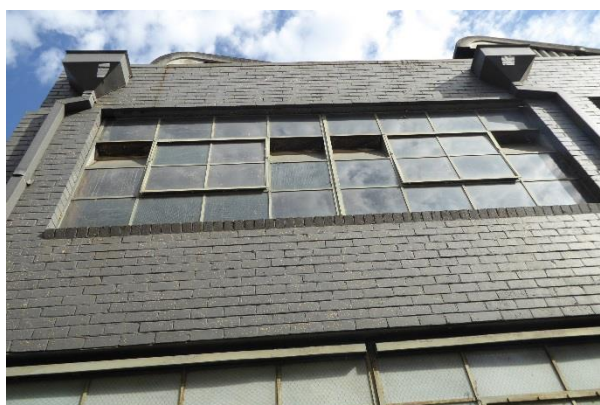
Steel framed windows on the Arthur Street (east) facade

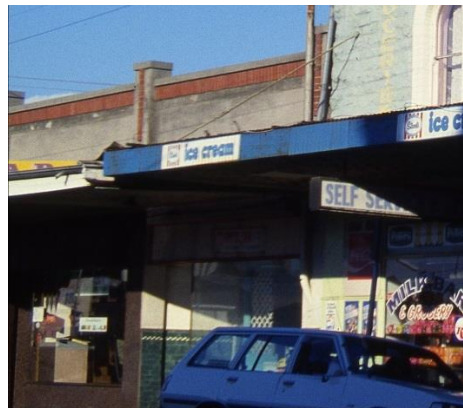
1982 image – showing original parapet detailing
